**TYTHE FARM, MAIN STREET,
HEMINGBROUGH, SELBY, NORTH YORKSHIRE**

WATCHING BRIEF REPORT

REPORT NUMBER 2010/78

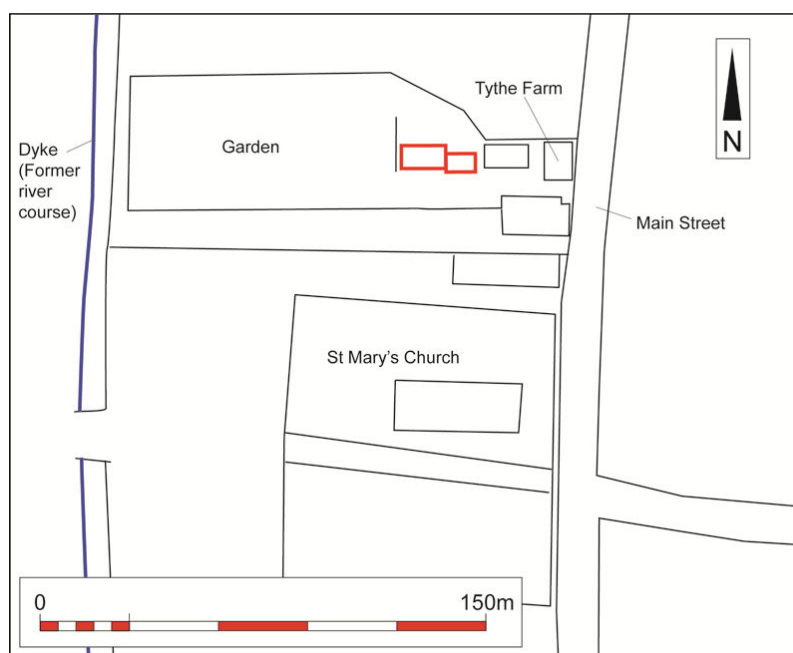
Figure 2 New building outline shown in red within grounds of Tythe Farm

Strip foundation trenches up to 0.70m wide were excavated by machine to a depth of 0.90m BGL, except at the western end, where the footing was excavated to 1.3m BGL to remove the root system of a former hedge, and at the eastern end, where a series of large pits necessitated excavation to a depth of 1.8m BGL (Figure 3). The northernmost trench was dug prior to YAT involvement, where the remains of at least two individuals were disturbed. It was not possible to confidently identify exactly where they had originally lain. The remainder of the footings were excavated under archaeological observation. Machine-excavation ceased on the discovery of bone and confirmation of articulation, and in total eleven inhumation burials were identified. Nine of these lay above the final formation level and were therefore recorded and lifted under licence number 10-0100, issued under the terms of section 25 of the Burial Act 1857. The other two were exposed, recorded and covered over. All of the lifted inhumations and disarticulated human bone fragments were subsequently re-buried on site.

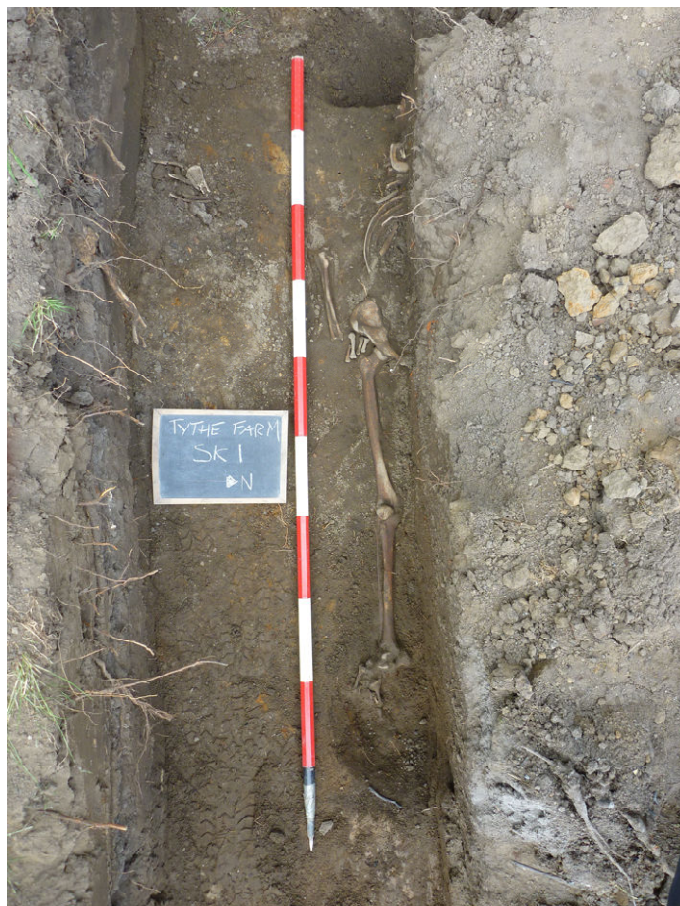
Plate 1 Skeleton 1, context 1010

Adult, supine, aligned east-west, 0.50m BGL, only right side within the trench. Cranium badly crushed, no R humerus or scapula.

Bone present: R radius and ulna, R hand, R pelvis, R ribs, R femur, R patella, R tibia, R fibula, R foot

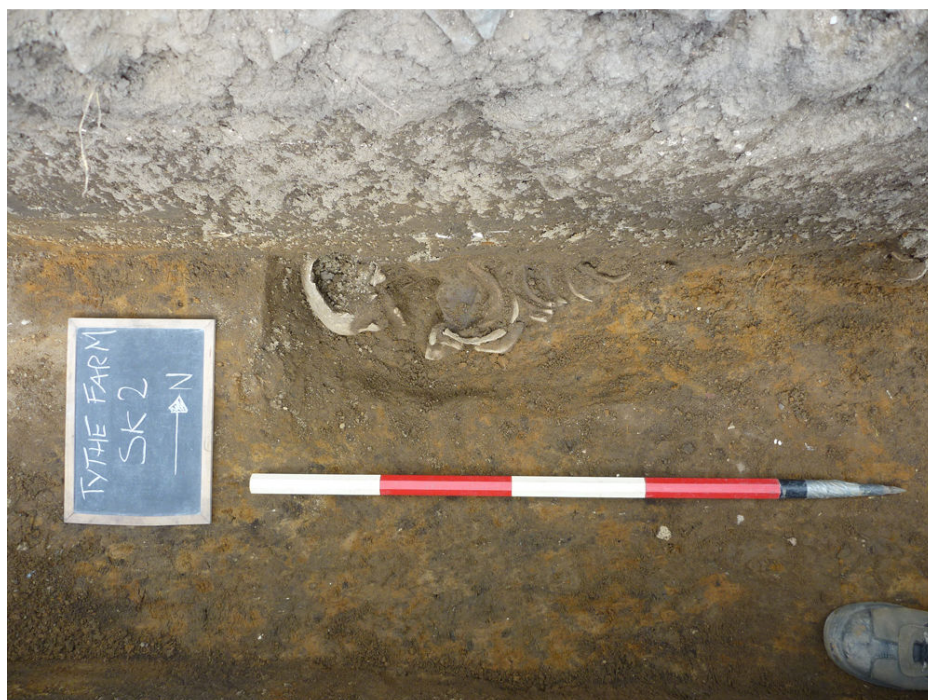
Plate 2 Skeleton 2, context 1013

Adult, supine, aligned east-west, 0.90m BGL, only right side within the trench, R arm, pelvis and R leg disturbed by machine

Bone present: cranium, R scapula, R ribs

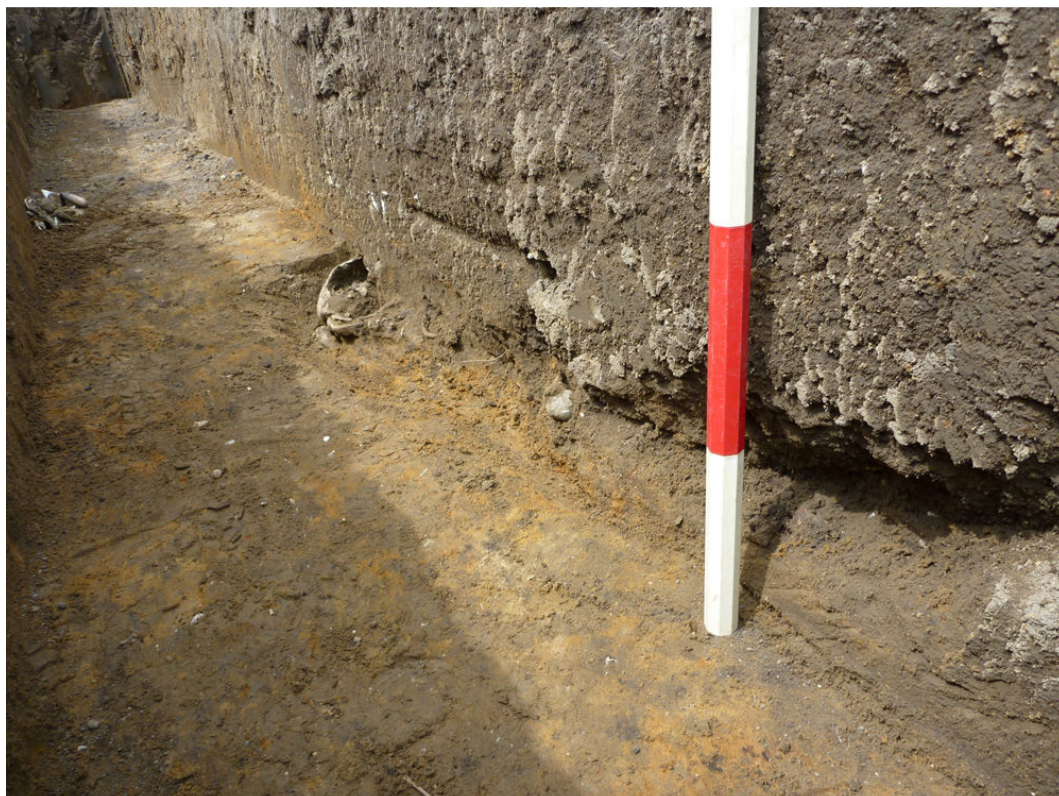
Plate 3 Skeleton 2 with section, looking north-west

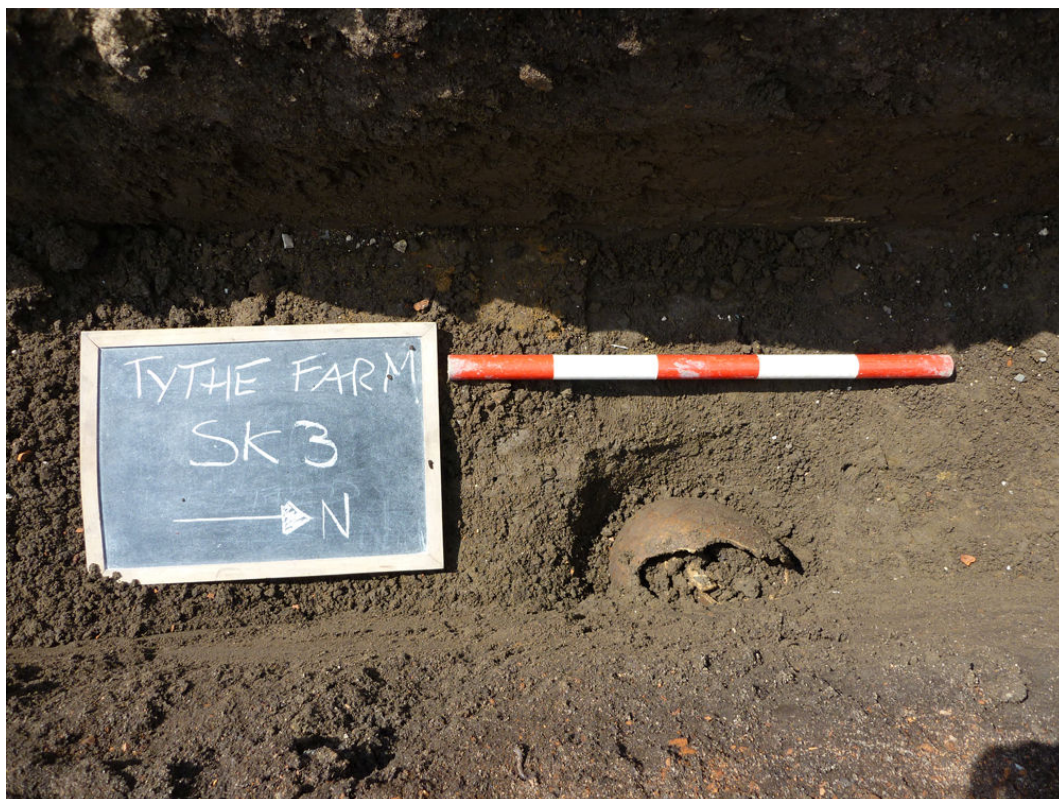
Plate 4 Skeleton 3, context 1016

Adult, supine, aligned east-west, 0.50m BGL, only skull within the trench

Bone present: cranium

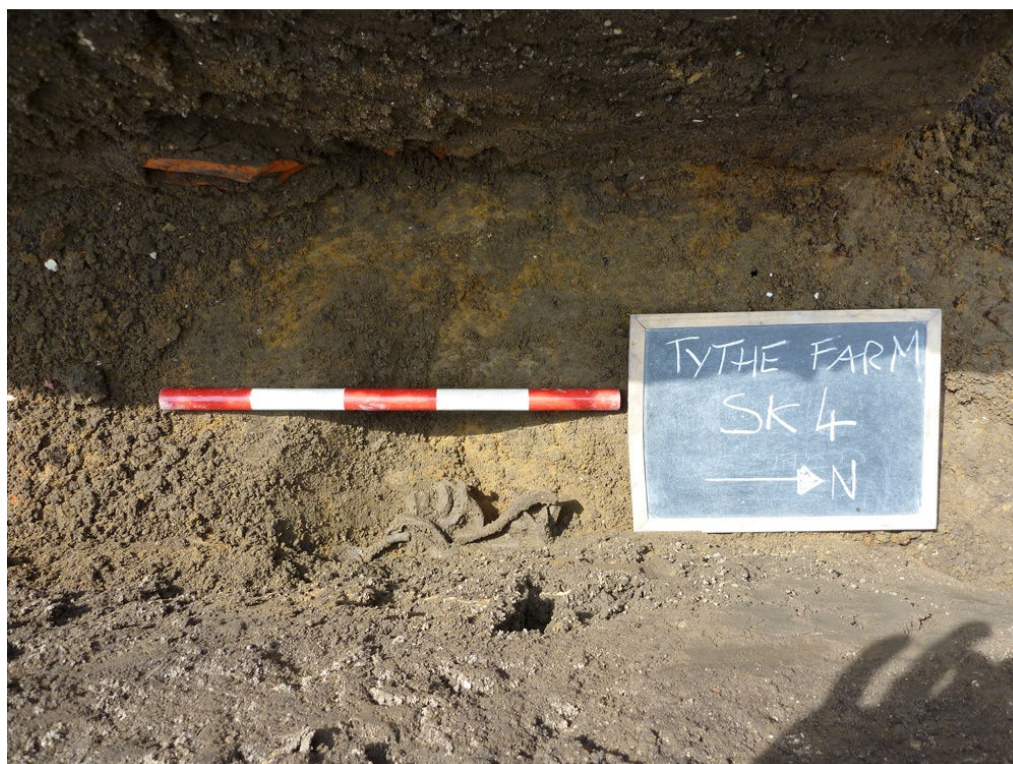
Plate 5 Skeleton 4, context 1019

?Juvenile, supine, aligned east-west, 0.80m BGL, badly truncated by a field drain, upper torso only.

Bone present: fragments of cranium, L clavicle, R humerus, cervical vertebrae, ribs

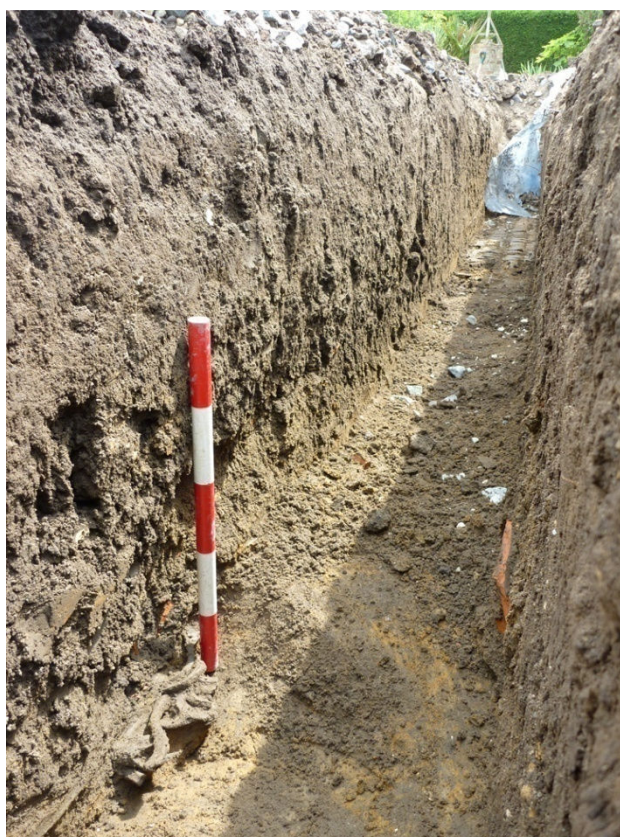
Plate 6 Skeleton 4 with section, looking SSE

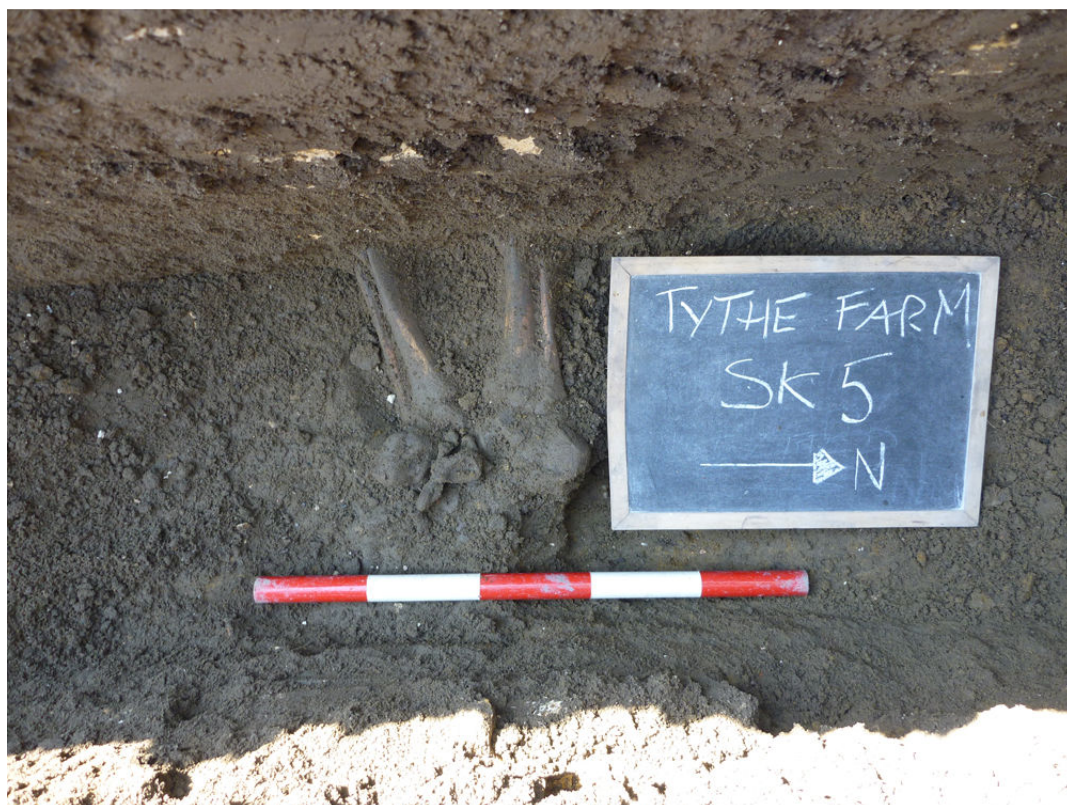
Plate 7 Skeleton 5, context 1022

Adult, supine, aligned east-west, 0.75m BGL, feet and lower legs only.

Bone present: R+L tibia and fibula, feet.

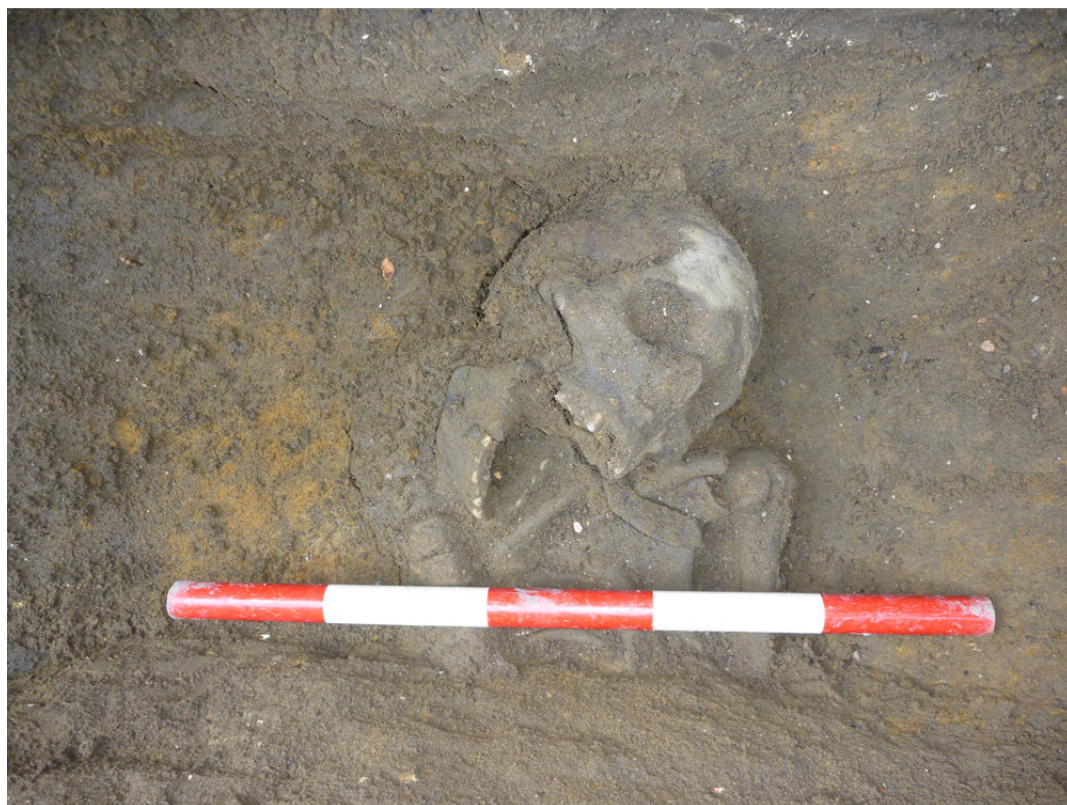
Plate 8 Skeleton 6, context 1025, north to right

Adult, supine, aligned east-west, 0.95m BGL, truncated by grave cut 1023 (for skeleton 5), no R arm

Bone present: cranium, thoracic and cervical vertebrae, ribs, L humerus, L scapula

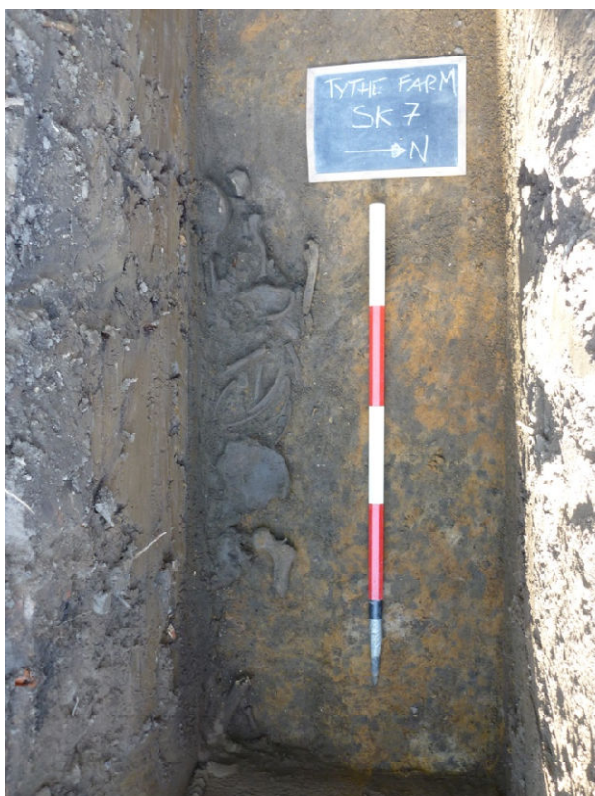
Plate 9 Skeleton 7, context 1028

Adult, supine, aligned east-west, 0.90m BGL, left hand side only within trench, no left hand or radius, NOT LIFTED

Bone present: cranium, L scapula, L humerus, L pelvis, L femur, L tibia, L fibula

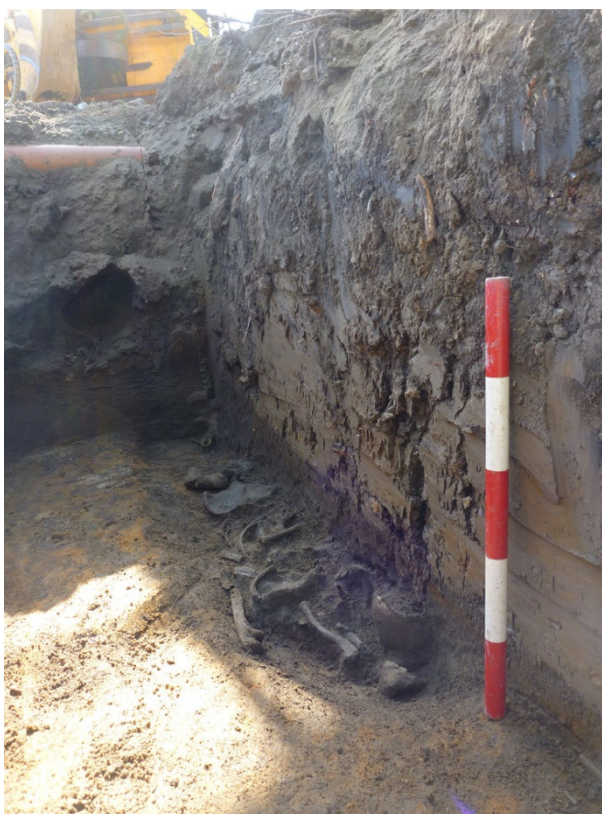
Plate 10 Skeleton 7 with section, looking south-east

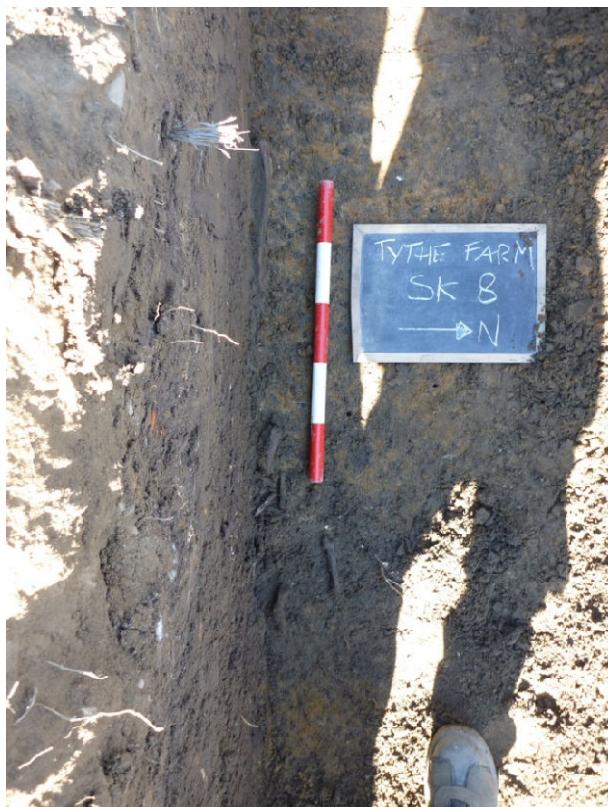
Plate 11 Skeleton 8, context 1031

Adult, supine, aligned east-west, 0.80m BGL, left side and feet only within trench

Bone present: L ulna, L femur, some of L hand, feet

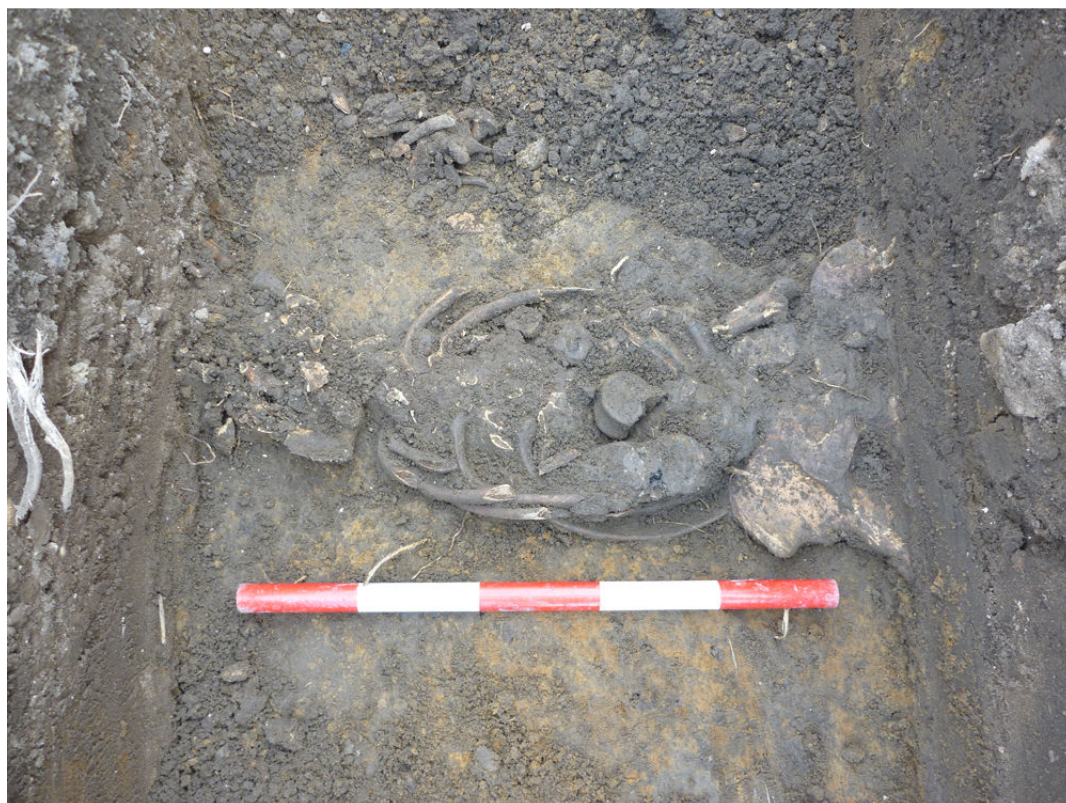
Plate 12 Skeleton 9, context 1034, north to top

?Juvenile, supine, aligned east-west, 0.70m BGL, very truncated, no arms, skull crushed

Bone present: cranium fragments, all vertebrae, both scapulae, ribs, pelvis, both femurs

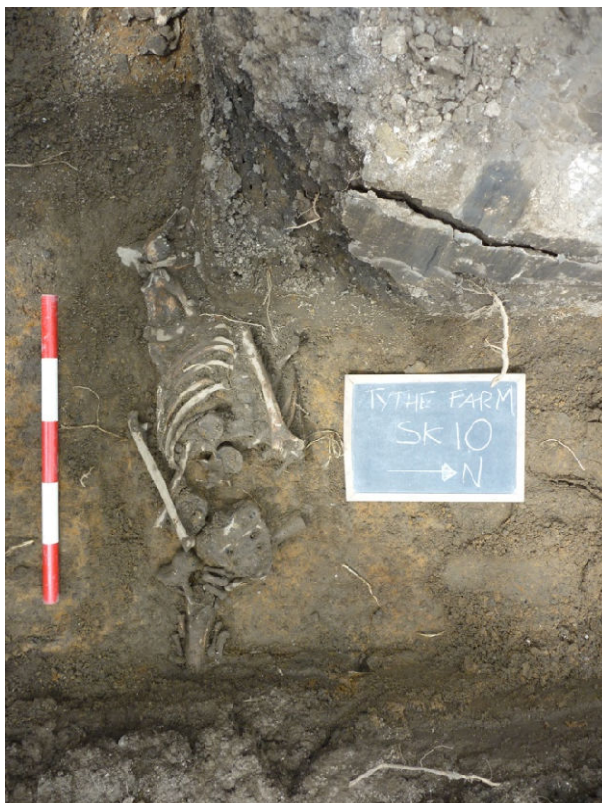
Plate 13 Skeleton 10, context 1037

Adult, supine, aligned east-west, 0.75m BGL, disturbed by machine

Bone present: cranium, mandible, all vertebrae, L humerus, R radius and ulna, both hands, pelvis, R femur

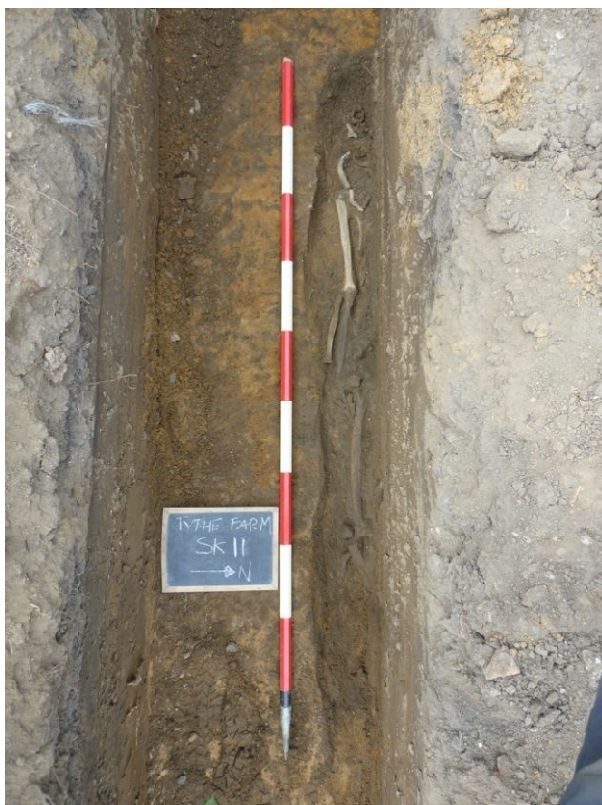
Plate 14 Skeleton 11, context 1040

Adult, supine, aligned east-west, 0.85m BGL, Right side only in trench, no skull – possibly rolled away to the north beyond limit of excavation, no R fibula or foot, mineralised coffin fragments present, NOT LIFTED

Bone present: mandible, R humerus, R radius and ulna, R hand, R ribs, R side of pelvis, R femur, R patella, R tibia

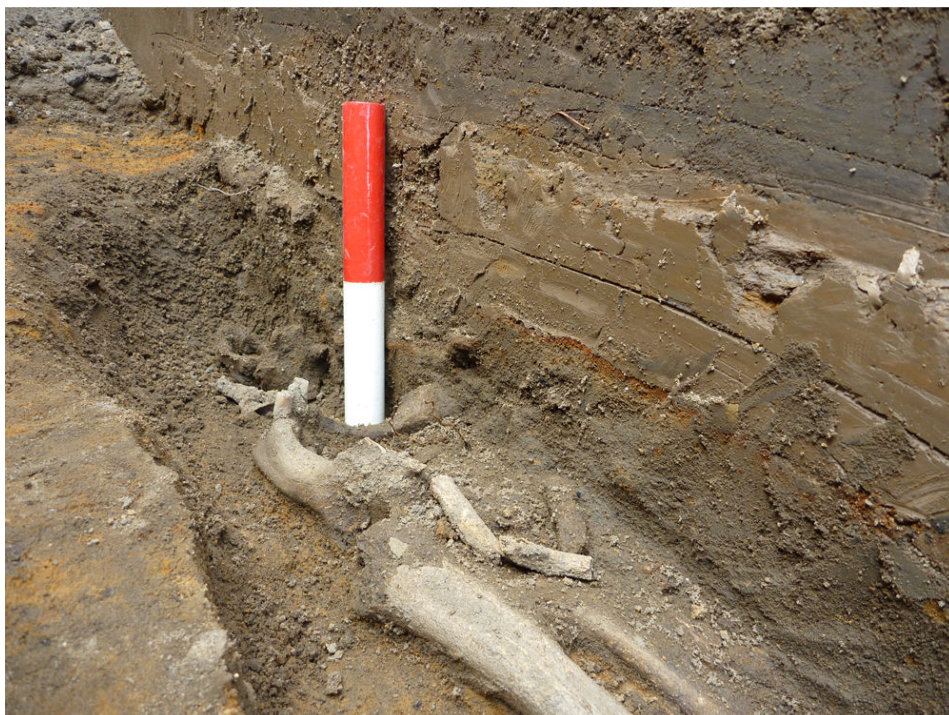
Plate 15 Detail of coffin stain associated with skeleton 11, looking north-west

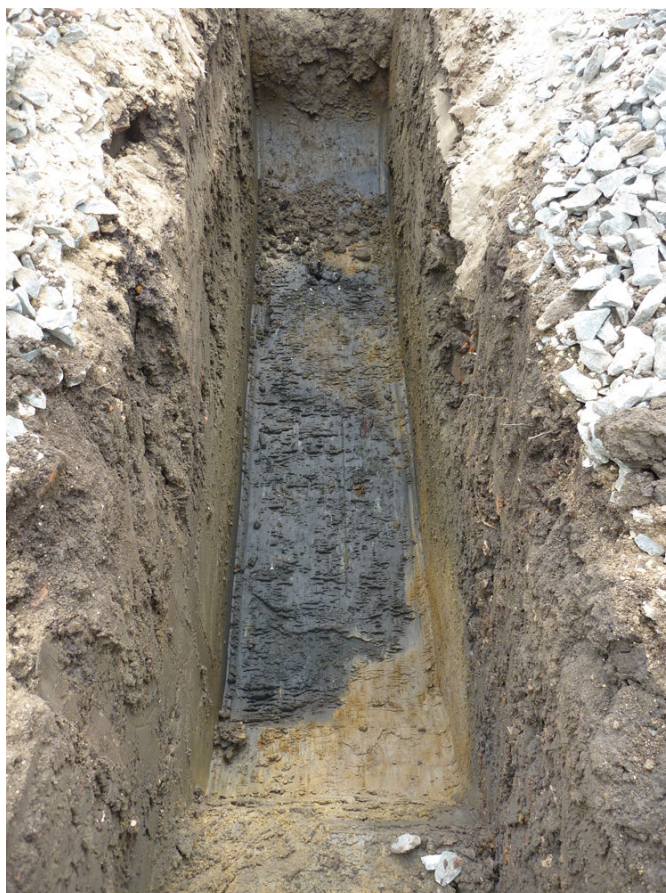
Plate 16 Pit backfill 1004, looking east

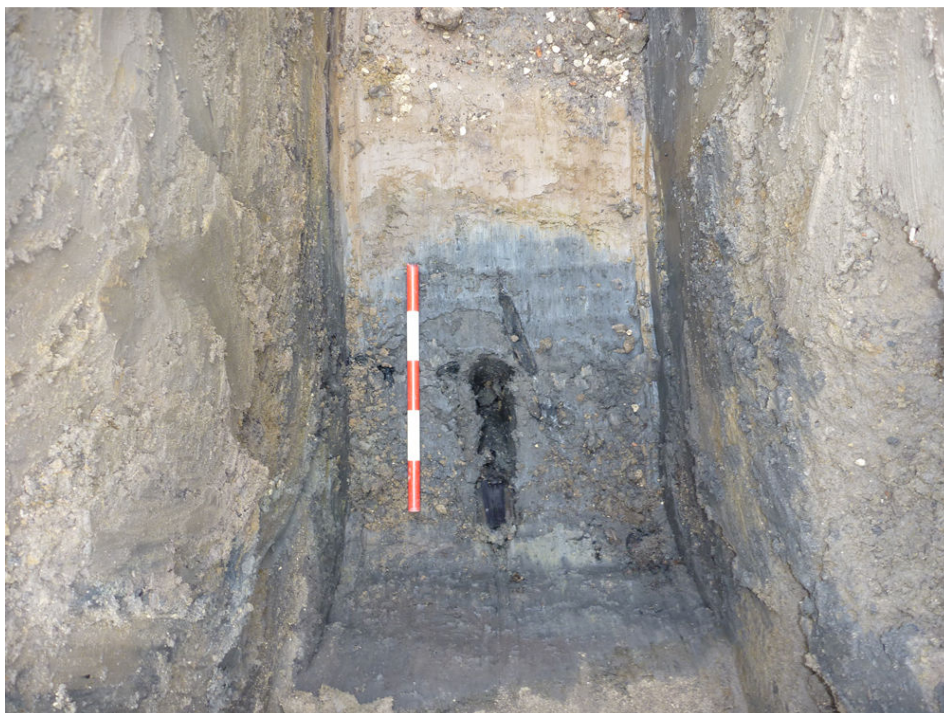
The large pits in the north-eastern corner of the excavation probably represent either agricultural or back-yard activity such as rubbish disposal, which as discussed above may be late medieval in date. The large posthole is probably later than the pits, and may be part of a building pre-dating the current layout of Tythe Farm. On its own, and with no dating evidence, this cannot be taken any further. The presence of organic deposits, however, is of considerable interest as it may imply good organic survival elsewhere in this area.

Plate 17 Posthole backfill 1007 with timber in situ, looking west

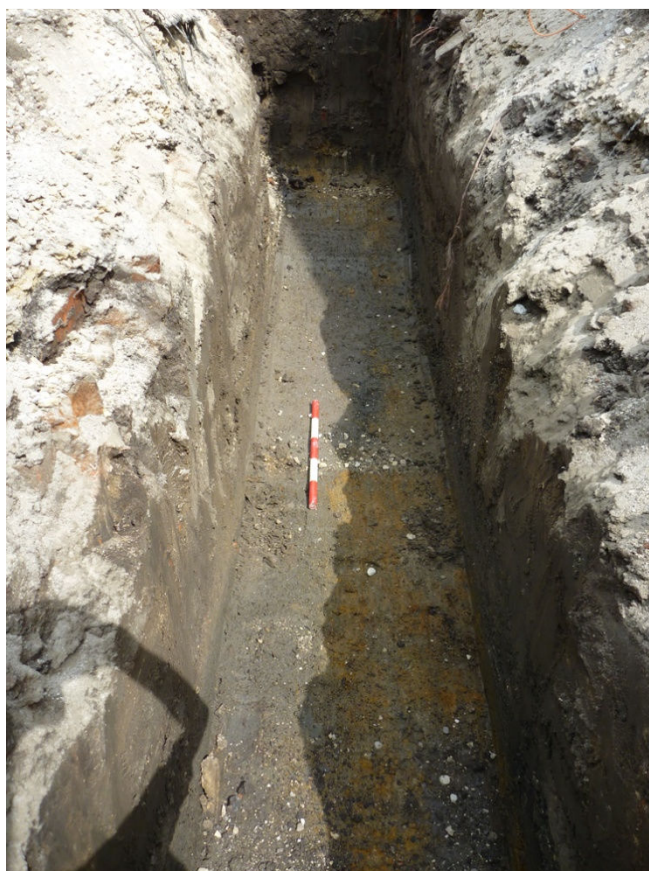
Plate 18 Pit backfill 1043, looking north

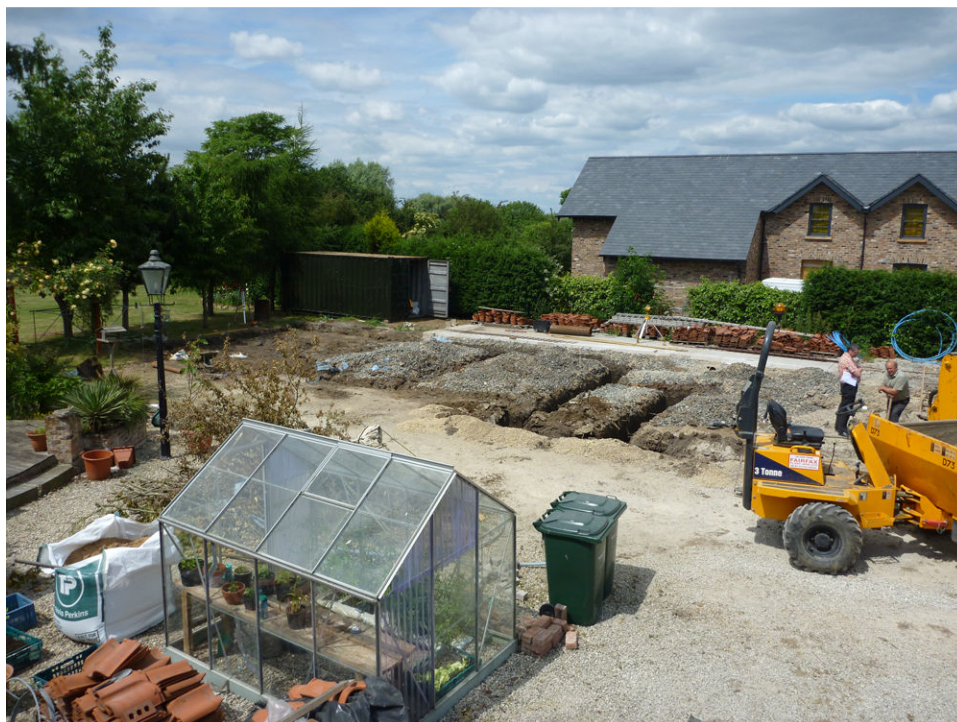
Plate 19 View of foundation trenches, looking north-west
