*A1 Dishforth to Barton Improvement  
Field 61a, Healam Bridge Gas Main Diversion,  
Summary Archaeology Report*

Reference D2B-0-W-30-002-RE09-A

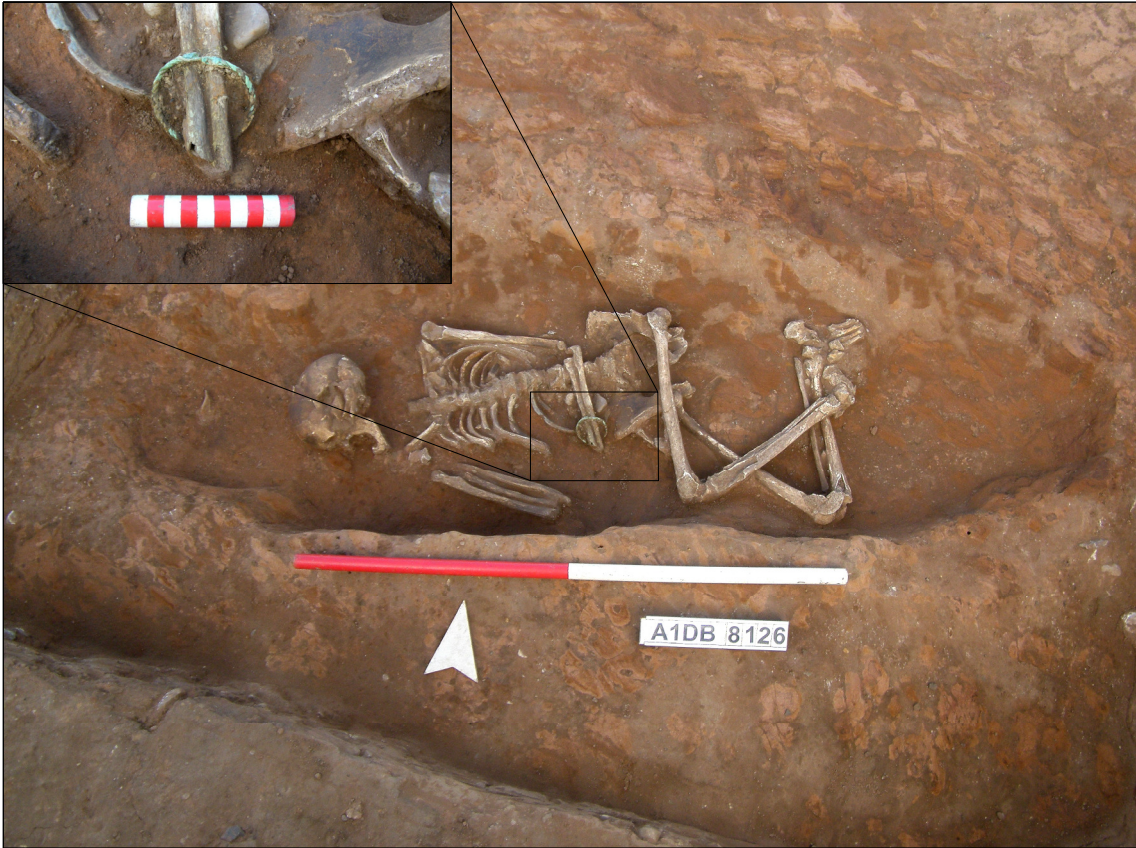
*Plate 1*

*A1D2B: Field 61a Healam Bridge, Burial 8126*

- 3.6 Two further inhumations (8126 and 8247) were identified to the south of ditch (8040). The easternmost burial 8126 (Plate 1) was aligned west to east and was crouched facing south. The right arm was folded back to the shoulder and the left arm lay across the waist. A twisted copper alloy bracelet encircled the left wrist. A group of iron hobnails was recorded around the feet suggesting the individual was interred wearing boots. The remains of an infant (8170), possibly neonatal, were identified within the same grave approximately 0.2m to the west of the adult skull.

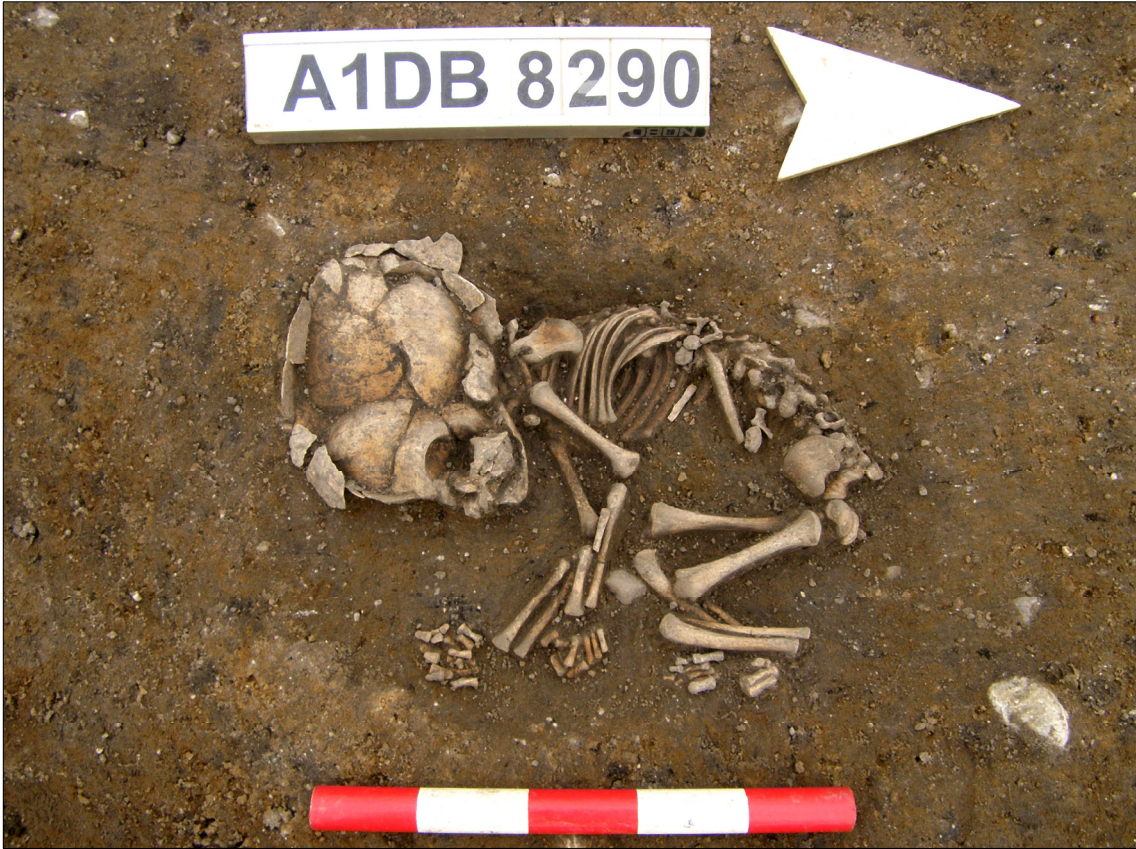
*Plate 3*

*A1D2B: Field 61a Healam Bridge: Burial 8290*

- 3.27 Neonate skeleton 8290 (Plate 3) was buried in a shallow cut aligned from south to north. The remains survived in excellent condition and were laid in the foetal position on the right side. Neonate burials 8286, 8287 and 8507 were all aligned from north to south and the grave cuts for all three burials were barely perceptible due to dry ground conditions. The remains of neonate burial (8286) had been interred in the foetal position lying on its left side and a large iron nail was recovered from the fill of this cut. Only a few bones of neonate skeleton 8507 remained *in situ* but it appeared to be supine. Neonate burial 8287 was also recovered in a poor condition, but could be seen to be lying in the foetal position on its left side.

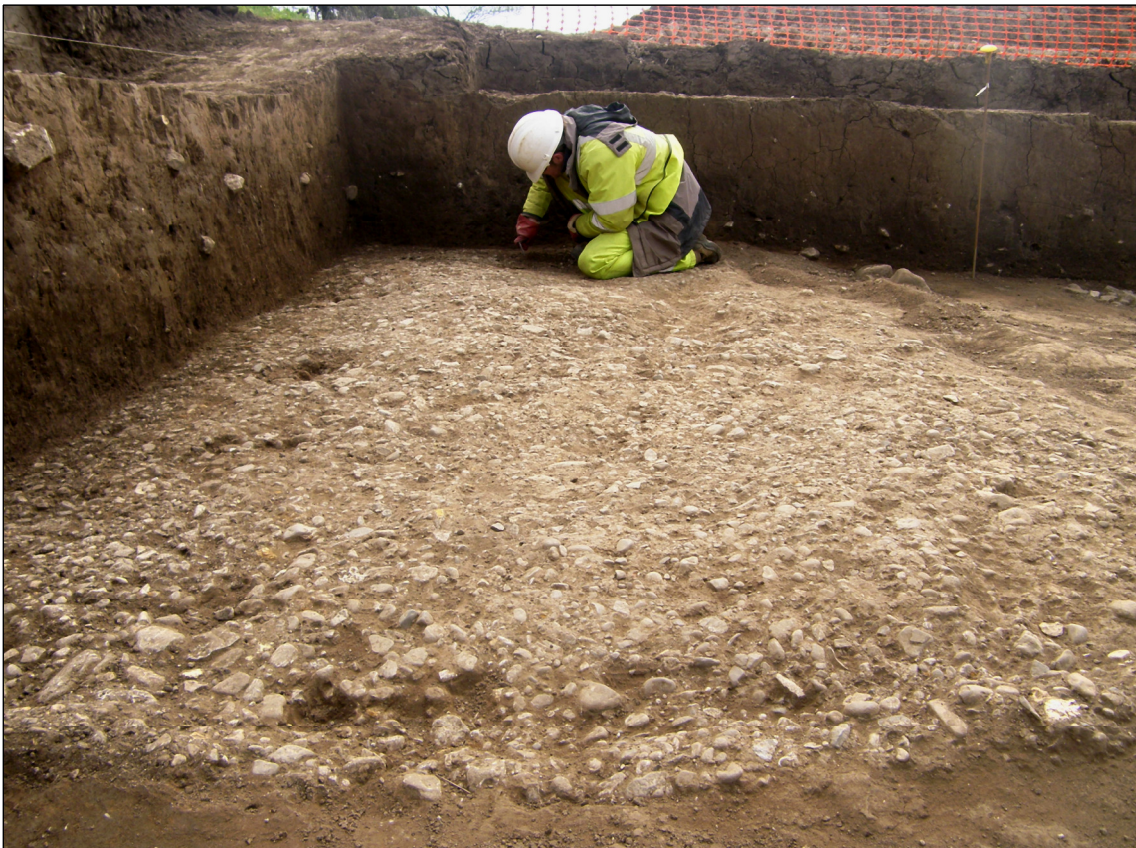
*Plate 4*

*A1D2B: Field 61a, Healam Bridge: Metalled Surface 8021*

- 3.30 Ditch 8019 appeared to enclose an area to the south-east which contained the remains of a building (8538). A foundation layer of sand (8227) was overlain by a potential floor surface (8322) comprising a thin layer of clay. A compact metalled surface (8021: Plate 4) overlay 8322 which measured 3.63m in length by 2.17m in width and had a maximum depth of 0.05m. The jaw of a horse (8213) was laid between the two floor surfaces and 0.13m to the east of it

the teeth of the horse had been placed separately. Two large postholes (8427 and 8435) were also associated with this building. Posthole 8435 was located directly beneath the north-western corner of metalled surface 8021 and posthole 8427 was situated 1.40m to the east beneath the northern edge of the metalled floor surface. Both postholes were filled with large packing stones and would have held posts of a substantial size. The remains of a later wall (8317), oriented from north to south, was identified to the west of floor surface 8021. It measured 2.60m in length by approximately 0.50m in width and comprised one course of stones bonded with mortar. A spread of stones lay to the immediate west of this wall, which possibly represented the collapsed make-up of the wall. A further wall (8047) was identified immediately to the north of floor surface 8021, which ran from east to west for a distance of 1.65m to the edge of the investigation area. It measured 0.54m in width and was bonded with clay rather than mortar.
