Archaeological Observation  
Investigation and Recording  
at  
85 Church Hill  
Sherburn in Elmet  
North Yorkshire

Site Code: WB2010.049  
National Grid Reference: SE 4872 3338  
Planning Reference: 8/58/813E/PA 2008/0134/FUL  
SMR Reference: 8058 C6810 ST

Watching Brief Report Number: 1219  
November 2010

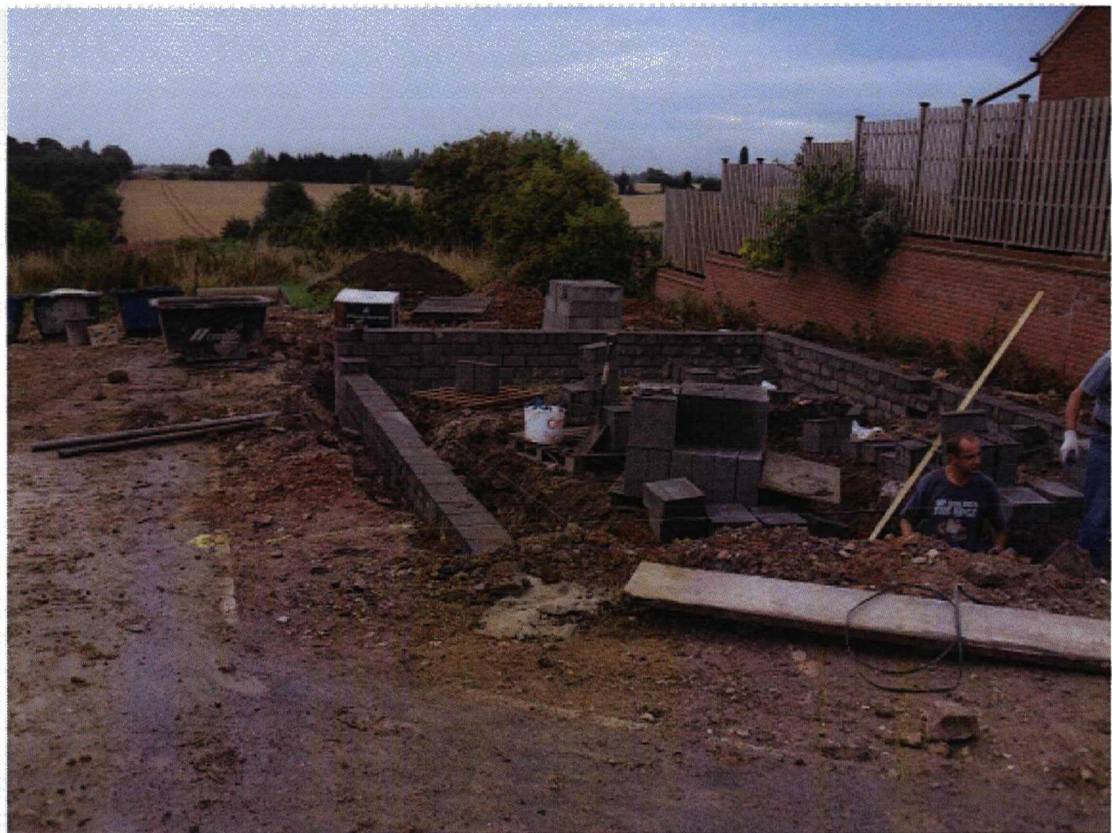
Plate 2 Plot 12, viewed from the north.

Plots 12 had its house footings dug out with the base concrete poured and breeze blocks laid to almost Damp Proof Course level prior to the initial visit to the site. Plot 12 had most of the foundations laid, so it was difficult to see if there were any features running through. However, the following deposits were exposed: a red and brown sandy clay layer (202) was viewed up to a thickness of 0.95m, which overlay natural limestone (203), and below the remnants of the topsoil and modern demolition debris (201) (Figure 2, Plate 2). The overall dimensions for the foundations here were 9.50m north/south, 6.00m west/east and the depth above the basal layer of concrete was 1.30m.

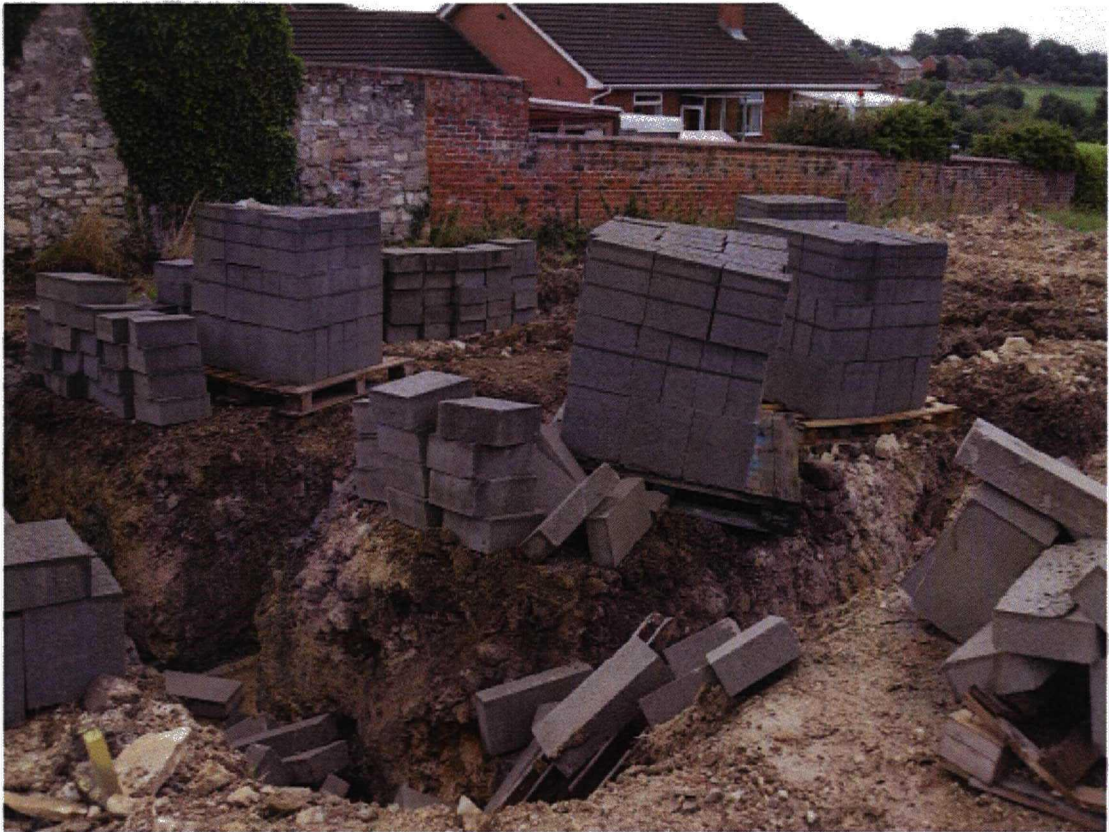
Plate 3 Plot 13, viewed from the northwest.

In Plot 13 however, the sections were still visible, and it was noticed the limestone natural (108), was over 0.80m deep, overlaid by red and brown clay (107) to a depth of 0.15m, with modern hardcore surfacing (106) overlaying this up to 0.08m deep.

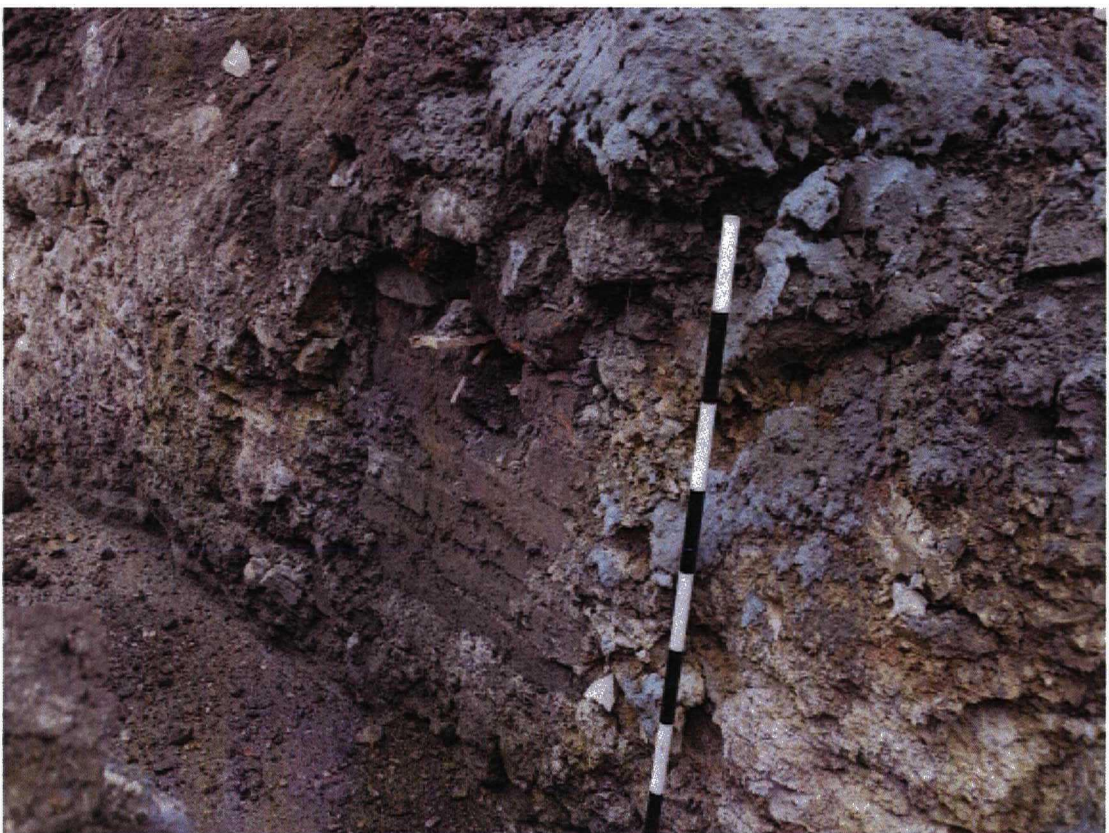
Plate 4 Section 1, showing brick lined ceramic drain/culvert (102/103) viewed from the northeast. 1.00m scale.

The construction cut (105) for a brick culvert (102), truncated these layers, backfilled with brown clay silt (104). The bricks used in its construction were 230mm x 70mm (viewed in two dimensions only) and a brown glazed ceramic pipe ran through it, on an east/west alignment. This was only seen in one section (Figure 3-S.1, Plates 3-4). There were two other service pipes on a north-south alignment, (109), which had a diameter of approximately 0.10m and may have connected to the brick culvert, whereas (110) was seen through three profiles of the foundation trenches. Sealing all of this was hardcore layer (106) in turn by the topsoil (101) up to 0.35m thick. The overall dimensions for the foundations here were 9.50m north/south, 6/00m west/east and the depth above the basal layer of concrete was 1.30m.

The brick lined ceramic drain/culvert (102/103) probably relates to previous infrastructure associated with Manor Farm. The rediscovery of the cellar for the recently demolished Manor farm is also of interest as it demonstrated the high quality of construction of the former farmhouse. The Yorkstone slab flooring was present throughout and very well cut, integral limestone slab steps leading down with the interior walls having the remains of a light blue grey plaster. The majority of the cellar was removed during the excavation of the footings, leaving the northern, frontage wall which project to the north, and thus just outside, the northern extent of the new dwellings.

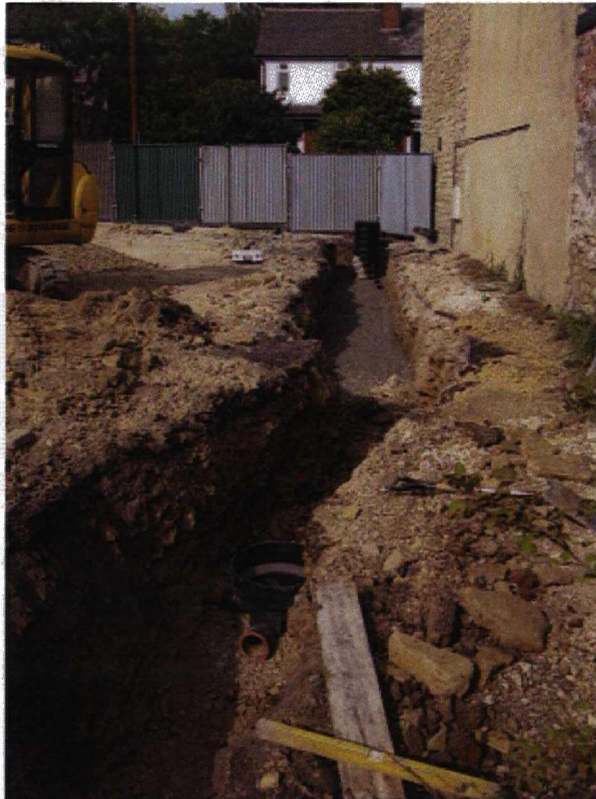
Plate 5 The foul drainage trench connection, part-way through excavation. Viewed from the south.

The large main waste service drain cut was made running roughly north/south from the northeastern corner of the development to the existing soakaway which runs beneath the completed access road. The overall width of the cut was 1.00m and ranged in depth between 1.60m at the frontage rising to 1.00m at the south due to the lie of the land heading down the hill away from the street. The observed length was 22.50m. The basal layer throughout was (304) natural limestone greater than 1.70m thick and continued below the level of excavation. Overlying this was (303) 0.05m thick layer of water or chemically altered (i.e. diesel) limestone, probably occurring as a result of gradual percolation. Above this lay (302) a Tarmacadam hardcore supporting layer consisting of a mixture of small stone and crushed brick material up to 0.22m thick in turn sealed by the current surface layer (301), the remains of black Tarmacadam up to 0.05m thick. This upper surface deposit appeared to cover the upper quarter of the development site (Figure 2, Plate 5).

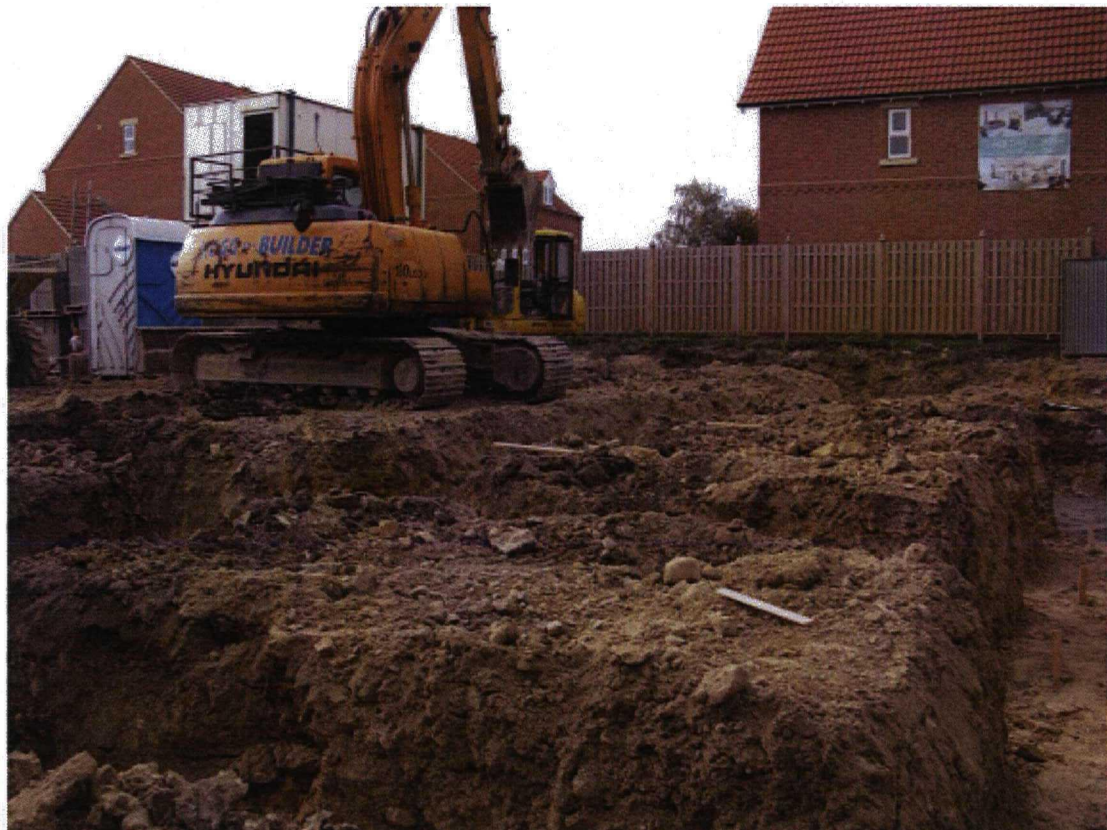
Plate 6 Plots 14 through 17 overall, looking southwest.

Plots 14 through 17 extend along the northern frontage of the development site. This part of the site was the site of the former farmhouse which was demolished several prior to the current period of archaeological monitoring. At that time, the whole of the former foundations for the farm house appeared to have been taken out and no real evidence of its former footing was apparent throughout this area. The strip foundation trenches for this had an average width of 0.80m and covered an area measuring 23.00m northeast/southwest and 9.50m northwest/southeast. The basal layer throughout was (402) natural limestone (Figure 2, Plate 6).

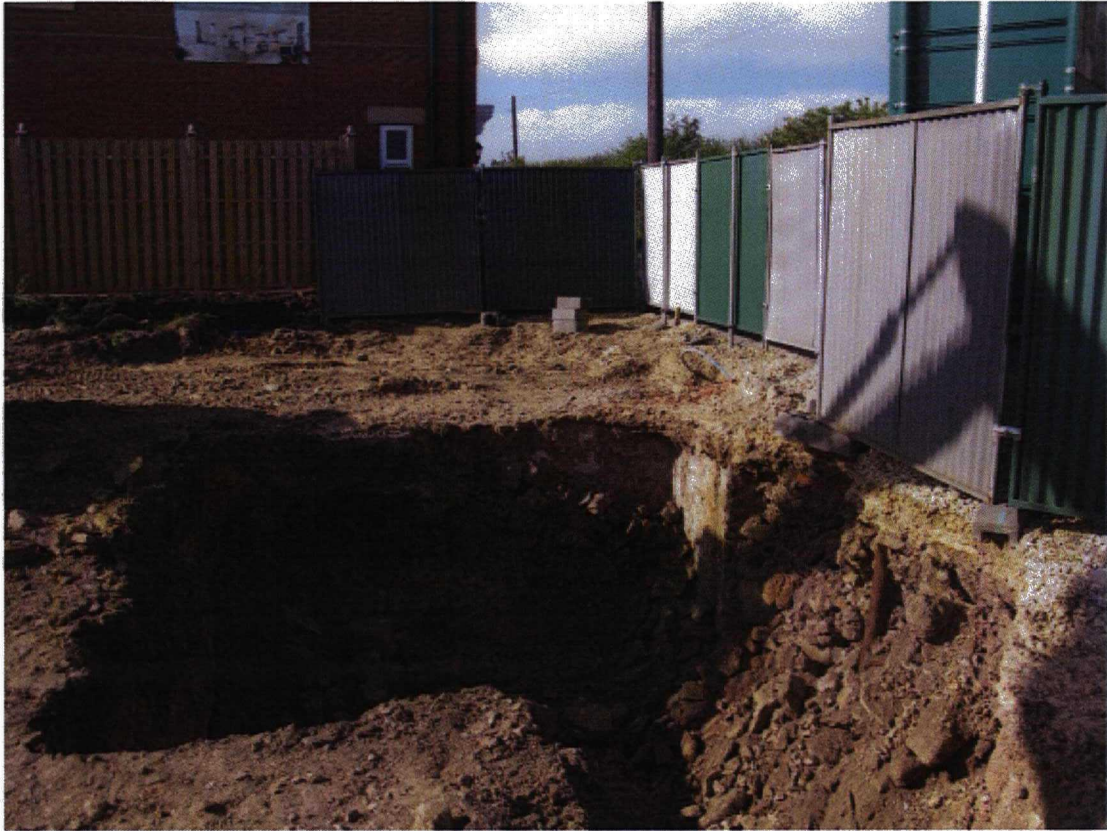
Plate 7 Former farm cellar (403), looking west.

Cut into this in the northwestern quadrant of the whole of the plots was the buried cellar for the farmhouse (403). The cut (404) measured 6.80m northeast/southwest and a minimum of 4.50m northwest/southeast; the cellar continued to the north outside the area of excavation for the new dwellings (Figures 2, 3-S.2, Plates 7-9). Following the removal of the modern farm demolition related backfill (407), it was noted that the construction of the cellar wall was of faced and squared small, limestone blocks each having average dimensions of 200mm x 220mm x 200mm and were bonded with a lime-based mortar. The internal face of the cellar wall displayed the remains of a light grey blue plaster which appeared quite roughly applied. The wall was one course thick and 12 courses high (2.40m). Set centrally on the northern section face of the cellar was the decaying remains of a vertical wooden post (406) 100mm x 100mm and at least 15000mm in length (the base of the post was covered by demolition debris). It appeared to be supporting a broken York stone slab, likely part of the original ground floor level. As the demolition layer was being removed, the original York stone slab floor was revealed. The floor slabs had varying dimensions in plan, each were approximately 30 to 40mm thick and covered the same area as the

cellar. They were laid directly upon a yellow pea gravelly bed, which appeared more like crushed natural limestone rather than anything else. The back fill of the construction cut, lying between wall 403 and cut 404 consisted of unworked and partially worked fragments of limestone (405), likely rubble originating from the construction of the farm house.

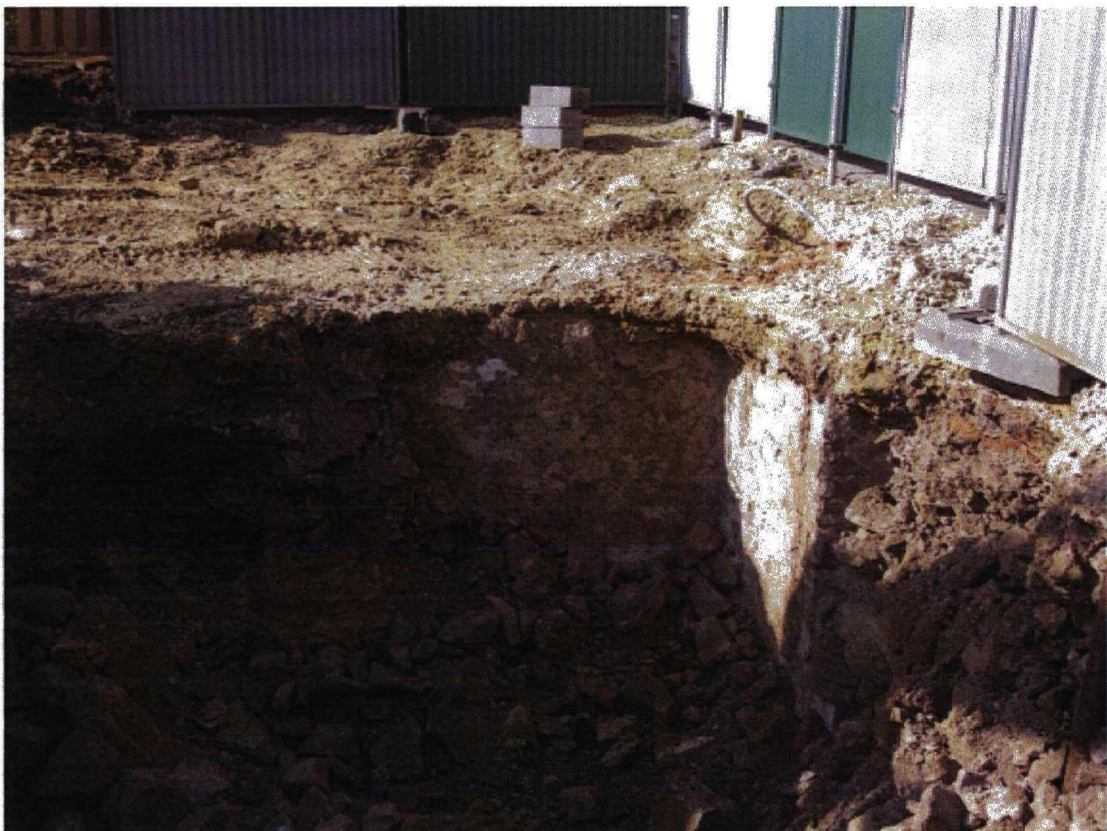
Plate 8 Showing detail of stone slab steps leading down into the cellar (403), looking west.

What was of interest also was that the steps leading down from the original ground level to the cellar were also still present, consisting of limestone slabs, each having average dimensions of 600mm x 200mm x 25mm.

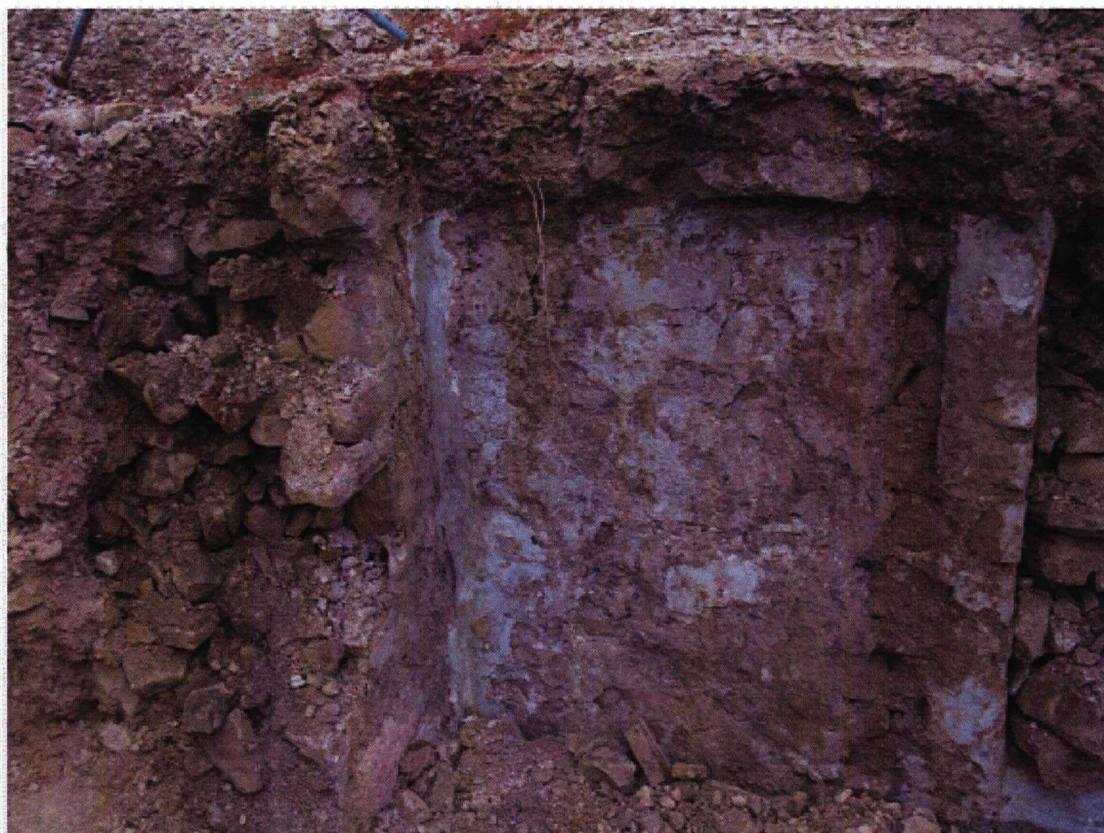
Plate 9 Showing detail of partially faced limestone with light blue grey plaster for cellar wall (403). Looking north.
