*A1 Dishforth to Barton Improvement
Sections 3 and 4, Summary Archaeology Report*

November 2010

D2B-0-W-30-002-RE12-A

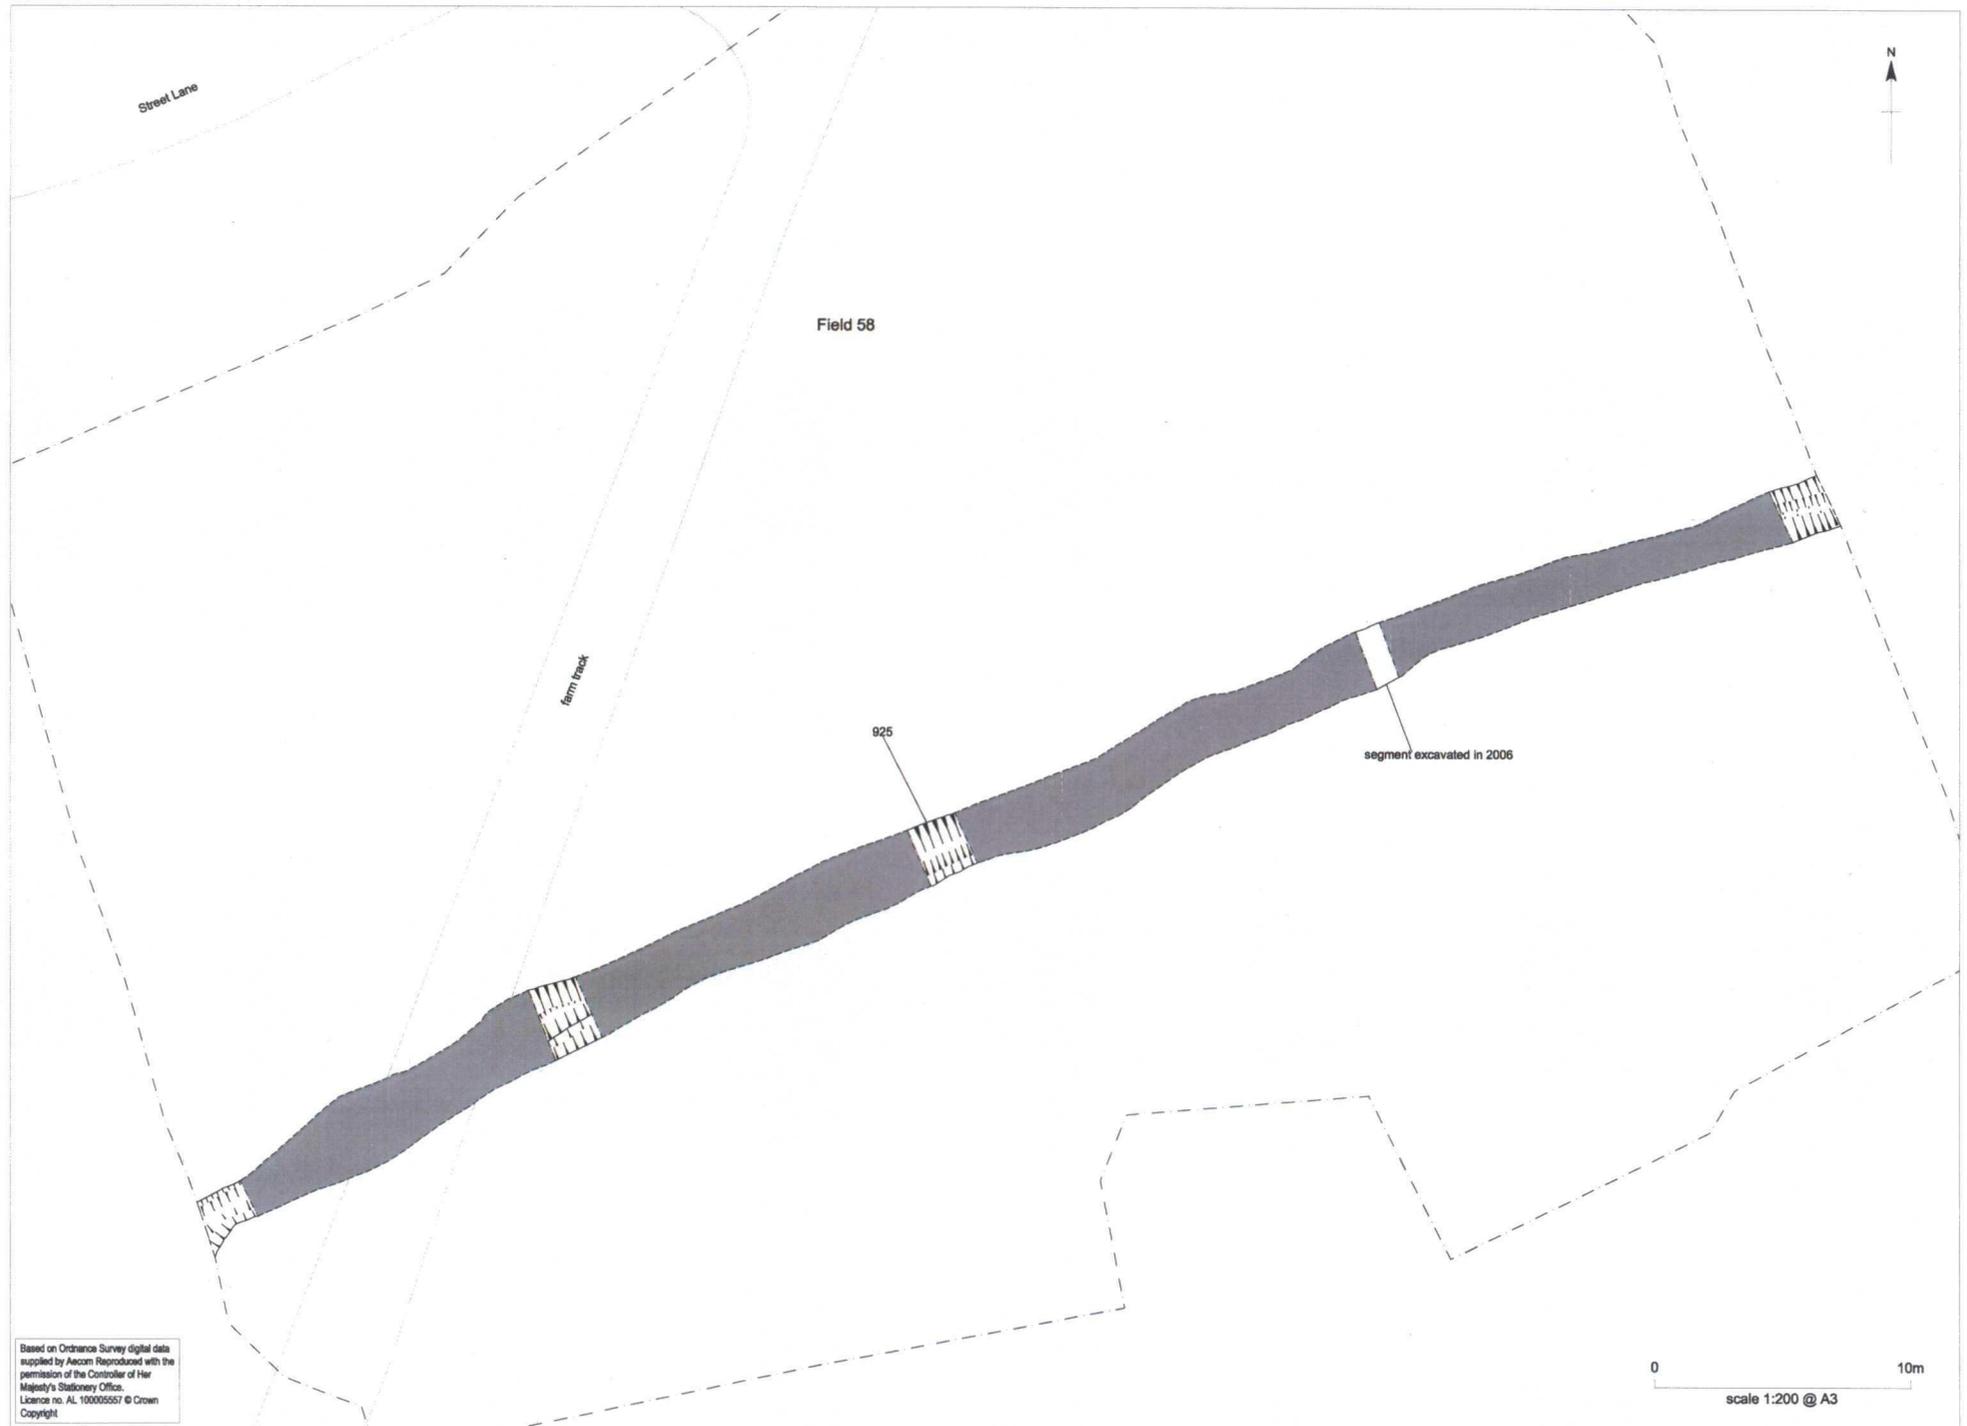
Figure 2

A1D2B: plan of archaeological features in Field 58

- 3.1 ^{MNY 36109} A single ditch (925) was recorded in Field 58 to the south of Street Lane. It was aligned east to west and was traced for exposed for c.70m. The ditch was recorded as an anomaly by the geophysical survey undertaken in 2005 and a trench was placed across it during the evaluation in 2006. An assemblage of Roman pottery was recovered from the fills of the ditch, including Samian, mortarium and amphora. A fragment of ceramic building material, an iron object and animal bone were also recovered. The ditch is likely to represent a Romano-British field boundary aligned perpendicular to Dere Street.
- 3.2 No evidence of the putative roundbarrow ditch identified in the earlier evaluation was observed following the stripping of the road corridor to the south of ditch 925.

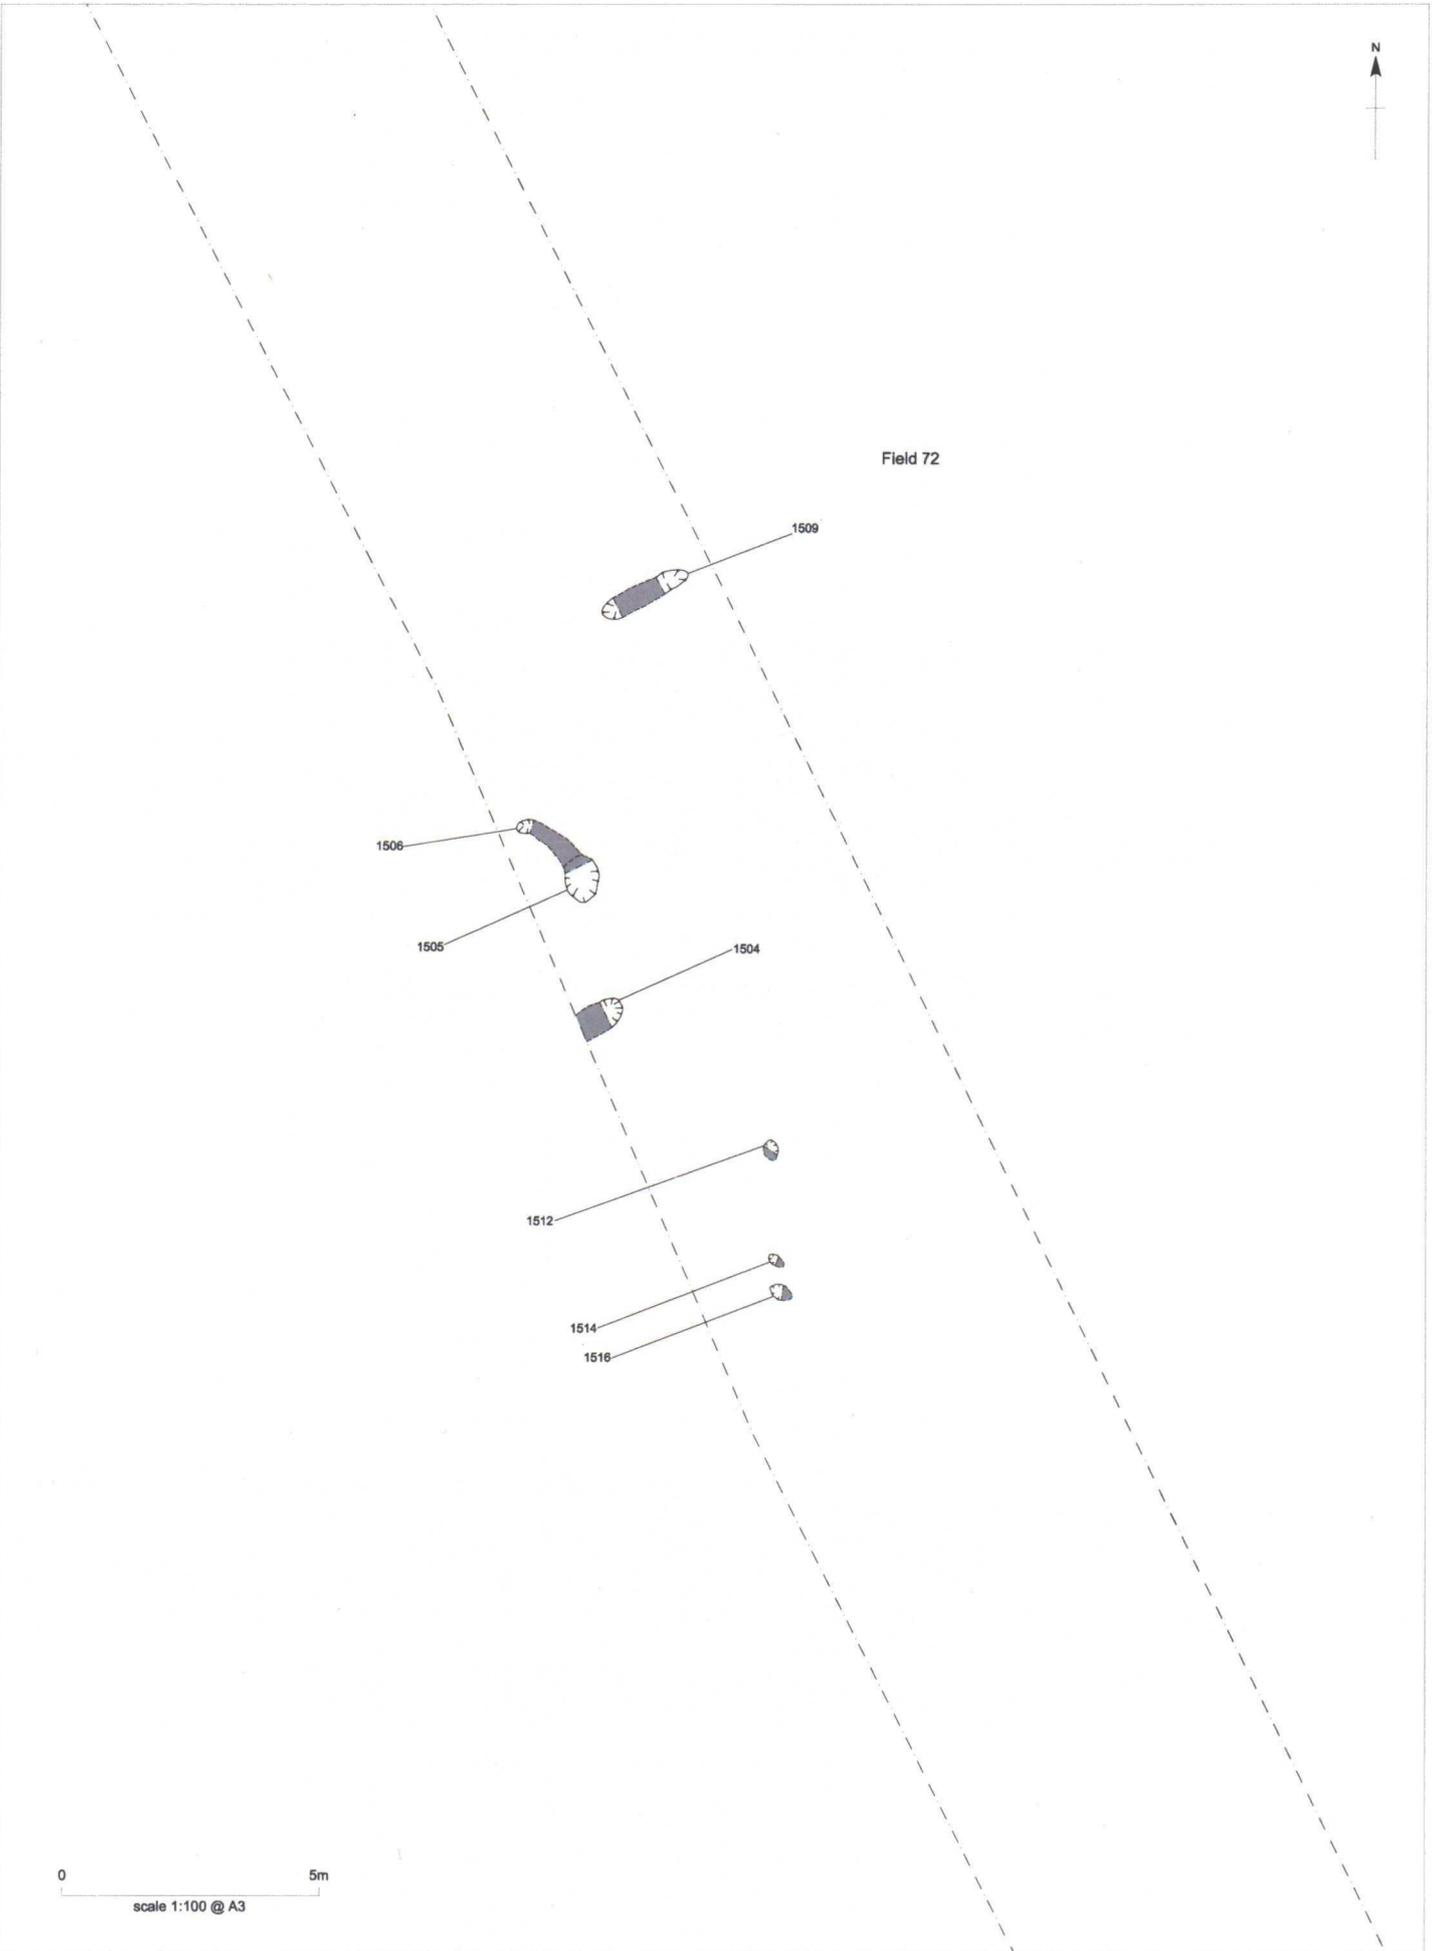
Figure 3 Field 72: Plan of archaeological features

- MNY 36110
- 3.3 A small cluster of features was identified towards the centre of Field 72 which comprised four pits and three segments of gully. The pits (1505, 1512, 1514 and 1516) were all sub-circular and one of them (1505) appeared to cut the central gully 1506. The gully segments (1504, 1506 and 1509) were all relatively short and measured between 1.8m and 0.8m in length and 0.4m to 0.5m in width. No artefacts were recovered from any of the features and they remain undated.

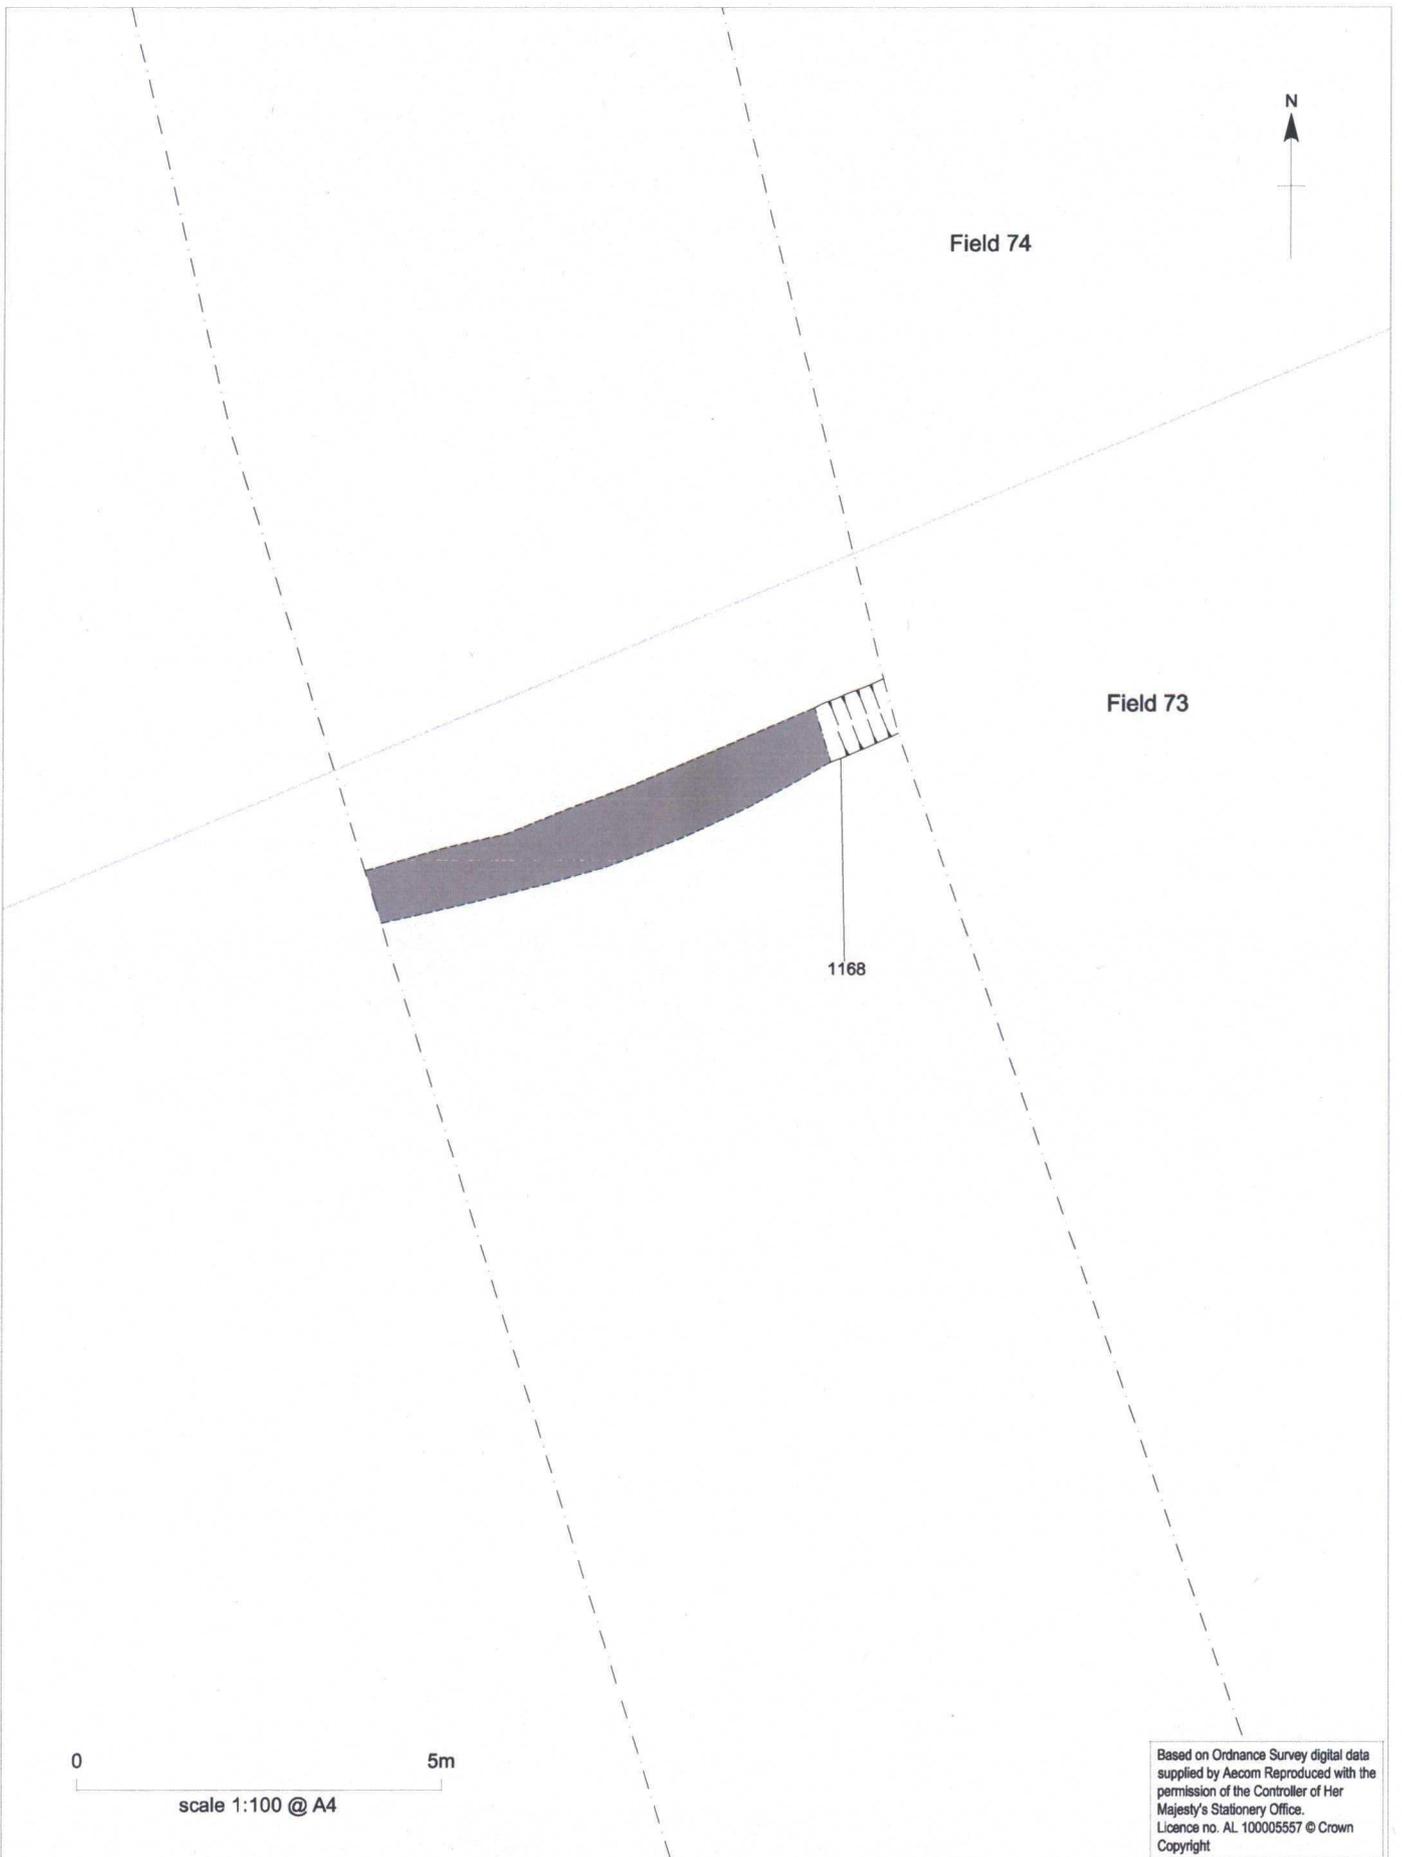
Figure 4 Field 73: Plan of archaeological features

- MNY 36111
- 3.4 A single ditch (1168) was identified in Field 73 to the south of and parallel to the existing boundary with Field 74. The ditch was V-shaped in profile, measured 1.64m in width and had a maximum depth of 0.65m. No diagnostic finds were recovered from the fill of the ditch but it was found to contain a significant quantity of fragmented animal bone. This feature appeared to be a forerunner of the present field boundary which had migrated north over time.

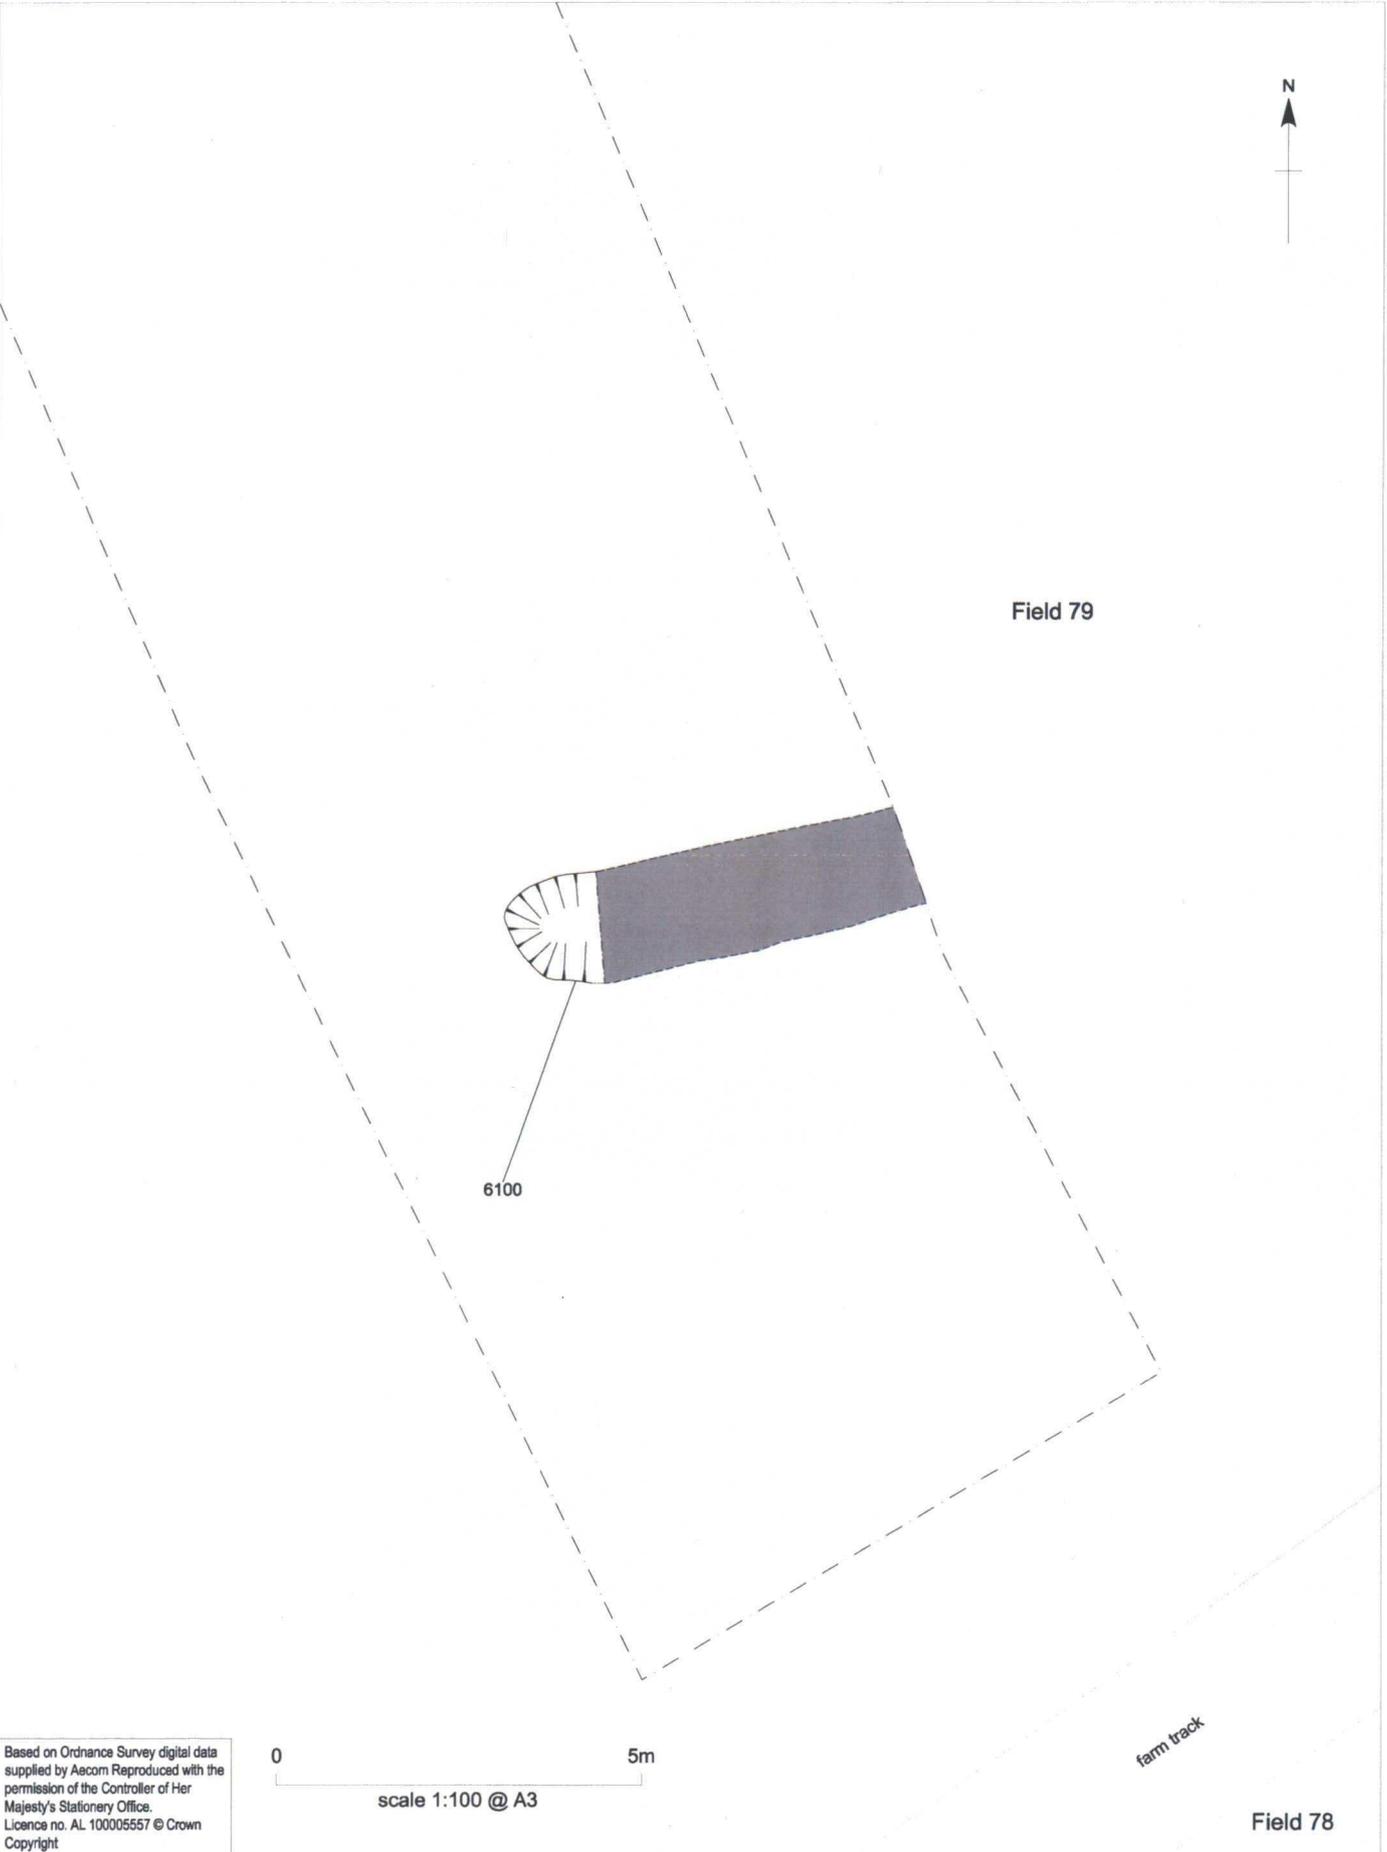
Figure 5

A1D2B: plan of archaeological feature in Field 79

- MNY 36112
- 3.5 Field 79 contained a single ditch (6100) which was located at the southern end of the field and 10m to the north of an existing farm track. The ditch had a rounded terminal to the west and continued beyond the edge of the corridor to the east. A quantity of slag was recovered from the fill but no artefacts were recorded.

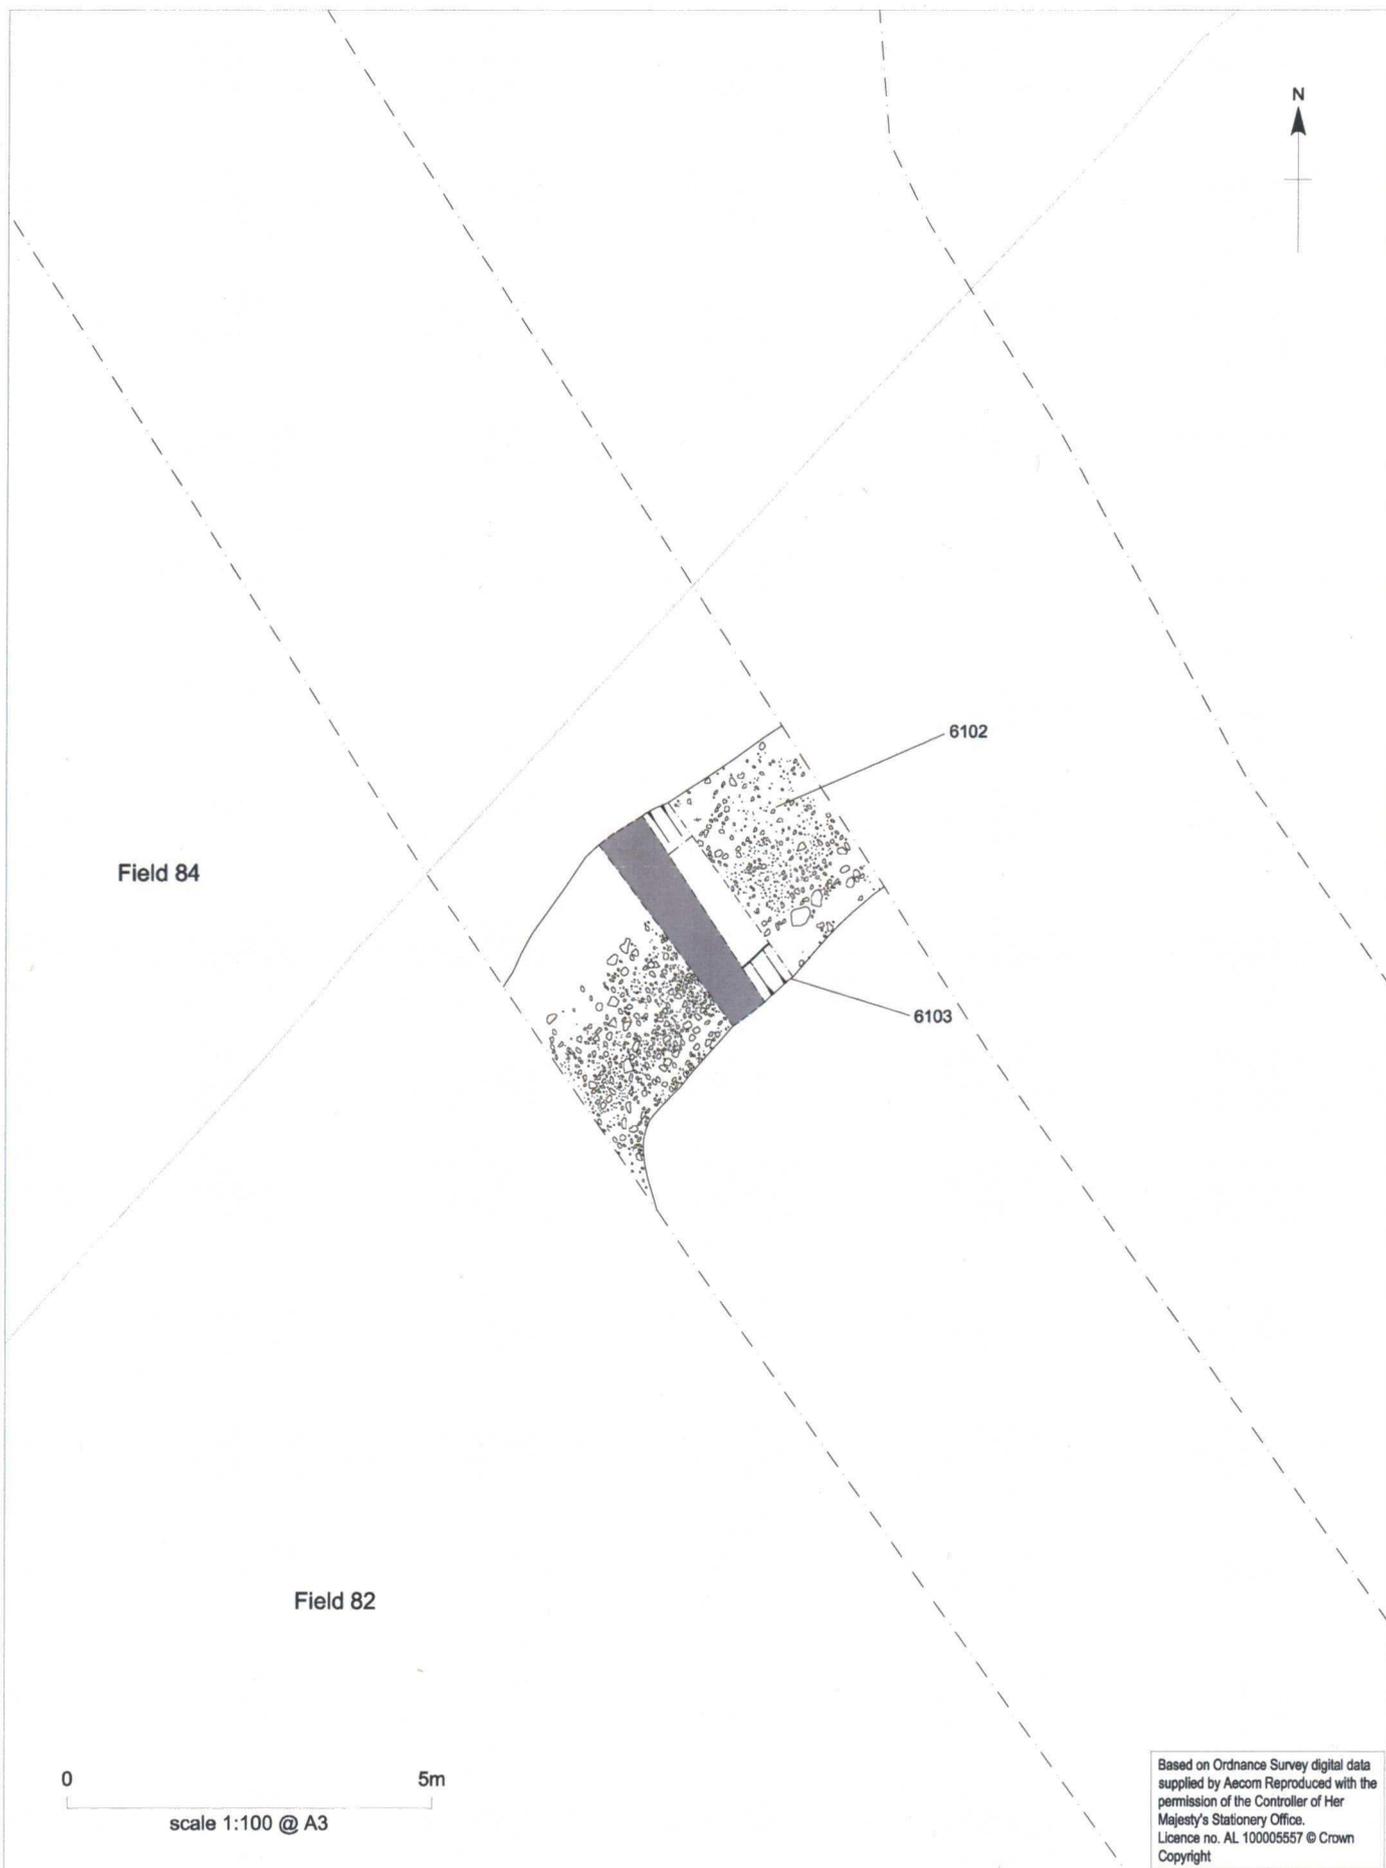
Figure 6 Field 82: Plan of archaeological features

- 4.1 The remains of an undated trackway were identified at the northern end of the road corridor within Field 82. The trackway was aligned north-east to south-west and ran parallel to the former field boundary. It lay within a slight hollow c.3.18m wide and had a compacted pebble surface (6102). Two distinct ruts (6103) were recorded cut into this surface, but no artefacts were recovered from any of the excavated deposits associated with it.

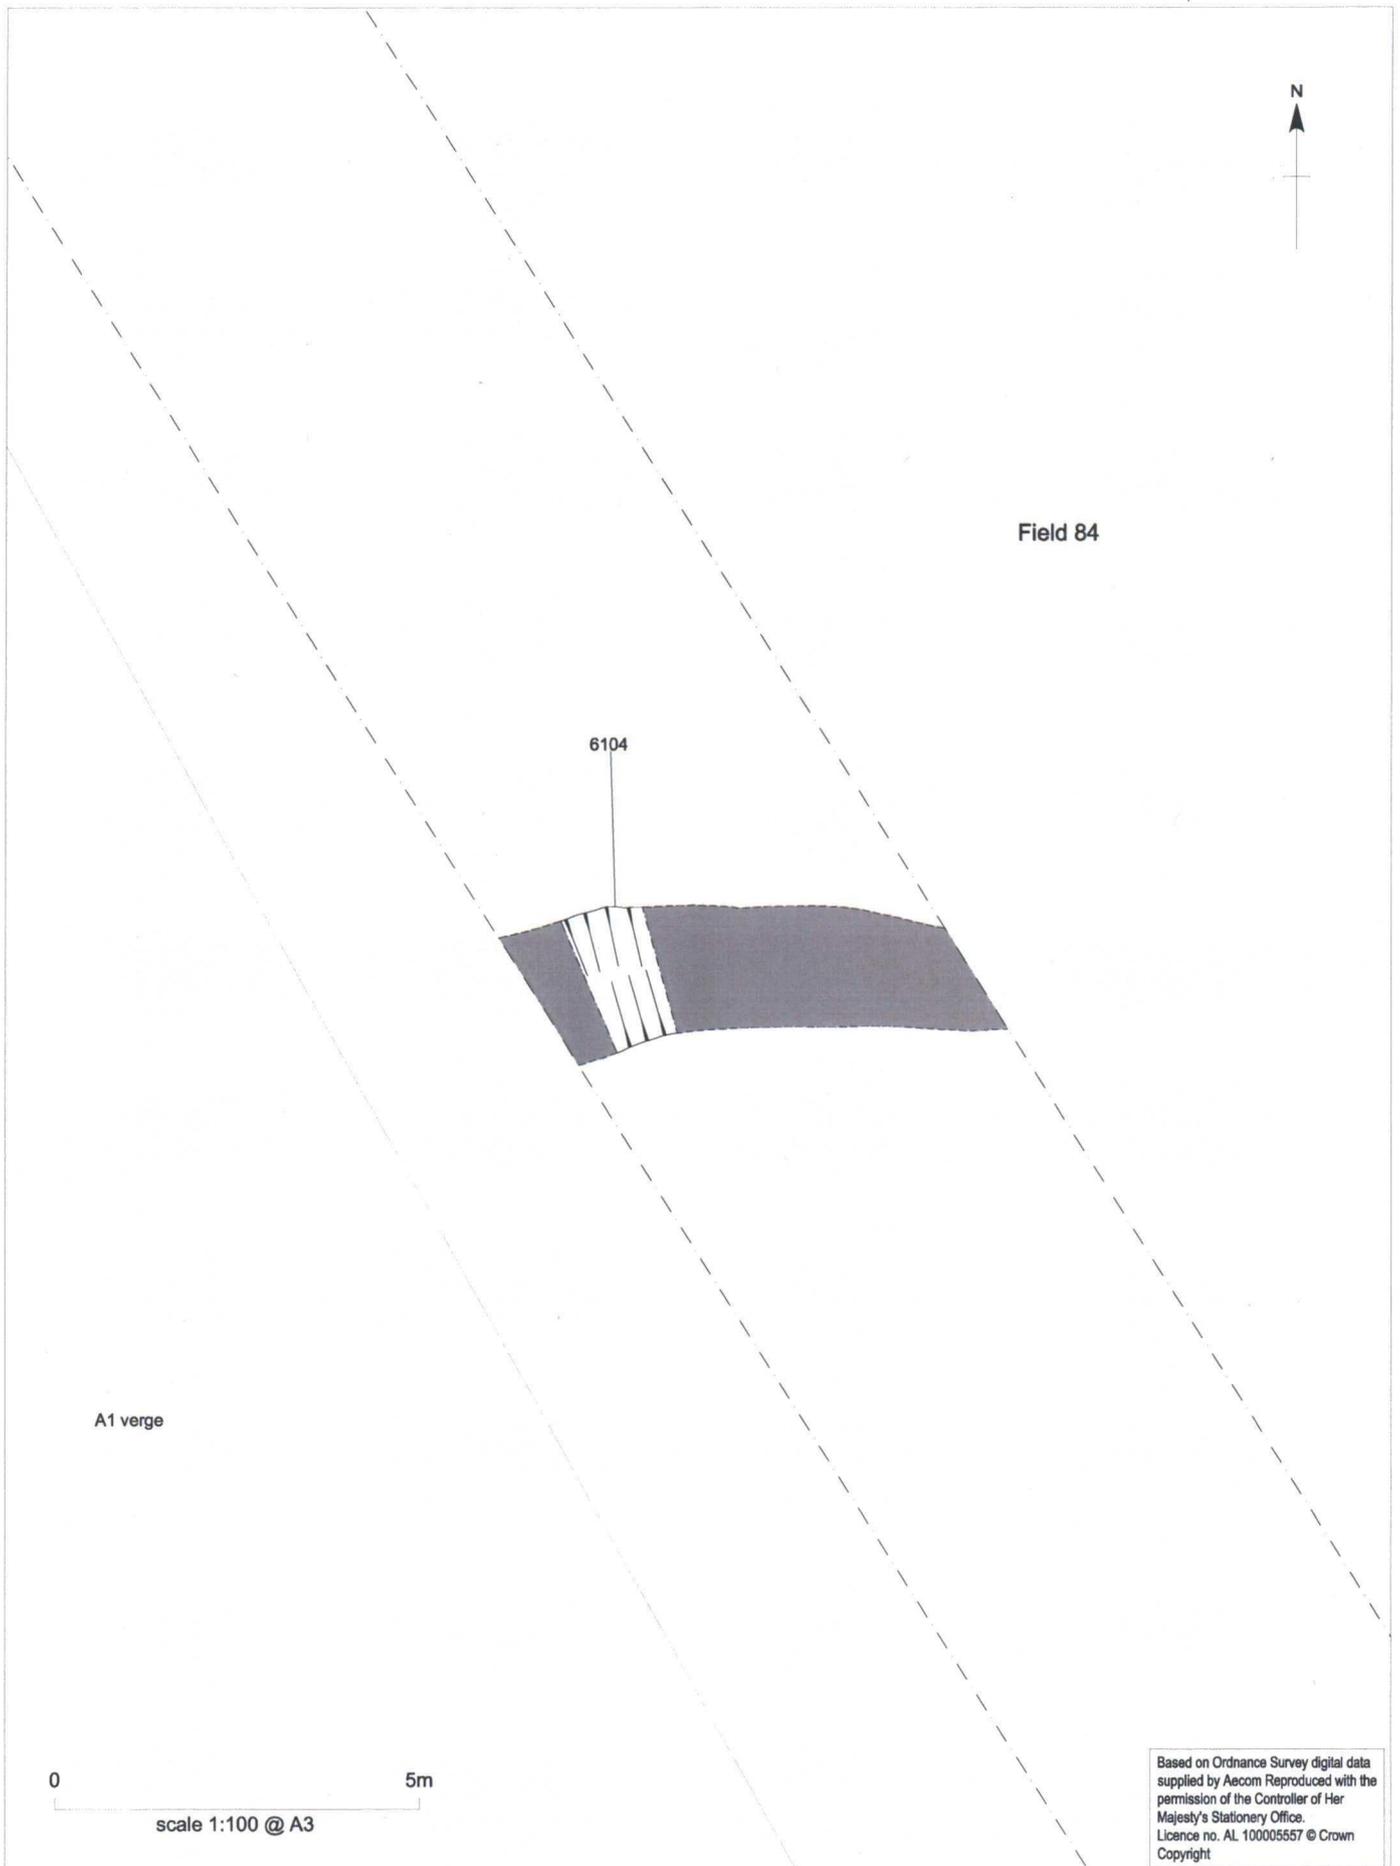
Figure 7 Field 84: Plan of archaeological features

- 4.2 Ditch (6104) was located 183m from the southern field boundary and measured c.4m in length. It crossed the road corridor on an east to west alignment. The ditch survived to a

depth of 0.65m and contained two fills. A single sherd of medieval pottery was recovered from the upper fill.

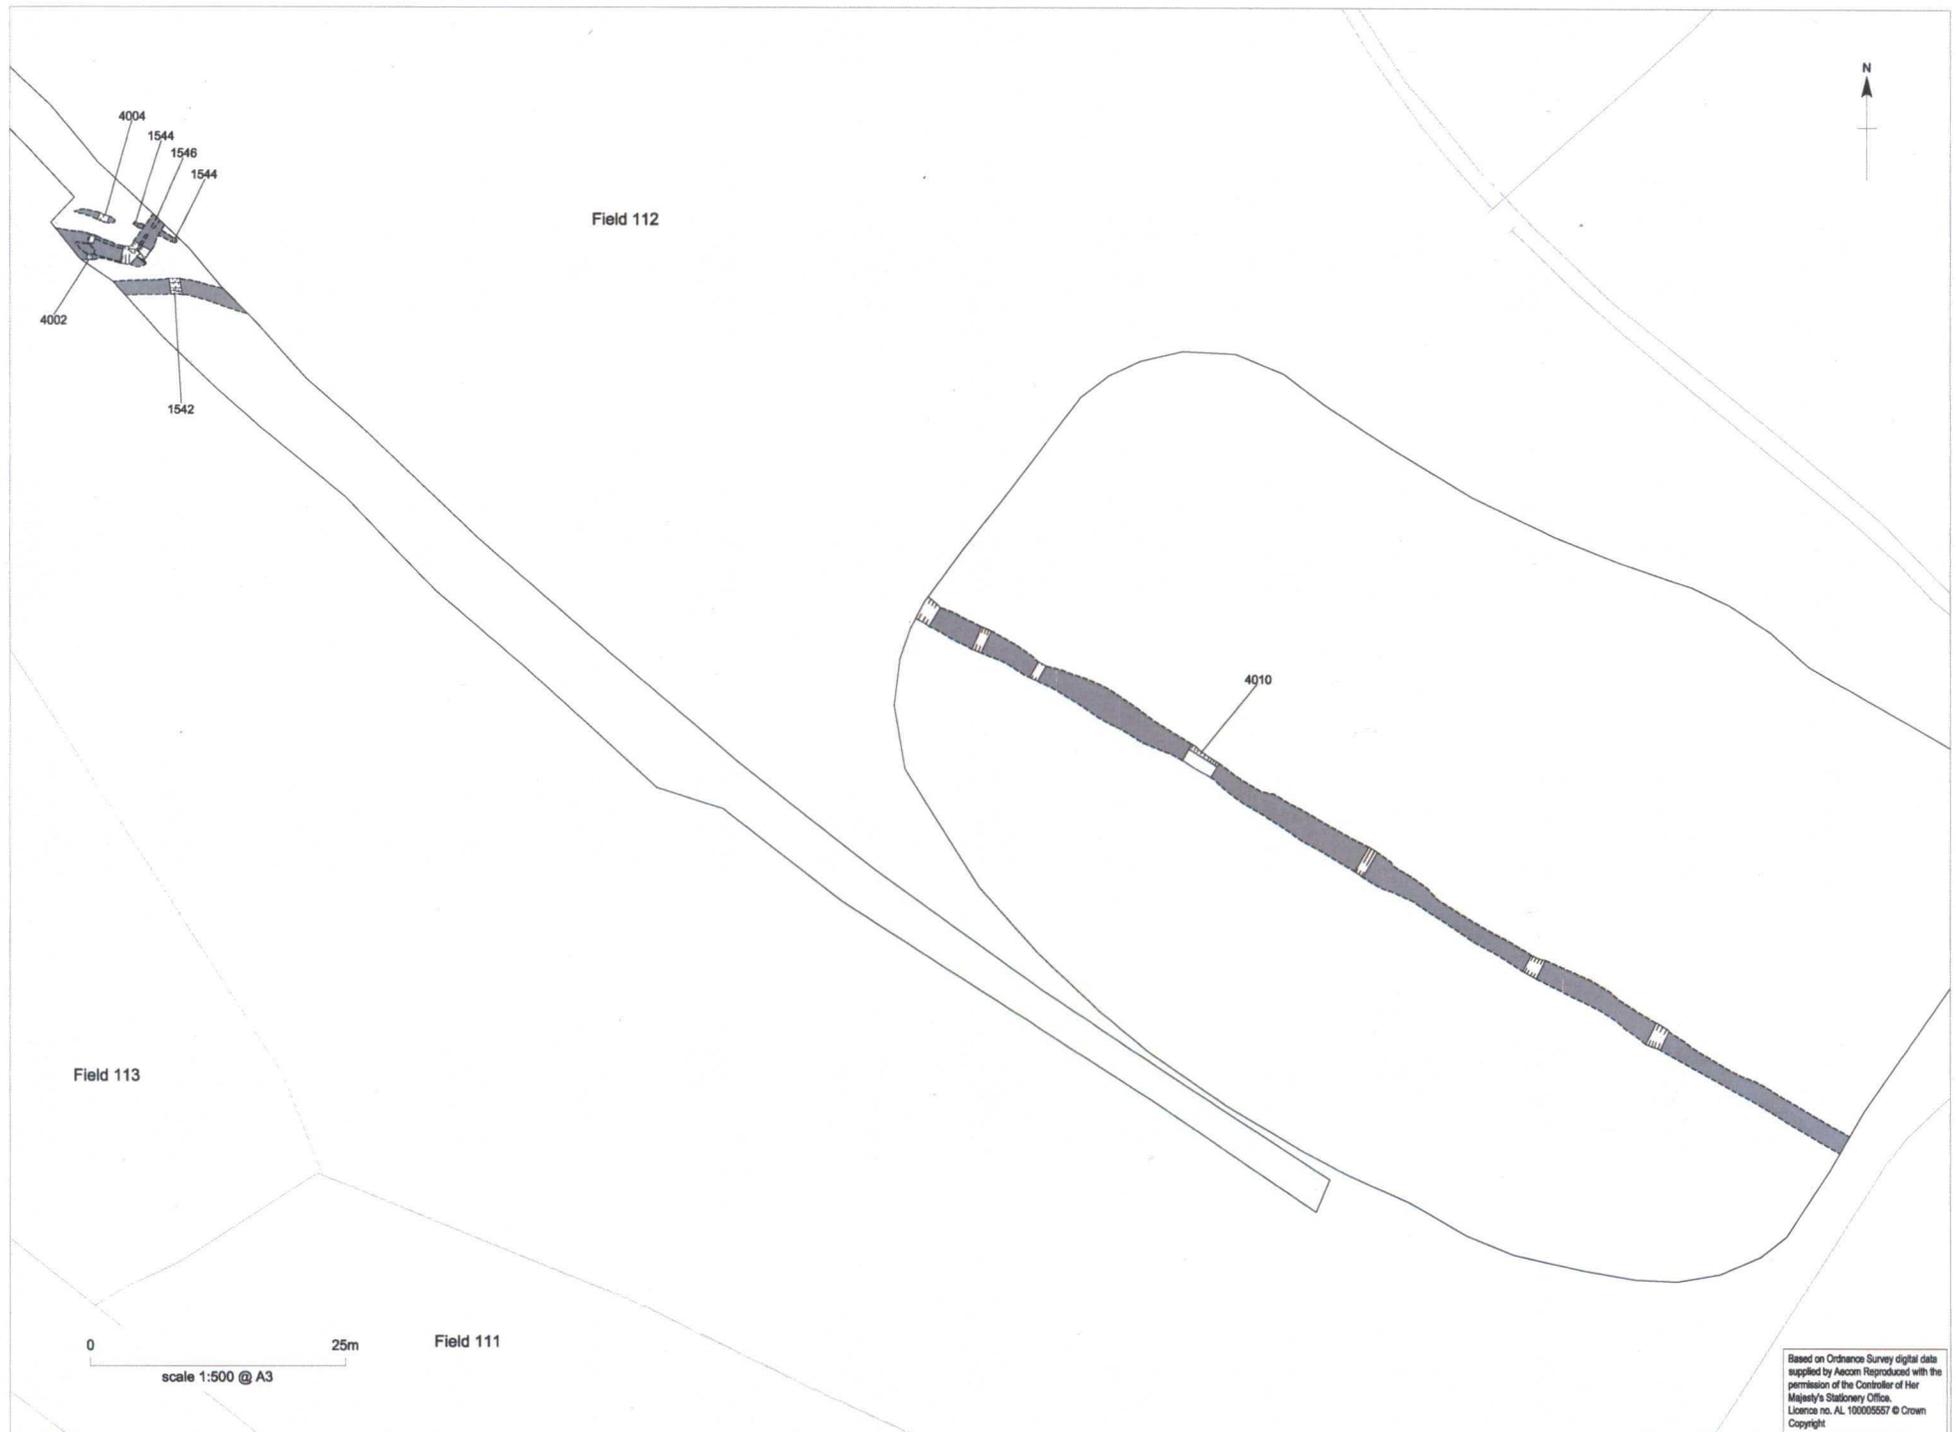
Figure 8 Field 112: Plan of archaeological features

- 4.3 To the north of Leeming Beck, a small number of features were recorded in an access track corridor and within the area of an adjacent balancing pond. The features identified comprised a ditch (4010) which was exposed for 145m within the balancing pond area, a possible extension of this ditch (1542) within the access track corridor, an angled ditch (4002) and a group of shallow plough scars (4004, 1544 and 1546). The fill of ditch 4010 contained three sherds of medieval pottery and a piece of worked flint. No artefactual material was recovered from any of the other features. MN 86115
