**LAND OFF MITFORD STREET, FILEY,
NORTH YORKSHIRE**

BUILDING 3 RECORDING REPORT

REPORT NUMBER 2010/113

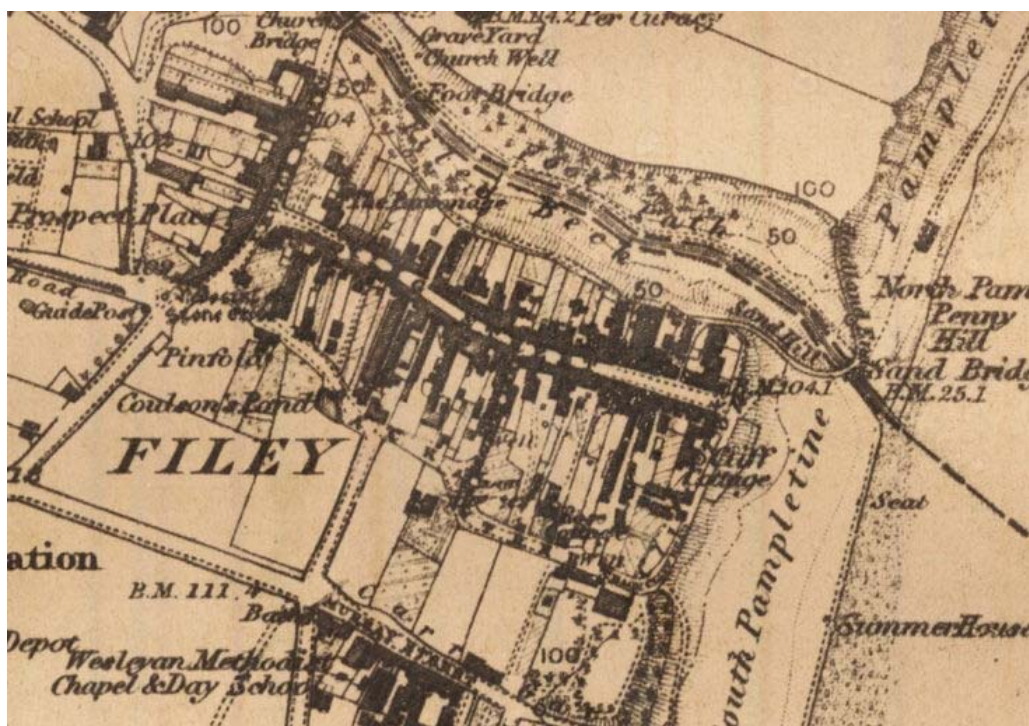
Figure 4 1854 OS map

The first edition Ordnance Survey of 1854 (Figure 4) shows the site as containing a number of small or medium sized buildings grouped around yards. Building 6 does not appear to present at this date although both 3 and 9 can be identified.

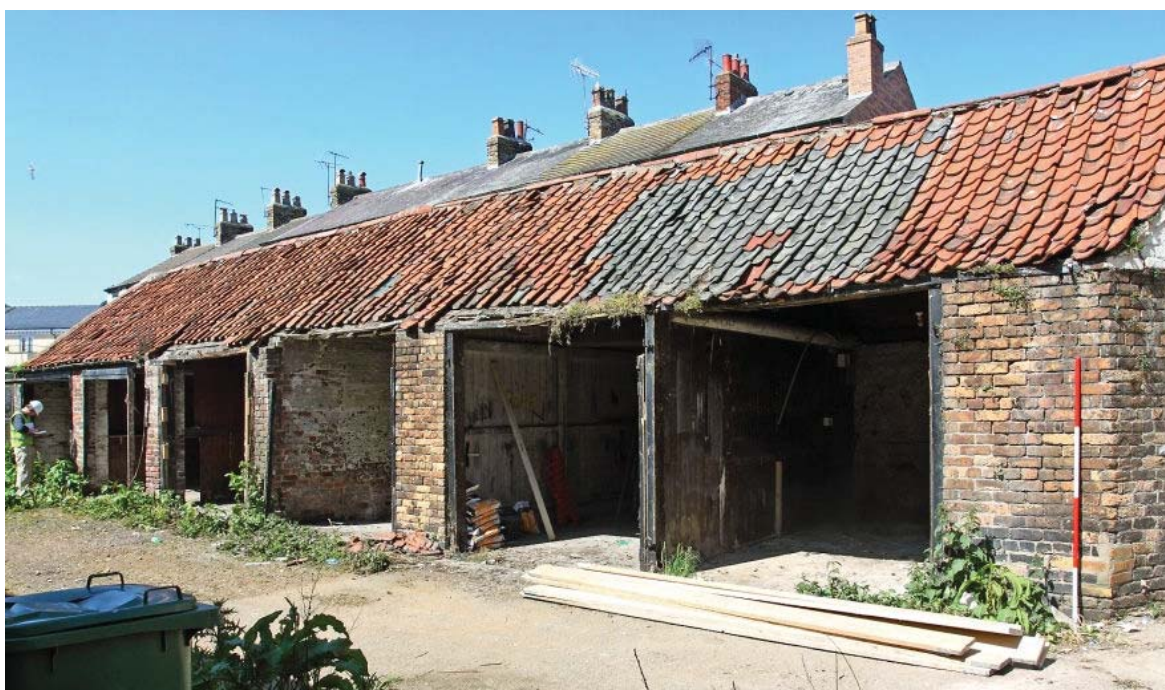
Plate 1 View of garage bays

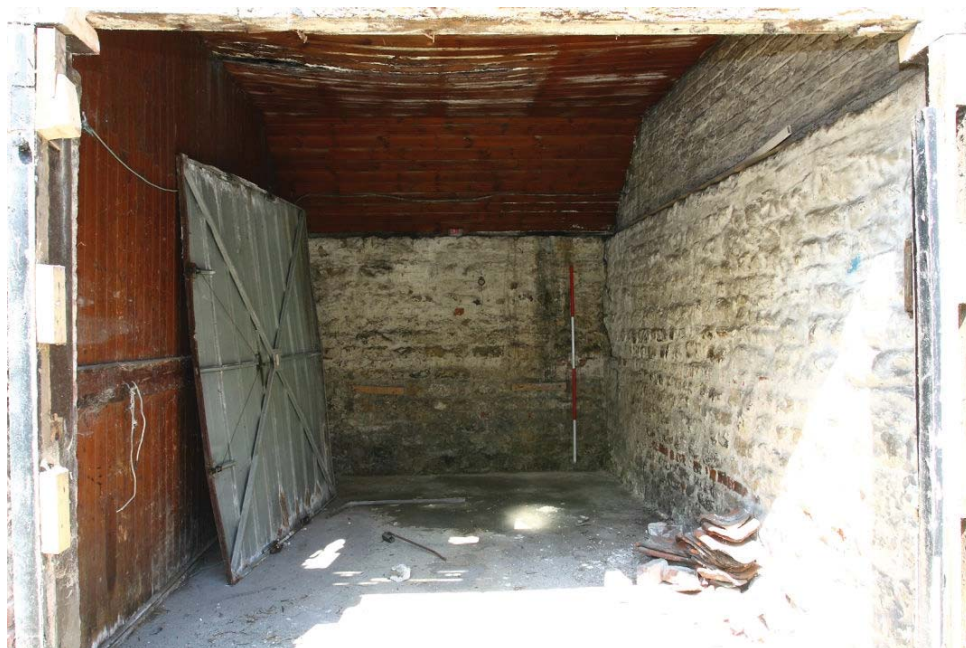
Plate 2 Interior view of one garage bay

Internally the bays to either side of the central cross wall are separated differently. On the south side the two dividing walls are plan timber stained brown. To the north they are plain white washed. There are few internal fittings which indicate former uses. A pair of small metal rings are set into the rear wall in bay 2 and there is a small corner water trough in bay 4. The floor has been cemented and in bay 3 there are shallow drainage channels. Pintles in the door surrounds indicate earlier hanging points.

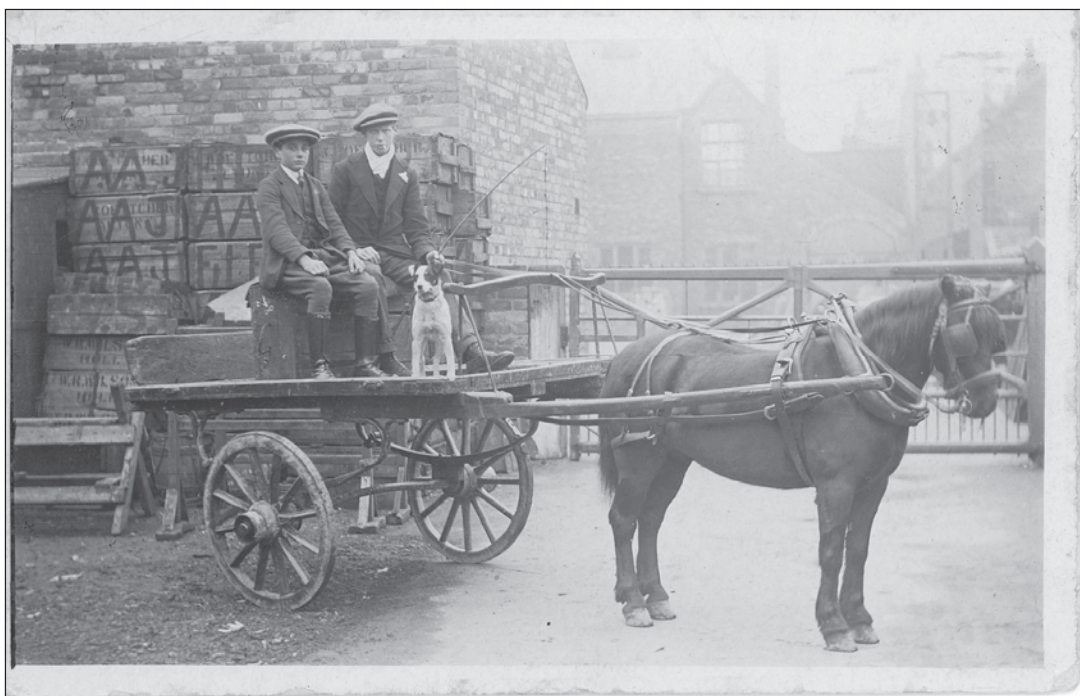
Plate 5 19th century image of yards

A set of photographs from the early 20th century are of interest as they show the rear of the Filey Town Council building and one in particular (Plate 5) shows part of Building 6 in the left background. This photograph depicts a horse and cart with two boys, and a dog, on the cart. Behind them are a large pile of what appear to be fish boxes, suggesting that this part of the site was used for fish processing and probably packing. Behind the boxes is the east/west wing of Building 6 with a gate attached to the south-east end of the structure which marks the boundary between the council yard and the fish processing activity. Whilst these photos are not dated it must post date the 1890s as Building 6 and the Filey Town Council buildings do not appear on the 1893 OS map. By 1911 Building 6 can be clearly identified and the present configuration of buildings and boundaries was established.

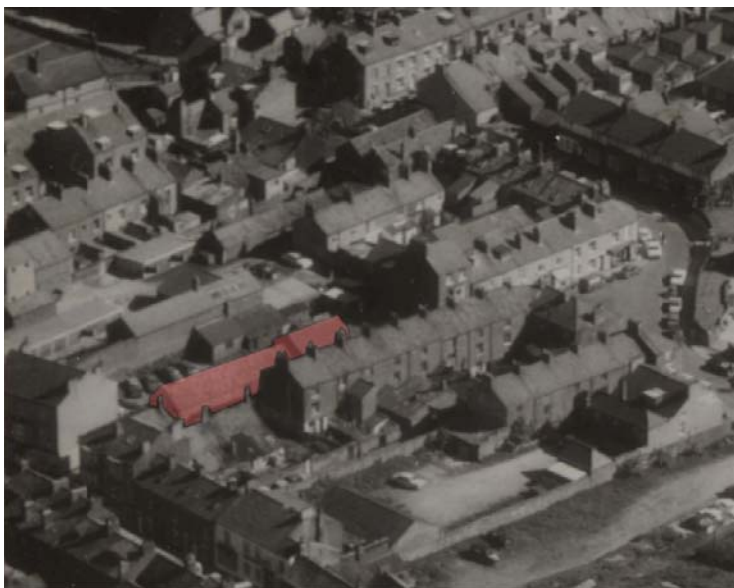
Plate 6 Aerial view of site

was brick built and that on the northern side there was a concrete floor with a make-up layer of broken brick 0.30m deep (2009/1013). An aerial photograph of the 1960s confirms that there was indeed a building over this area although it was clearly a separate build as it had a higher roof line. The brick facing on the western side of the wall on Reynolds Street also continues along this extent of masonry.

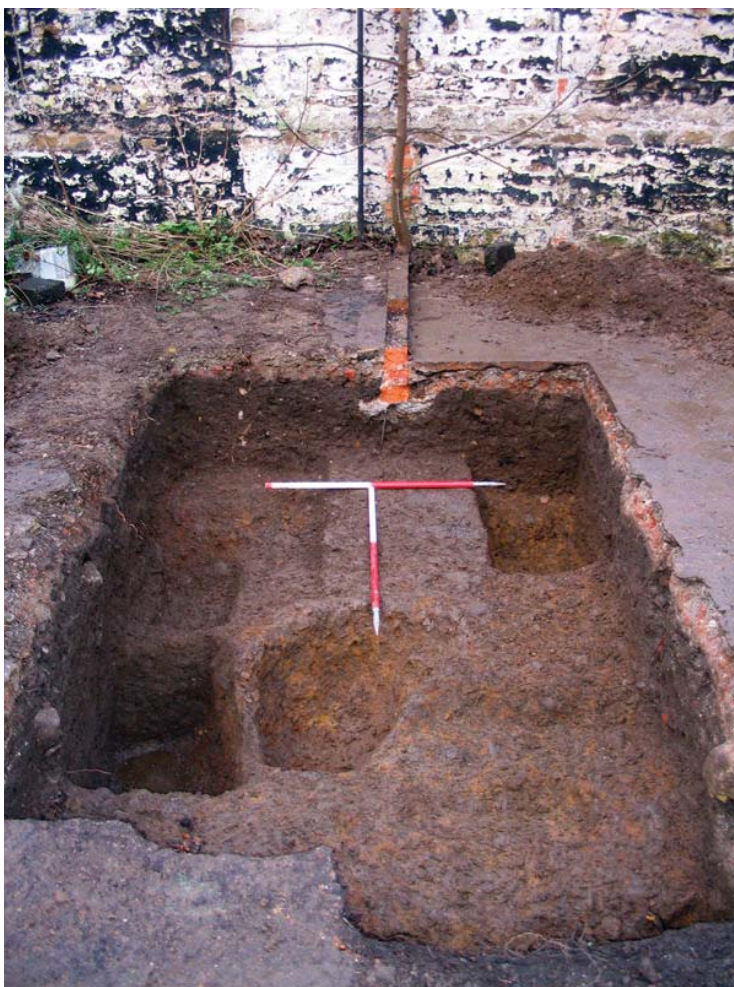
Plate 7 Footings exposed in 2009 excavation trench

On the south side of the building the rear stone wall continues at the same height for a further 7m and then turns through 90° and ends on the same line as the frontage. Paint work on the inner face and remains of a cross wall visible on the wall and uncovered during the evaluation excavation in 2009, show this area was originally covered over and was probably a continuation of Building 3. The 2009 investigation showed that the cross wall (2009/1012)
