GAS WORKS HOUSE, HORSEFAIR, BOROUGHBIDGE.

REPORT ON AN ARCHAEOLOGICAL WATCHING BRIEF
OSA REPORT No: OSA10WB17

July 2010

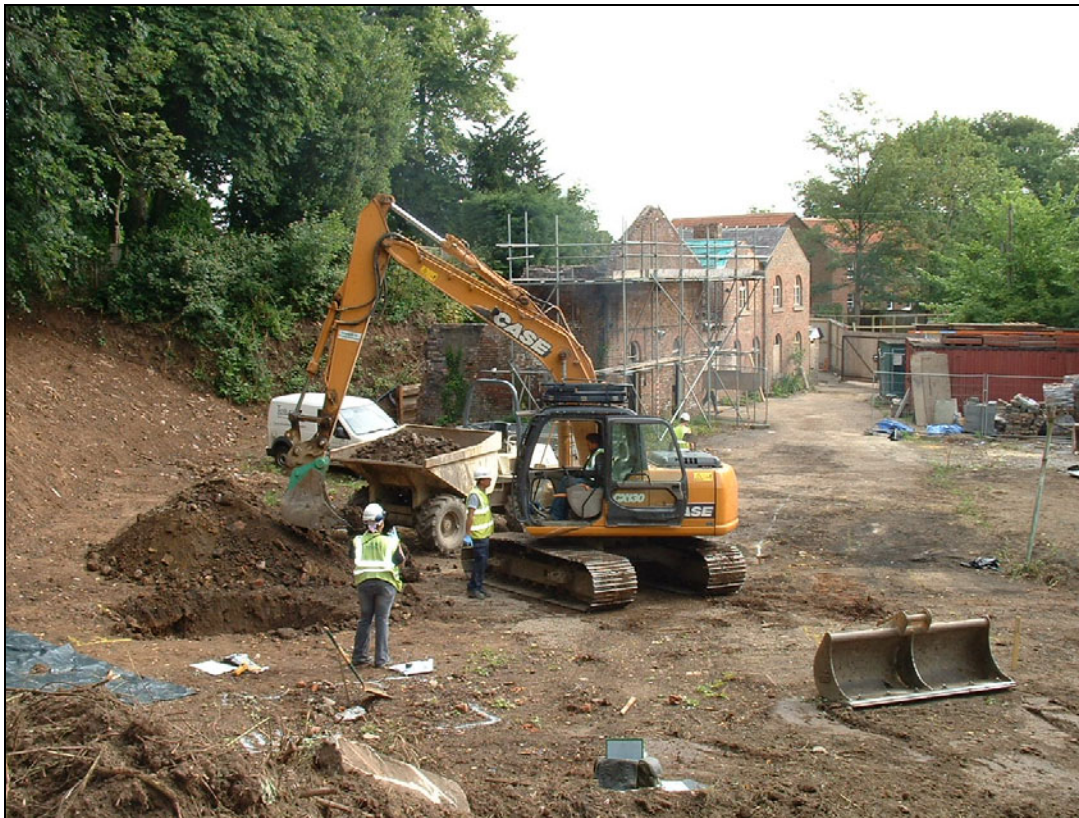
Plate 1. General site shot looking north

The site is located at NGR SE 39422 66474 to the south of the historic core of Boroughbridge, North Yorkshire (Figure 1). Gas Works House was bounded by residential properties to the north, west and south, and to the east by Horsefair, a road that leads from the south into the town. The site is situated upon alluvium associated with the River Ure floodplain, which overlies drift geology comprising silt and clay Glacial Lake Deposits. These deposits are founded upon a solid geology of the Sherwood Sandstone Group. At the time of the investigation the disused land had been cleared of scrub and was banked on the north and west sides the ground surface rose slight up to the southwest (Plate 1).

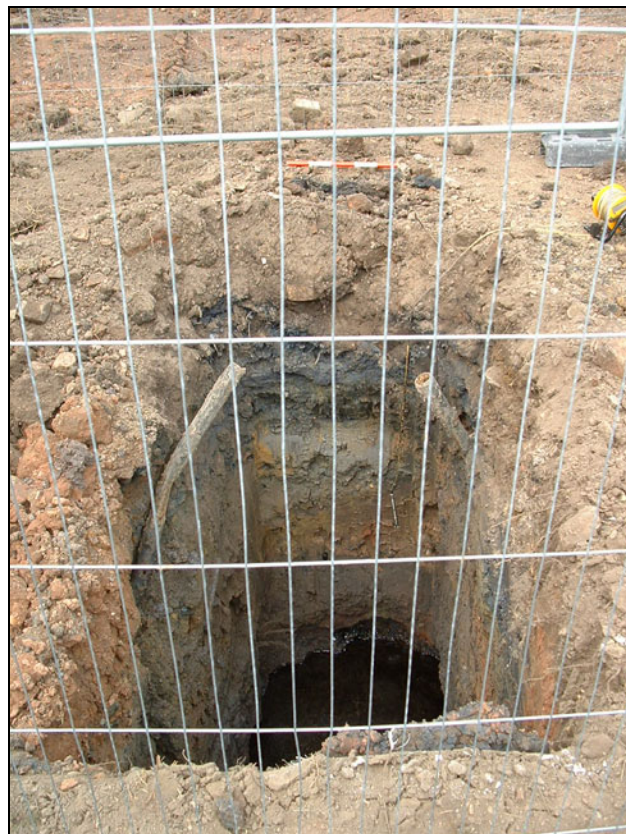
Plate 2. North-facing section Trench D

Trench D measured 2.8m by 1.2m and was excavated to a maximum depth of 3m (Plate 2). The earliest deposit detected was a dark greyish-black silty-clay alluvium layer (103) that had an excavated depth of 1m. Layer (103) was sealed by two clayey-silt levelling deposits (102) and (101) respectively. Levelling deposit (102) was a yellowish-brown colour measuring 1m in depth and (101) a greyish-black colour also 1m in depth. Sealing (101) was a greyish-brown sandy-silt topsoil containing moderate 19th – 20th century ceramic building material (CBM). No finds were recovered from this trench.

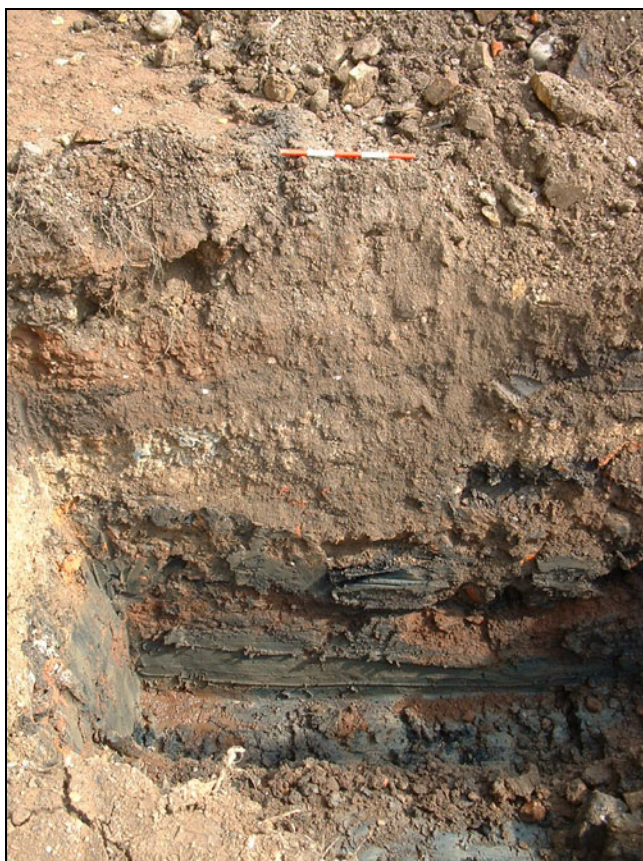
Plate 3. South-facing section Trench F

This trench measured 4m by 2.3m and was excavated to a maximum depth of 3m (Plate 3). Layer (205) was the earliest deposit detected within the trench, which consisted of a mixed red sand and clay excavated to a depth of 1.5m. Layer (205) appeared to represent the contaminated natural geology. Sealing this layer was a brown sandy-silt bedding layer (204) for an above concrete layer (203) that was 0.35m in depth. The concrete layer (203) appeared to have been a former external surface associated with the former gas works. Above the concrete was a dark-brown sandy-clayey soil layer (202) that measured 0.2m in depth, this layer probably formed or was deposited after the concrete surface went out of use. This was sealed by a reddish-brown gravel levelling/dumping layer (201) that measured 0.4m, which was later sealed by layer (200) a greyish-brown sandy-silt topsoil containing moderate 19th – 20th century ceramic building material (CBM). No finds were recovered from Trench F.

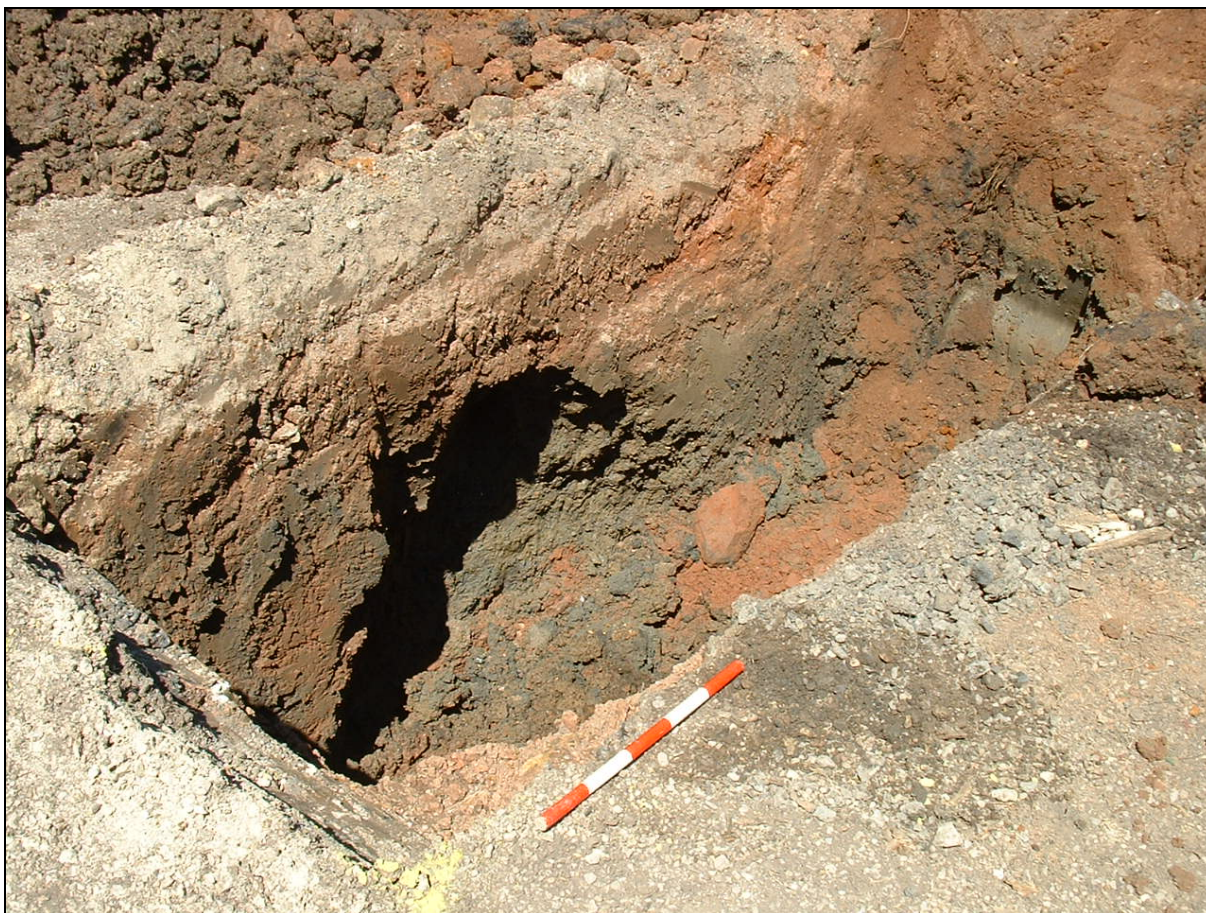
Plate 4. East-facing section Trench E

Trench E measured 5m by 2.3m and was excavated to a maximum depth of 3m (Plate 4). The earliest deposit detected was a mixed red sand and clay natural, excavated to a depth of 1m. This was sealed by two levelling deposits (302) and (301) respectively. Levelling (302) was a greenish-grey clayey-silt that measured 1.2m in depth and (301) was a reddish-brown sand with moderate stone inclusions with a depth of 0.4m. Layer (301) was sealed by a topsoil that measured 0.4m of a similar description as topsoil seen in Trenches D and F. No finds were recovered from Trench E.

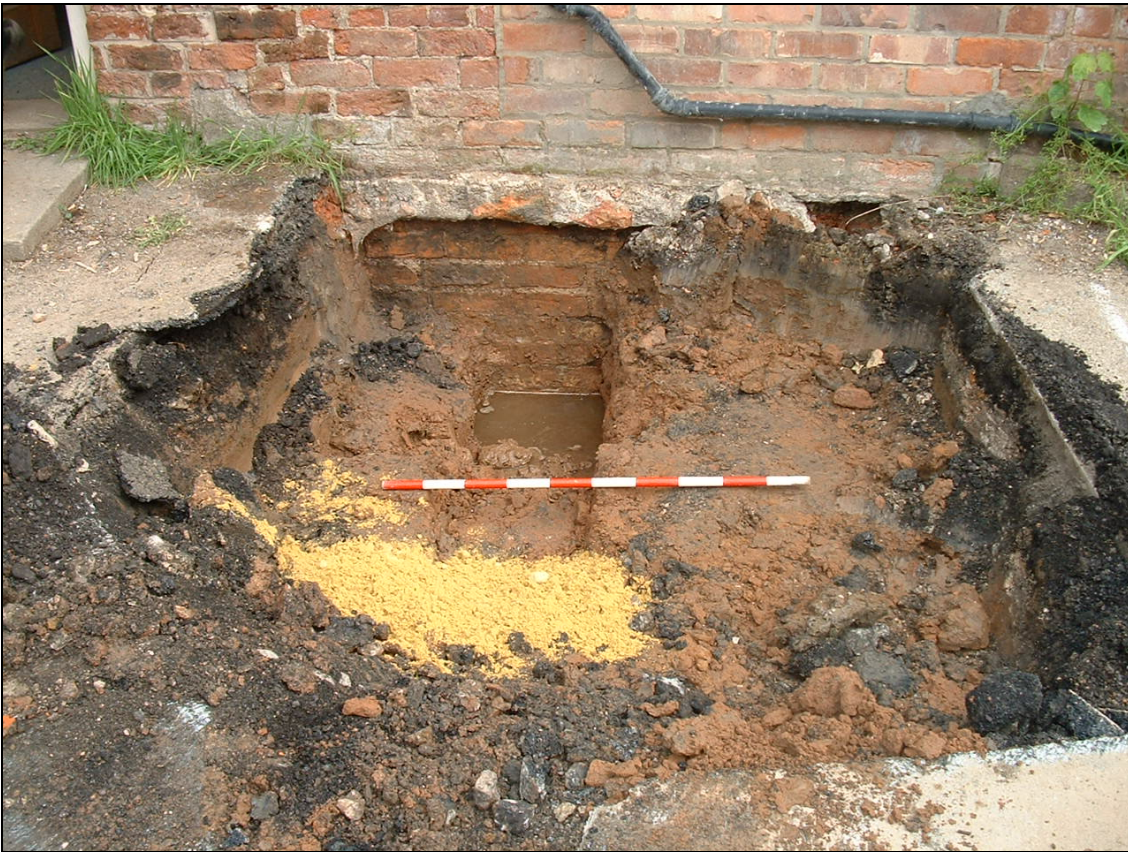
Plate 5. Trench H looking northeast

Trench H measured 5m by 2.3m and was excavated to a maximum depth of 0.8m (Plate 5). A reddish-brown silty-clay layer (404) excavated to a depth of 0.2m was the earliest deposit detected and possibly represented the natural. Truncating layer (404) was the construction cut of the Gas Works House foundation that extended further than 0.4m below excavation. The construction cut was in-filled by a reddish-brown silty-clay (401). This was sealed by a dark-greyish-brown/black sandy-clayey-silt levelling (401) that measured 0.2m in depth and contained 19th – 20th century CBM inclusions. Above layer (401) was the tarmac surface (400). No finds were recovered from this trench.

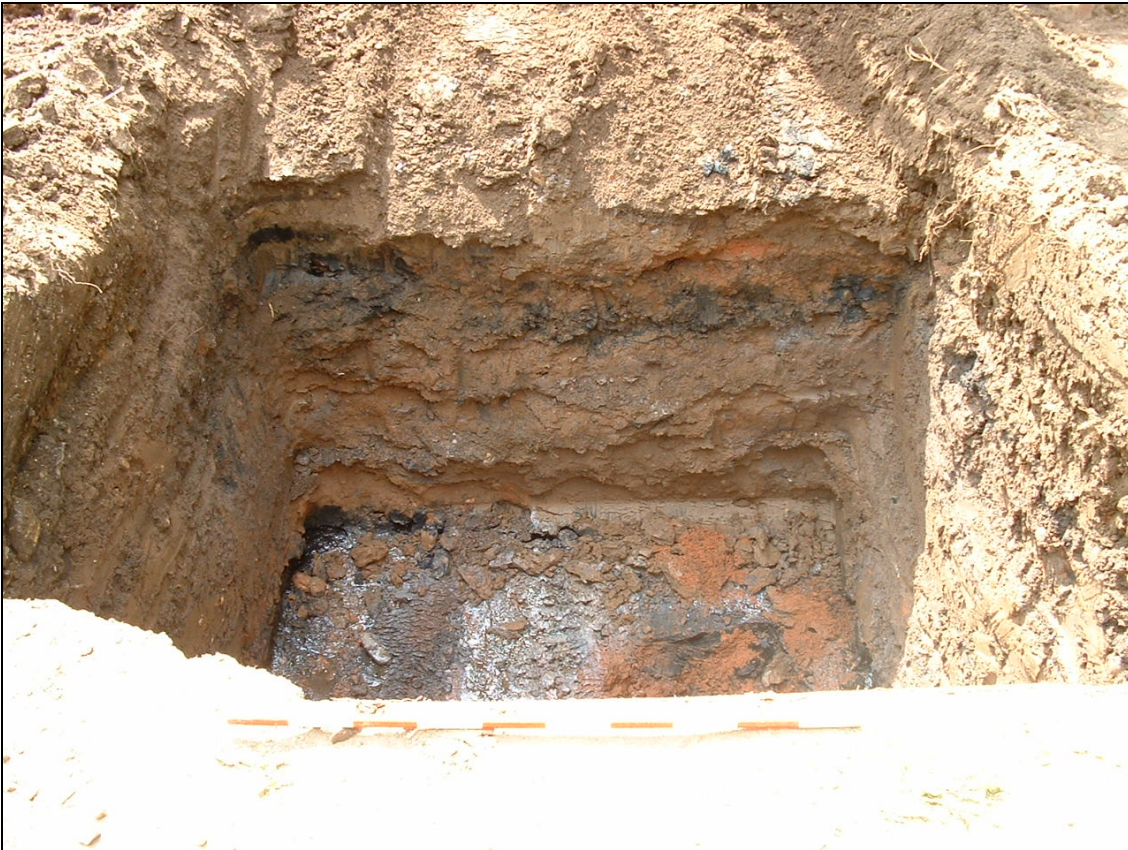
Plate 6. East facing section Trench A

Measuring 3.5m by 3m Trench A was excavated to a maximum depth of 2.5m (Plate 6). The earliest deposit identified within this trench was red sand (505) excavated to a depth of 0.1m. This was sealed by a contaminated layer (504) that consisted of a black tarry sludge/residue, which measured 0.15m in depth. This deposit appeared to have been capped by a reddish-brown silty-clay re-deposited natural (503) that was 1.1m in depth. Above layer (503) was another contaminated layer (502) that consisted of greyish-black clayey-silt and measured 0.4m in depth. Sealing layer (502) was a levelling (501) that consisted of a dark brown sandy-clayey-silt 0.5m in depth. Above layer (501) was a topsoil (500) that measured 0.4m in depth. No finds were recovered from Trench A.

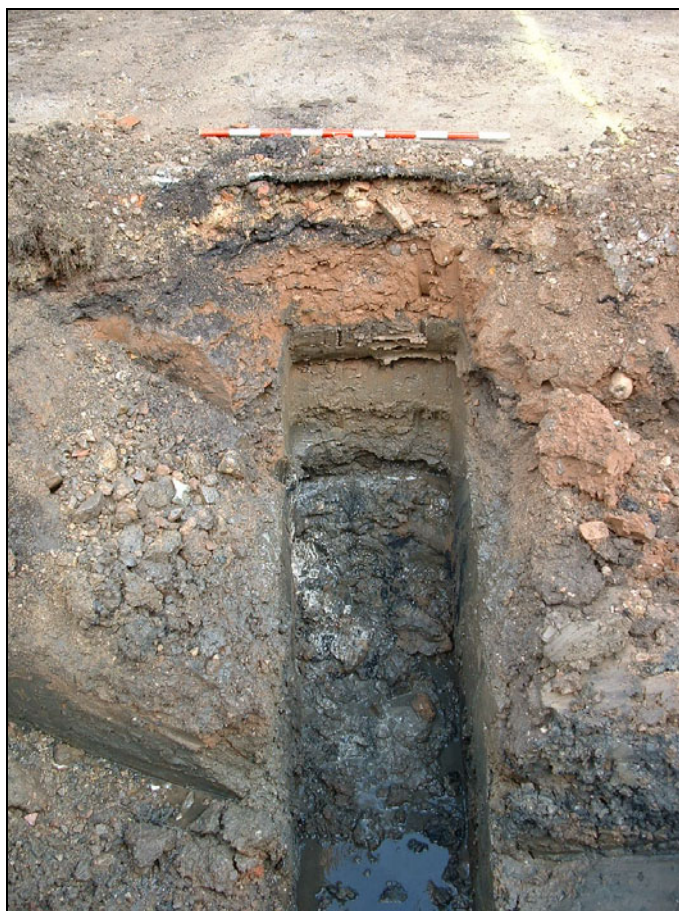
Plate 7. East-facing section Trench C

Trench C measured 5m by 2m and excavated to a maximum depth of 2.7m (Plate 7). The basal deposit within this trench was a dark blackish-grey alluvium (603) that contained rare CBM inclusions. This was sealed by two layers of re-deposited natural (602) and (601) respectively. Layer (602) was 0.5m in depth and consisted of greenish-grey silty-clay and (601) was 0.3m in depth and was a reddish-brown silty-clayey sand. Above (601) was a hardcore bedding and tarmac surface 0.25m in depth. No finds were recovered from this trench.

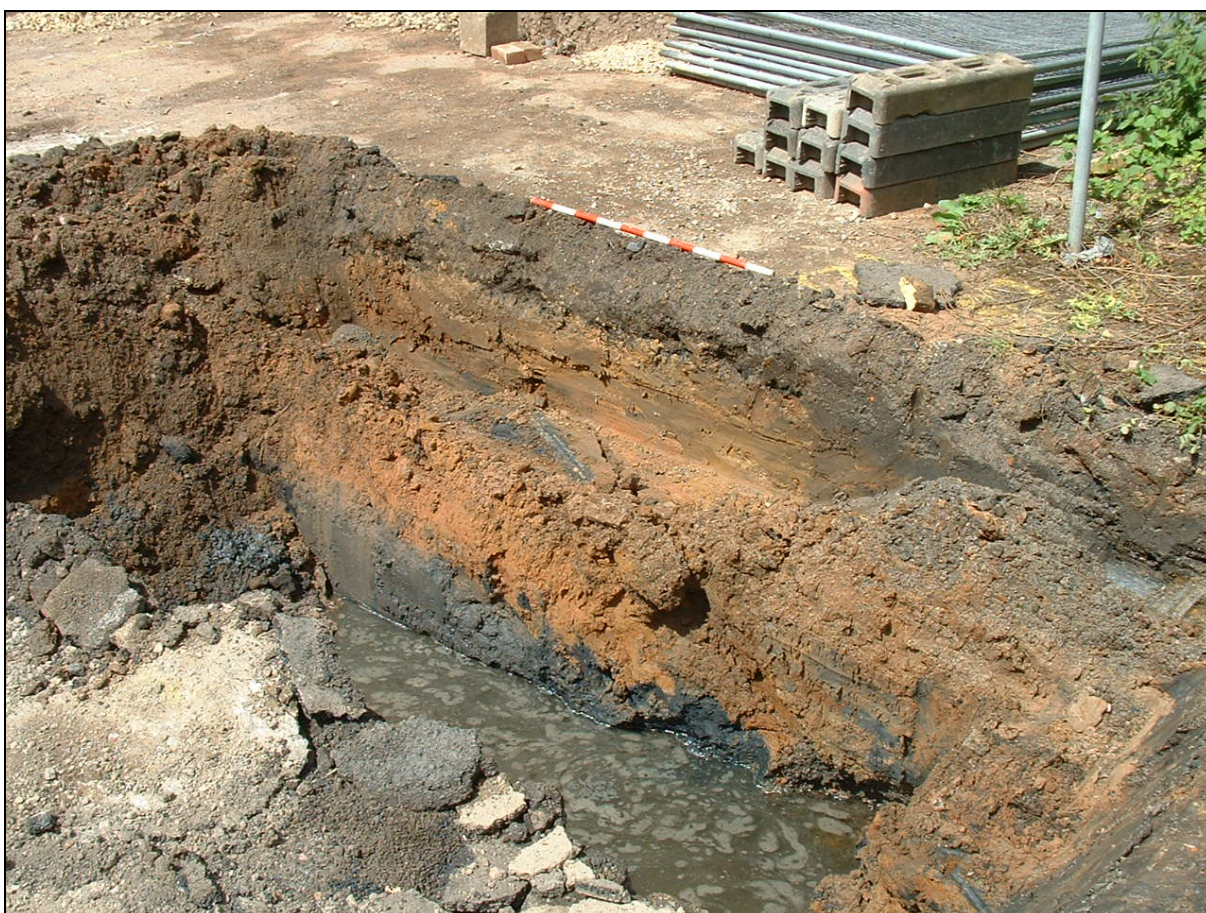
Plate 8. East-facing section Trench B

This trench measured 5m by 2m and excavated to a maximum depth of 1.3m (Plate 8). The earliest deposit within this trench was a dark blackish-grey alluvium (702) that excavated to a depth of 0.5m. Above (702) was layer (701) that consisted of a reddish-brown silty-sandy-clay re-deposited natural 0.6m in depth. Sealing (701) was a hardcore bedding and tarmac surface 0.2m in depth. No finds were recovered from Trench B.
