**NORTH YORKSHIRE COUNTY COUNCIL,
WEST OF HARROGATE HIGHWAYS DEPOT,
PENNY POT LANE, HARROGATE
NORTH YORKSHIRE**

ARCHAEOLOGICAL RECORDING BRIEF

Planning reference NY/2009/0104/FUL

May 2011

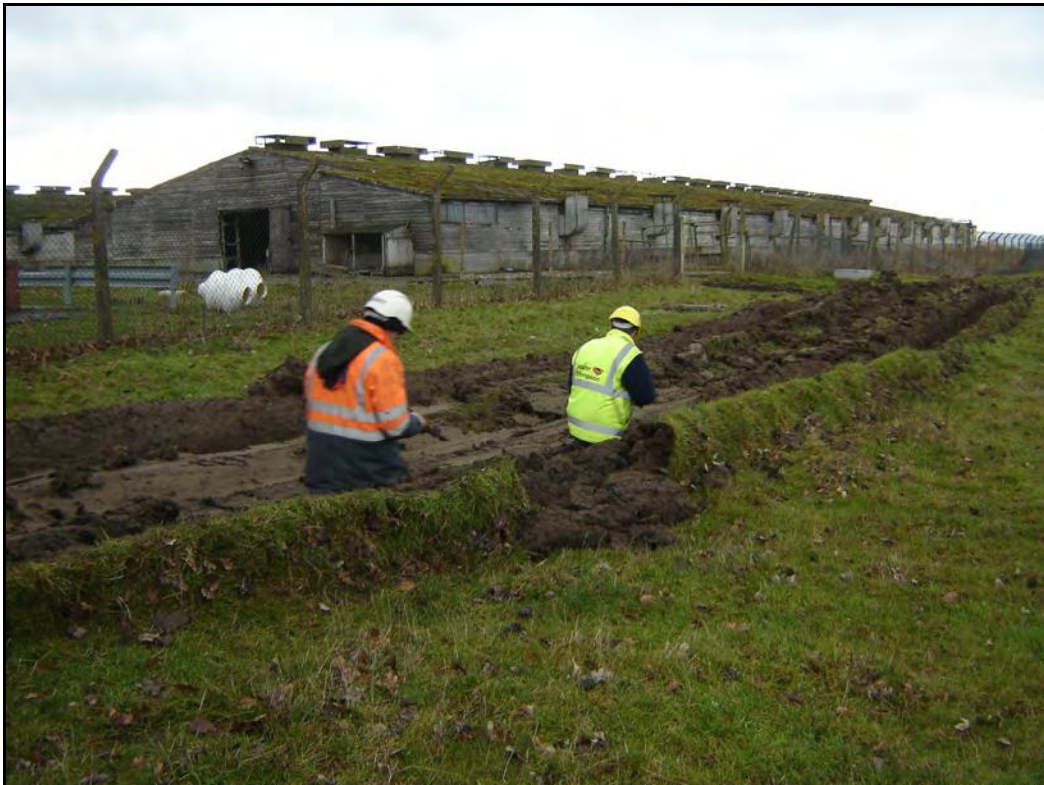
Front Cover: Problems with rutting removing stripped soil

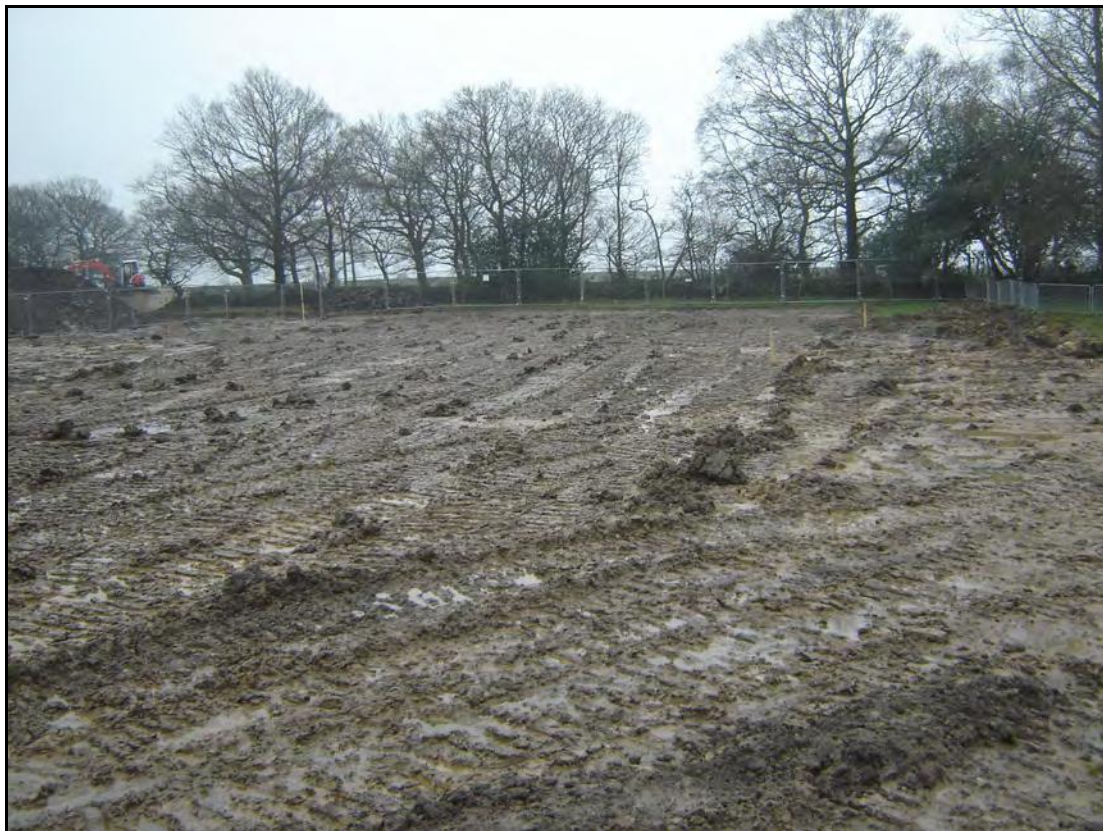
5.1 The recording brief on the green field part of the site recorded that the majority of the site was covered in a 0.15-0.25m thick topsoil, which directly overlay the natural underlying geology (Plate 1). The only exception was an area along the western boundary of the field where a layer of topsoil and natural clay had been dumped and partially levelled. This area of dumping was from the construction of the chicken farm in the 1980s when the site had been levelled and the resulting material spread along the edge of the adjacent field.

Plate 1. General view of eastern portion of the site after stripping, looking south.

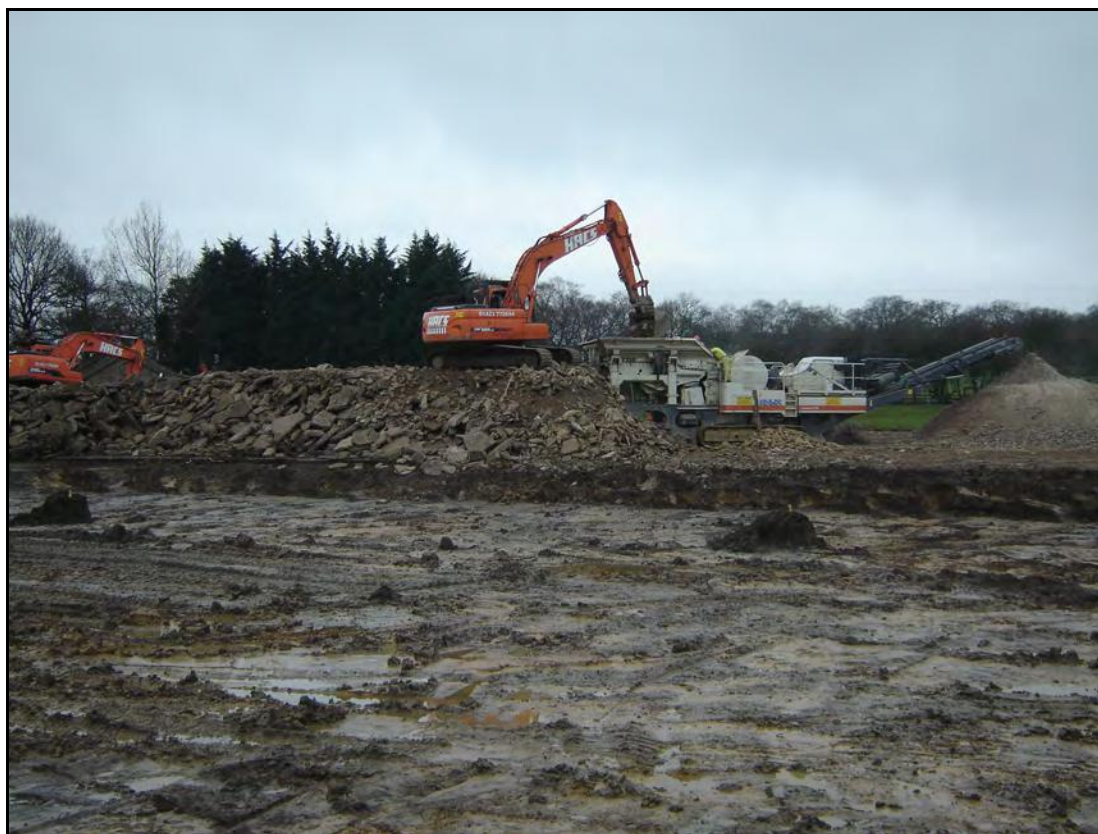
- 5.3 In the area of the former chicken farm the majority of the site was covered in a c.0.25m thick layer of concrete, which had been laid on a c.0.2m thick layer of crushed limestone aggregate. Directly beneath the entire site the naturally occurring geology of glacial drift with occasional large cobbles/boulders was encountered. The underlying geology had been partially cut into when the site was levelled for the construction of the chicken farm in the 1980s. This levelling appears to have cut into the underlying clays by up to 1m along the western side of the site, potentially removing any archaeology that may have been present.

Plate 2. General view of crushing hard standing and site stripping, looking SW.

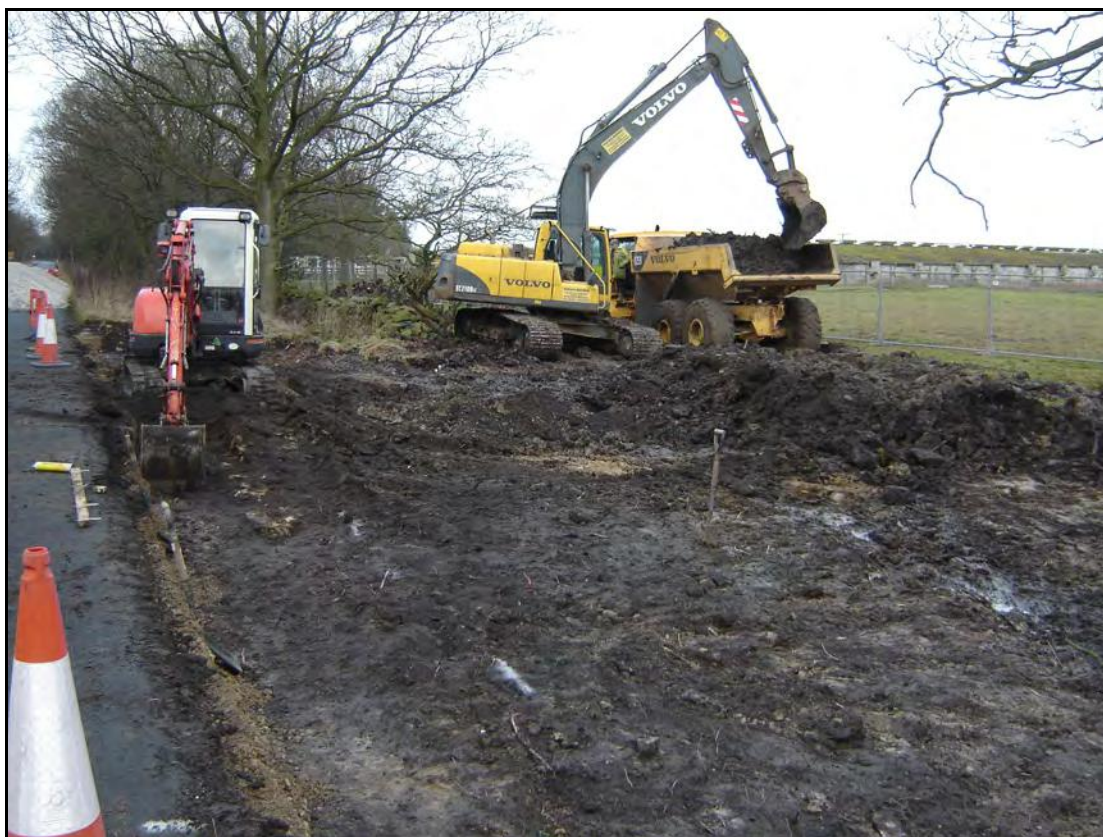
- 5.4 The road widening works largely encountered previously disturbed ground due to modern services along both sides of the road (Plate 3). There was one area of exception where a 110m long section of cobbling was observed. The cobbling ran westwards from the entrance to Prospect Farm on the southern side of the road. The cobbles were predominantly water rolled sandstones/grit stones which had been dry laid (that is with no bonding material). The layer was continuous under the current macadam road and on the same alignment. The cobbles [03] were directly under a 0.25m thick subsoil [02] which in turn lay under a 0.16m thick layer of topsoil [01]. The cobbles themselves formed a layer 0.26m thick and survived for 110m east-west. They could be seen to extend both under the modern road to the north and into the verge to the south, though by how much in each direction is unknown. The cobbles had been laid directly on to the underlying natural clay, which had originally acted to help secure the stones.

Plate 3. General view of road widening, looking north-north-west.

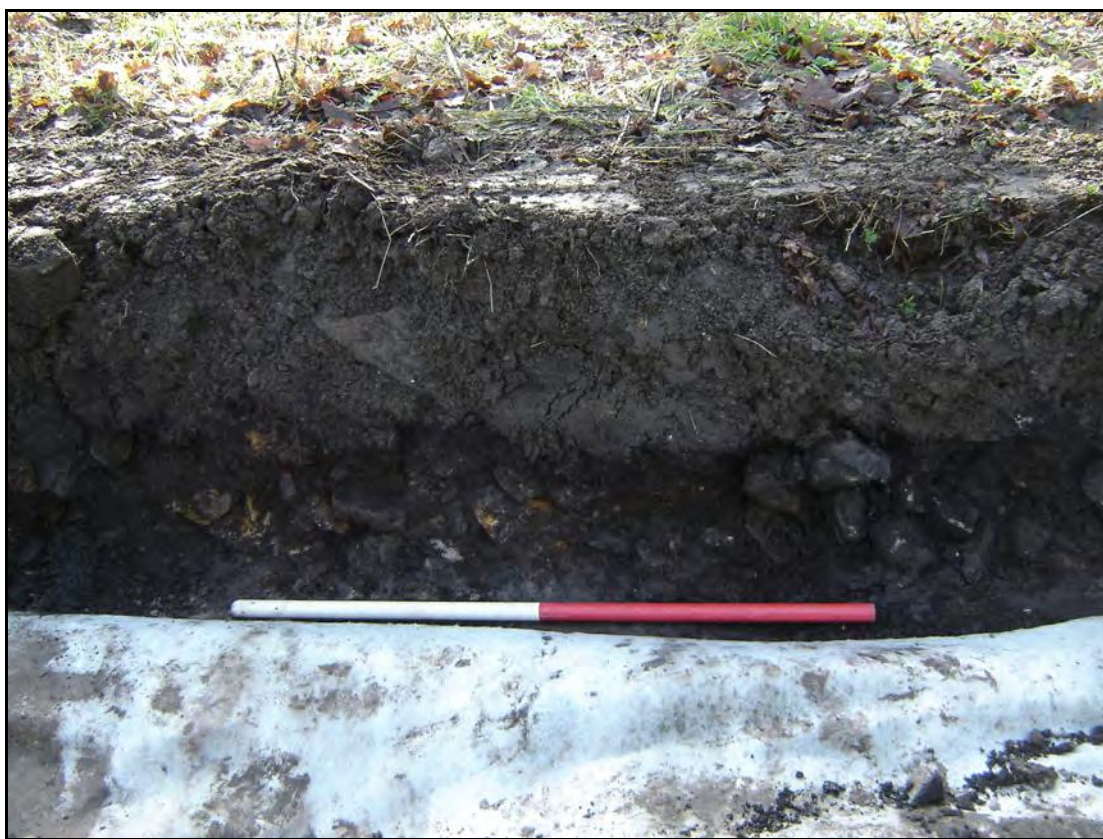
- 01 Loosely compacted dark brown topsoil, 0.16m thick.
- 02 Loosely compacted black/dark grey silty clay subsoil, 0.25m thick
- 03 Loosely compacted yellow sandstone water rolled cobbles, 0.26m thick.
- 04 Natural geology of glacial drift.

Plate 4. Section of earlier road exposed during widening. Looking south, scale 1m.
