MINING SHAFT

WOOGILL MOOR, NORTH YORKSHIRE

ARCHAEOLOGICAL SURVEY AND WATCHING BRIEF

April 2011

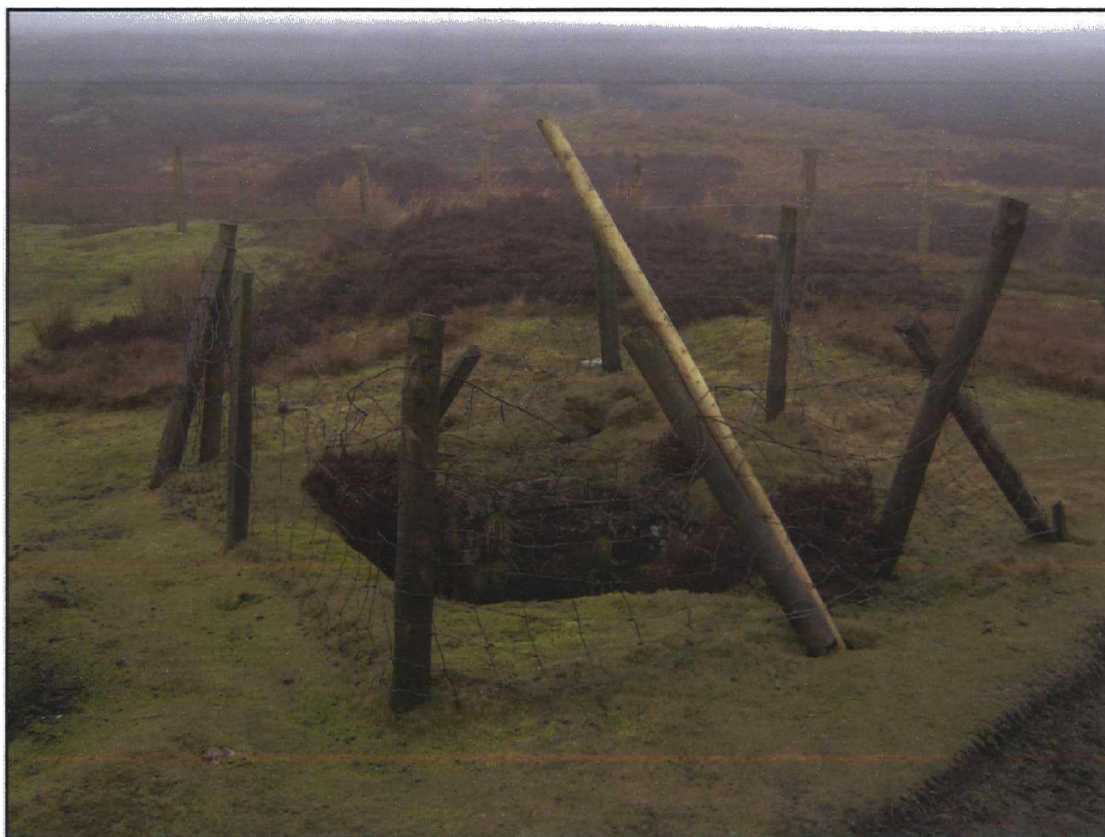
Front Cover: Top of shaft prior to works, looking north-east

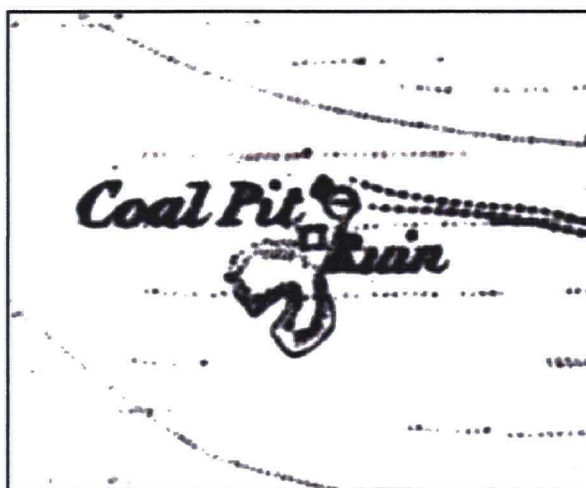
1856 Ordnance Survey

- 5.4 It was also possible to locate the site of a small building shown as a ruin on the 1856 OS map (Plate 3). Little evidence of the building remains at ground level

apart from what appears to be a corner showing as a turf-covered right angle. This feature lies *c.*3m to the south-west of the shaft and is crossed by a modern farm track, which may well have had an impact on any buried remains.
