**RICHMOND DISTRICT COUNCIL HIGHWAYS DEPOT,  
GATHERLEY ROAD, BROMPTON ON SWALE  
NORTH YORKSHIRE**

**ARCHAEOLOGICAL WATCHING BRIEF**

**Planning Decision C1/12/49Q/FUL**

February 2011

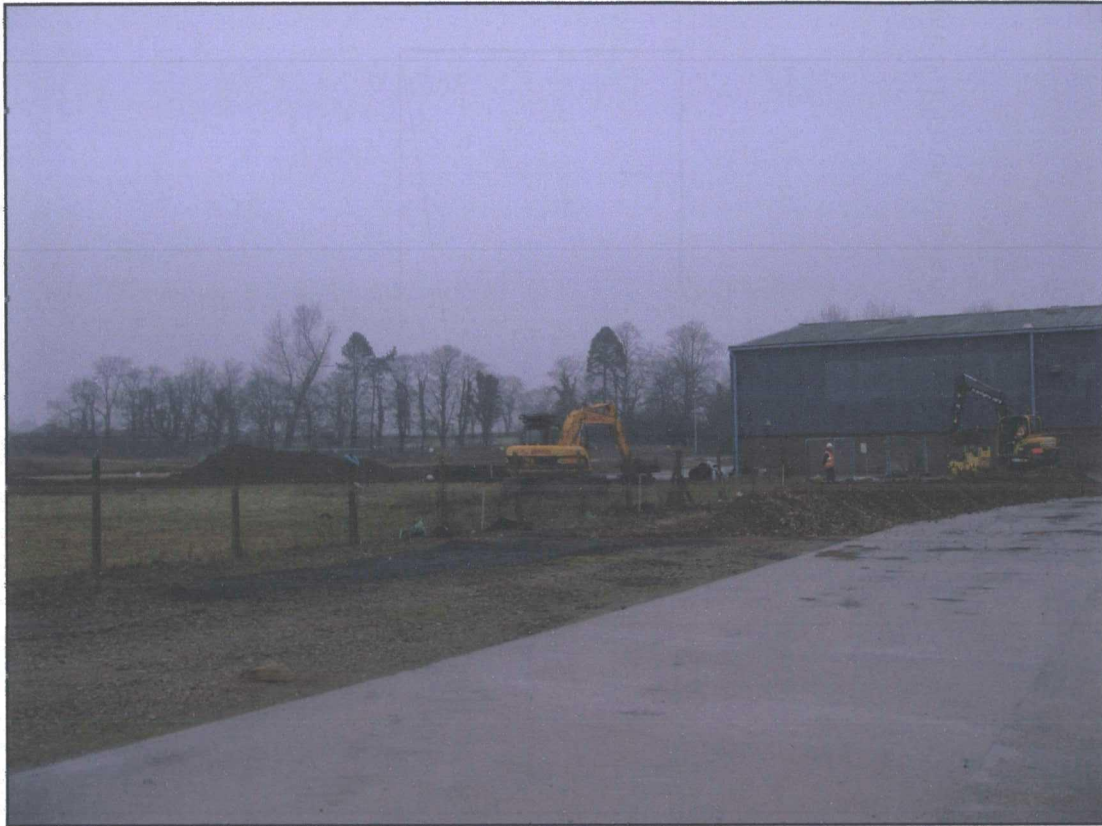
Plate 1. General view to north-east of stockpile area during works.

4.1 All of the monitored ground works were undertaken using a wheeled mechanical excavator with a toothed bucket (due to the amount of concrete and hardcore) under direct archaeological supervision. The ground works consisted of cutting the trenches for the foundations of a new storage area, new service trenches and four underground tanks (Figure 2 and Plate 1).

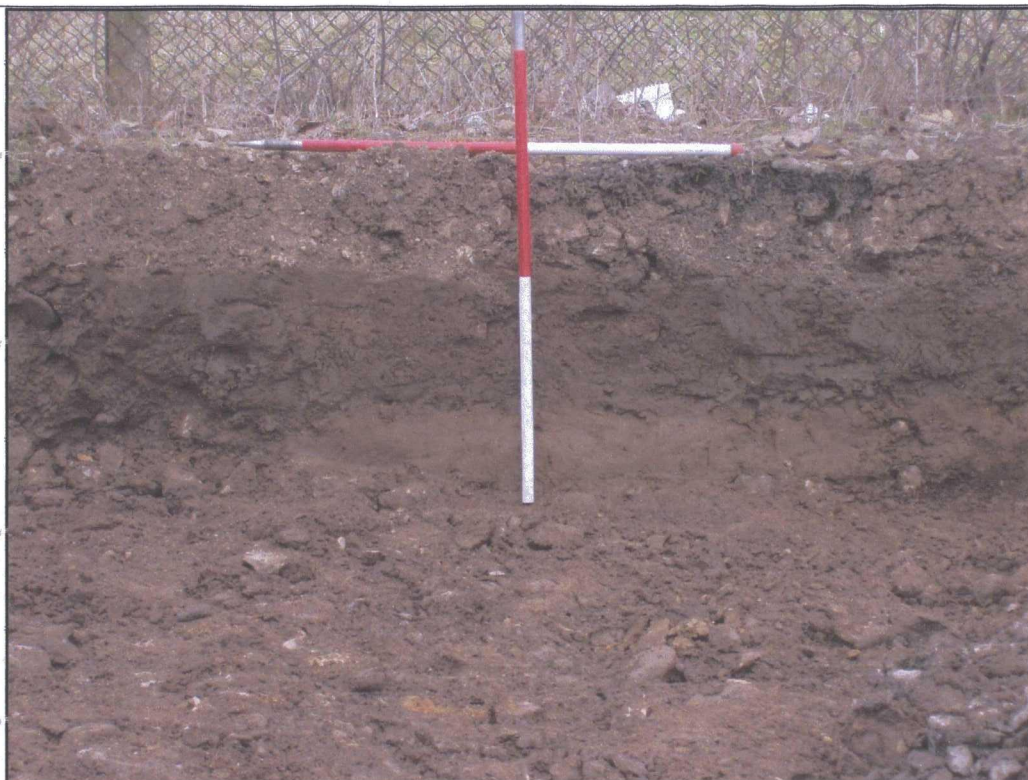
Plate 3. Profile of ridge and furrow in stockpile area. Looking north, scales 1m.

5.2 The ridges are represented by light brown silty-clay [003] and were identified in section and recorded in a plan. This context was a light brown silty-clay evident as clear bands or ridges 2m wide with the interval between the two ridges of 6.8m. The furrow [005] between the ridges was a reddish brown clay with frequent, rounded stones. At the western end of the trench a small area of heat affected stones [004] was recorded protruding from a loamy/clay deposit, some of the stones were obviously fire-cracked. Context [004] was a brown silty-clay with large rounded heat affected stones up to 0.25m diameter (Plate 4). No artefacts were identified within this deposit. There was no form identifiable to this deposit and, as it was going to be left *in situ*, it was not investigated further.

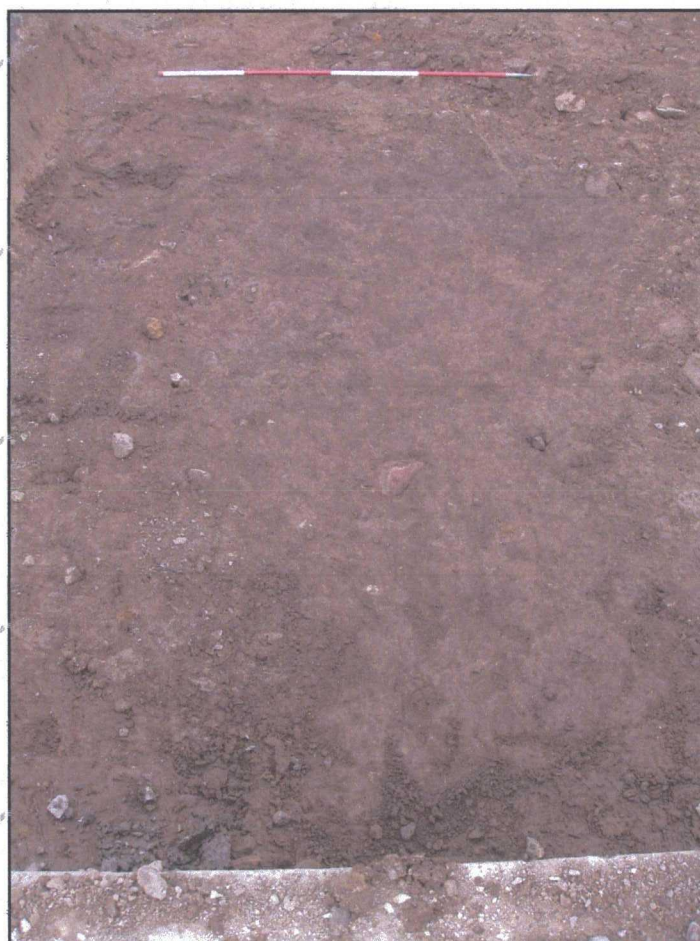
Plate 4. Context 004 – area of heat affected stones.

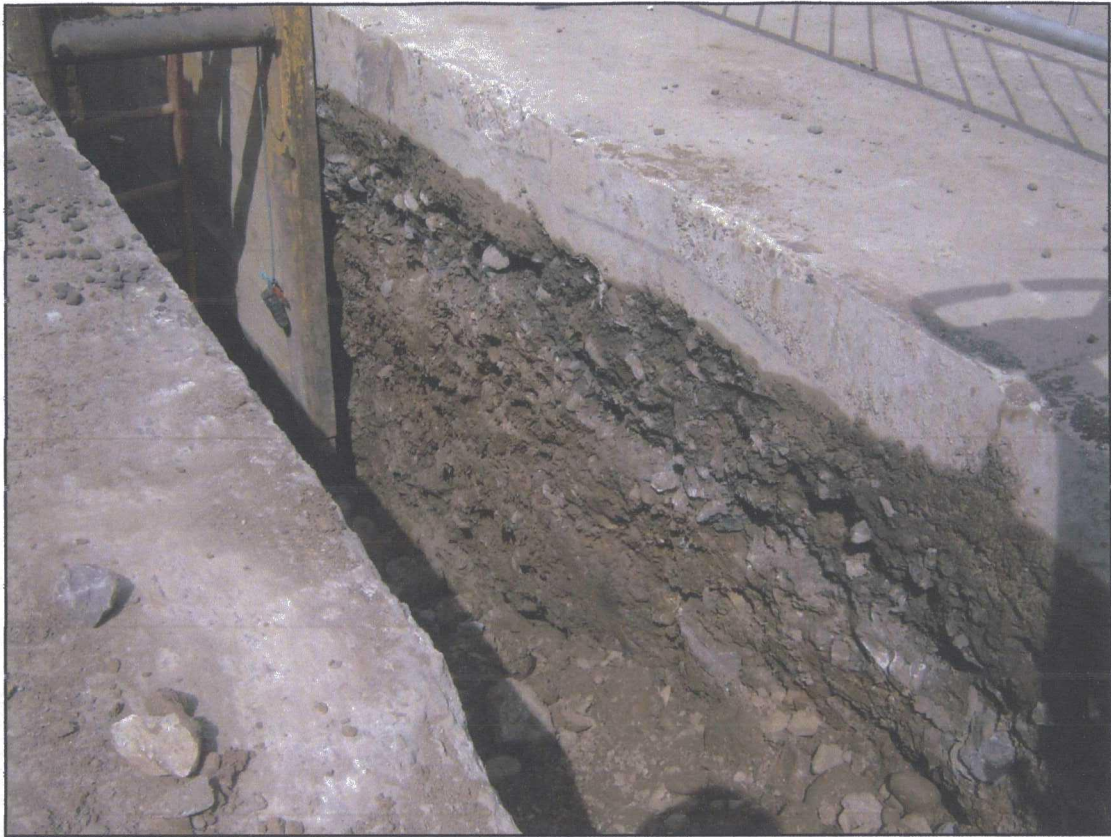
Plate 5. General view of excavation of service trench.

- 5.3 In the western part of the site the areas of watching brief recorded that this part of the site appeared to have previously been topsoil stripped prior to the laying of a c.0.3m thick layer of limestone hardcore [007] and a c.0.35m thick layer of partially reinforced concrete [006]. Beneath this were the undisturbed, naturally occurring alluvial sands and gravels [008] (Plates 5 & 6). The previous topsoil stripping when the site was originally developed appears to have removed any archaeological remains, should anything have been present originally.

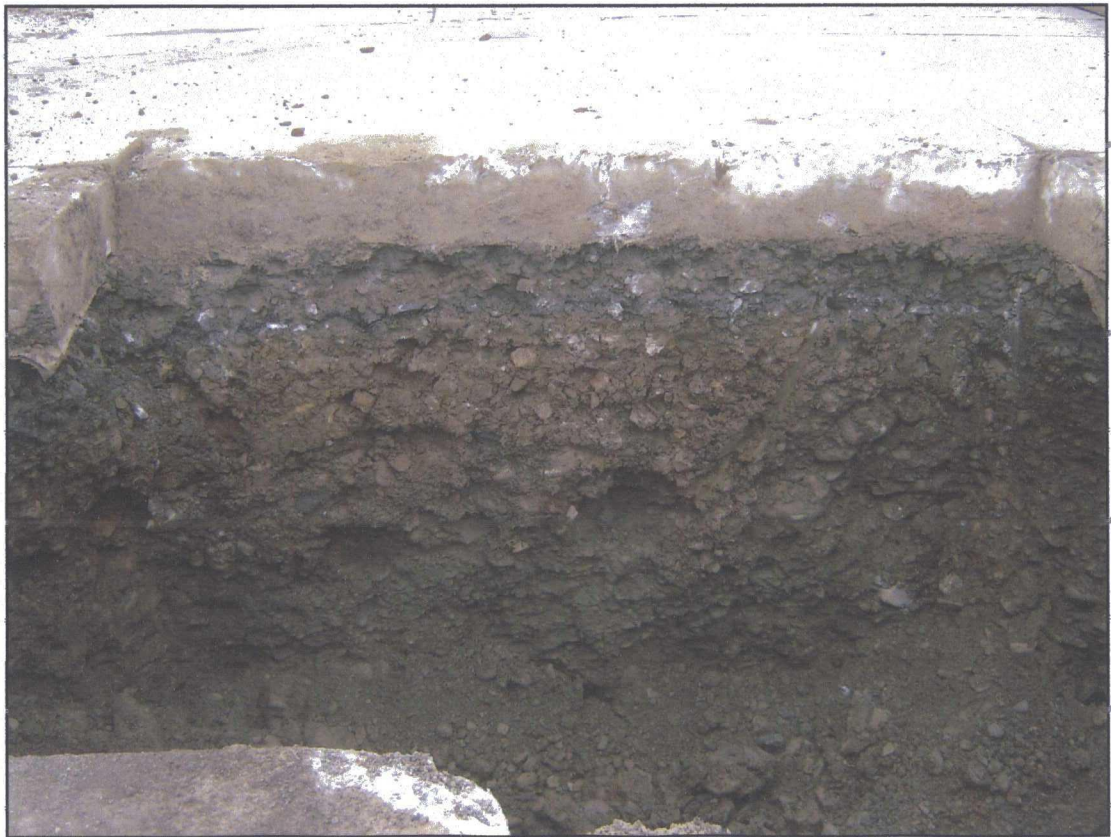
Plate 6. Typical section through side of manhole trench.
