**Land at Back Side,
Duggleby,
North Yorkshire**

SE 8774 6699

Archaeological Excavation

MAP 05-01-04

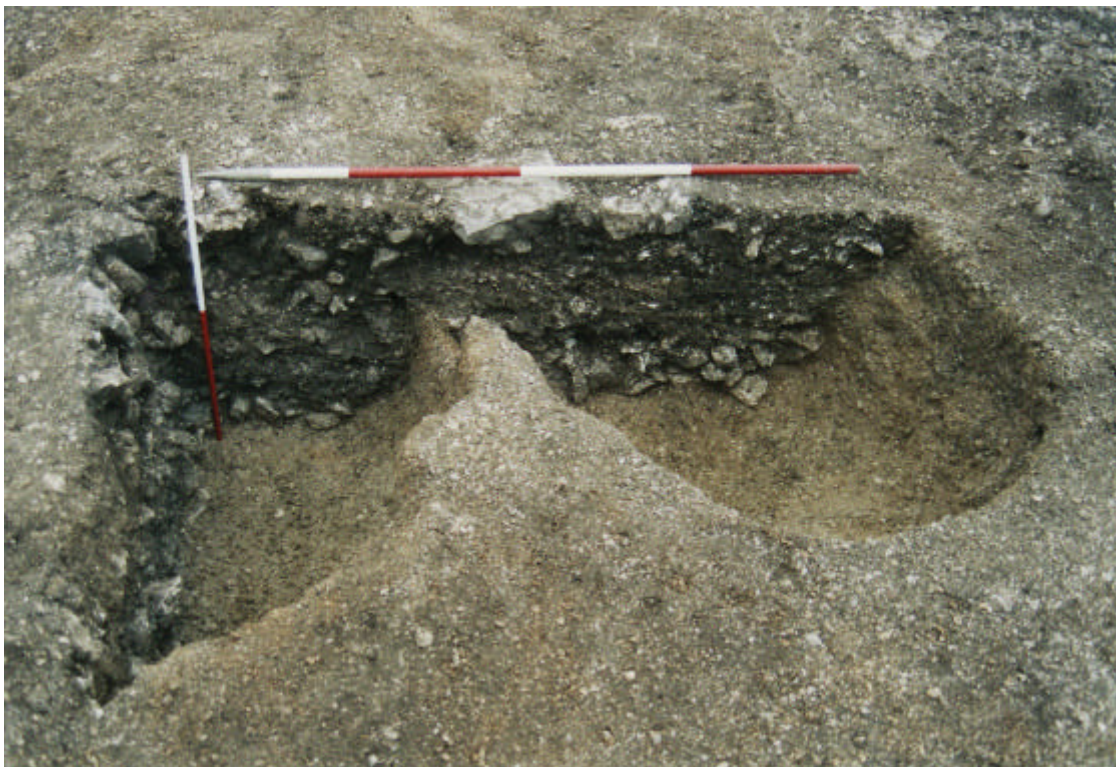
Plate 4. Pits 5105 and 5106. Facing South-east.

Pit 5105 lay to the east and was similar in size to Pit 5083. The primary fill (5109) consisted of angular chalk cobbles in a brown silty matrix (containing a quern fragment), with an overlying layer of dark brown silty gravel (5108). The top of the pit was filled dark brown silty gravel (5107), which contained in excess of 100 sherds, comprising Staxton, York Glazed, Gritty, Splashed and Scarborough wares, along with animal bone fragments. Further to the east lay a large pit over 3m in diameter (cut 5120, fill 5021), with a relatively shallow, broad dished profile; neither of the two fills (5121 and 5122) contained any finds.

Pit 5106 was situated in the north-east part of the site, and was a sub-circular feature with a diameter of around 3m, steeply-sided and flat-based. The primary fill (5112) was an unstable deposit of chalk and flint rubble, overlain by a more gravely intermediate deposit (5111); the uppermost fill consisted of chalk gravel in a matrix of darker clay silt (5110). Fill 5111 contained Staxton, York Glazed and Humber Ware sherds many of which belonged to the same large jug. Fill 5110 had finds of Staxton, York Glazed and Beverley sherds. The Humber Ware dates the pit to the late medieval period.

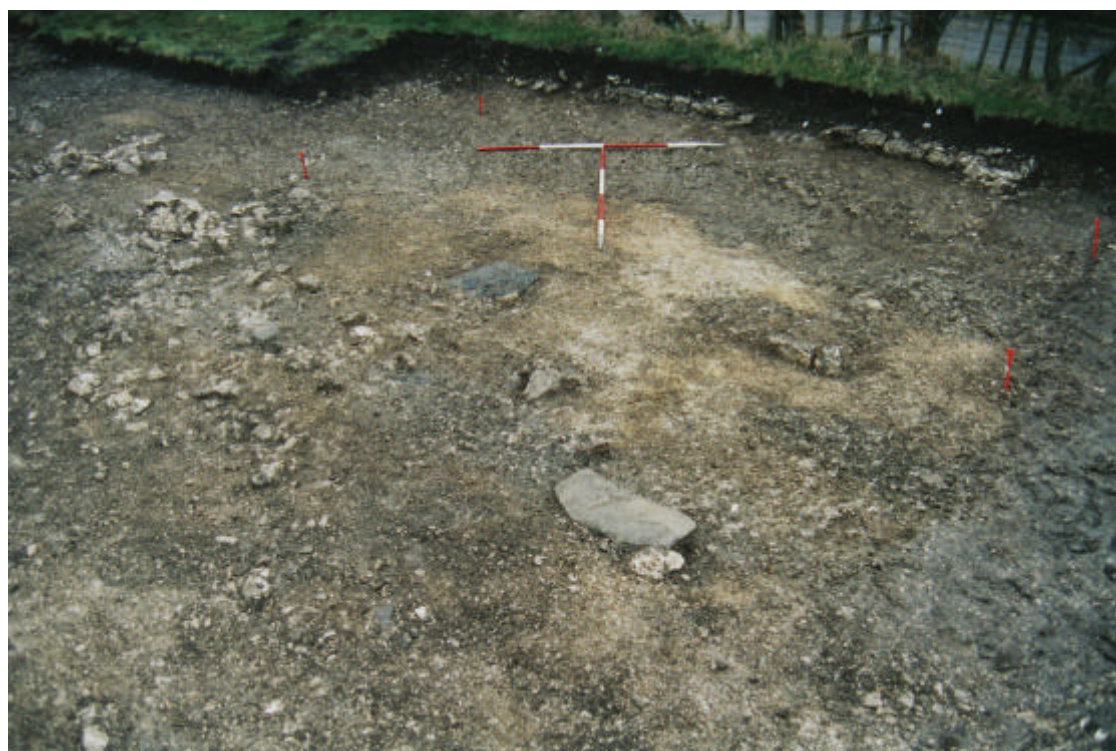
Plate 8. Structure 2: Walls 5017, 1046-1050 and 5061. Facing North-west.

The remainder of the structural remains formed a coherent unit, consisting of four fragmentary stretches of un-bonded chalk walling (1046, 1049, 5017 and 5061), a post-pad (context 1045), surfacing (contexts 1042 and 1051), a rubble spread (context 1043 – perhaps more surfacing), and a hearth (context 1047). Although fragmentary (presumably due to demolition and robbing) enough of the structure survived to show that it formed a rectangle 6m long east to west and 5m wide north to south.

Wall 1049 formed the southern wall of the structure and consisted of an intermittent stretch of chalk blocks running on a west to east alignment for approximately 4m. The blocks were a single course high, around 0.30m wide and were faced to the north.

Wall 1046 formed the eastern wall, and ran at right-angles to the end of Wall 1049, the two being separated by a narrow gap. Wall 1046 was formed by a single course of shattered chalk blocks. Both east and west faces were present, giving a total width of 0.50m. The wall was contained within a shallow construction trench (cut 5028, fill 5029).

The northern wall was represented by Wall 5017, a 3.50m long east to west stretch of squared chalk blocks, surviving to a maximum of two courses in height. This wall was also laid within a shallow construction trench (cut 5018, fill 5016), from which no finds were recovered.

Structure 2's western wall was represented by Wall 5061, whose fragmentary remains consisted of a single course of seven roughly squared chalk blocks with both a western and an eastern face. There were no associated finds.

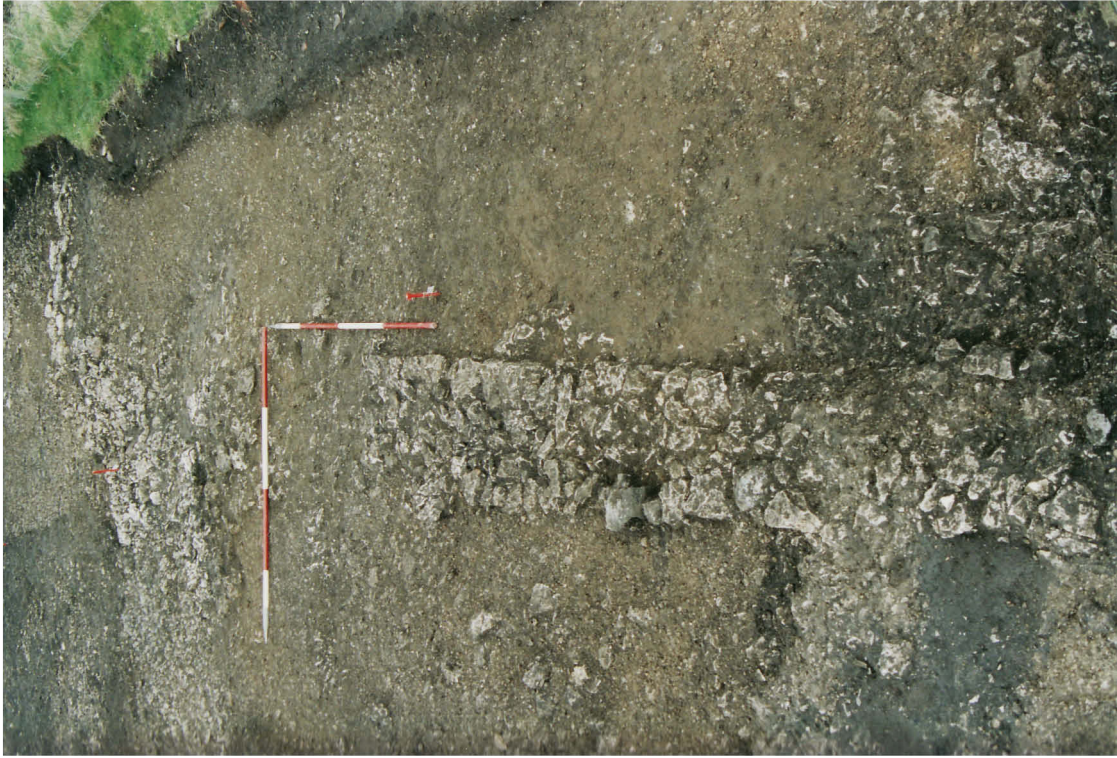
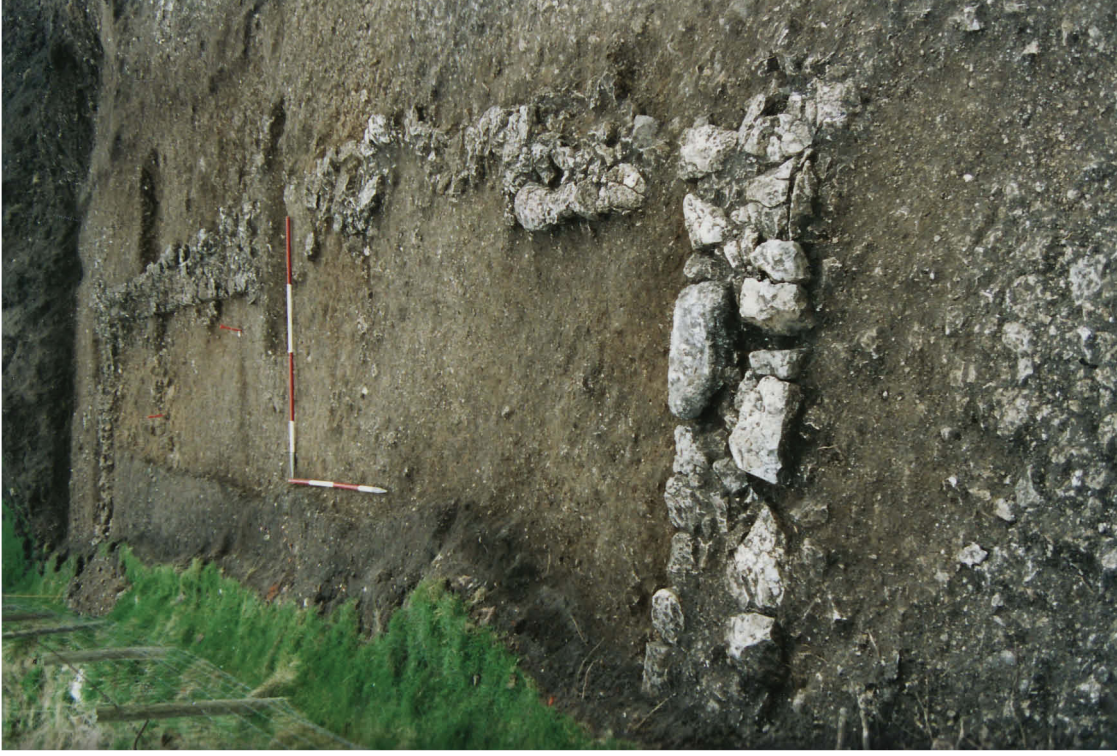
Plate 9. Structure 3: Walls 2005, 2007, 5117 and 5119. Facing North.

Plate 10. Structure 3: Walls 2005, 2007, 5117 and 5119. Facing North.

The western and southern walls of Structure 3 were represented by a 0.45m wide chalk construction (2005). Wall 2005 was made of roughly squared unbonded chalk blocks running in a discontinuous line on a rough north to south alignment. Wall 2005 terminated at its southern end at a rectangular setting of laid chalk rubble (context 2007), 1.1m x 0.85m in size, possibly a buttress. A maximum of six courses remained at its southern end where it was terraced into the natural slope.

The northern wall was recorded separately as Wall 5117; it was similar to Wall 2005, but only survived to a maximum of 2 courses in height. The wall was faced with squared chalk blocks with a core of sub-angular chalk rubble.

A possible internal division of a 1.20m length of roughly squared chalk blocks (5119) was recorded c.3.5m from the northern end of the building. Wall 5119 butted Wall 2005, but not at right-angles; it was clearly an addition to the original structure.

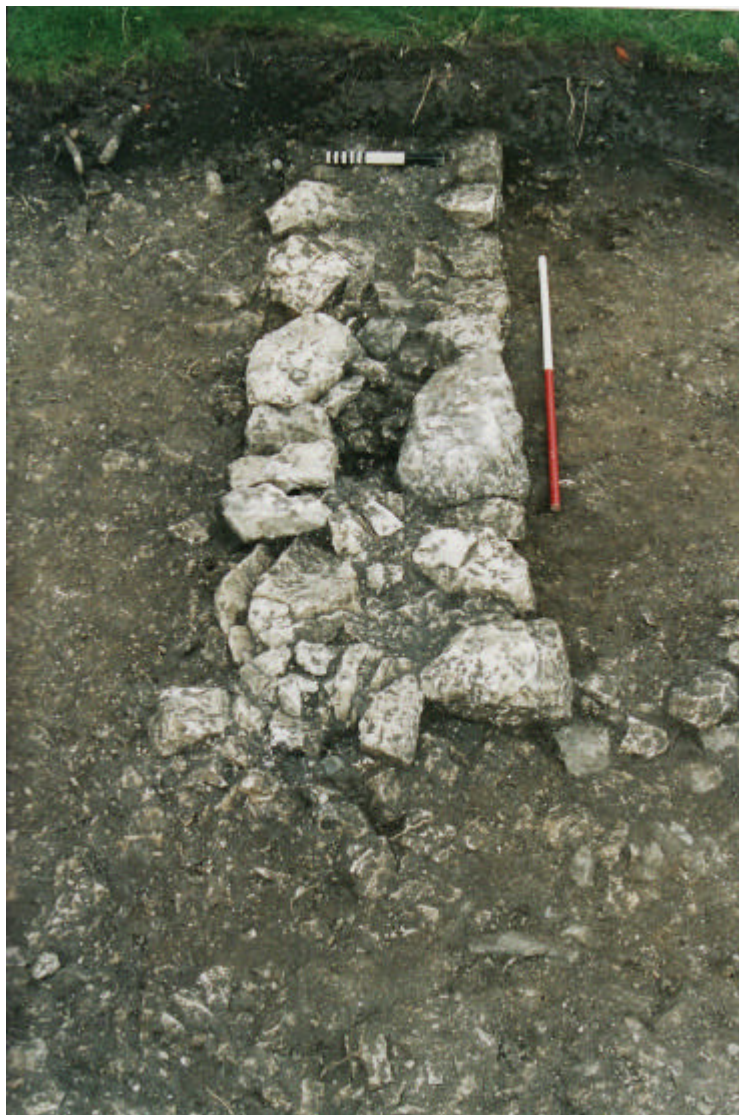
Plate 11. Structure 3: Wall 5117. Facing East.
