**KILLERBY HALL, KILLERBY, CAYTON,
SCARBOROUGH, NORTH YORKSHIRE**

DESK-BASED ASSESSMENT

REPORT NUMBER 2011/58

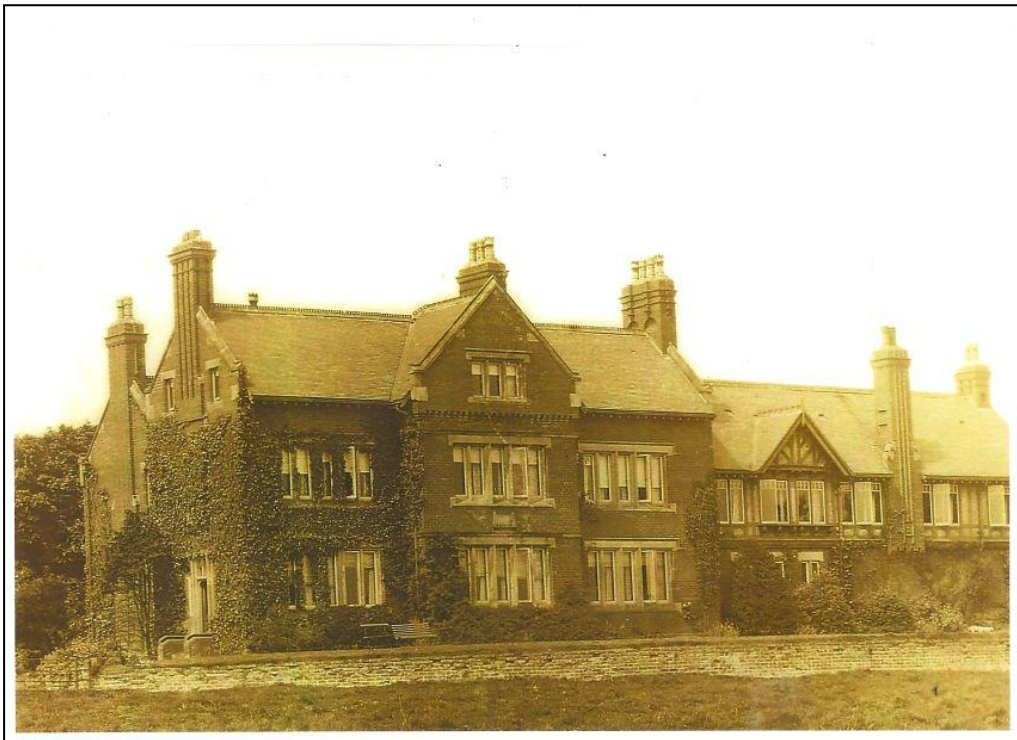
*Plate 1 Undated, possibly early 20th century, view of Killerby Hall and Tudor Lodge
Reproduced by permission of Mrs S. Bushby*

Although a number of sources, including the North Yorkshire Archives Online Catalogue, were searched no old photographs of Killerby Hall and its grounds were located. However, during the visit for the site walkover the current owner produced a small collection of old photos which fell roughly into two categories. Firstly were a group of photographs of various unidentified persons apparently on the lawn immediately south-west of the Hall. The second group comprised a number of views of the lawns and gardens around the Hall. These had no captions and it was not possible to be certain of where they were taken since the grounds appear to have changed somewhat since they were taken. Some at least should date from the early 20th century since amongst these photos are a number which have been identified as of the James Cooper who was living at the Hall in 1905. Possibly of the early 20th century is a fine photo of the south-west and south-east facades of the Hall (Plate 1) showing little difference to the present day although much of the south-west end is covered by ivy.

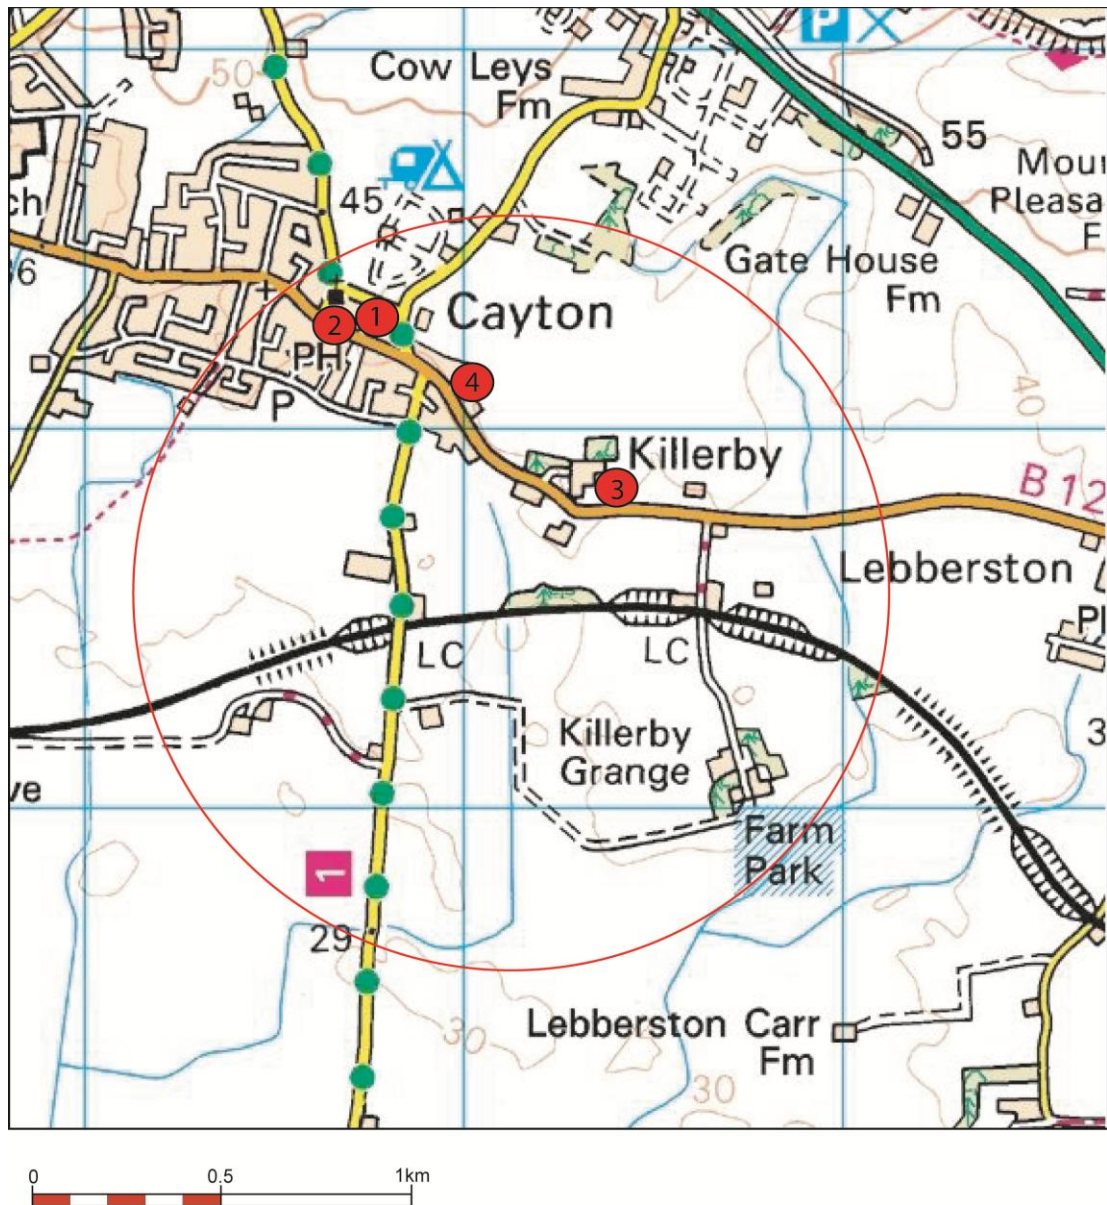
Figure 10 Listed Buildings within the study area

Information from the North Yorkshire HER indicates that just four listed buildings lie within the study area. The numbers in bold refer to Figure 10. The buildings were; The Church of Saint John the Baptist, Church Lane, Cayton, Grade I (**1**) (NYHER DNY 11105), 87 Main Street, Cayton, Grade II (**2**) (NYHER DNY 11106), Killerby Old Hall, Killerby, Cayton, Grade II (**3**) (NYHER DNY 12998) and Whitfield Cottage, Main Street, Cayton, Grade II (**4**) (NYHER DNY 12999). No further information was derived from any other source.

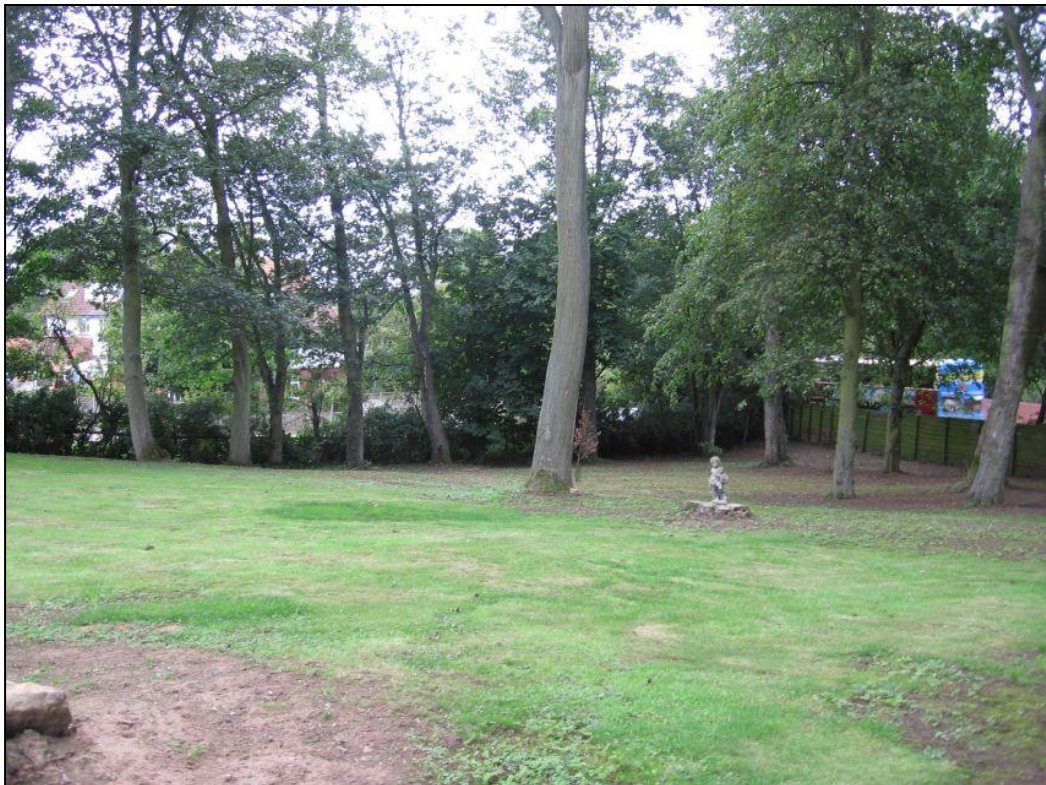
Plate 3 The north-western corner of the site, looking north-west

The area between the hall and the B1261 is, apart from the drive, mainly lawn but with trees forming a screen by the road and the north-west boundary of the site. A number of mature trees are situated within the central parts of this lawn. Much of the lawn is roughly level but there is a quite sharp slope down towards the main road. West of the south-west end of the hall is a more modern building used as a holiday let. The ground in the vicinity of this is still mainly lawn but with shrubs and small trees at intervals rather than the more mature trees to the north-east. Towards the south-western limit of the lawn, adjacent to part of the north-western boundary of the site, stands a small brick-built structure which is in use as stables for horses. The area described above effectively makes up the north-west corner of the site.

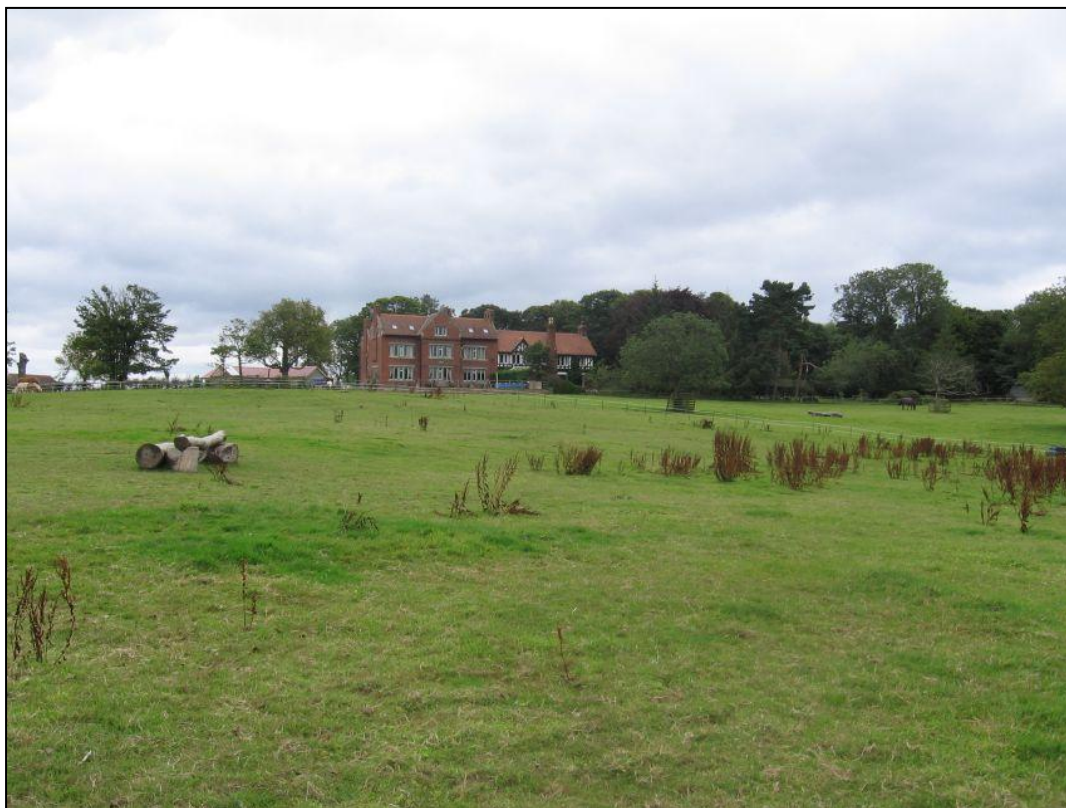
Plate 8 The pasture area with hall in background, looking north

Much of the rest of the site is rough grass / pasture, most of it in use for grazing horses although part of it contains a series of horse jumps. This pasture slopes downward, sometimes quite steeply, to the south levelling out at the southern site boundary, a screen of trees marking the northern limit of land occupied by part of the Scarborough to Hull railway line. The Eastern boundary of the pasture land is marked by a mature hedge and the northern by a low fence beyond which lies a semi-wooded area which is not part of the site.

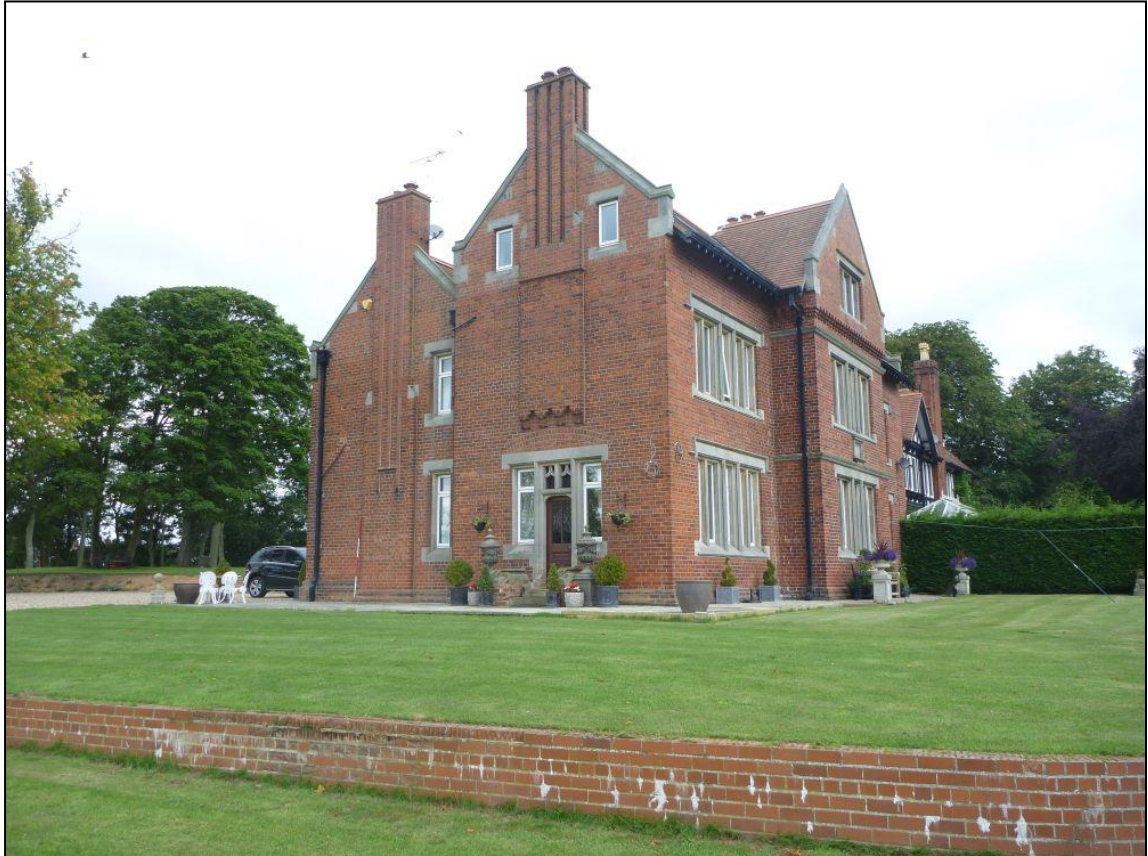
Plate 9 The south-west and south-east facades of the hall, looking north

The hall is of two storey's, constructed of red brick with substantial stone dressings to window and door openings. Many of the windows are large though are broken into smaller glazed areas by stone mullions. All roofs are pitched, with gabled ends, and have a covering of red tiles. There are red ceramic ridge tiles to the apex of the roof and heavy stone coping to the gables. Drainage of the roof is via cast iron guttering to the eaves and lead-lined roof valley's that feed to cast iron hoppers and down-pipes of cast iron. There is a fine terracotta panel, within a classical surround, that depicts a cooper working on a barrel. This may be a reference to the surname of the builder and original owner of the hall. There are three

chimney stacks, each of which is has restrained decoration in brick. Stylistically, the hall belongs to the later 19th century and draws on the Gothic tradition. This Gothic influence is highlighted by a full-height hall on the north-west side which takes up a substantial part of the building's footprint.

Although of no great age Killerby Hall has a number of interesting features both externally and internally and should the proposed works involve any demolition or substantial alteration to the fabric some form of building recording might be justified since there is no evidence of any detailed survey of the structure apart from the modern architects drawings.
