ROCKING HALL SHOOTING HUT,
ROCKING MOOR, THRUSCROSS,
NORTH YORKSHIRE

ADDITIONAL ARCHAEOLOGICAL AND
ARCHITECTURAL RECORDING

Report no: 2010/389.R02
Version: Final
Date: October 2011
Authors: Shaun Richardson & Ed Dennison

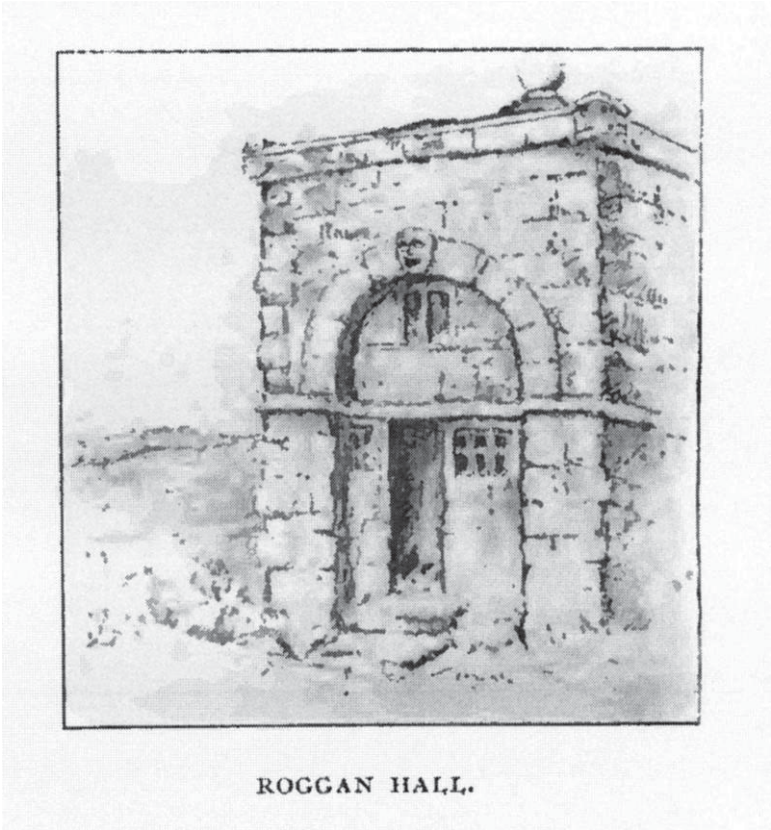
PROJECT		ROCKING HALL	
TITLE		HISTORIC DEPICTIONS	
SCALE	NTS	DATE	OCT 2011
EDAS		FIGURE	3

- 2.5 Edmund Bogg, writing in 1904, produces an illustration of Roggan Hall, drawn by A Sutton (Bogg 1904, 41) (see figure 3). The original date of Sutton's work is not given, although the frontispiece notes that the illustrations were "prepared expressly" for the book. However, it is a very puzzling sketch as it differs from the

existing structure in a number of significant respects. Firstly, it only depicts the central part of the existing three bay structure, and the north and south wings are not shown. This implies that they are later additions, although there is no convincing structural evidence to suggest this, and indeed the three bays are clearly shown on the historic Ordnance Survey maps (see figure 4). Secondly, rather than having a pitched roof, the upper part of the structure is carried upwards in the form of a rather squat, sub-square tower, with a projecting low parapet which appears to have further angled projections to the corners. The sketch also suggests that the structure may have been surmounted by a low pyramidal roof topped by a ball finial. Assuming that the sketch is an accurate representation, it is of considerable importance as it suggests that Rocking Hall might not have originated as a shooting lodge (see Chapter 4 below).

Roggan Hall sketched by A Sutton, reproduced by Bogg 1904, p41.

- 4.2 The watching brief has provided further support that Sutton's undated sketch of 'Roggan Hall' (see figure 3) is a realistic depiction. In its original form, this was apparently a tower-like structure, probably only of a single tall storey internally, surmounted by a low parapet with corner projections, and a pyramidal roof with a ball finial. Its plan and former east elevation are partly preserved in the central cell of the shooting hut. The wider east and west walls were retained from the tower, indicating that it was originally c.4.80m square (externally), but the north and south walls were then demolished when the north and south cells were added. This removed evidence for the former ceiling vault to the north and south walls, but the curves which remain to the east and west walls indicate that a shallow vaulted ceiling rose into the pyramidal roof space. There was probably a fireplace in the centre of the west wall (although it is not absolutely certain that the surviving example is that fireplace), with a hood or mantelshelf over and flanked by flat-headed cupboards or niches. It apparently stood in isolation, although the possible wall footings recorded to the south of the shooting hut suggest at least the possibility, if nothing more, of an associated structure or enclosure. Quite why the original north and south walls were demolished to make way for the new north and south cells, instead of utilising the original structure, is unknown.

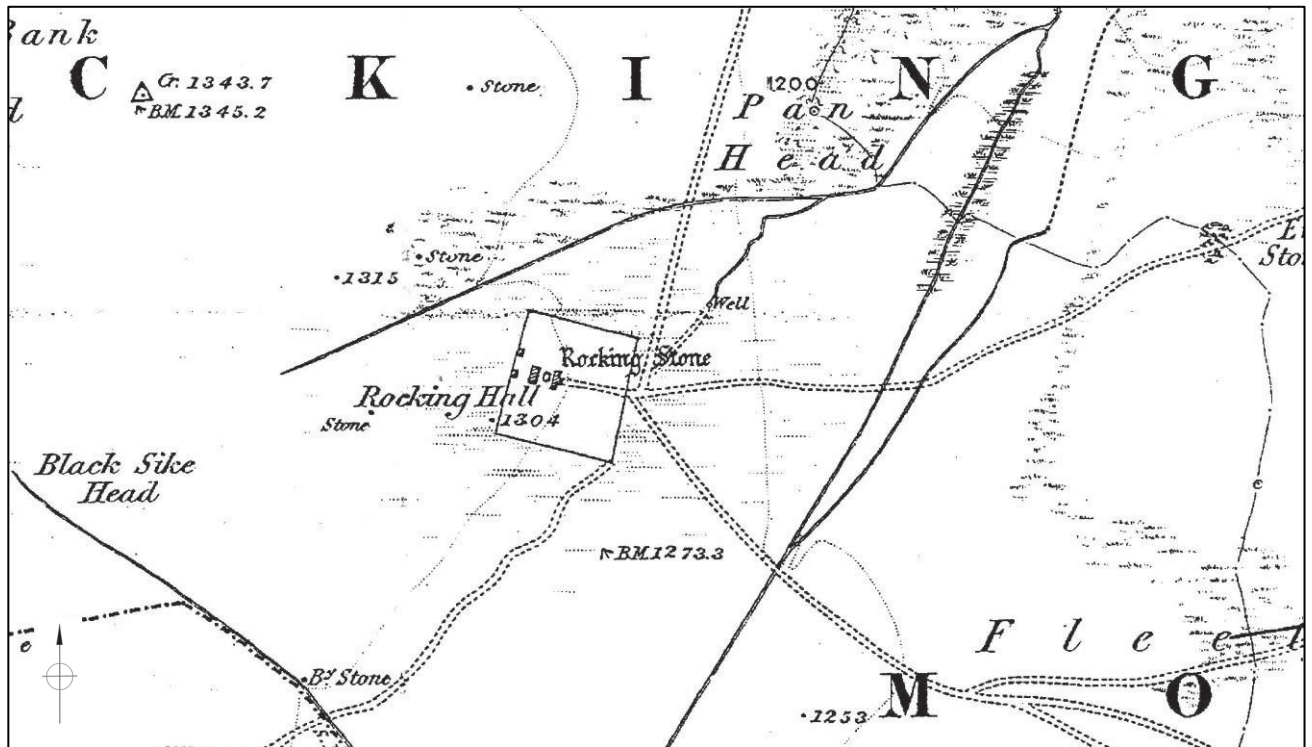
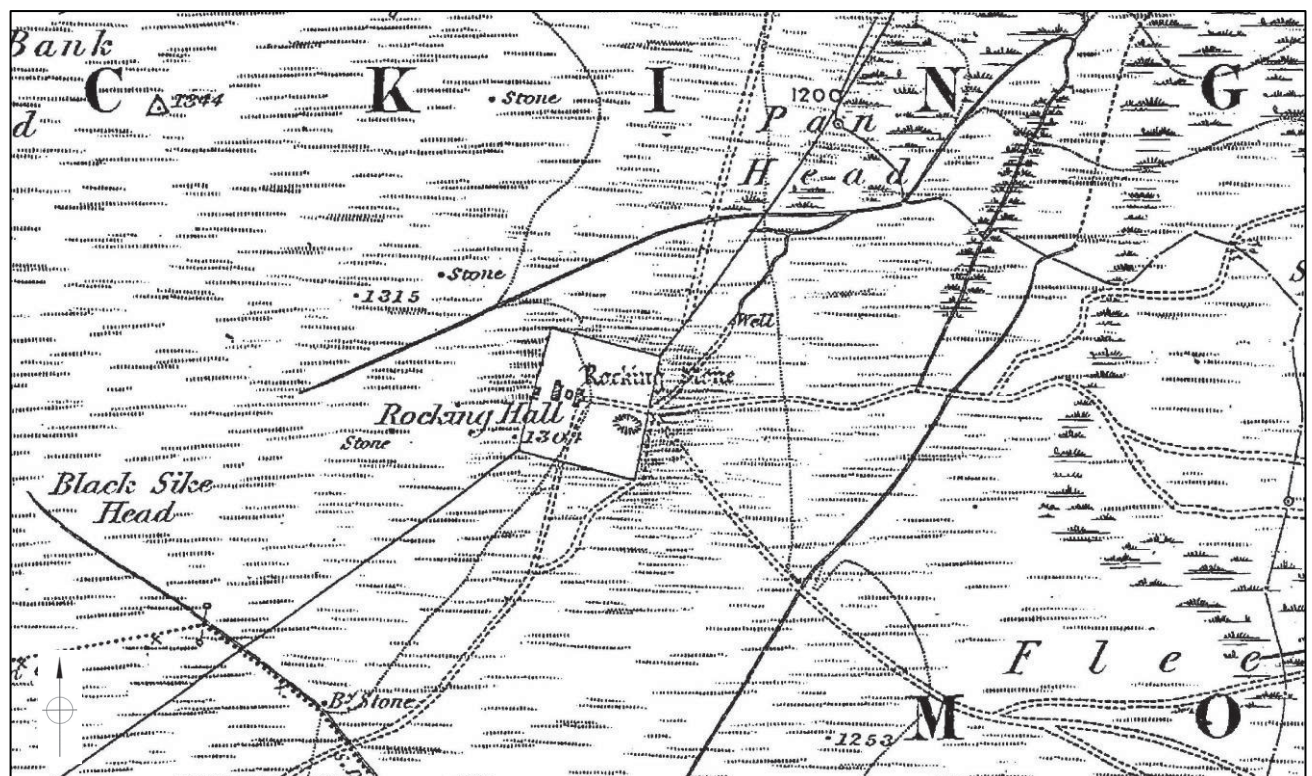
PROJECT		ROCKING HALL	
TITLE		HISTORIC ORDNANCE SURVEY MAPS	
SCALE	NTS	DATE	OCT 2011
EDAS		FIGURE	4

- 2.3 The 1st edition 6" Ordnance Survey (1854) map names the shooting hut as 'Rocking Hall', and places it to the west of centre of a square walled enclosure (see figure 4 top) in an otherwise open and largely unenclosed landscape. Three tracks converge on the east side of the enclosure, where at this date the only apparent point of entry seems to have been located; in fact, it is noticeable that for some distance to the east, the majority of tracks shown on the map are converging on the enclosure. These tracks to Rocking Hall run from Hay Slack Allotments to the north, Raven Stones and Bramley Heads to the east, and King's Allotment to the south-east. A single track, directly aligned on Rocking Hall, then passes through the east wall of the enclosure and runs straight to Rocking Hall. To the west, the 'Rocking Stone' is marked, and to the west of this, the house. There are two small square structures shown attached to the west wall of the enclosure. A 'Well' is also depicted just to the north-east of the enclosure.

- 2.4 There had been only minor changes by the time the 2nd edition Ordnance Survey 6" map was published in 1892 (see figure 4 bottom). In addition to the tracks noted above entering the east side of the enclosure, a further track ran into the enclosure and to Rocking Hall from the south and south-west across Long Ridge. An oval depression had appeared to the south side of the earlier track running in from the east, which the modern map marks as a disused shaft (see figure 2). The northern of the two small structures attached to the west wall of the enclosure in 1854 is no longer shown. By now, the square enclosure formed part of the enclosure landscape, with a long wall running north-east/south-west across Rocking Hall. No shooting butts are marked in either 1854 or 1892. On the 1909 Ordnance Survey map, no structures are attached to the west wall of the enclosure.

Top: Ordnance Survey 1854 6" map sheet 152.
 Bottom: Ordnance Survey 1893 6" map sheet 152.

- 3.8 The ruin encased in the west wall is in approximately the same position as that shown here in 1854 and 1893 (see figure 4). In 1854, a similarly sized structure is shown to the north, as if they formed a pair, but absolutely no trace now survives above ground. The surviving structure is clearly butted by the enclosure wall to the south, while the joint between it and the enclosure wall to the north is not so prominent [2/537, 2/538, 3/129 and 3/131] (see plate 3). The structure measured c.4.60m north-south by 2.40m east-west, and was built of coursed squared gritstone, with quoins still visible to the former south-west corner. Further quoins in the centre of the west side might define a central doorway or more probably a window [2/532, 2/533 and 3/128]. Inside the enclosure, the structure is represented by a sub-square mound, measuring c.2.50m along each side and standing 0.50m high; the south side appears to be partly faced with stone [3/112, 3/113 and 3/146] (see plate 4). It is possible that it formed a privy for those using the shooting hut - on the basis of current evidence it is difficult to suggest an alternative function.

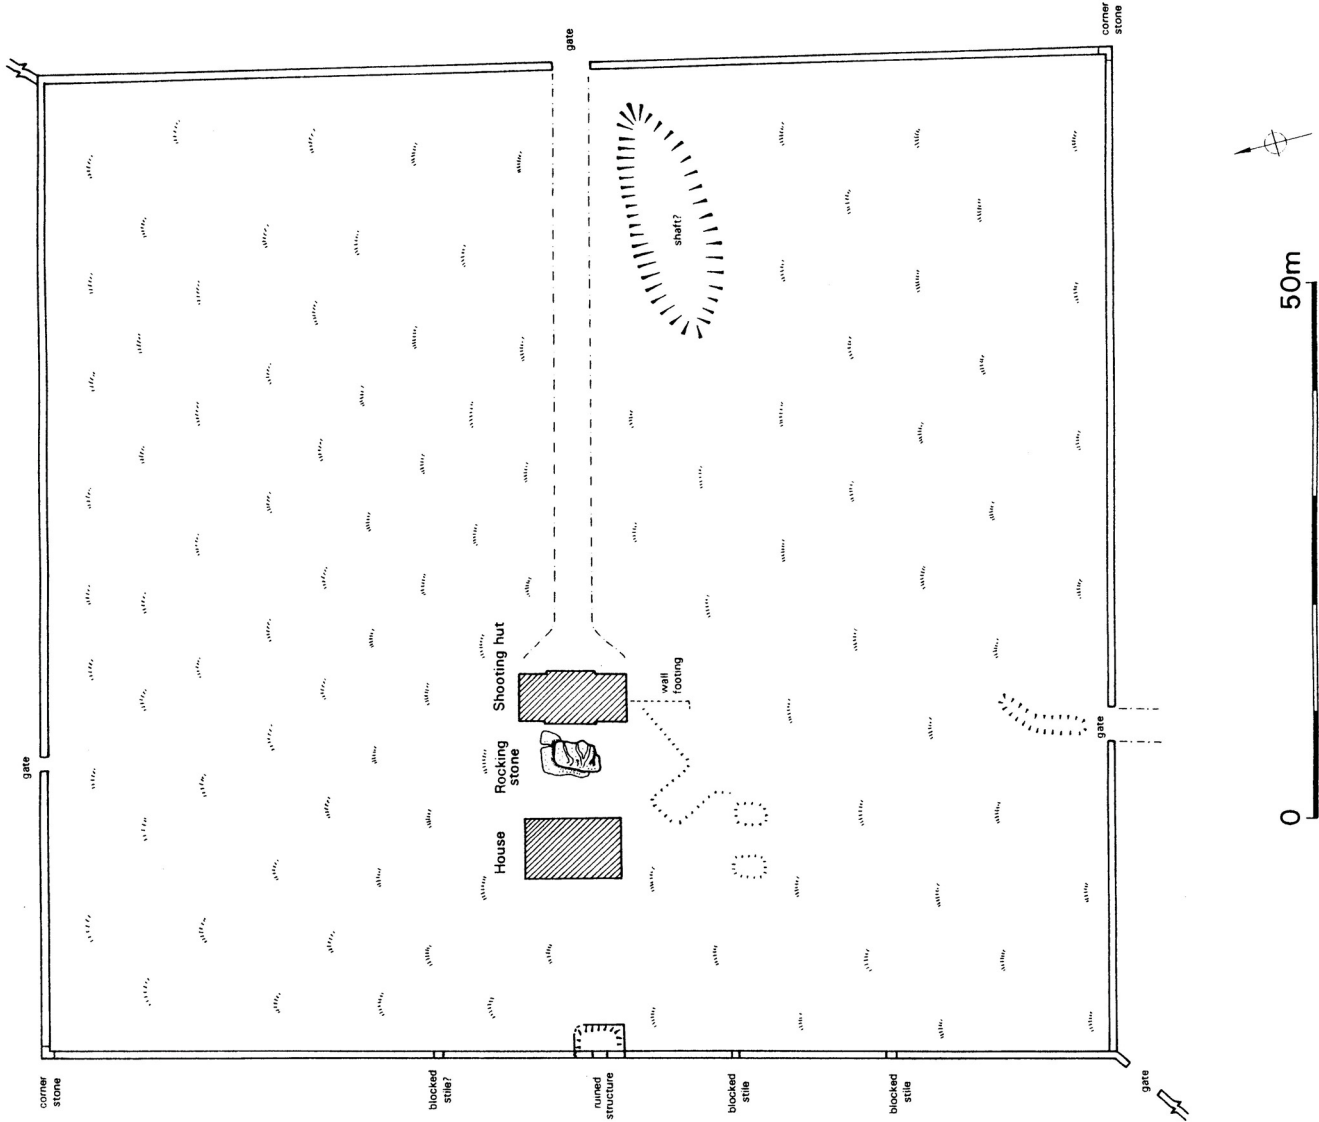
PROJECT	ROCKING HALL		
TITLE	SKETCH PLAN OF ENCLOSURE		
SCALE	AS SHOWN	DATE	OCT 2011
	EDAS	FIGURE	5

- 3.3 Both the shooting lodge and house are located within an almost square drystone-walled enclosure which, like the buildings, is placed on a slight north-east / south-west alignment. Both the east and west sides of the enclosure measure 100m long, whereas the north side is 92m long and the south side 95m. The two field walls which run up to the north-east and south-west corners of the enclosure are of a different construction, and both were constructed between 1854 and 1893 (see figure 4). The enclosure is set at an elevation of c.395m, in an isolated location on Rocking Moor, some 4km to the west of Thruscross Reservoir. As noted in Chapter 1 above, the area to the immediate south of the shooting hut in particular provides wide-ranging views to the south-east, south and south-west. The shooting hut and adjacent house are visible on the skyline from some distance away.

- 3.4 The drystone wall defining the encircling square enclosure stands on average 1.50m high and measures between 0.70m-0.95m wide at the base, tapering to an average 0.50m wide at the top. It is built from roughly coursed and squared gritstone, with upright, slightly slanting, coping, and no projecting throughstones; in several places, particularly along the northern half of the west side, the upper part of the wall has been rebuilt using a much more thinly coursed stone **[2/531]**. The north-west and south-east corners of the enclosure preserve an unusual feature, in that they have an angled coping stone which returns around the corner **[2/536]**. It is probable that these angled stones were originally present at all four corners, but those at the north-east and south-west corners have been removed, presumably when the attendant field walls were constructed. A shallow ditch runs parallel to the outside of the west and south sides of the enclosure.

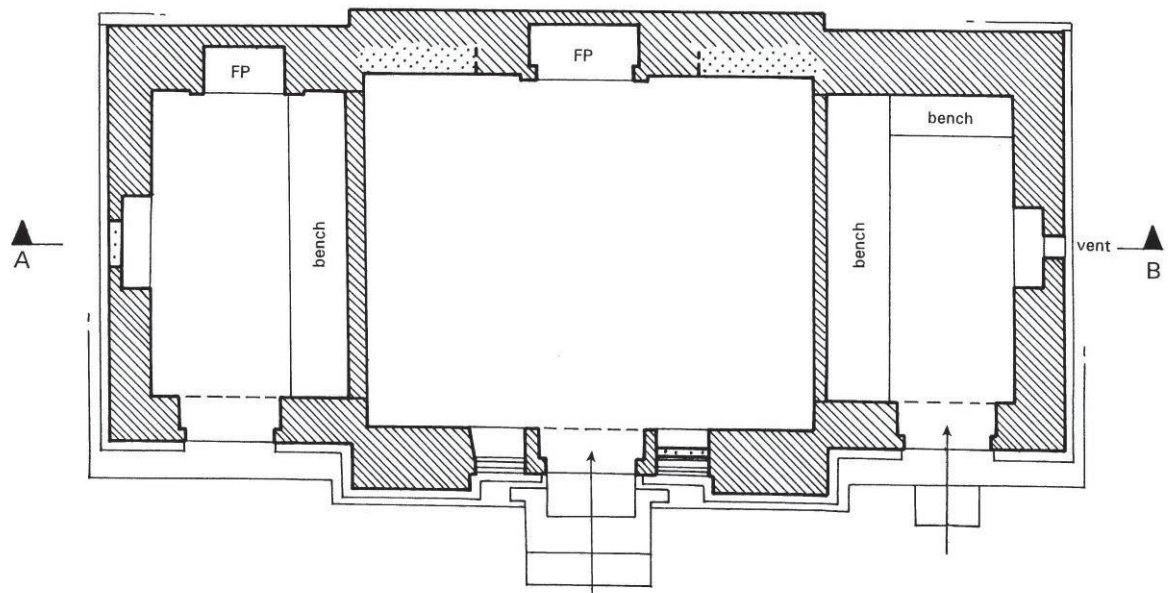
PROJECT		ROCKING HALL	
TITLE		PLAN AND SECTION	
SCALE	AS SHOWN	DATE	OCT 2011
EDAS		FIGURE	6

- 3.9 The main area of the shooting hut where new structural information was recorded was in the central cell, following the removal of wall plaster. This revealed that the fireplace in the west wall was flanked by two blocked openings, apparently former niches or cupboards rather than doorways, each 2.30m tall and 1.16m wide [2/505, 2/508, 2/511, 2/520, 3/087, 3/088, 3/090 and 3/105]; the northern opening retained

Section

Ground floor plan

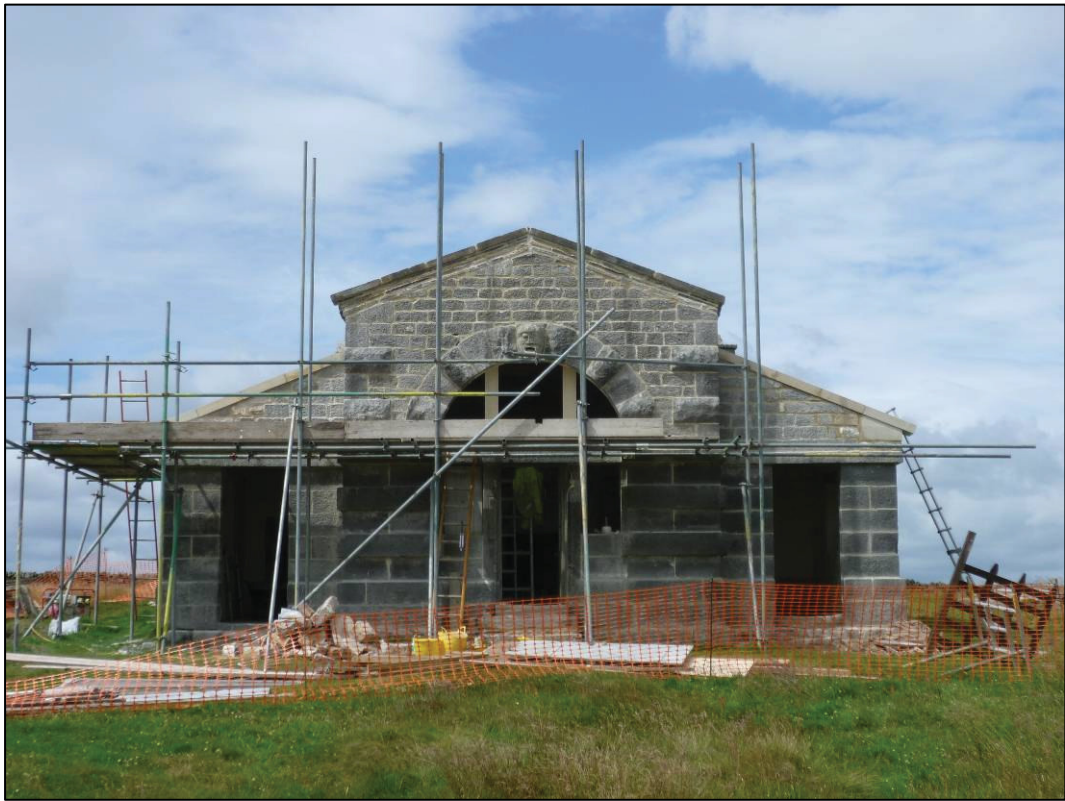
Plate 1: Rocking Hall under repair, looking W (photo 3/118).

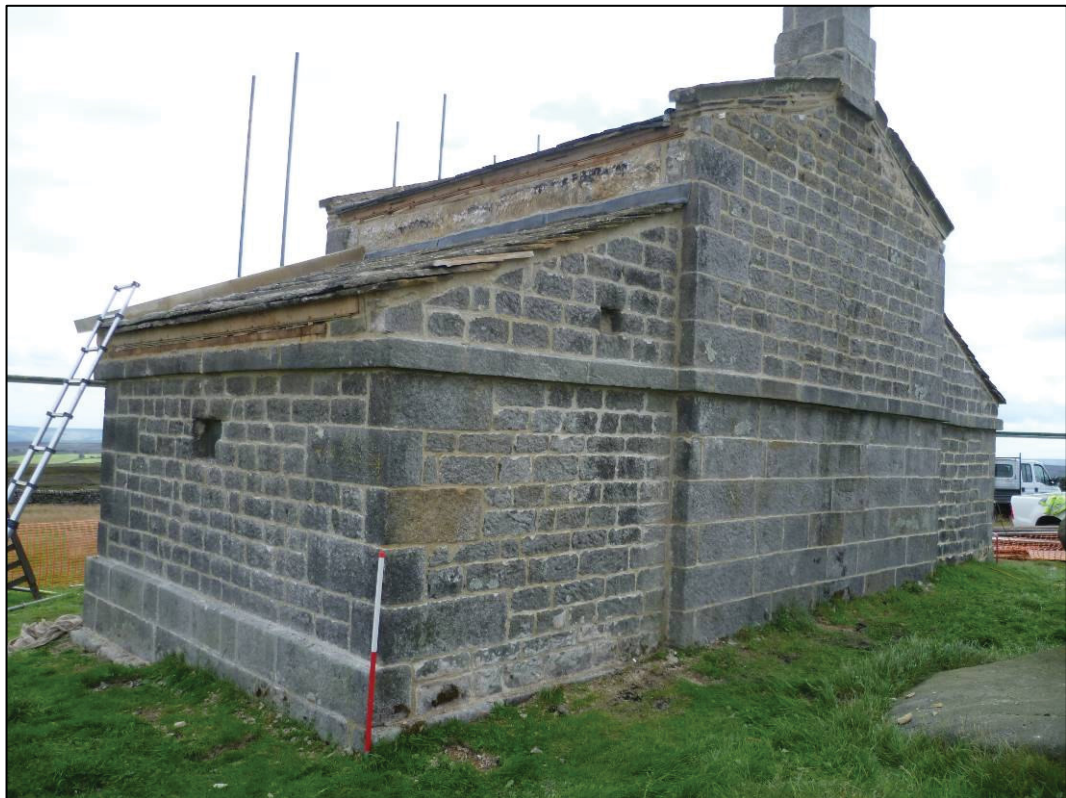
Plate 2: Rocking Hall under repair, looking S (photo 3/101).

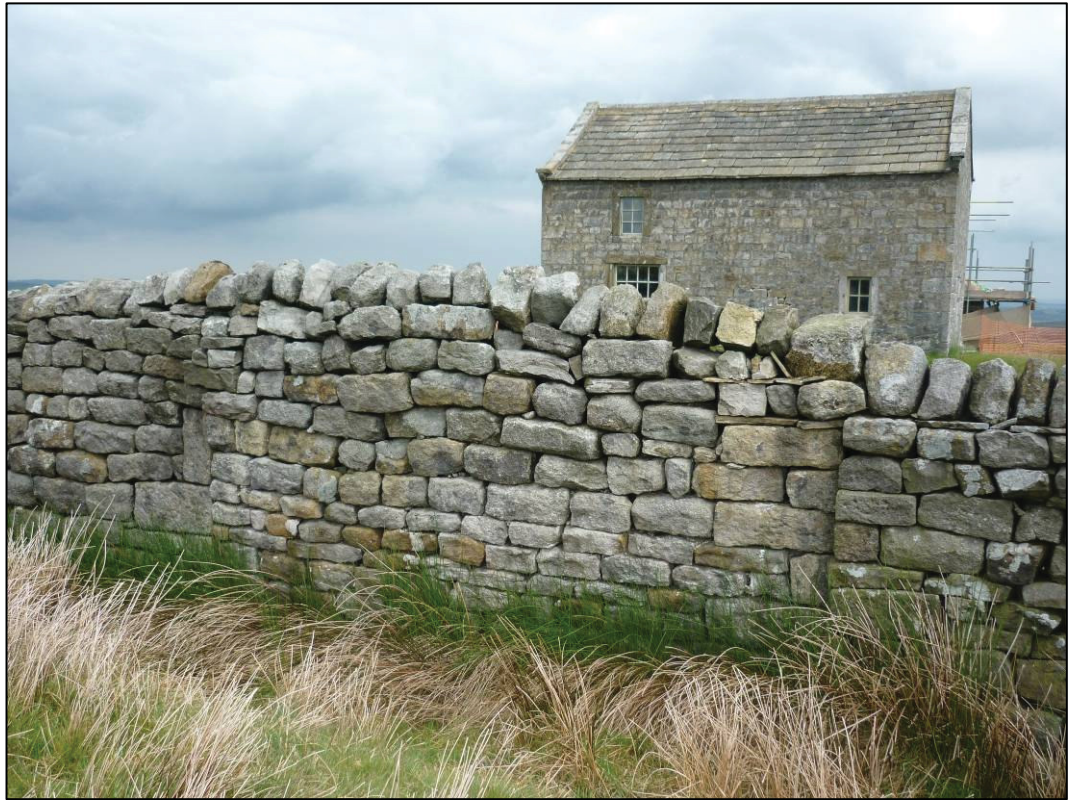
- 3.7 With the exception of the two buildings, the only two other significant features within the enclosure are the rocking stone itself placed between them, and a ruined structure encased in the enclosure's west wall. The rocking stone no longer 'rocks' (as it has slipped), but it comprises a larger base stone and smaller upper stone. The base stone preserves a modest amount of graffiti, some of which dates back to the mid 19th century, while the upper stone has prominent erosion channels in its upper surface [2/524 and 2/525].

Plate 3: Structure in west enclosure wall, looking E (photo 2/537).

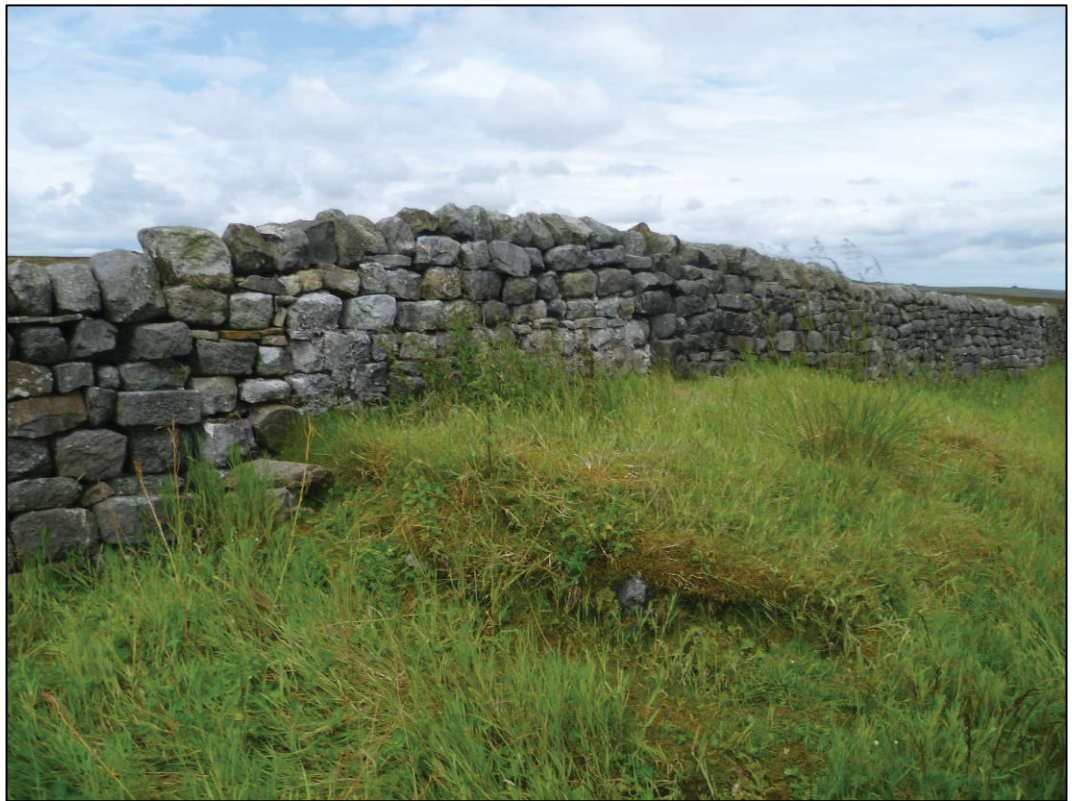
Plate 4: Structure in west enclosure wall, looking NW (photo 3/112).

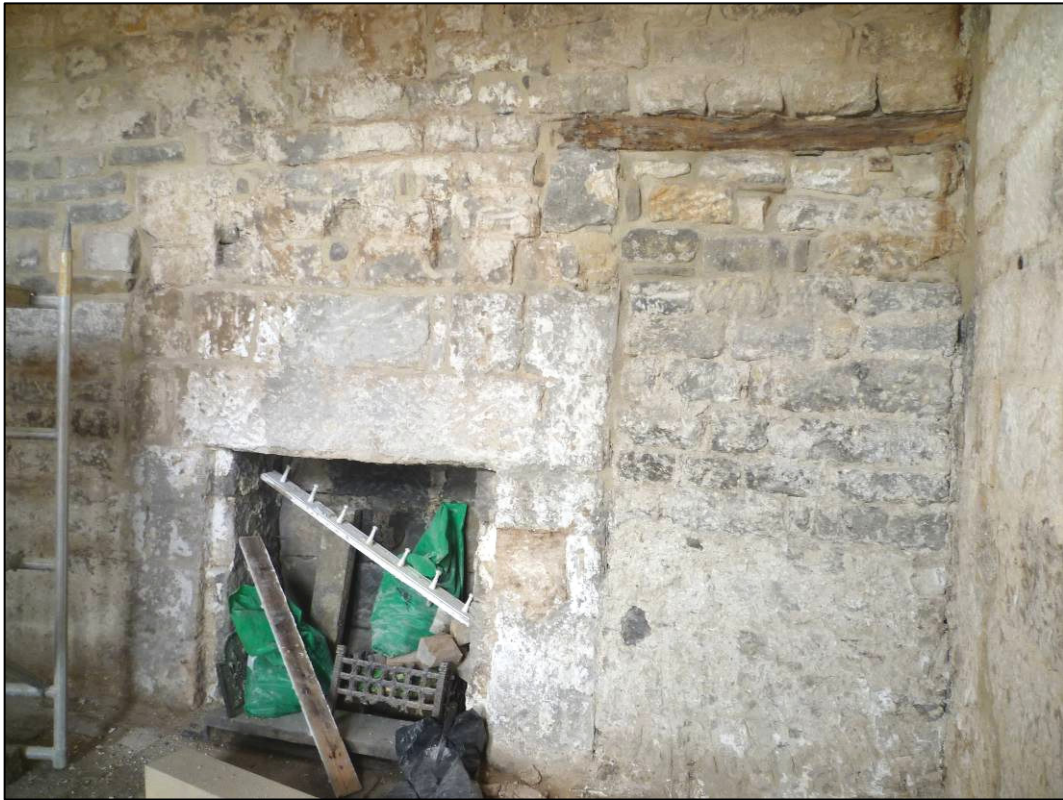
its original wooden lintel (see plate 5) whereas the lintel for the southern opening had been replaced by stone presumably at the time of blocking. In addition, five shallow recesses, up to 0.10m deep, were revealed forming a shallow arc above the fireplace, perhaps having formerly supported a decorative hood or mantelshelf of some kind [2/506, 2/509 and 3/104] (see plate 5). At the north and south ends of the west wall, at 3.10m above the internal flagged stone floor, the remnants of a curve within the masonry could be seen, suggesting that the space over the central cell was once vaulted in some way [2/512 and 2/513]. At 3.60m above the internal floor, the masonry of the west wall changed slightly in form; significantly, this is approximately the same height as the external change in masonry noted in the west elevation of the hut.

Plate 5: North end of central cell after removal of plaster, showing blocked niche and recesses over fireplace, looking W (photo 3/087).

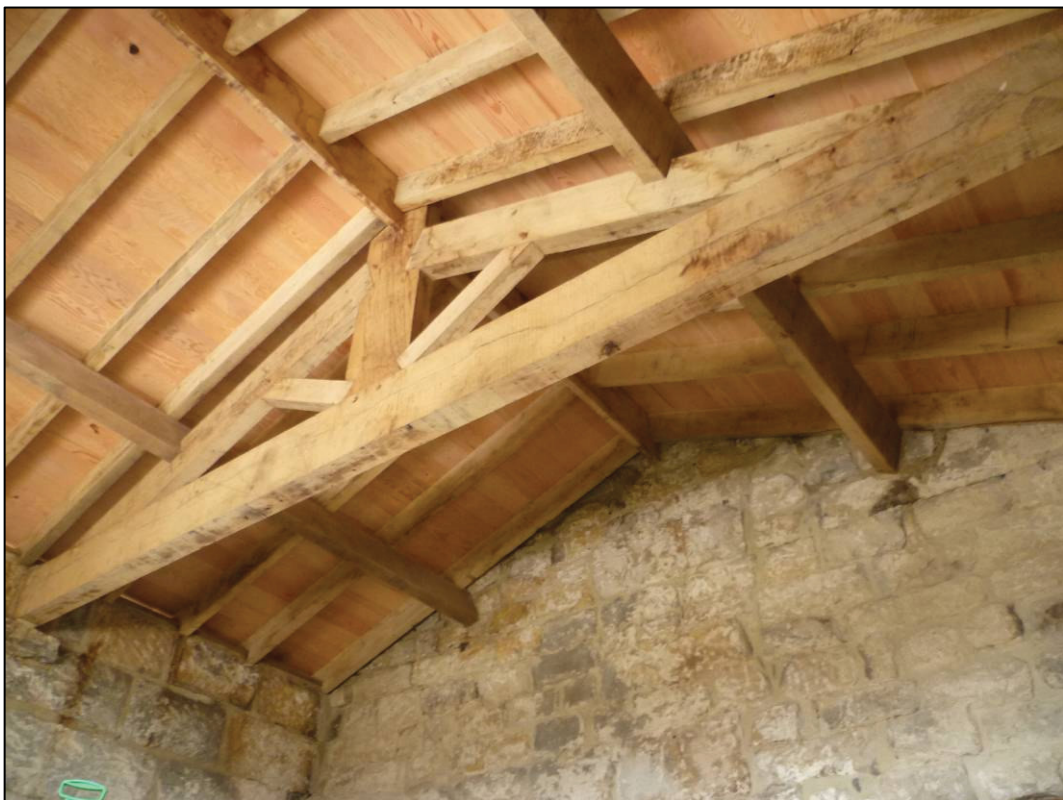
Plate 6: New roof truss to central cell, looking N (photo 3/089).

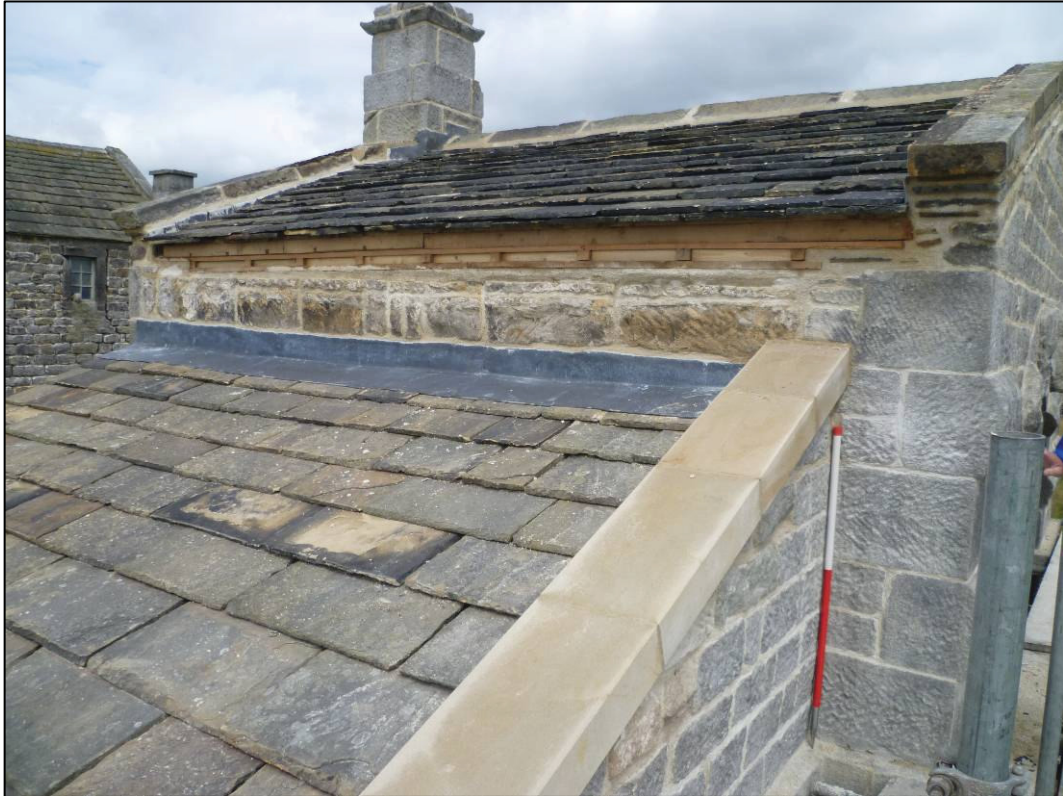
Plate 7: New roof pitch to south cell, with bat-friendly fascia, looking N (photo 3/093).

- 3.11 The scaffolding of the exterior of the building meant that areas not previously accessible during the earlier survey work could now be reached, for example, the carved male face forming the keystone of the semi-circular arch in the central cell of the east elevation [2/527-2/529, 3/096 and 3/097] (see plate 8). The repair and conservation works also included reducing the pitch of the roofs of the north and south cells to match that of the central cell [3/079, 3/093 and 3/123] (see plate 7), replacing the majority of the roof structure over the central cell [3/089] (see plate 6), renewing the windows and doors in the east elevation [3/103, 3/125 and 3/126], and generally repointing the whole structure [2/526, 3/080, 3/100, 3/101 and 3/102] (see plate 2). In addition, various measures to accommodate bats within the building were taken, which included creating gaps in the mortar on the west elevation and the insertion of bat access gaps within the roof ridge and as part of the new fascias under the eaves of the central cell [3/084 and 3/095] (see plate 7).

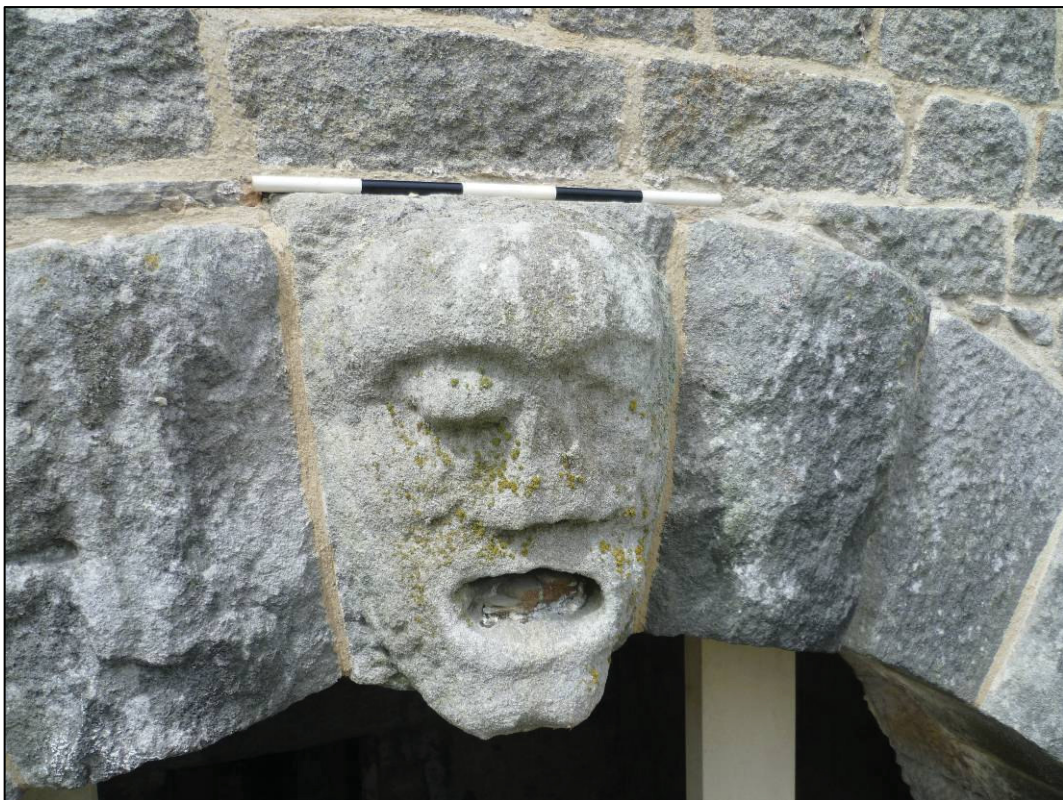
Plate 8: Carved head to east elevation after repointing, looking W (photo 3/096).
