LONG PRESTON DEEPS, RIBBLESDALE, NORTH YORKSHIRE

Archaeological Watching Brief

October 2011

ENVIRONMENT AGENCY

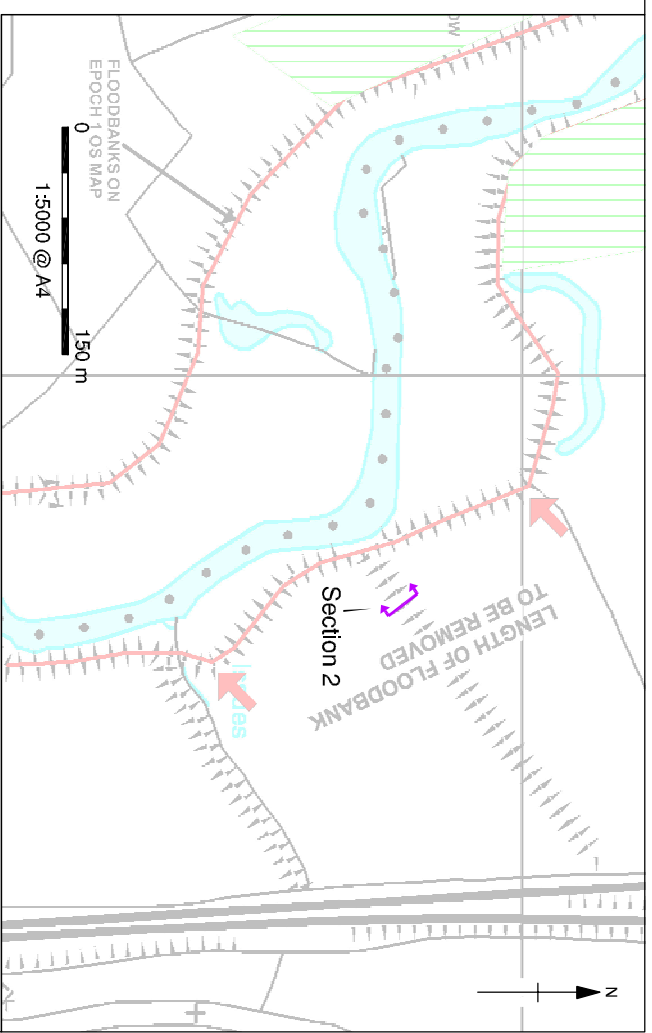
Figure 3: Section 2, south-west-facing profile through embankment 103

3.2.4 **Embankment 103:** this low bank measured 6.8m wide and 0.78m high and featured a gently rounded profile (Fig 3; Plate 5). This bank had also been formed with pure mid-brown alluvial silt (**102**) and was overlain by a thin layer of topsoil (**106**) measuring approximately 0.1m thick.

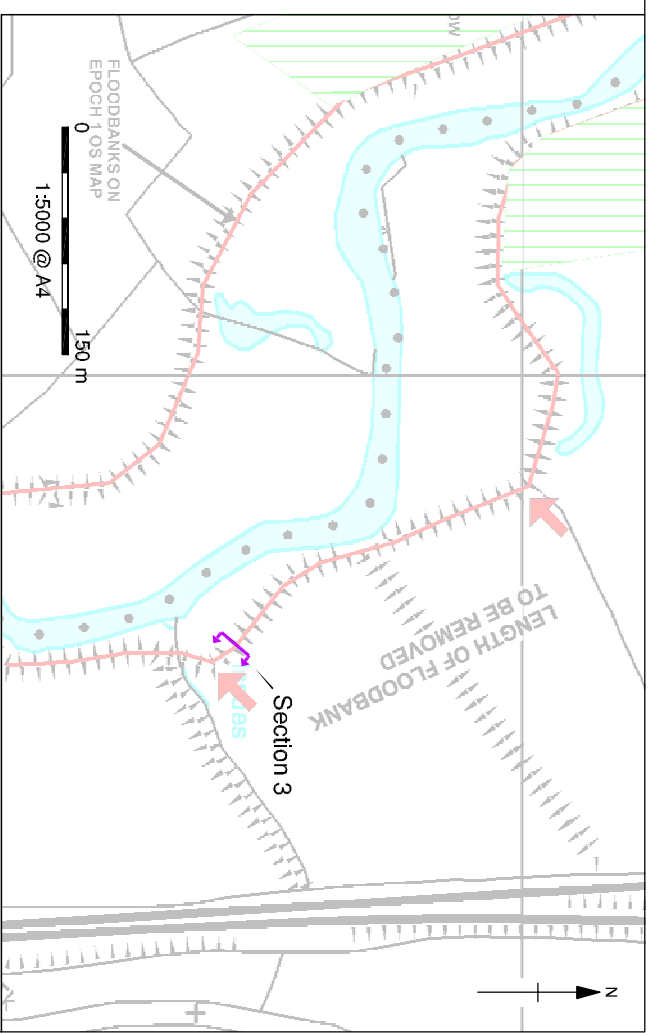
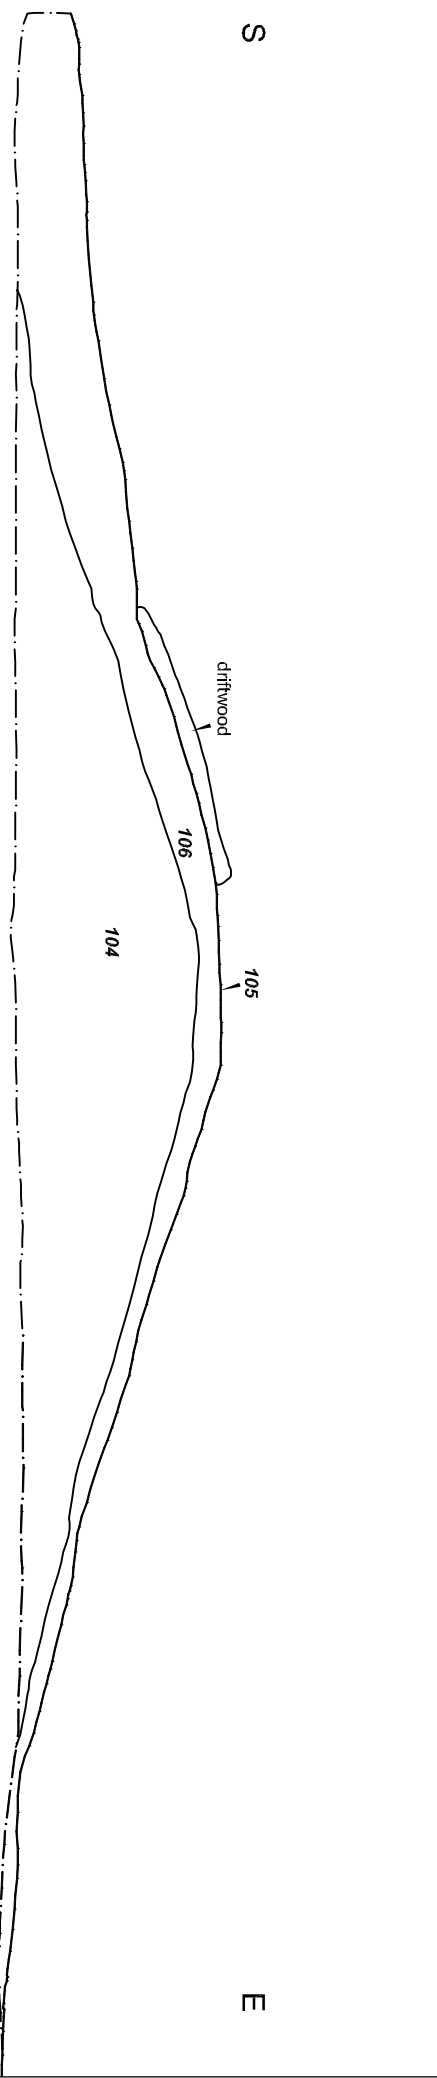
Figure 4: Section 3, south-east-facing profile through embankment 105

3.2.2 The top of the silt levels at the highest point of the bank was relatively flat for approximately 1m, demonstrating that the bank had originally featured a flat-topped profile (Fig 4). The subsequent build-up of topsoil (**106**) and the growth of grass disguised this characteristic and gave the impression that the bank was relatively uniform and convex.

3.2.3 The topsoil (**106**), which overlay the silt (**104**), measured an average of approximately 0.2m to 0.25m thick. However, at the southern end of the embankment (**105**), where the full western extent of the bank remained *in-situ*, successive flood events had deposited large quantities of debris, such as drift wood and branches, over the western side of the bank, and the topsoil in this area was up to 0.45m thick (Fig 4; Plate 7). This suggests that soil that had been eroded from the surrounding area was immediately re-deposited over this portion of the embankment. However, a significant lack of debris within the topsoil suggests that either this was not a successive

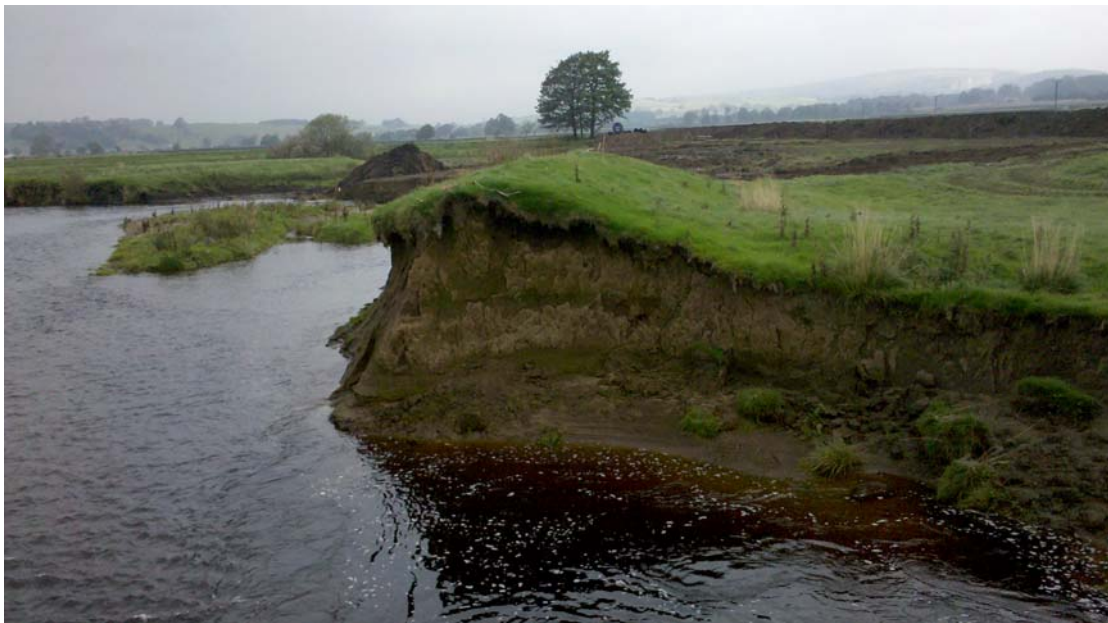
Plate 2: The result of severe riverine erosion, which has truncated a portion of embankment **101=105**, looking north

3.2.1 **Embankment 101=105:** this embankment lay immediately adjacent, and parallel to, the river Ribble, and the western edge had become severely eroded as a result of periods of raised river levels (Plate 6; Fig 1). In some places the whole of the bank had been washed away and the remaining portions of banking had been reduced in width by erosion by up to a third of their former extents. The remaining portions measured between 9m and 13.5m wide and between 1.4m and 2.1m high. Cross-sections were recorded through the central and southern portions of this bank (Figs 2 and 4), both of which demonstrated that it had been formed by mounding huge quantities of mid-brown silt (**102=104**). There were no inclusions of stone, or mixed deposits of topsoil, sand, or clay, which suggests that the very pure silt was formed by alluvial action associated with the river, and it may have been dredged from the river or dug from the surrounding flood plain.

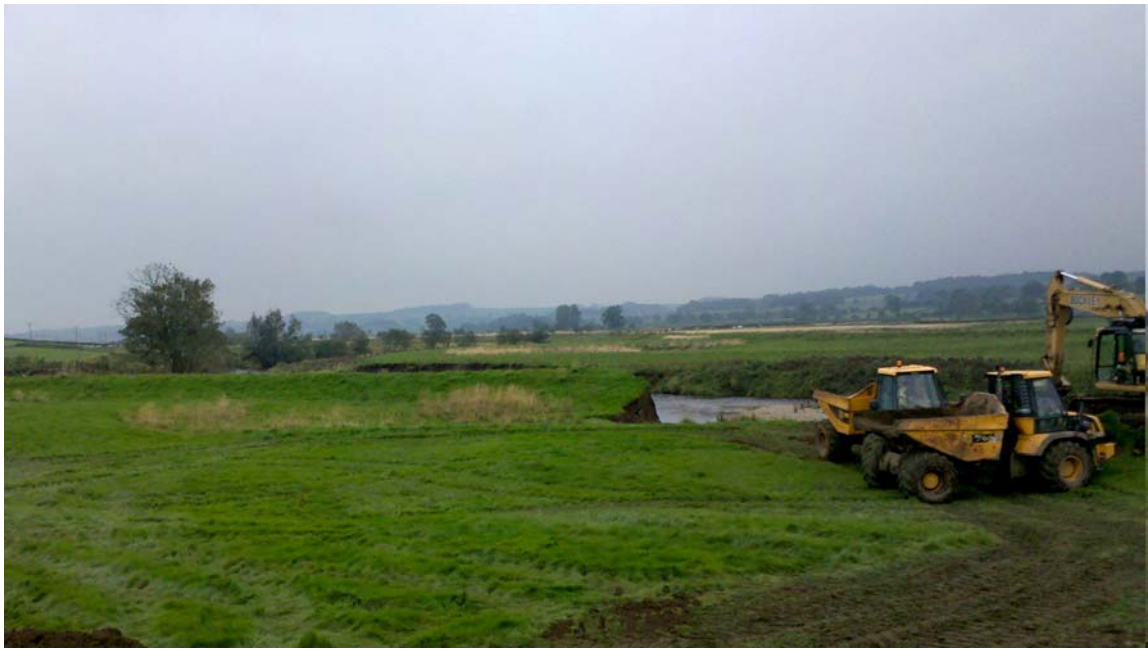
Plate 3: Embankment **105**, looking south-west

3.1.2 Two portions of banking were removed, and were recorded as Sections 1-3 (Figs 1-4). One of these (**101=105**) ran approximately north/south; parallel to the eastern side of the river, and was approximately 240m long (Plates 3 and 4). The second portion of banking (**103**) ran north-east/south-west and was perpendicular to the river (Plate 5). This portion was 28m long. Both of the embankments were reduced by a machine with a toothed bucket down to the same level as the surrounding ground level of the grassed fields.

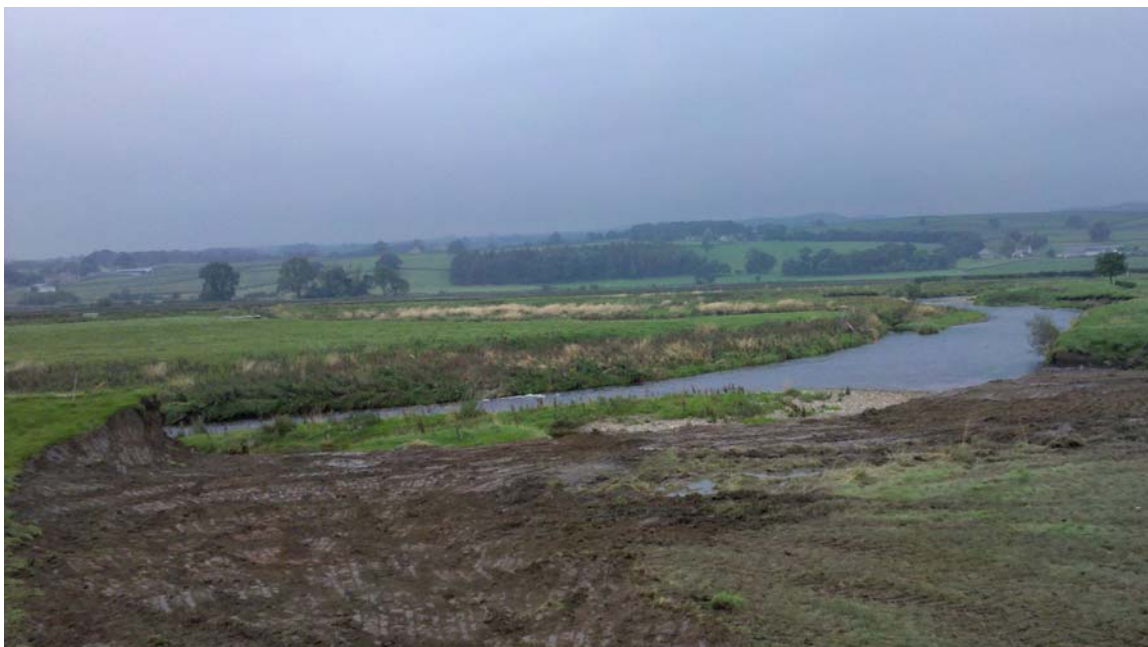
Plate 4: The area adjacent to the river Ribble following the removal of most of embankment **101**, looking north-west

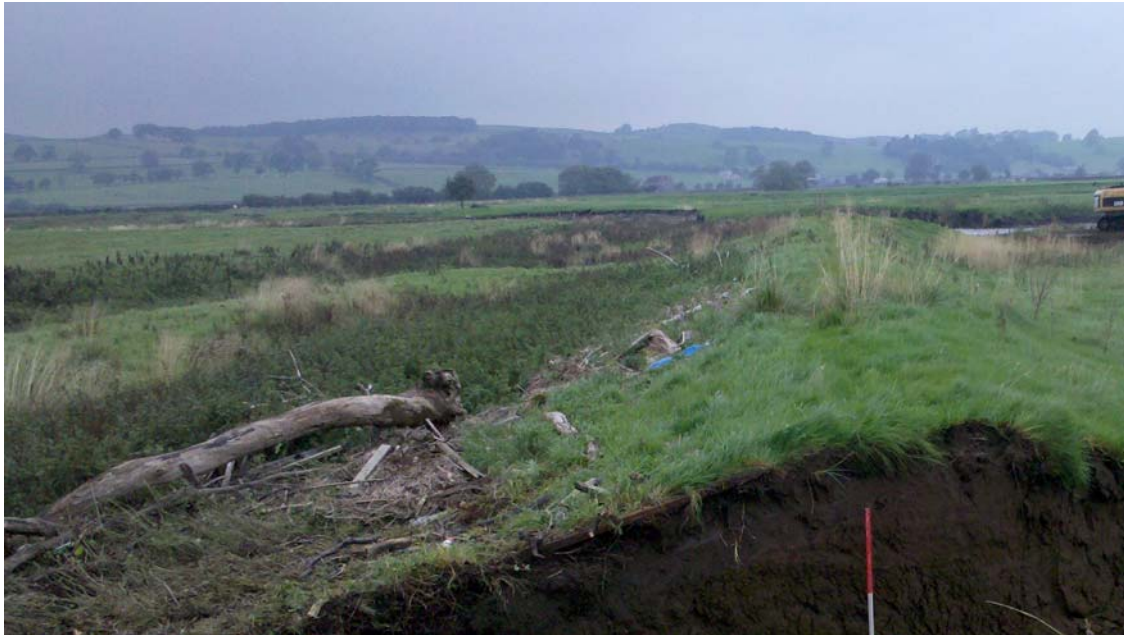
Plate 7: Cross-section through embankment **105**, looking north
