YORK ARCHAEOLOGICAL TRUST REPORT

SITE ADDRESS	2 Bridge Street, Bedale, North Yorkshire		
CLIENT NAME	HACS Construction Ltd.		
YAT PROJECT #	5553	YAT REPORT #	2011/65
MUSEUM ACCESSION #	n/a	GRID REFERENCE	SE 267 881
PLANNING REFERENCE #	10/01895/FUL	AAI OPS NOTICE #	n/a

INTRODUCTION

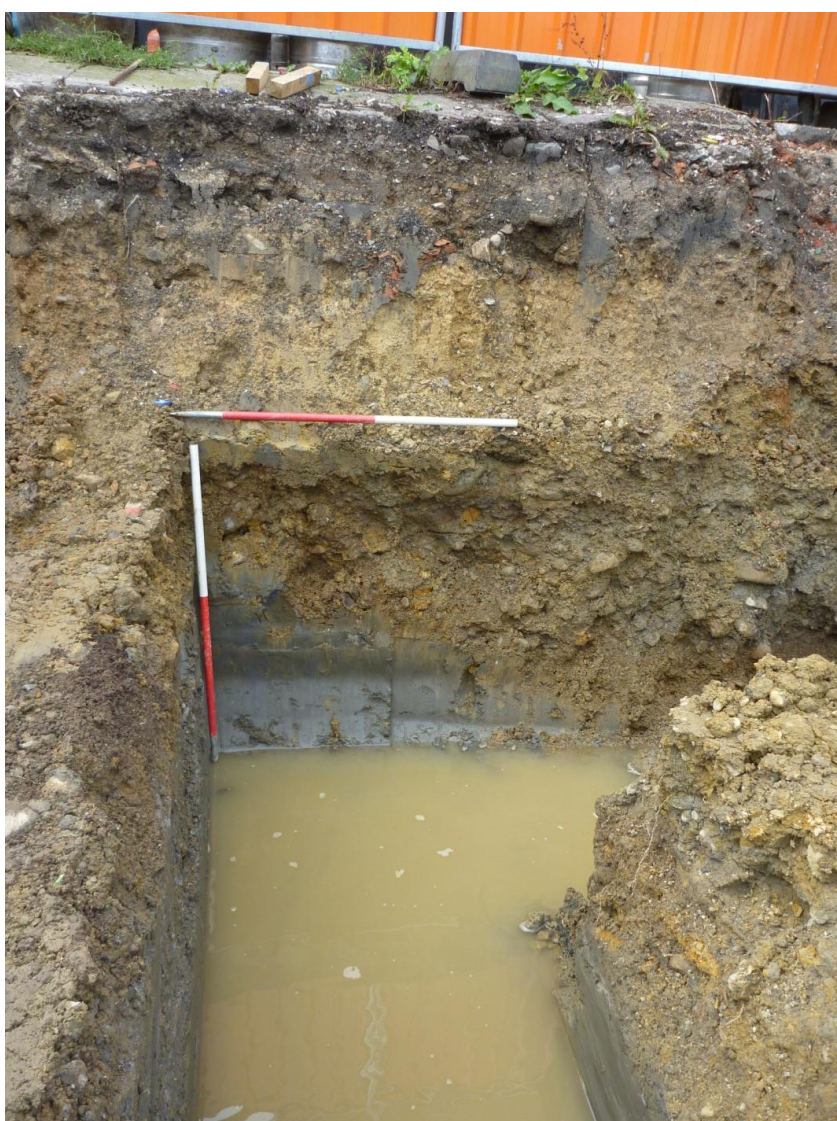
Plate 2 Profile of section no. 2, looks south-east (0.5m scale division)

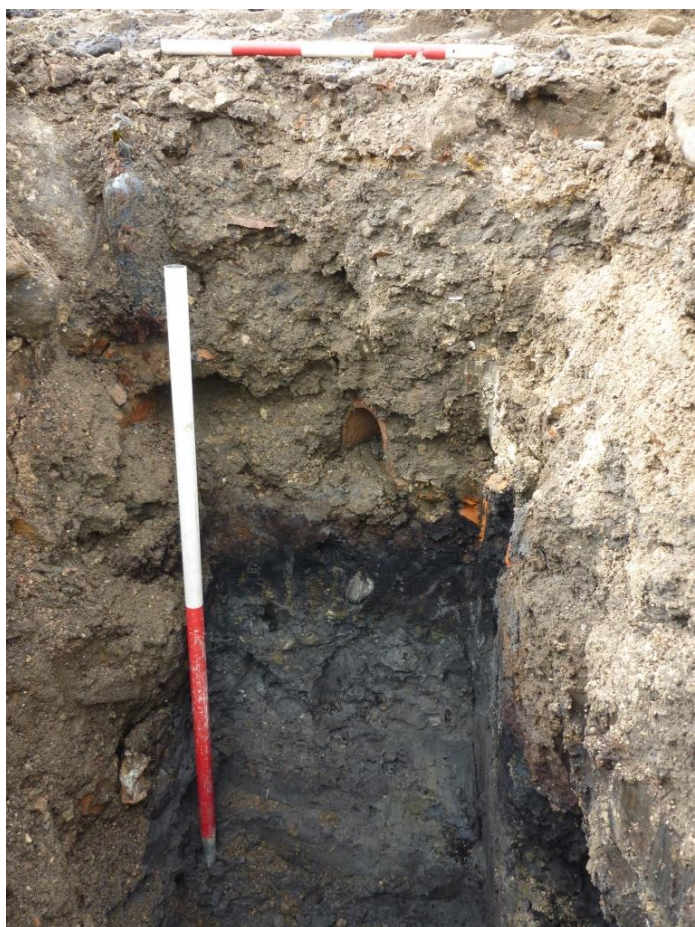
Plate 3 Profile of section no. 3, looks north-east (0.5m scale division)
