## YORK ARCHAEOLOGICAL TRUST REPORT

<b>SITE ADDRESS</b>	51 Market Place, Richmond, North Yorkshire		
<b>CLIENT NAME</b>	RBA Moody Bros (Contractors) Ltd		
<b>YAT PROJECT #</b>	5518	<b>YAT REPORT #</b>	2011/48
<b>MUSEUM ACCESSION #</b>	n/a	<b>GRID REFERENCE</b>	NZ 1719 0082
<b>PLANNING REFERENCE #</b>	1/92W/1090Q/FULL	<b>AAI OPS NOTICE #</b>	n/a

### INTRODUCTION

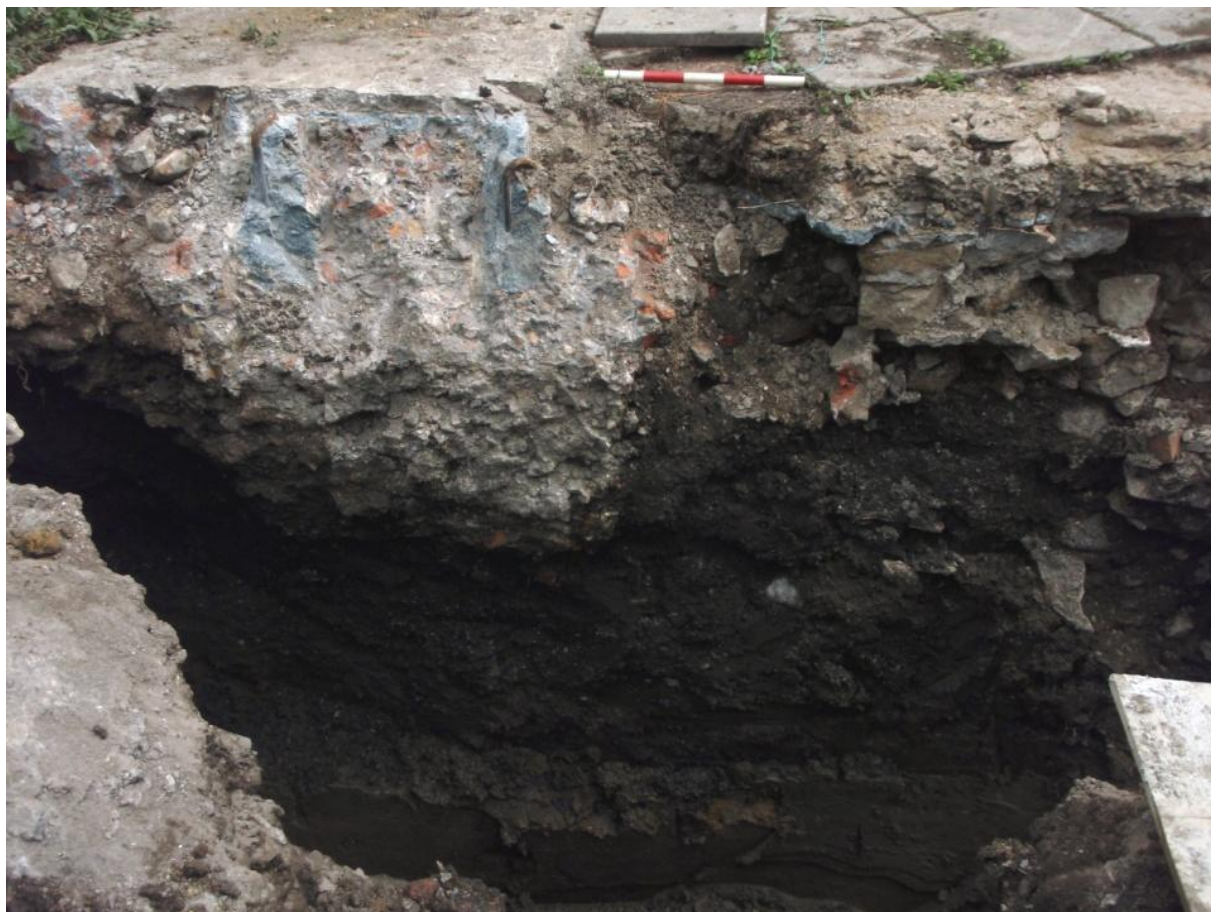
*Plate 2 Part of NE foundation trench, looking NE*

More recent deposits are represented by context 2002, a deposit of stone fragments visible in the south-eastern part of the north – east wall foundation trench (Plate 2). This measured in excess of 1.50m across by 0.85m deep and, given the pitching of stone at all angles, appears likely to represent a stoney element within the ground levelling operations rather than a disturbed wall. Immediately to the north-west of 2002 lay a roughly cast block of concrete, context 2005, within a foundation cut, context 2004. This concrete, which contained some steel reinforcing bars, had a width in excess of 1.6m and a thickness of around 1.1m. This modern structural element is presumed to relate to recently demolished building/s at the site.
