THE GRAPES INN, EBBERSTON,
NORTH YORKSHIRE

PRELIMINARY
ARCHITECTURAL APPRAISAL

Report no: 2008/323R.01
Version: Final
Date: February 2008
Author: Shaun Richardson & Ed Dennison

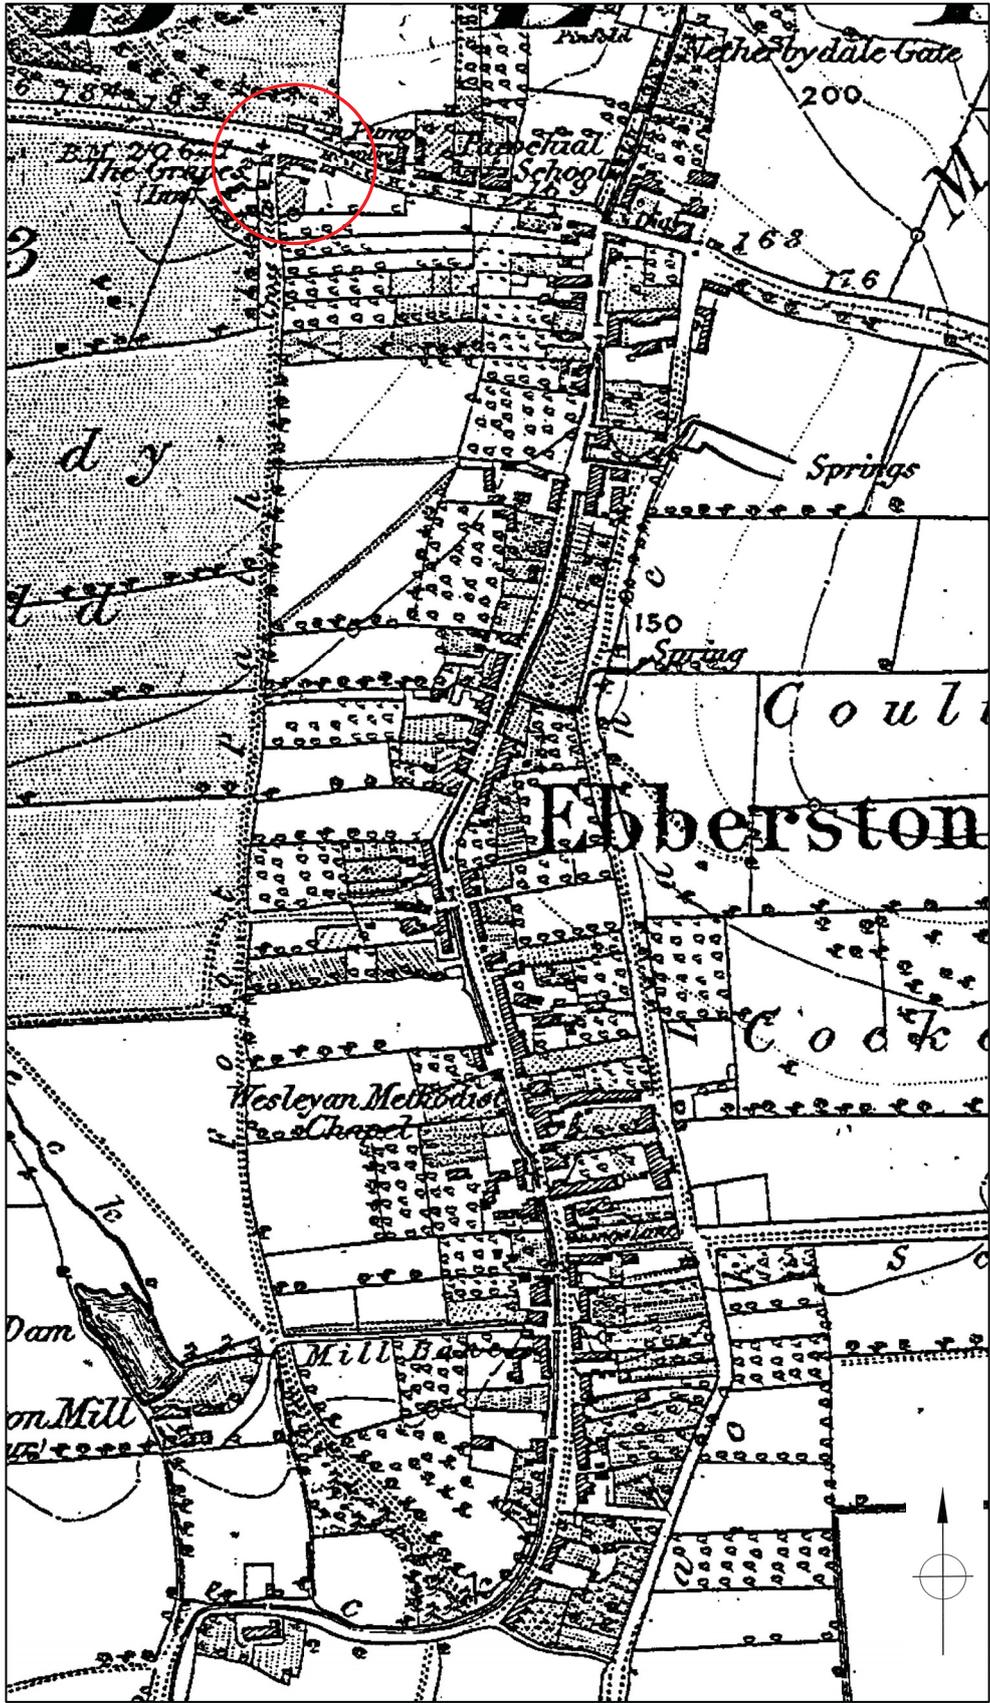
PROJECT		THE GRAPES INN, EBERSTON	
TITLE		ORDNANCE SURVEY 1854 MAP	
SCALE	NTS	DATE	FEB 2008
EDAS		FIGURE	3

Source: Ordnance Survey 1854 6" map sheet 92.

- 2.3 The 1st edition Ordnance Survey 1854 6" map (see figure 3) marks the "The Grapes (Inn)" and essentially shows a building with a narrower central section flanked by wider return at either end; the west return runs slightly further to the south than the eastern one. There is a medium-sized detached building to the east and another smaller one to the south, set at one corner of a small enclosure. At this date, Cross Cuts (lane) separates the site and the building immediately to the west; this had probably been the case for some considerable time and it is possible that the southward continuation of the route as a footpath represents another medieval back lane leading to the mill. The later Ordnance Survey map of 1893 shows that the western return extends further to south than previously.

- 4.3 No features of probable medieval or very early post-medieval date were noted by the architectural appraisal. The layout of the village as shown on the Ordnance Survey 1854 6" map (see figure 3) suggests that the inn stands away from the medieval street frontage, possibly at the rear of a plot close to an original back lane of the settlement (represented by Cross Gate). Any medieval buildings that might have been present here were most probably demolished and rebuilt from the 17th century onwards (see below), conforming to a pattern already noted over the wider region (RCHME 1987, 62). The RCHME reproduced an extract from a late 17th century map of the manor of Ebberston in their book on North Yorkshire houses (RCHME 1987, 25), but unfortunately it does not cover the area where The Grapes Inn is located.

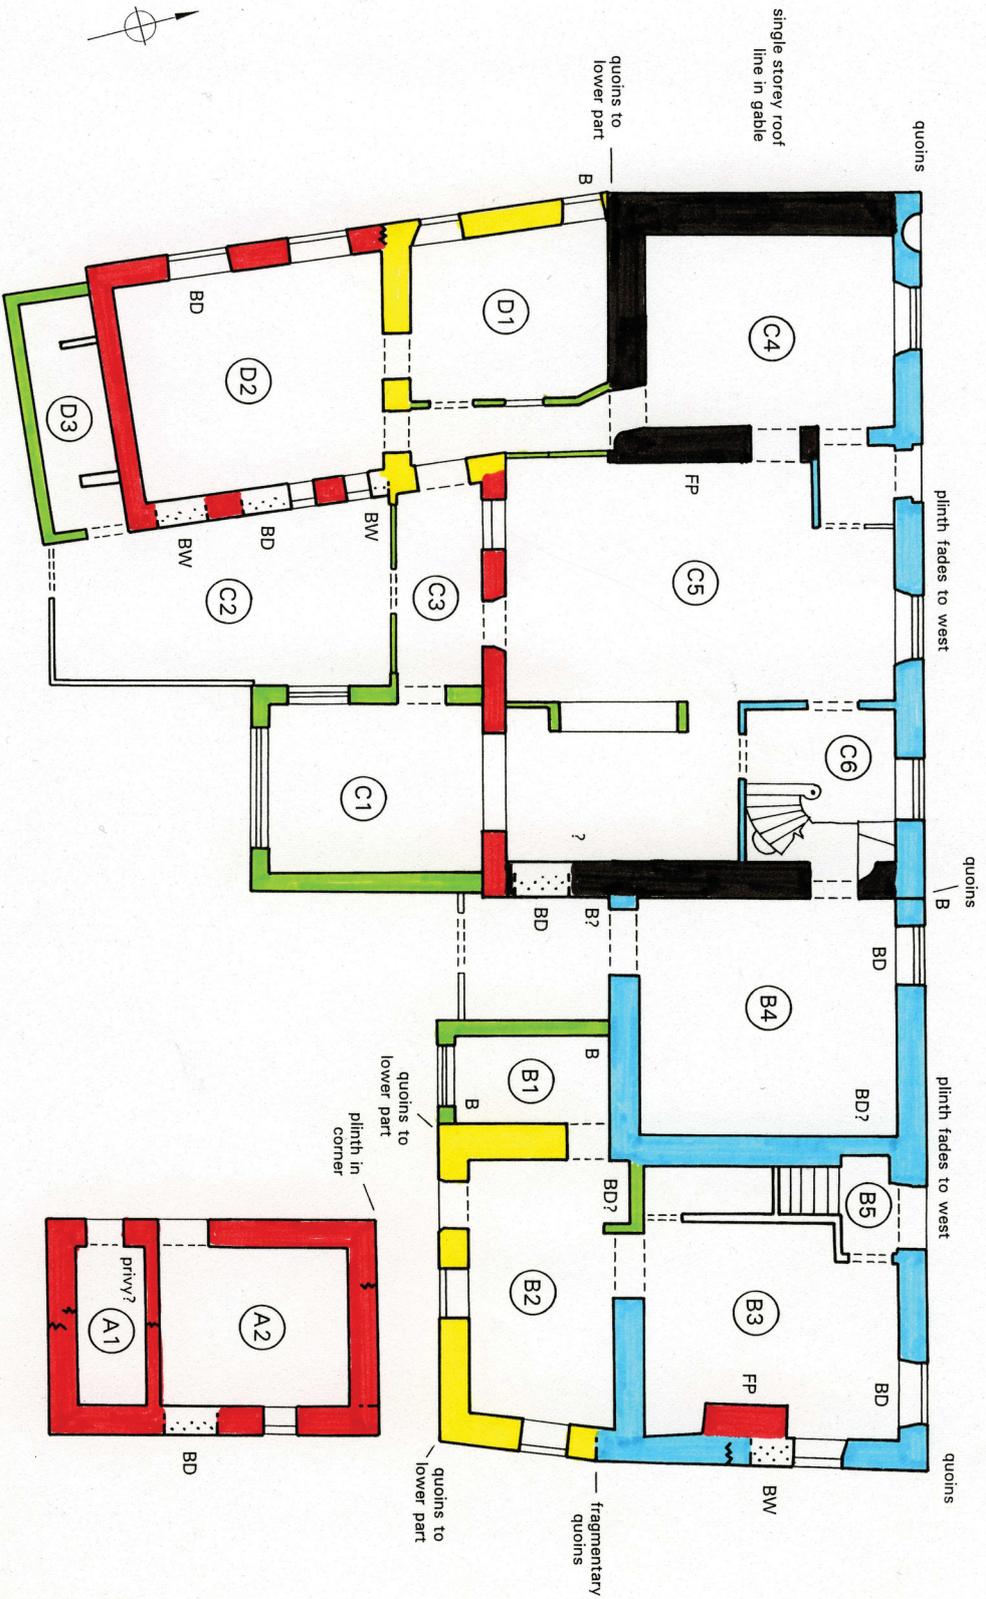
PROJECT	THE GRAPES INN, EBERSTON	
TITLE	SUGGESTED DEVELOPMENT	
SCALE	AS SHOWN	DATE
		FEB 2008
	EDAS	FIGURE
		4

Ground floor plan

Sharrock Rymer has been used to prepare a 1:100 ground floor plan showing features of historic interest such as plinths, blocked openings, construction joints etc. It should be noted that this new plan remains schematic, and has been produced for interpretative purposes rather than being an accurate record of the building.

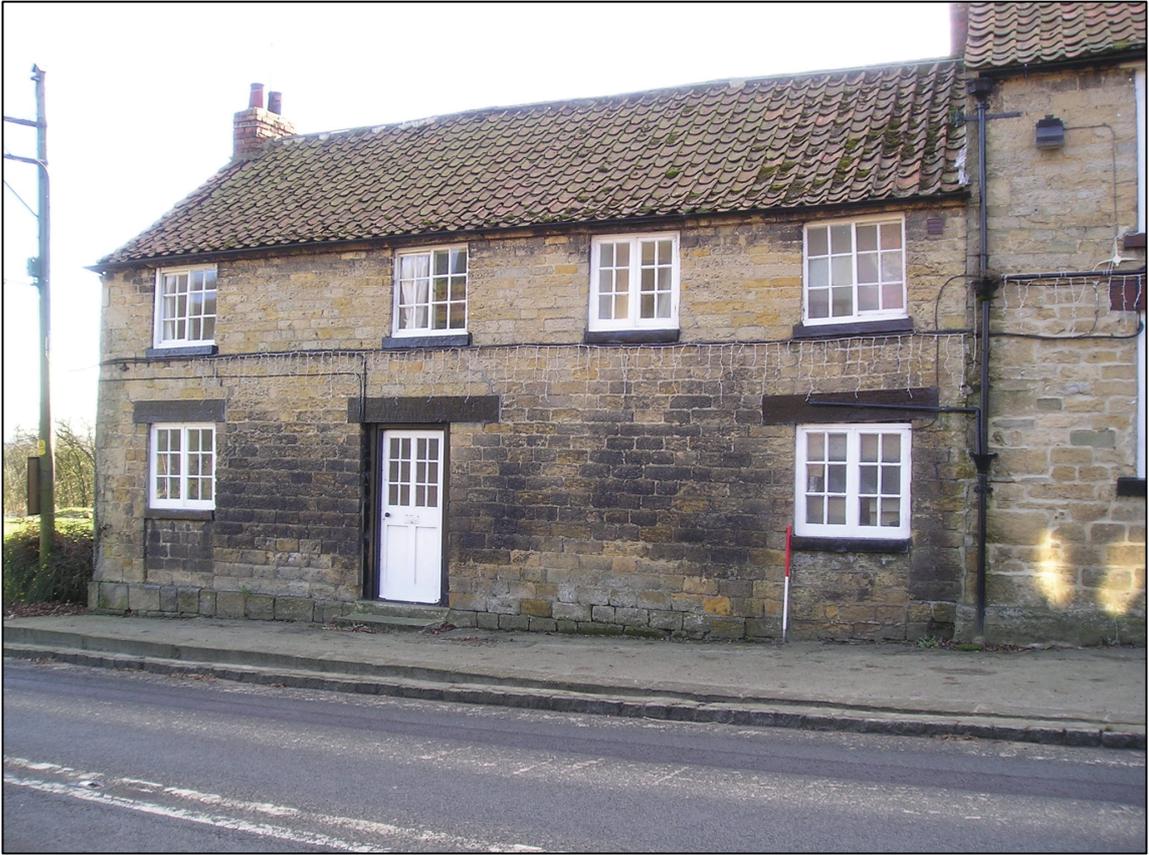
Plate 1: North elevation of house (B), looking SE.

- 3.11 The principal elevation of the house faces north onto the road (see plate 1). It is of four bays, and built of hammer-dressed coursed squared stone with a watershot profile, rising from a slightly projecting plinth which runs the full length of the elevation; the plinth does not run parallel to the wall face above, but angles inwards towards the west end, and it is difficult to make out any relationship between it and the similar plinth beneath the inn (see below). There is a ground floor doorway to the east of centre. The existing doorway and frame are both modern, and are placed off-centre beneath a substantial stone lintel. The doorway is flanked by ground floor windows to the east and west ends of the elevation, each fitted with a 12-pane (6 and 6) opening timber casement, with projecting stone sill and flush stone lintel; both windows have recessed blockings beneath, perhaps suggesting that they were once doorways. The west end of the north elevation appears to butt that of the adjacent inn. There are four windows to the first floor, all with projecting stone sills and all, apart from the second window from the west end, retain 12-pane (6 and 6) horizontal sliding sashes.

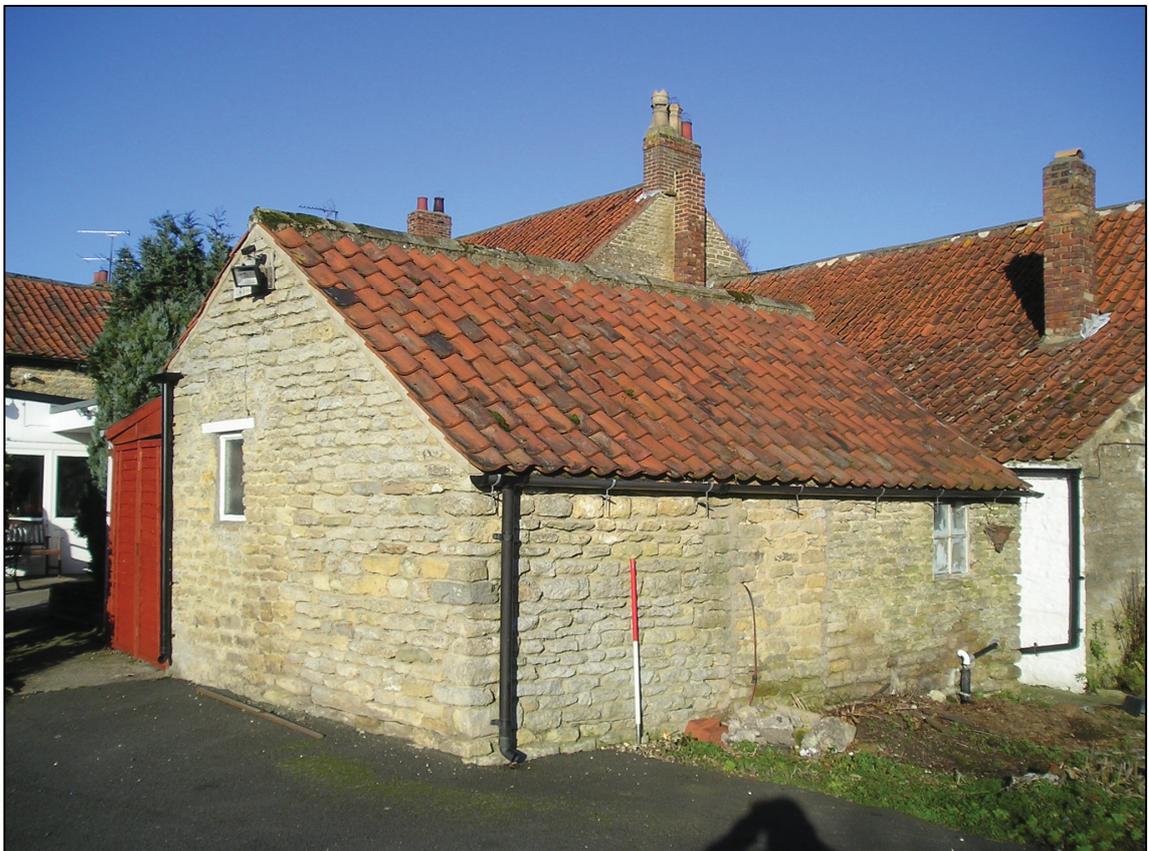
Plate 2: Outbuilding (A), looking NW.

- 3.8 The outbuilding is rectangular in plan and of a single storey, with an unevenly pitched pantiled roof, the east slope being considerably longer than the west (see plate 2). The majority is built of roughly coursed and squared rubble, with no quoins; the external walls are on average 0.45m thick. The south gable is pierced by a single modern window, which has partly disturbed the remains of an earlier, lower gable of a smaller building incorporated into the standing one; this may be the structure shown here on the 1854 6" map. The east elevation is largely blank, with a blocked doorway opening to the centre and a four-pane fixed timber casement to the north end. The north gable has been subject to a number of alterations. There is a straight joint visible towards the east end, but this does not run the full height of the gable, terminating 0.30m above ground level. Similarly, towards the west end, a ragged joint rising from ground level is associated with a projecting rubble plinth; at 1.77m above ground level, the north-west corner of the building preserves a slight inset, which continues along the west elevation. Much of the west elevation is obscured by modern dog kennels but the masonry above the level of the inset appears to be a modern rebuild. There are two doorways, each fitted with a modern plank and batten door.

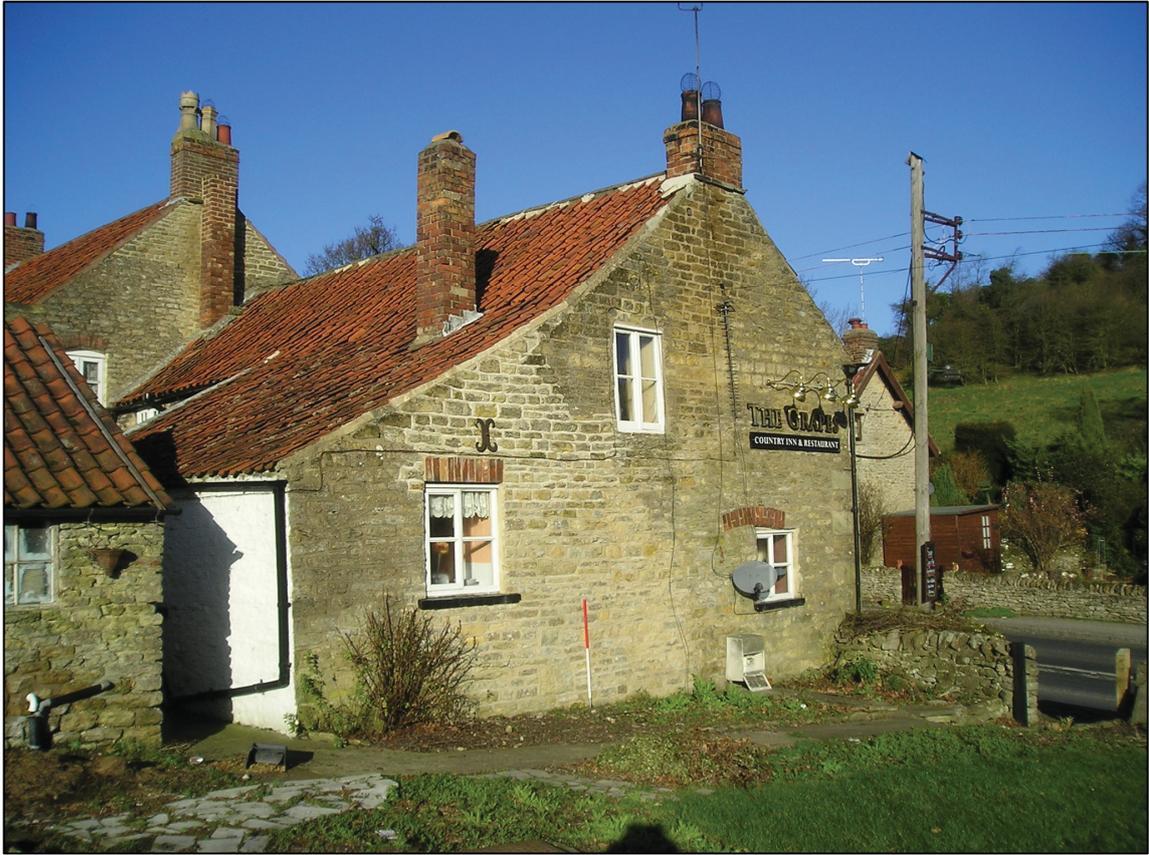
Plate 3: East elevation of house (B), looking NW.

- 3.12 The east gable of the house retains evidence apparently pointing to several phases of building or alteration (see plate 3). The majority of the ground floor is built of thinly coursed and squared rubble, much of which has been subject to modern repointing. Approximately half way across the gable, there appears to be a ragged joint at ground level, with the coursing to the north being somewhat deeper. Further south, a fragmentary line of quoins appears to mark a joint between the main body of the house (B3) and the rear outshut (B2). The north end of the gable has herringbone and margin tooled quoins rising through the full two storeys, whereas at the south end (part of the rear outshut) large edge-laid quoins with no tooling survive to the lower part. The outshut has a single modern inserted window to the ground floor, with a fish-tailed wall-tie plate over, and there is another inserted window to the main body of the house. This has disturbed an earlier and slightly larger window opening with a shallow arched brick head, which appears to be blocked by an internal chimney-breast. There is a single window to the south side of the first floor, which may also be inserted. At approximately eaves level, the masonry of the east gable changes from the thinly coursed squared rubble to a better coursed and squared stone, similar to that used in the north elevation.

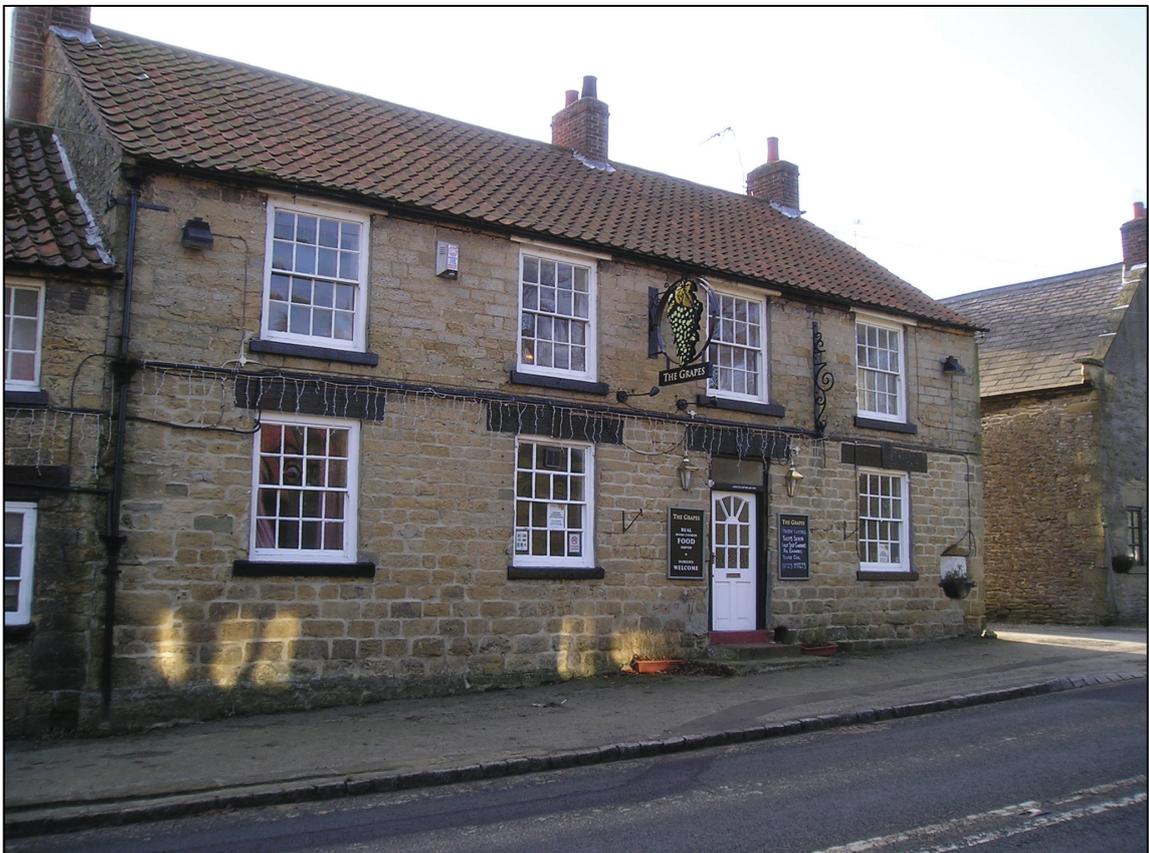
Plate 4: North elevation of inn (C), looking SW.

- 3.5 The Grapes Inn (C) is of two storeys with an attic, and a half-sunken cellar actually occupying the west end of the ground floor of the adjacent house (see plate 4). The house (B) also rises to two storeys, but is substantially lower than the inn, as is the west range (see plate 1). The outbuilding (A) is of a single storey (see plate 2).

- 3.17 The principal elevation of the inn faces north onto the road (see plate 4). It is of four bays, and is built of hammer-dressed coursed squared stone, the courses diminishing in depth as they rise toward the eaves. The elevation rises from a slightly projecting stone plinth, as noted to the north elevation of the adjacent house. Like the latter, the inn plinth does not run parallel to the face above, but angles inwards, disappearing to the west of the ground floor doorway (see below). At both ends of the elevation, there are herringbone and margin tooled quoins; at the east end, the lower quoins are larger and appear less finely tooled than those above, although this could just be the result of differential weathering. However, there appears to be a similar pattern to the west end,

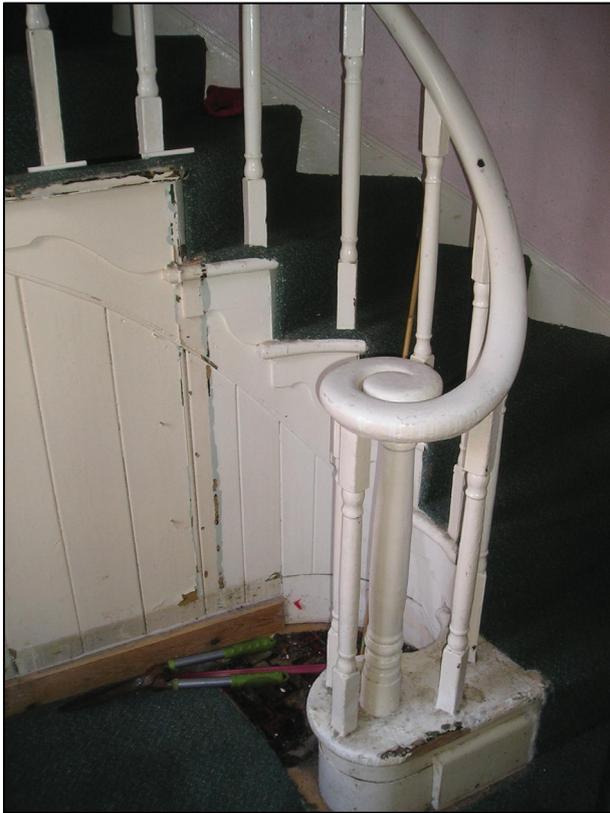
Plate 5: Staircase in inn (C6), looking SE.

- 3.23 The stair hall (C6) is a small sub-square space, which houses a curving open-string softwood staircase with a ramped handrail (see plate 5). At its lower end, the handrail is scrolled around the top of the turned newel. There is a single turned baluster to each tread at a lower level, but pairs to the upper part. The tread ends have a simple moulding with tongue and groove panelling beneath; comparison with other Yorkshire examples suggests that the staircase is late 18th to early 19th century in date (Alcock & Hall 1994, 9; RCHME 1975, plate 127). The joists over the west side of the stair hall have moulded ends and there is a small wall niche half way up the stairs.

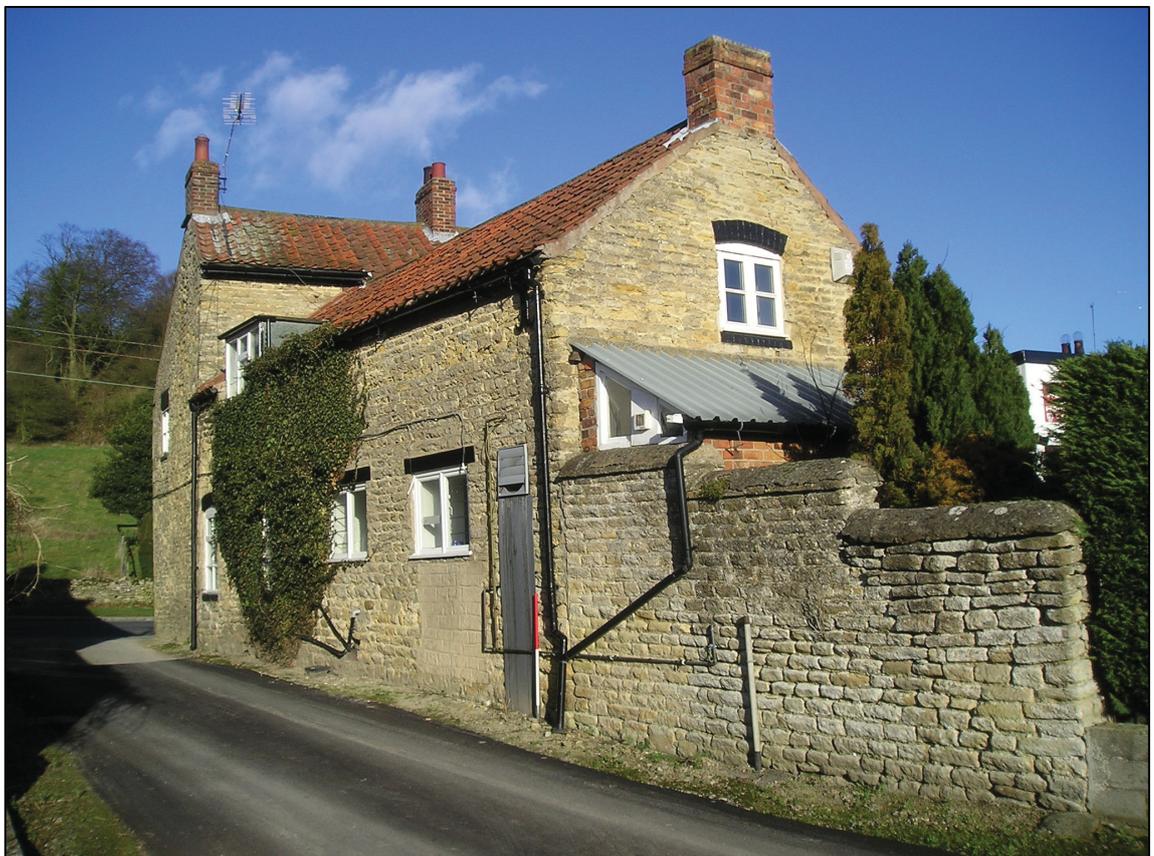
Plate 7: West and south gable of west range (D), looking NE.

- 3.28 The south gable of the west range is partly hidden by a modern lean-to structure housing the male toilets (D3) which abuts its base (see plate 7). At first floor level, there is a central window with similar detailing to those on the ground floor of the west elevation's northern half. The east elevation is also obscured by a modern addition (C2) to the rear of the inn. However, the west wall of this addition is formed by the original ground floor of the east elevation. This formerly had a central doorway flanked by windows, all with similar detailing to that noted in the west elevation and south gable, but much altered since. At first floor level, there are two windows, probably modern insertions, and a single fish-tailed wall tie-plate at the very south end.
