**FORD COTTAGE, FORD LANE  
THORNTON LE STREET  
NORTH YORKSHIRE**

**ARCHAEOLOGICAL WATCHING BRIEF**

November 2011

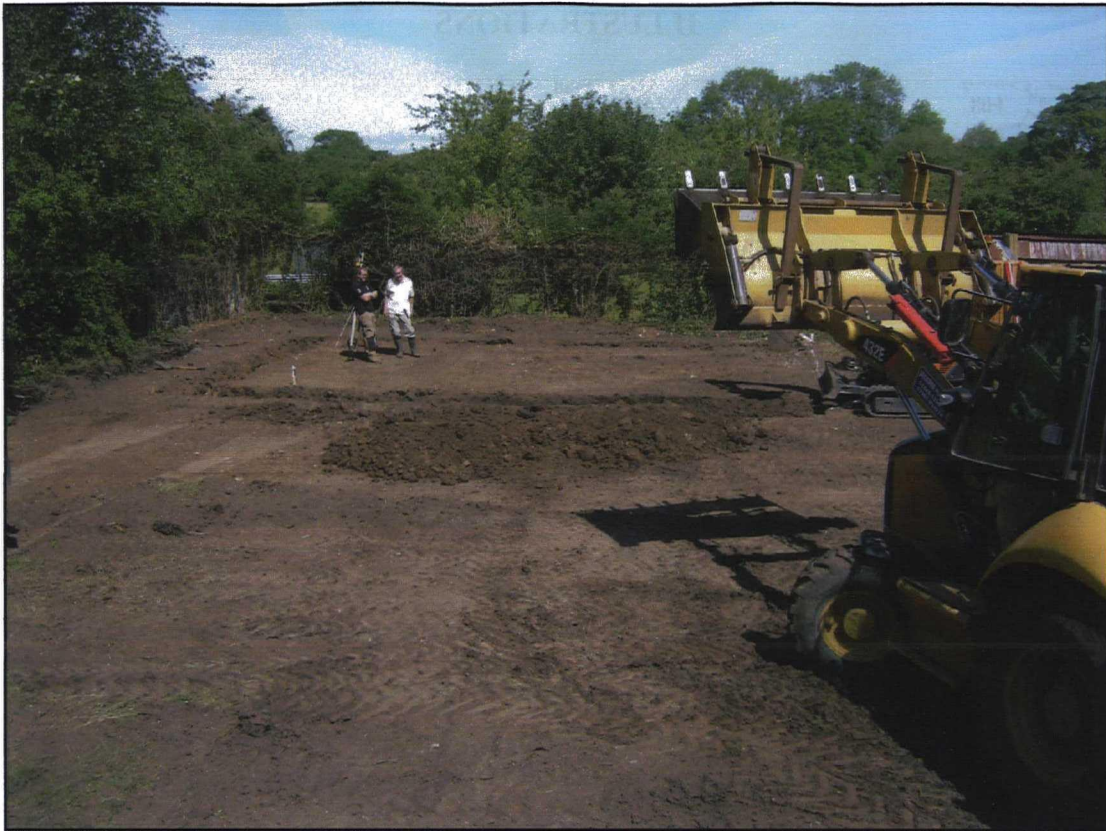
5.2 The watching brief was undertaken on the ground works for the new garage which consisted of an area of ground reduction for the hard standing and driveway for the garage along with its footings. A service trench was also excavated alongside the driveway to connect to the existing drainage system.

5.3 The archaeological monitoring recorded a deep, well developed topsoil [01] (up to 0.5m deep in places) which overlay a thin subsoil [02] which in turn overlay the natural drift geology [03] of the area. The topsoil contained a large number of 19/20<sup>th</sup> century pottery, brick and glass fragments along with a small number of abraded sherds of medieval pottery which were retained for spot dating. The artifactual remains are typical of manuring of a garden plot with midden type material.

Plate 1. General shot of site of garage during ground works, looking north.

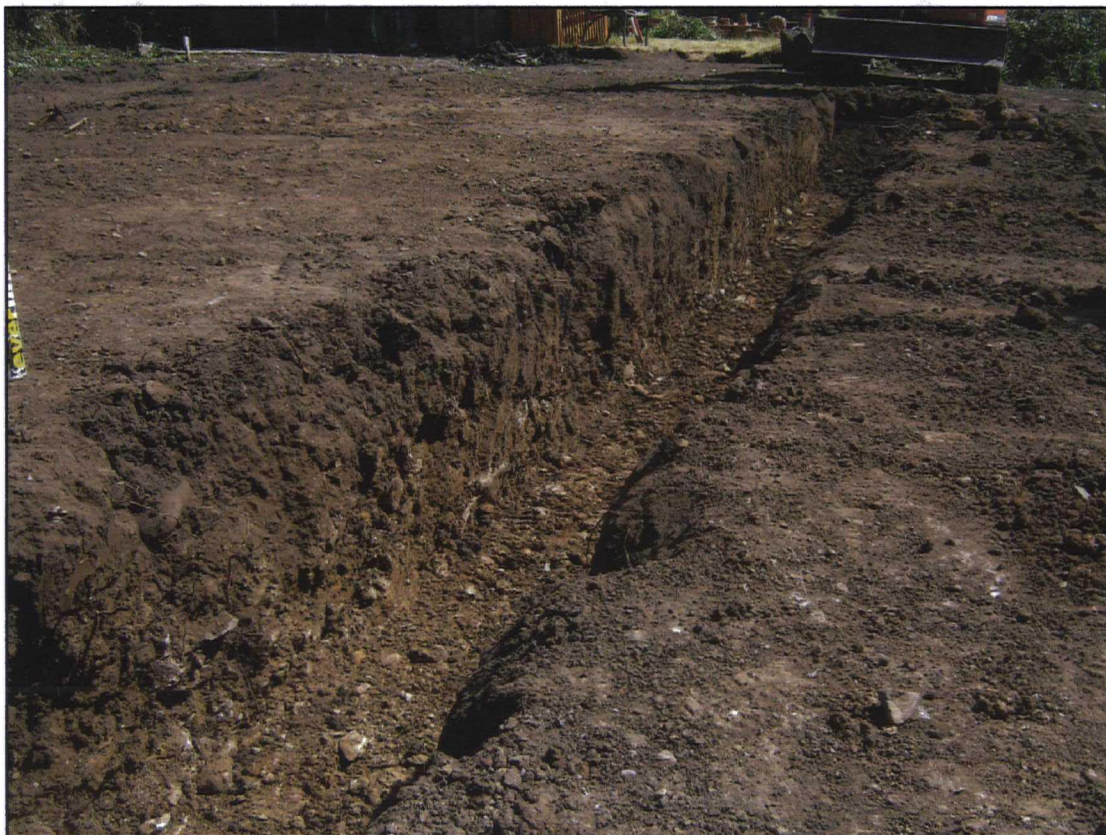
Plate 2. General view of foundations trench for garage, looking north-east.

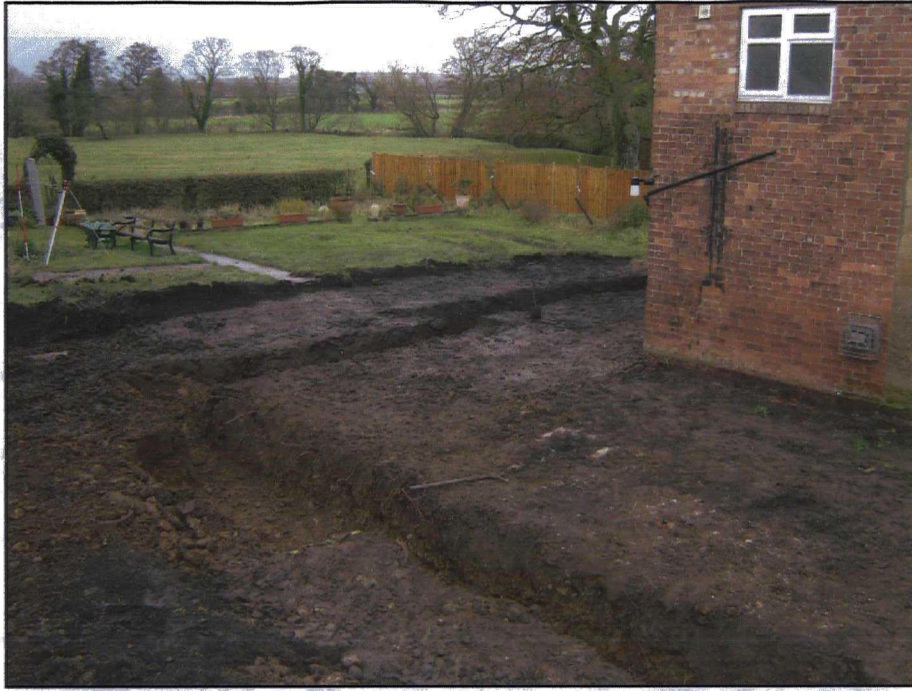
- 5.4 This phase of the watching brief was on the ground reduction for the extension to the north and west of the existing cottage.
- 5.5 The archaeological monitoring recorded the same soil profile to that already recorded for the work on the garage and described above. The deep, well developed topsoil [01] (up to 0.5m deep in places) covered the entire area investigated. As before this overlay a thin subsoil [02] which in turn overlay the natural drift geology [03] of the area. As already observed the topsoil contained a large number of 19/20<sup>th</sup> century pottery, brick and glass fragments. The amount of medieval pottery collected was much less than during the previous works.

Plate 3. General view of foundations trench for extension, looking north-east.

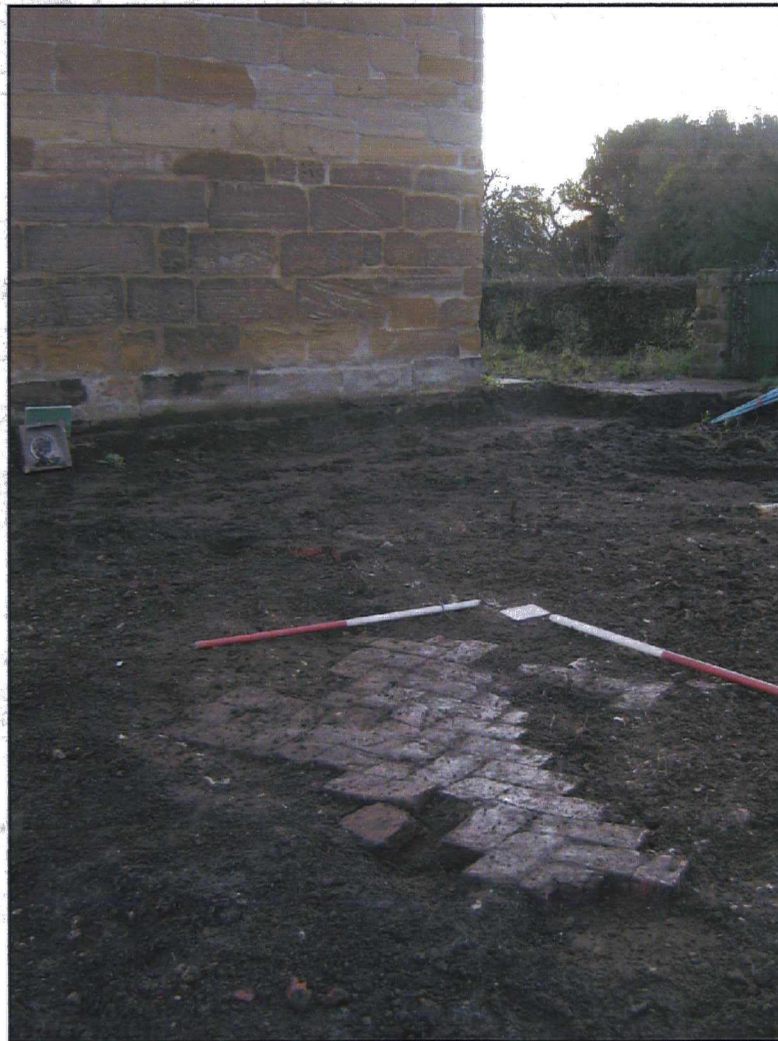
- 5.6 A single feature was recorded 4.3m to the west of Ford Cottage. This was a small area of herringbone-laid 18<sup>th</sup> century bricks. The bricks formed an irregular shape (maximum dimensions 1.5m north to south and 1.8m east to west) and were laid on a bed of sharp sand within the topsoil. They are the remains of a modern garden feature re-using 18<sup>th</sup> century bricks.

Plate 4. Area of herringbone brickwork, looking south-east, scales 1m.

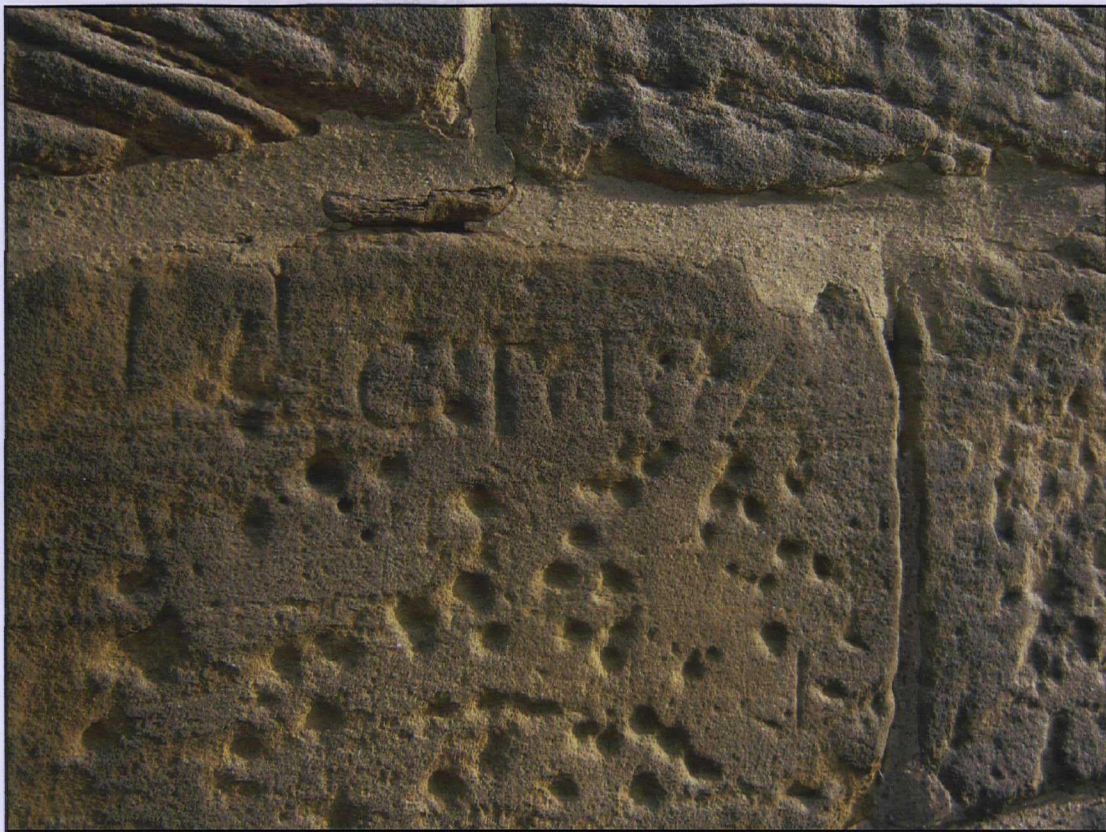
- 5.9 During the archaeological works it was possible to briefly examine the exterior of Ford Cottage. This examination noted that it appears that the western end wall of the cottage has at some stage been rebuilt. The evidence for this could be seen in four features. Firstly, the irregularity of the stone courses when compared with the southern elevation. Secondly, the presence of a stepped foundation only along the western end. Thirdly, several masons' marks were noted on the exterior face of the blocks of the western wall when there were none showing in the southern wall. Additionally the blocks would normally be laid so that the masons' marks would not be visible. Finally, there appears to be a faint set of initials (CT) with a date (177?) cut into the stonework on the western end towards the southern side, which may represent the date of the rebuild.

Plate 5. Initial CT and date 177? in the western end of Ford Cottage
