LODGE, UPPER NIDDERDALE

ARCHAEOLOGICAL SURVEY

**LODGE, SCAR HOUSE RESERVIOR, UPPER NIDDERDALE AONB
NORTH YORKSHIRE**

INITIAL ARCHAEOLOGICAL SURVEY AND ASSESSMENT

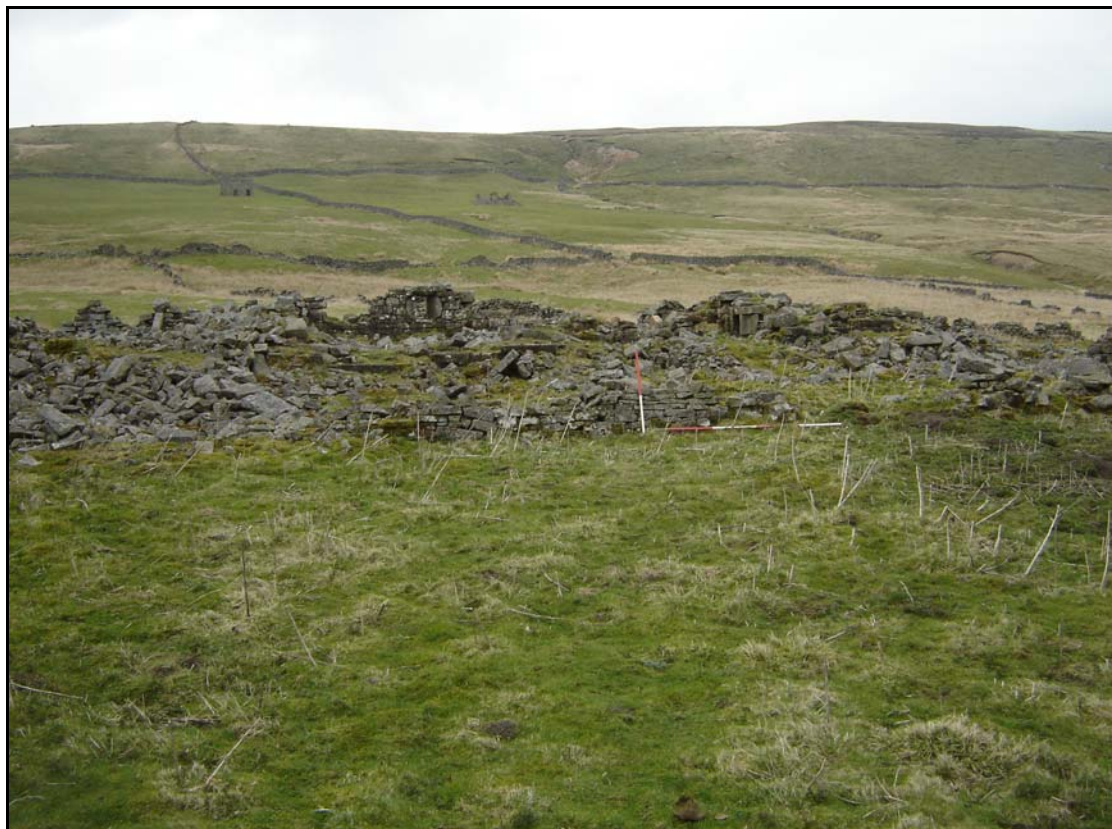
- 5.3 The first complex of buildings is located at the northern side of the site (Plates 1 & 2) and is composed of three main elements. The first is what appears to be the main house with a number of associated outbuildings. The second is a series of three buildings to the east of the house and the final element is two gardens or allotments to the south of the house.

Plate 2. General View of Building Complex I, looking north scales 1 & 2m

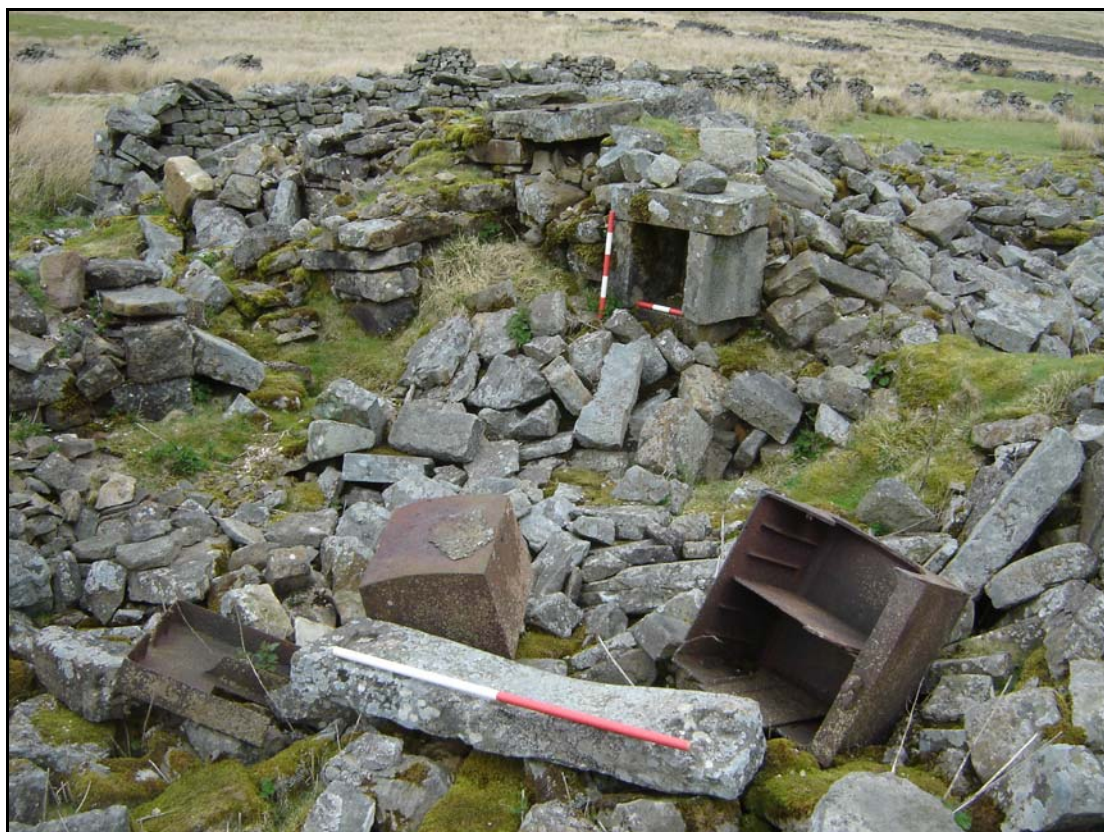
- 5.6 Rooms B and C were the main living space of the house with Room C containing the remains of cast iron ovens lying in the middle of the room on the stone debris (Plate 5). From the presence of the remains of similar cast iron ovens in the eastern wall of the other houses on the site it would seem likely that there were originally set in the eastern wall. This suggestion is supported by the presence of what appears to be a stone built salt box in the eastern wall (Plate 5). In Room B the location of two windows in the northern wall can be clearly seen with the eastern window being substantially intact (Plate 6). As would be expected on the northern side of the building these windows are small in order to reduce heat loss. The location of the front door of the house in the southern wall could not be identified due to the large amounts of fallen stonework, but it is assumed that it would have opened into Room C. Similarly the position of none of the windows along the southern elevation could be determined.

Plate 5. Cast iron ovens, door sill & saltbox in Room C, looking NE, scales .3, .5 & 1m

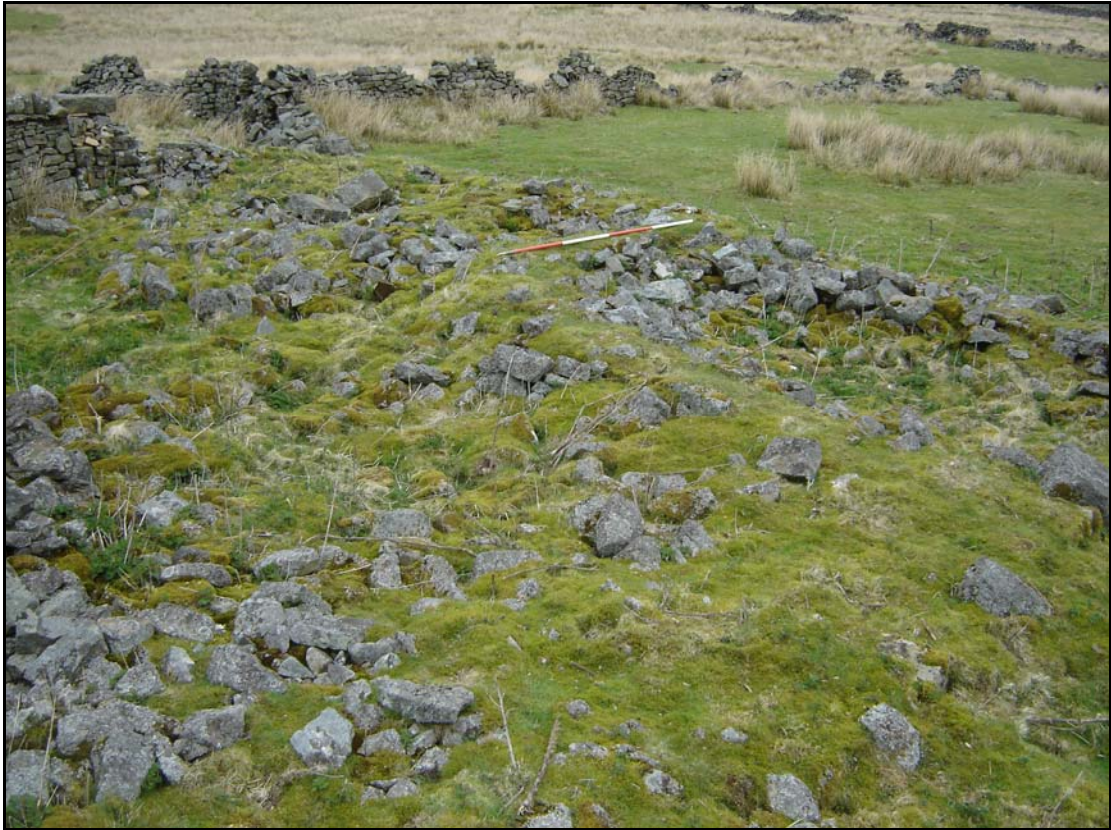
- 5.9 Building 2 consisted of a range of three rooms (G-I) arranged running north-south (Plate 7). The most northerly room (G) had a small stone built feeder trough in the north-east corner (Plate 8) and from its general layout appears to have been a pig sty. To the south of the pig sty there was a small room (H) with a narrow entrance looking out on to the yard space. It is possible this was for chickens or a small store.

Plate 7. General view of Building 2, looking north-east, scale 2m

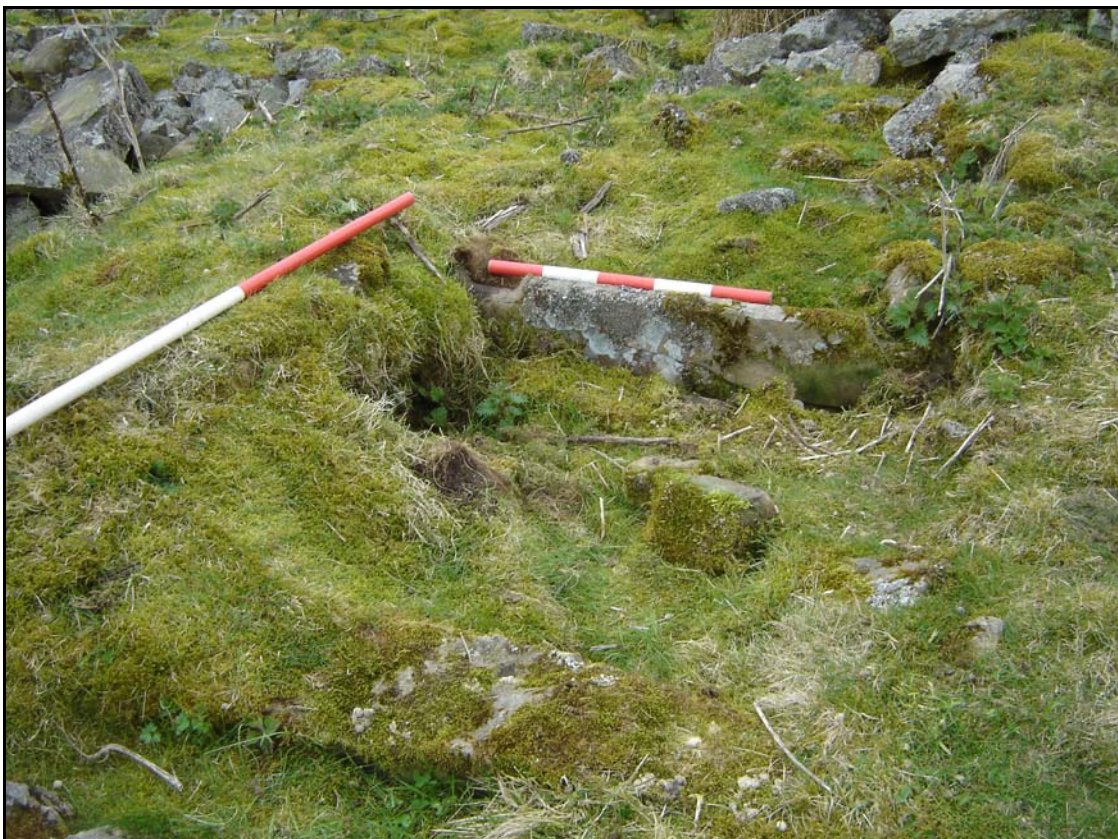
Plate 8. Stone trough in Room G, looking north-east, scale 0.5 and 2m

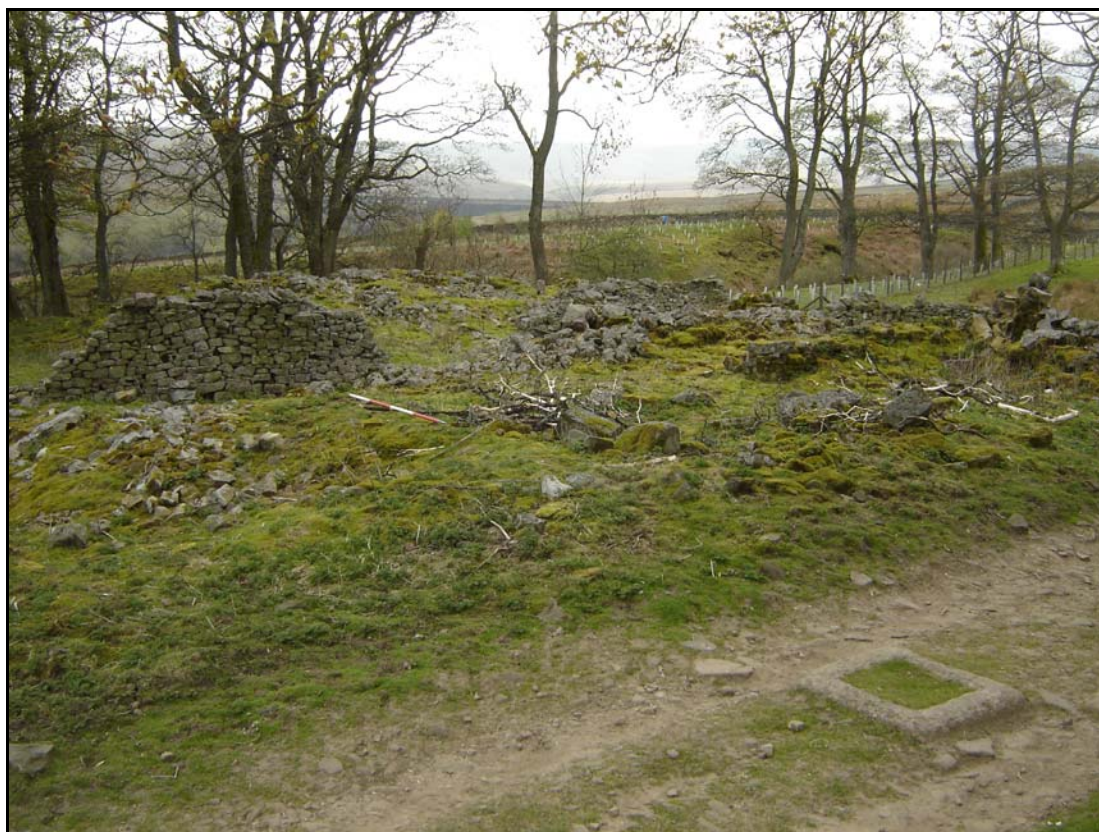
- 5.17 This range of buildings consists of eight 'rooms' (A – I) arranged in a row one bay deep on an east-west axis. Due to the collapsed and jumbled nature of these remains it is not possible to be certain as to possible roles and functions of much of the building (Plate 9). However, a few details were visible and some initial conclusions can be made. The core of the building (and probably the main living area) appears to be formed by Rooms C – E. The evidence for this is not particularly compelling and is based on the size and central location of the rooms rather than any physical features such as ovens.
- 5.18 The division between Rooms C and D was made from a stone sill with evenly spaced square holes which appear to have been cut to take the upright timber posts for an internal wall (Plates 10 & 11). A similar stone sill was also noted

Plate 9. General view of Rooms C-E and L & K of Complex II, looking SW, scale 2m

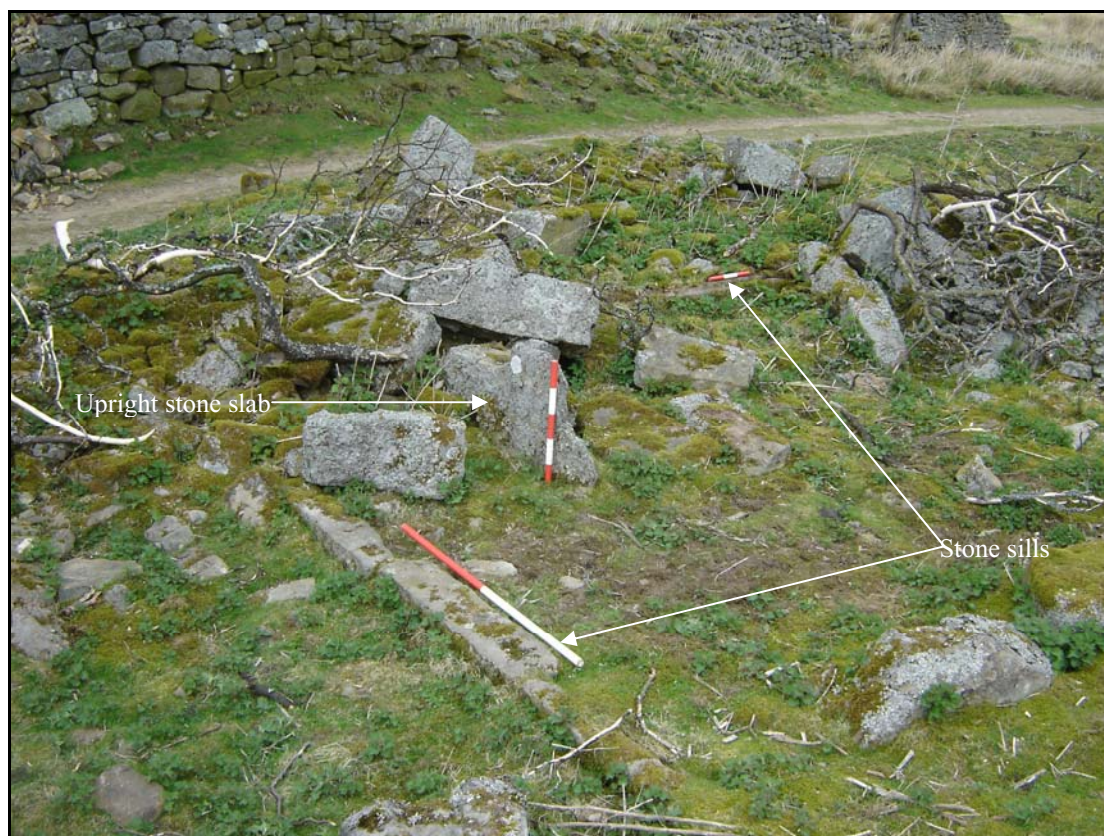
Plate 10. Stone sill between Rooms C & D, looking north-east, scales .3, .5 and 1m

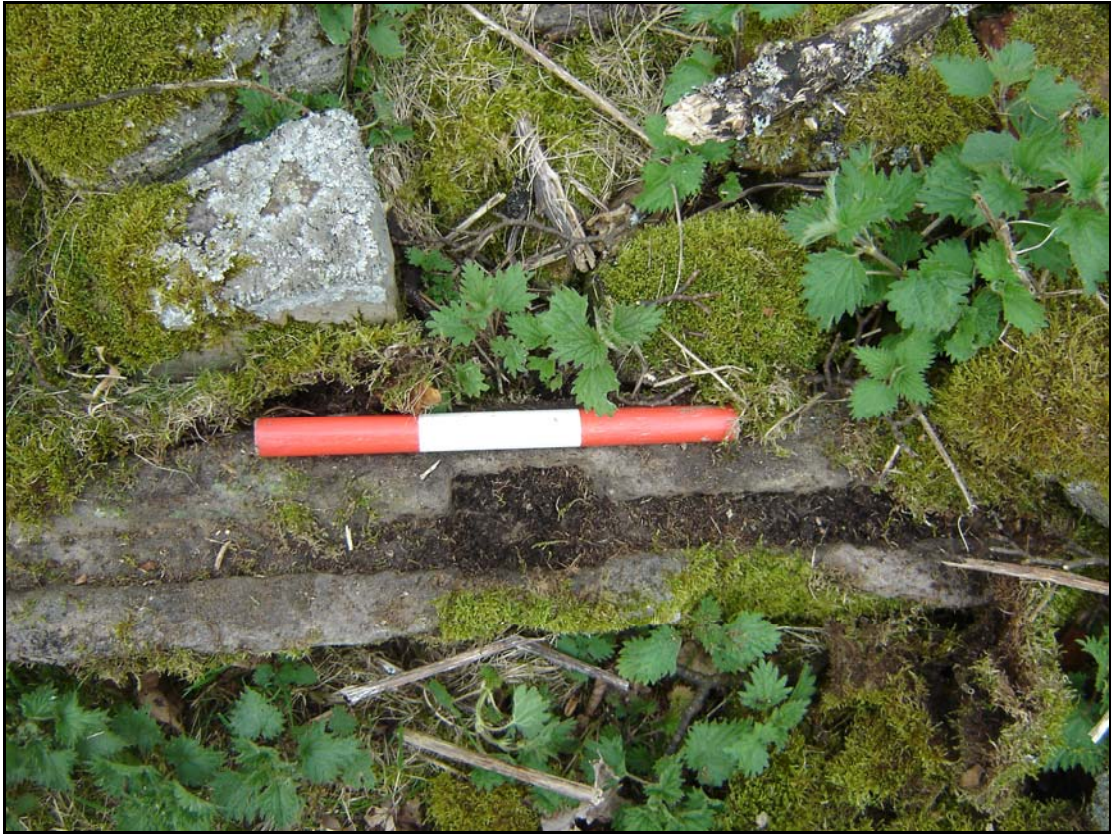
Plate 11. Detail of stone sill in Room C, scale 0.3m

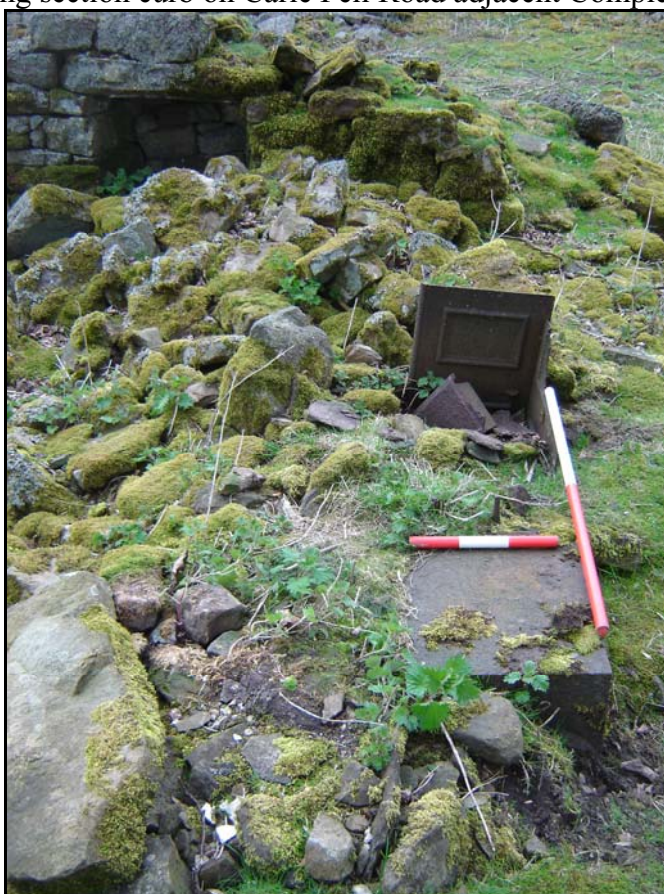
Plate 14. Remains of cast iron ovens and niche in Room H, looking N scales .3&1m

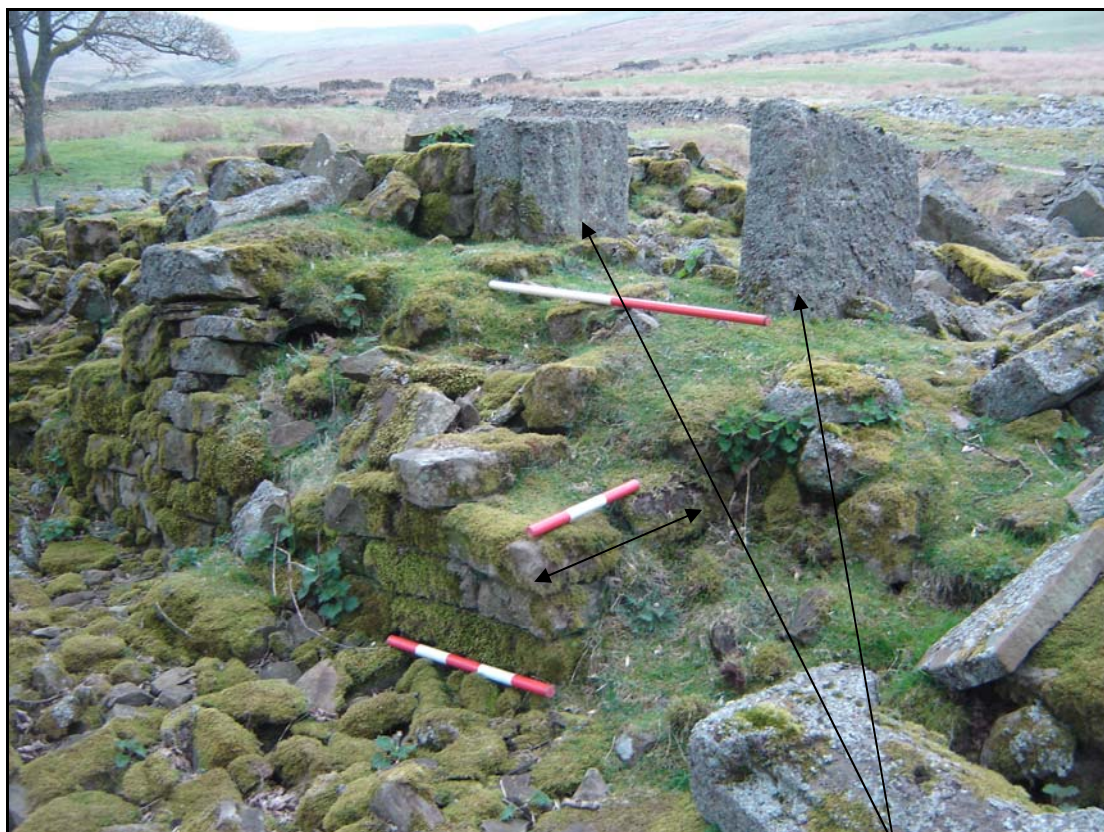
- 5.32 In addition to the buildings described above a number of other features were noted in and around the building complex. As already described above there are what appear to be reused architectural stones in the window in the southern wall of the byre (Plate 17). These stones appear to be either a sill with the longer downward [outside] slope of the face (with the hole) which was intended to throw off water and the rebate behind [on inside?] is for a window shutter (J Hatcher, *pers comm*). Alternatively, it could be a section of a moulded door jamb with quoin incorporated (J Deadman, *pers comm*). As well as these two stones there are at least 10 other whole or fragments of architectural stone lying around these buildings (Plates 20 & 21) mainly on the southern side but some fragments have been observed in Building Complex V. The commonest fragment is of mullioned window and the example shown in Plate 21 has an exterior hollow moulding in the chamfer, possibly dating to the first quarter of the 17th century (J Hatcher, *pers comm*). The hole in the centre of each light was for a central iron stanchion to which a leaded light could be attached. The nature and quality of the stonework suggests a building of possible 'yeoman farmer' status.

Plate 17. Possible earlier wall to south of Rooms E & F and reused stones in window, looking north-west, scales 0.3, 0.5 and 1m

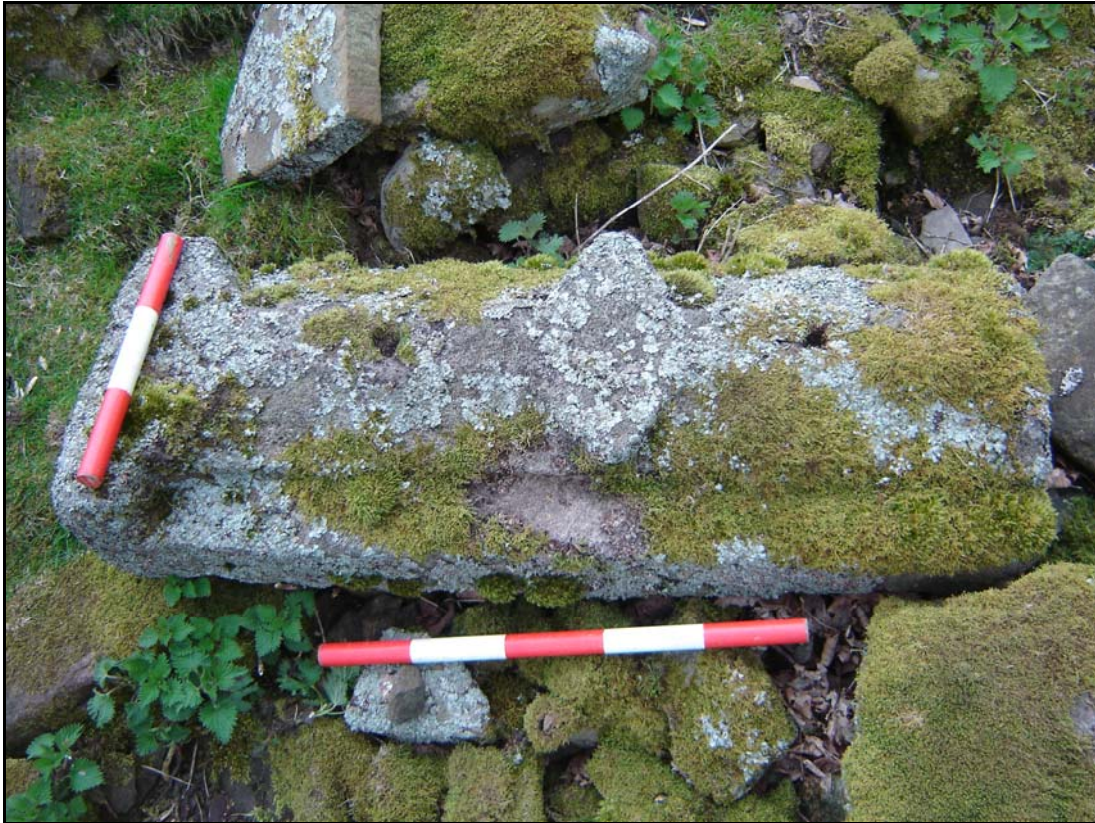
Plate 21. Detail of ?17th century stone mullion, scales 0.3 and 0.5m

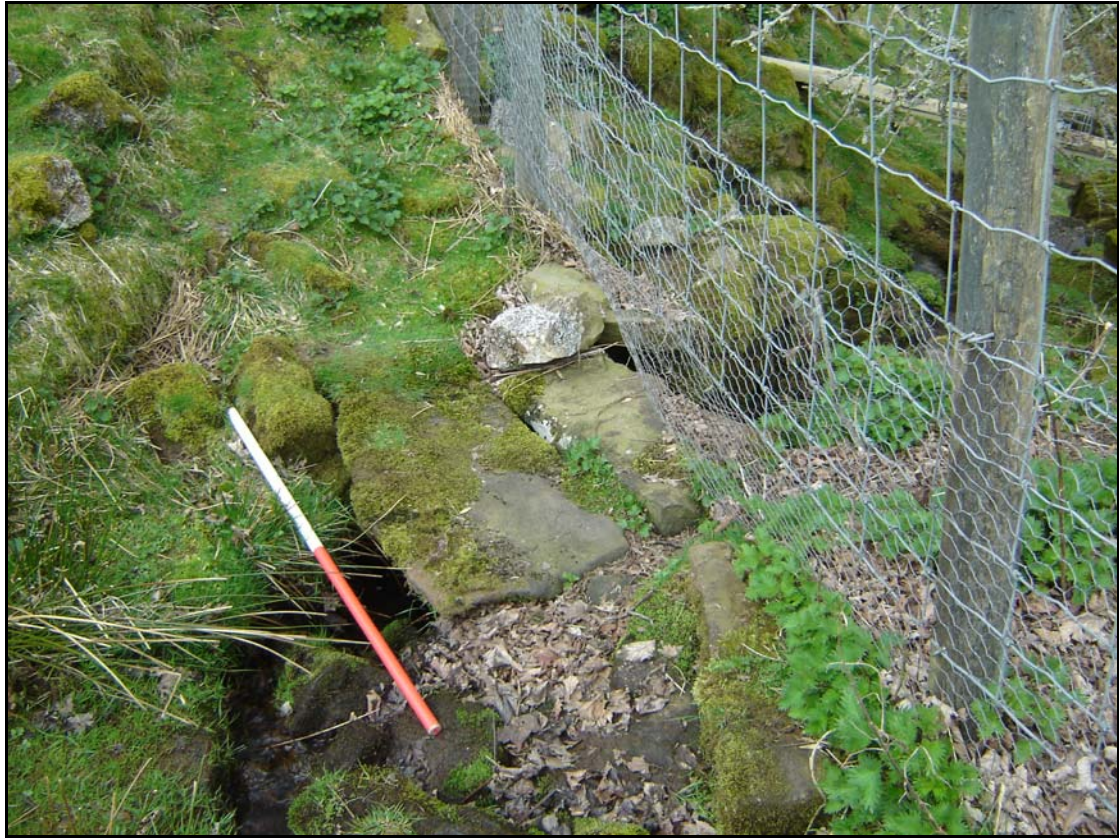
- 5.34 The final feature noted was the use of two small stone slabs to form a crossing of Shaw Gill Sike immediately to the west of the earth closet (I) in Building 2. It is currently uncertain if this is a short cut to the fields to the west of Lodge contemporary with the buildings or if it much more recent and related to the building of the fence (Plate 23).

Plate 23. Stone crossing Shaw Gill Sike to west of Room I, looking SE, scale 1m

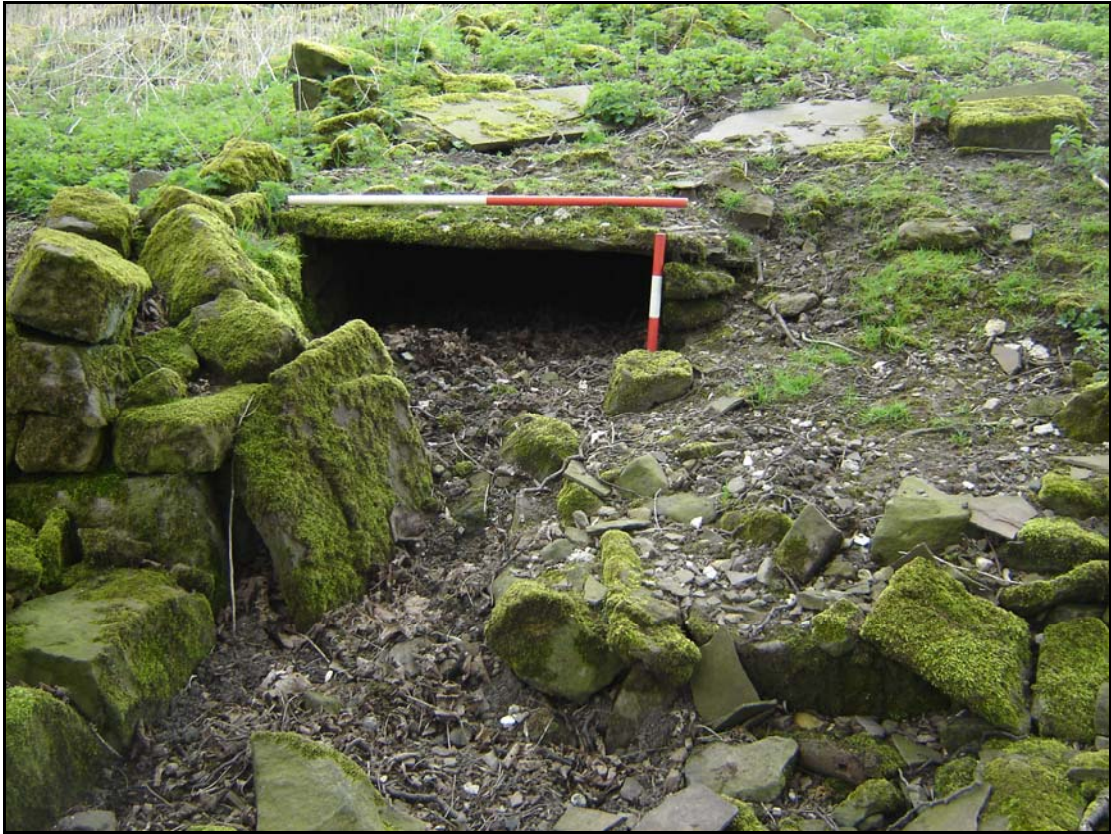
- 5.45 Two additional features in the area around this building complex were also noted. The first of these is in the area immediately to the west of the animal pen A there are two upright stone posts with semi-circular holes cut into their tops (Plate 32). The current interpretation of these is that they would have supported a sharpening or grinding wheel for maintaining the edge on scythes and sickles etc. The second feature was in the garden/allotment to the south of the main house. Here on the southern edge of the raised garden there is what appears to be the outlet for some form of drain (Plate 33). The source and route of the drain is currently unknown.

Plate 33. Possible drain outlet under garden, looking north, scales 0.3 and 1m
