TALBOT HOTEL, YORKERSGATE, MALTON,  
NORTH YORKSHIRE.

REPORT ON AN ARCHAEOLOGICAL EVALUATION

OSA REPORT No: OSA12EV04

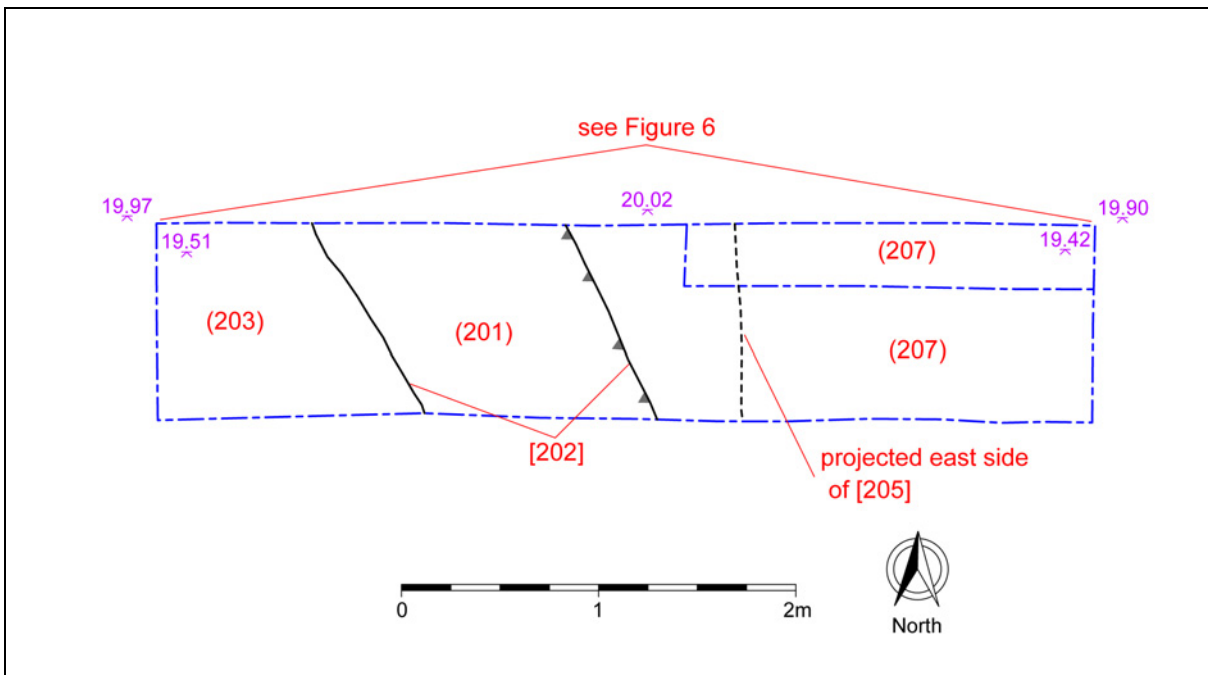
Figure 5. Plan of trench 2

Trench 2 was located to the south of the standing garden wall, straddling the boundary between Areas D and E (Talbot Hotel lower garden and the west part of York House Garden) and was orientated east-west. It was 4.75m long and 1m wide and was excavated to a maximum depth of 0.75m below the modern ground surface, in a limited sondage next to the northern edge of the trench. The earliest deposit recorded within this trench was only partially excavated, the majority being left in-situ.

Soil deposit (206) (and (208) at the west end of the trench) were truncated by a substantial cut [205]. Only the eastern side of this feature lay within the limits of the trench, but it appeared to be a broad, (3.00m +) shallow (0.37m deep), north south aligned linear feature. Its fill (203/204) comprised loose, light yellow brown sandy silt and mortar with frequent limestone rubble, together with brick and pantile fragments. The quantity of rubble within this fill, and the location of the cut, on the southward continuation of the extant garden wall, initially suggested that this feature may represent a robber trench. However, the width of the cut, and its stratigraphic date, may indicate that it formed another garden footpath, similar to that recorded in Trench 1 (see above).

The centre of feature [205] was truncated by a substantial, steep sided, north-northwest to south-southeast aligned, linear cut [202]. This was 1.05m wide and a minimum of 0.50m deep, although the base was not reached. The fill (201) of dark brownish grey sandy clay silt, contained frequent limestone and brick rubble inclusions, together with occasional roof slate, fragments of glazed drain pipe and plastic. Although this feature was not bottomed it is likely to contain a relatively recent service.

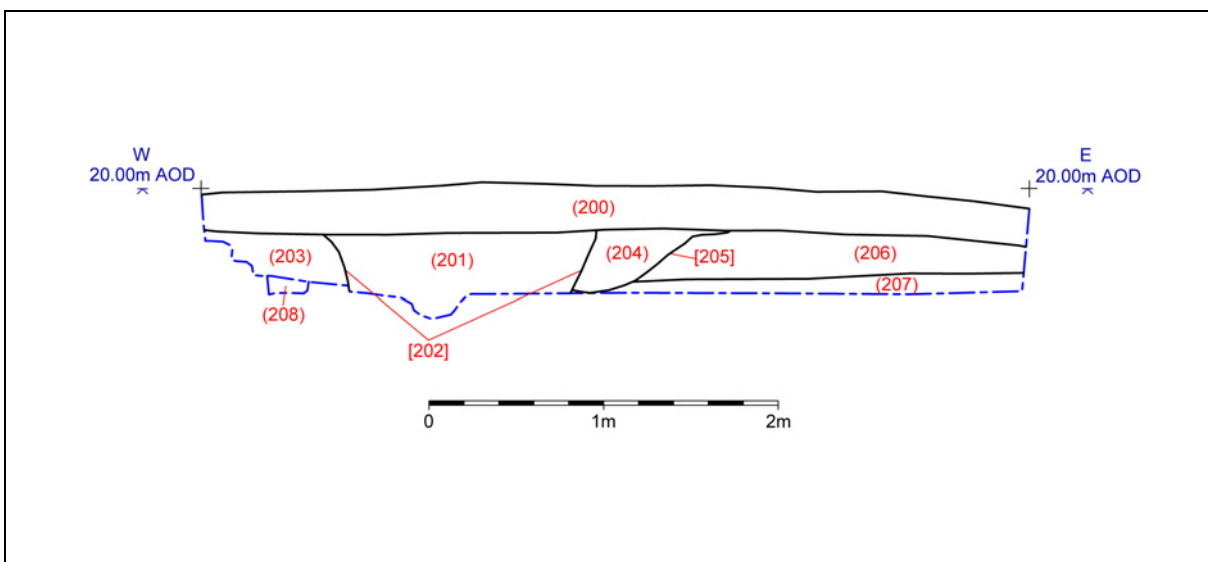
Figure 6. South facing section of trench 2.

The earliest recorded deposit was (207) a mid grey brown clay silt. This was located in the eastern half of the trench, at a maximum level of 19.50m AOD (0.40m below the modern ground surface). It is likely to represent a garden soil and contained fragments of mid 18<sup>th</sup> to 19<sup>th</sup> century pottery. A small area of similar deposit (208) was revealed, but not excavated, towards the western end of the trench, at a depth of 0.60m below the modern surface. In the eastern half of the trench (207) was overlain by another garden soil deposit (206), again a grey brown clay silt. The boundary between the two deposits was very diffuse and it is possible that they represent a single soil horizon, containing a subtle change on colour.

The trench was sealed by a 0.25m thick layer of dark brownish grey sandy clay silt topsoil (200), up to the modern ground level of 20.02m AOD.

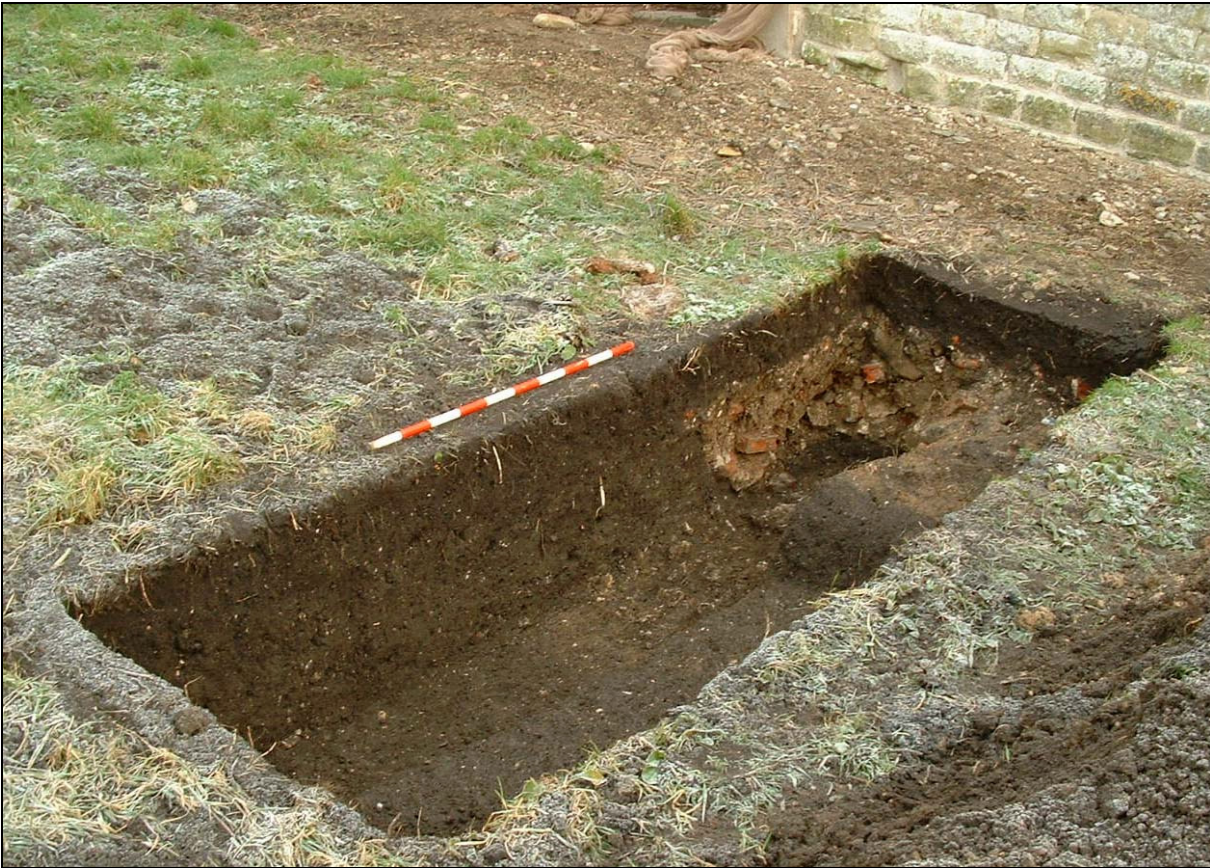
Deposit (101) was cut into at the eastern end of the trench by another north-south aligned feature [102]. This was a minimum of 1.10m wide, extending beyond the east end of the trench, with a moderately sloped side and a flat base at a depth of 0.40m. The single fill (103) comprised mid brownish yellow sandy silt with frequent limestone and brick rubble, with 18<sup>th</sup>-19<sup>th</sup> century pottery. Although much of this fill was loose it was notably more compact at the surface, suggesting that it had formed a garden footpath, running parallel to the adjacent wall. Such a footpath is visible on the mid to late 19<sup>th</sup> century Ordnance Survey maps showing the gardens.

*Plate 1. Trench 1, looking northwest including footpath [102].*

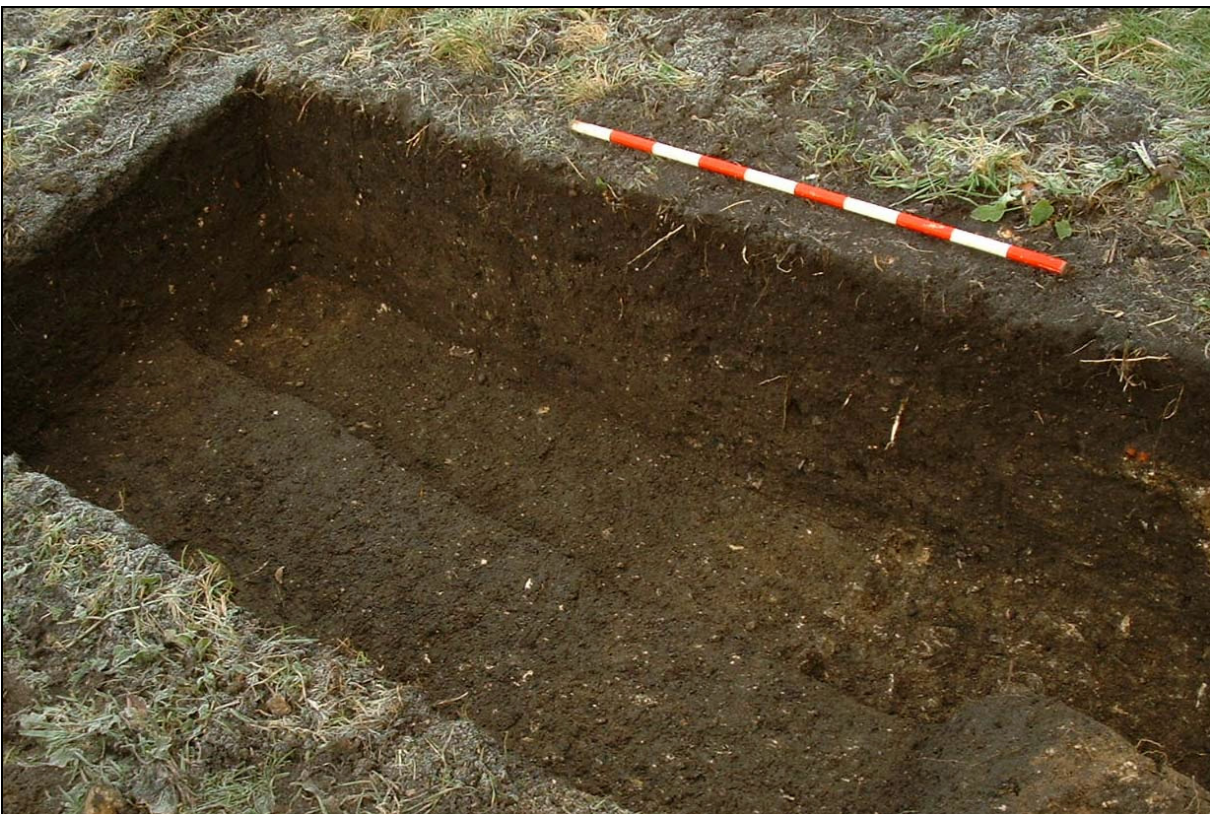
The earliest deposit appeared to be cut into by two parallel, linear, north-south aligned features. The westernmost was [108], which was a maximum of 1.05m wide. It contained a fill of dark brownish grey silty sand (107), from which sherds of later 18<sup>th</sup> to 19<sup>th</sup> century pottery were recovered. Although not excavated this is interpreted as a possible ditch. Approximately 0.40m to the east lay the second linear feature [106], which was up to 0.85m wide. The fill of this differed from (107) to the west as it consisted of mid yellow brown sand containing frequent fragments of limestone rubble (105). This fill is more suggestive of a robber trench, or possibly a garden footpath, rather than a ditch fill.

*Plate 2. Trench 1, earliest, unexcavated features and deposits.*

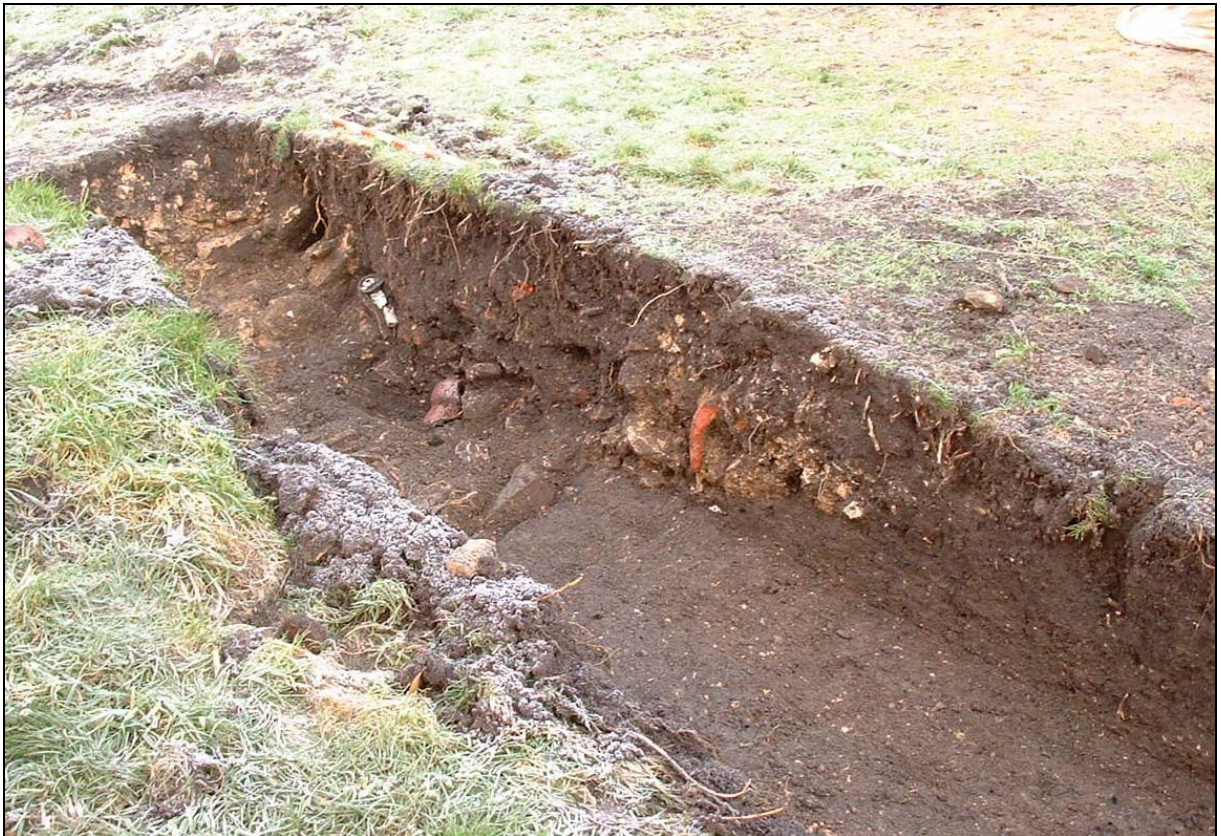
*Plate 3. Trench 2, garden soils (206) and (207), cut by footpath [205] and service trench [202]*

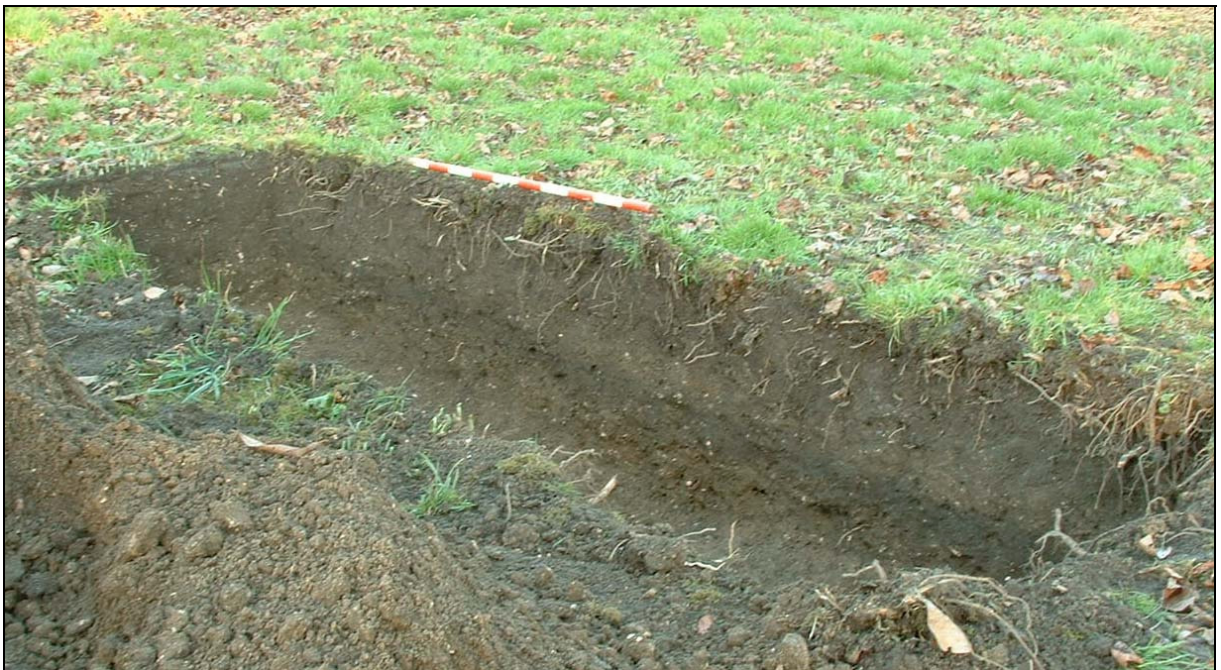
*Plate 4. Trench 3, looking northwest.*
