THE OLD CHURCH, CHAPEL LANE

MARTON LE MOOR, NORTH YORKSHIRE

ARCHAEOLOGICAL WATCHING BRIEF

Planning Application 11/04554/LB

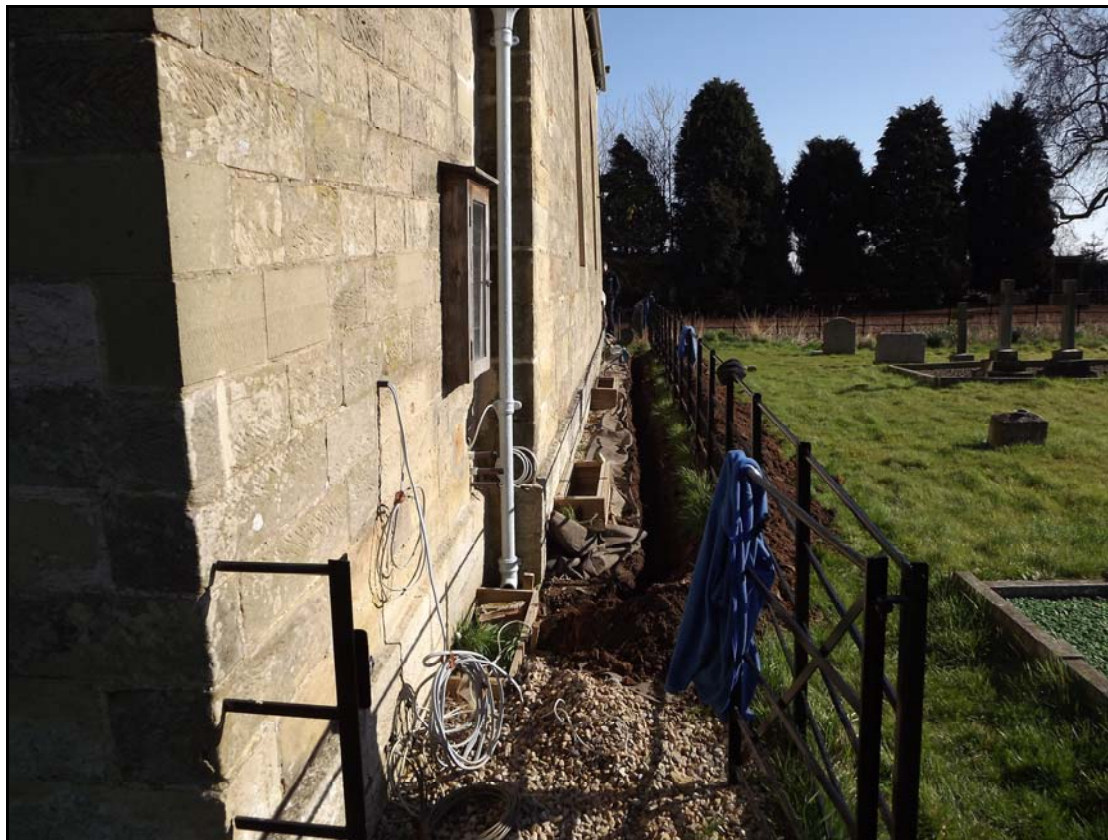
Plate 1. General shot of service trench, looking east.

- 4.1 The service trench was excavated by hand under direct archaeological supervision. The ground works were carried out on the 12th March 2012 (Figures 2 & 3; Plates 1 & 2).
- 4.2 During the ground works, the exposed ground surfaces were inspected for archaeological features and the resulting topsoil stockpiles were monitored for archaeological artefacts.

- 5.1 The archaeological sequences for these excavations are described in detail below. In the text the context numbers for each archaeological deposit or feature are given in [] brackets.
- 5.2 The watching brief recorded a very simple stratigraphic sequence of a deep topsoil [01] which directly overlay the natural geology [02]. The topsoil contained a modest amount of building debris from the construction of the chapel. This was concentrated towards the south-western and south-eastern corners of the building. Along with the building debris there were very occasional fragments of 18/19th century domestic pottery and glass sherds throughout the topsoil.
- 5.3 No other archaeological finds or features were recorded during the ground works.

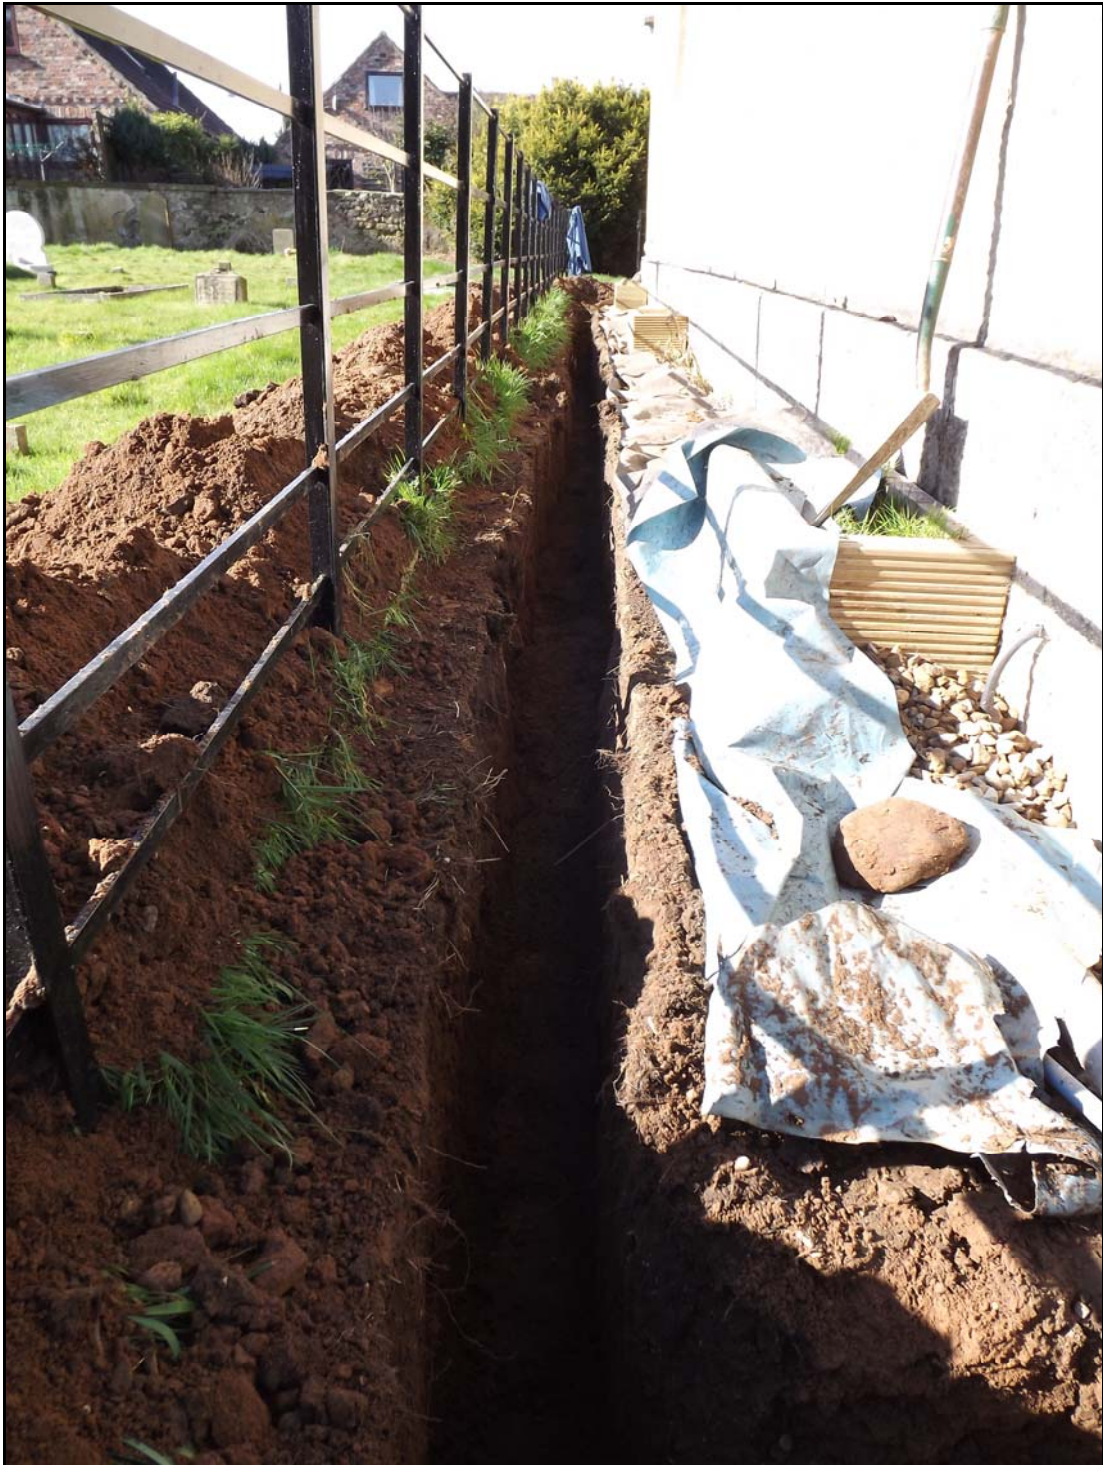
Plate 2. General shot of service trench, looking west
