Archaeological Evaluation

**Kings Mill
Malton**

KINGS MILL - MALTON
Archaeological Evaluation

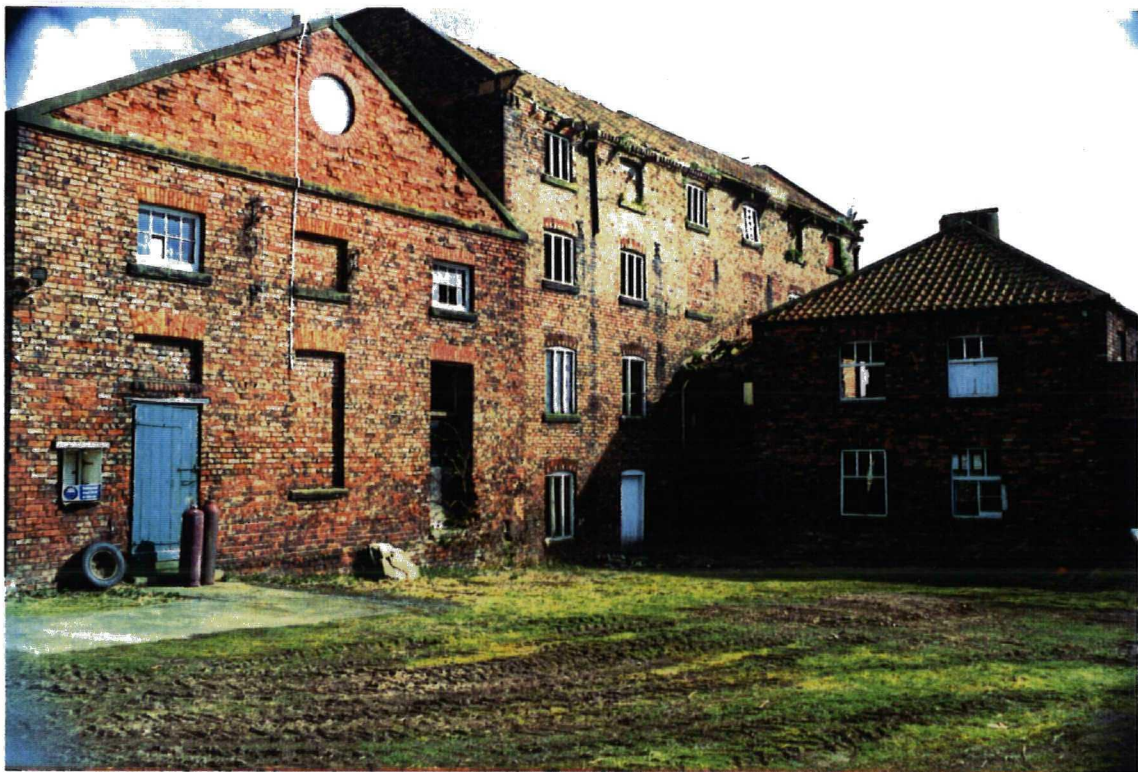
View of King's Mill, facing south-east.

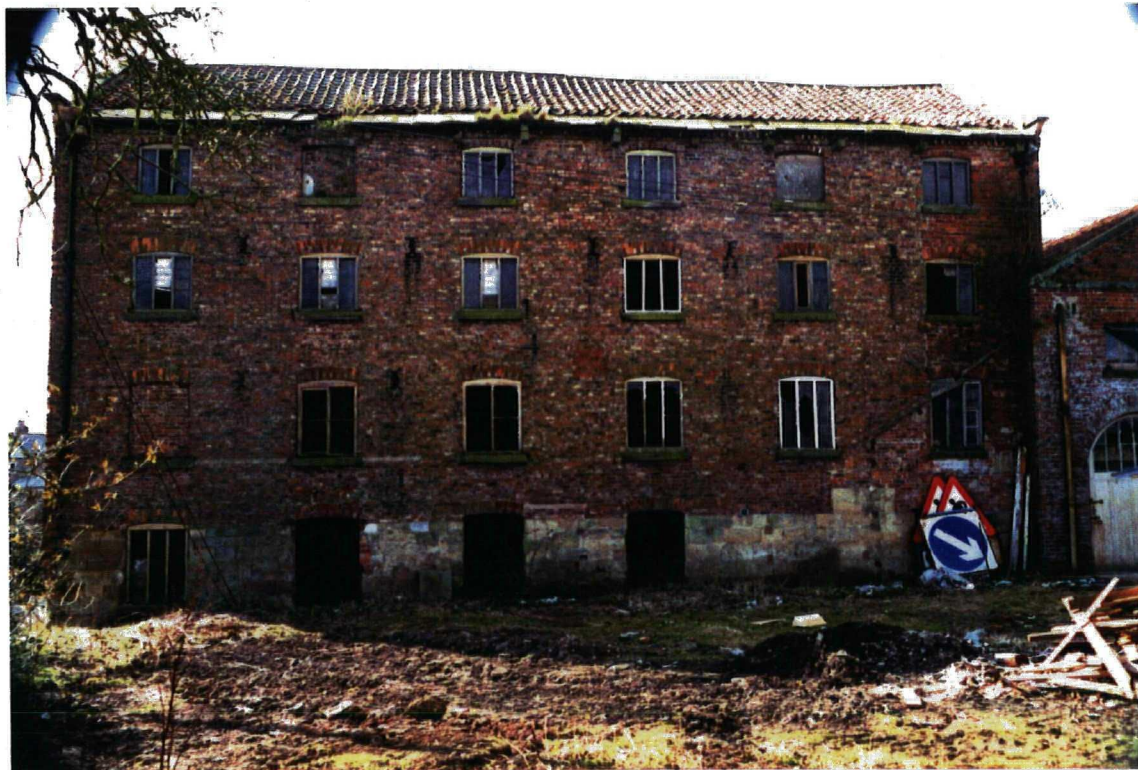
View of King's Mill, facing west.

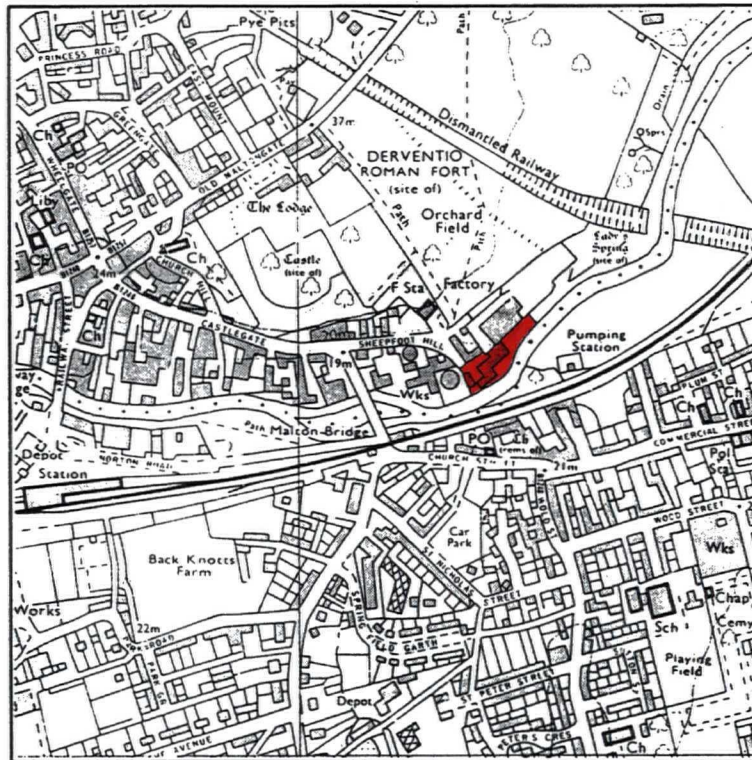
Figure 1.
Scale 1:10000.

An archaeological evaluation was undertaken by MAP Archaeological Consultancy Ltd in March, 1995 at the site known as Kings Mill (SE 79260 71510: Fig. 1). The Mill, a Grade II listed building, and the associated land unit are situated on the north bank of the River Derwent and 160m. to the south of the Roman Fort of Derwentio (SAM County No. NY 285).
