**Grange Farm
Great Broughton
North Yorkshire**

**Archaeological Watching Brief
NGR NZ 5514 0550**

MAP 04-02-01
April 2001

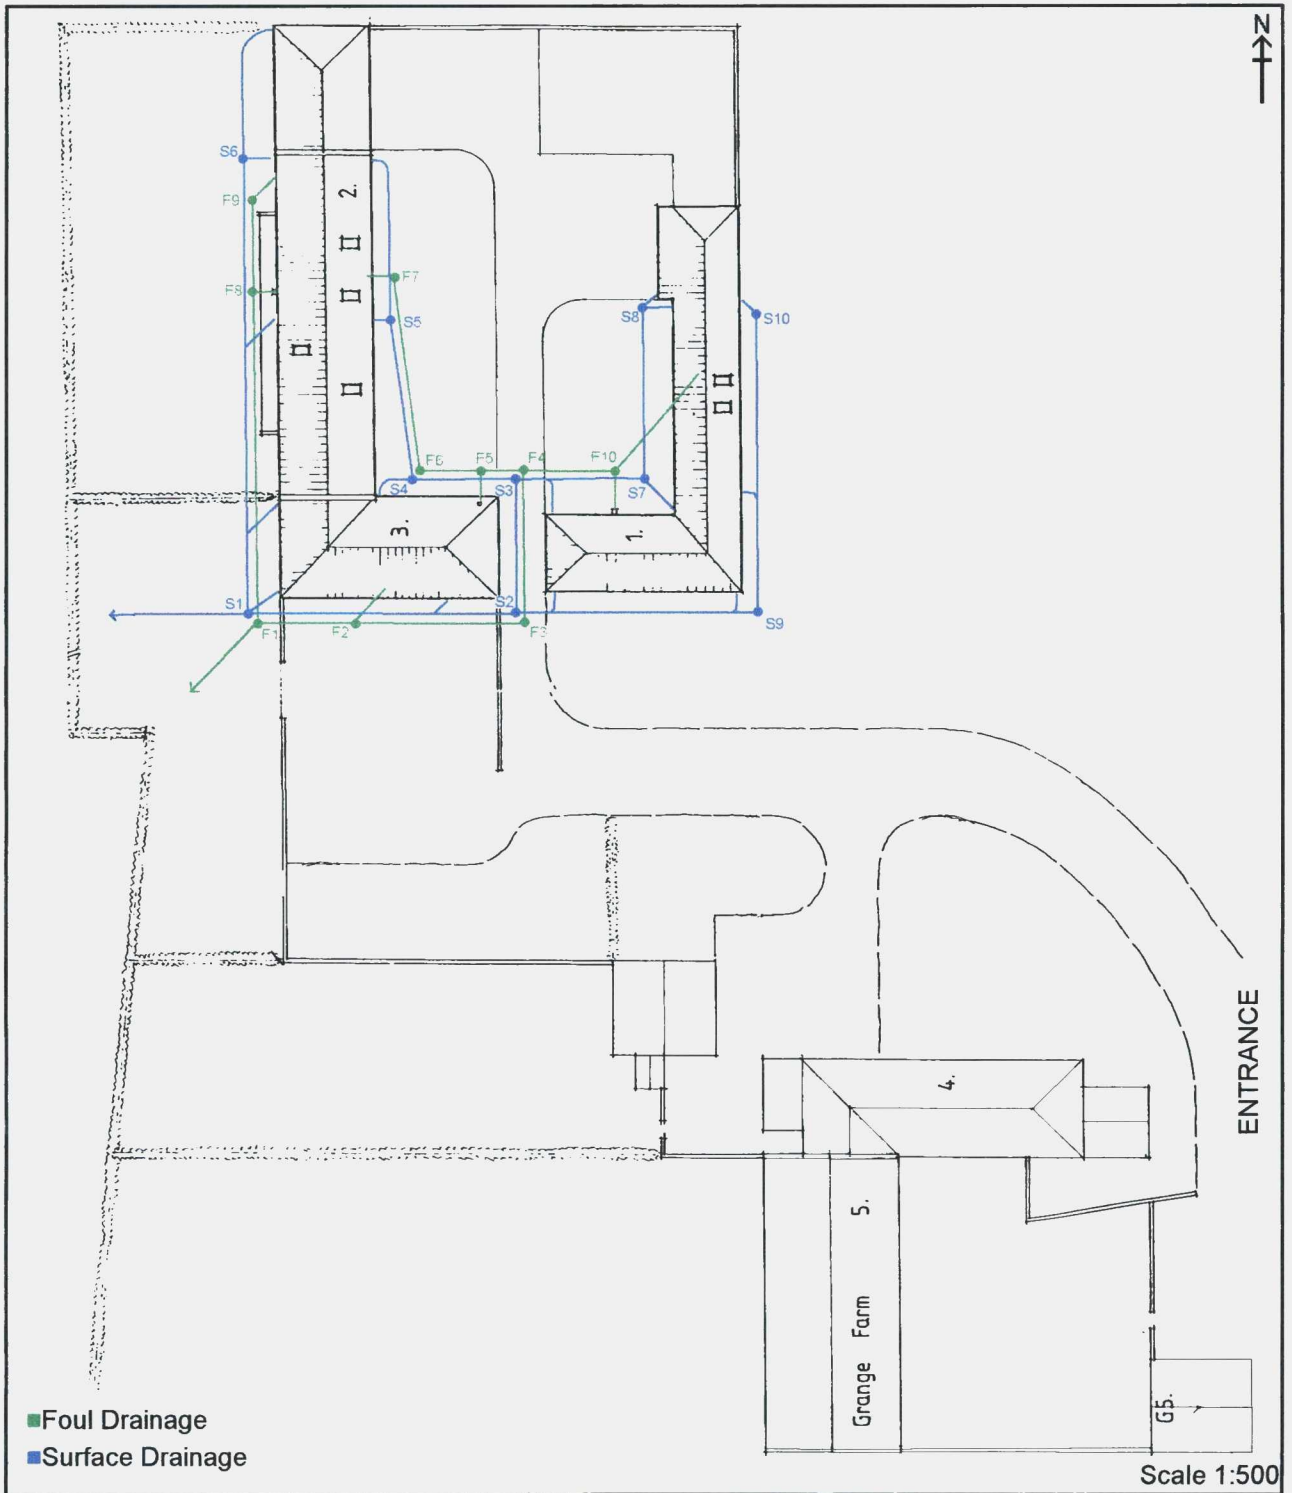
Figure 2. Development Plan.

The footings for the two garages were observed and the excavation to a depth of approximately 0.45m revealed identical stratigraphy to that shown in the foul and surface water trenches (Fig 2).

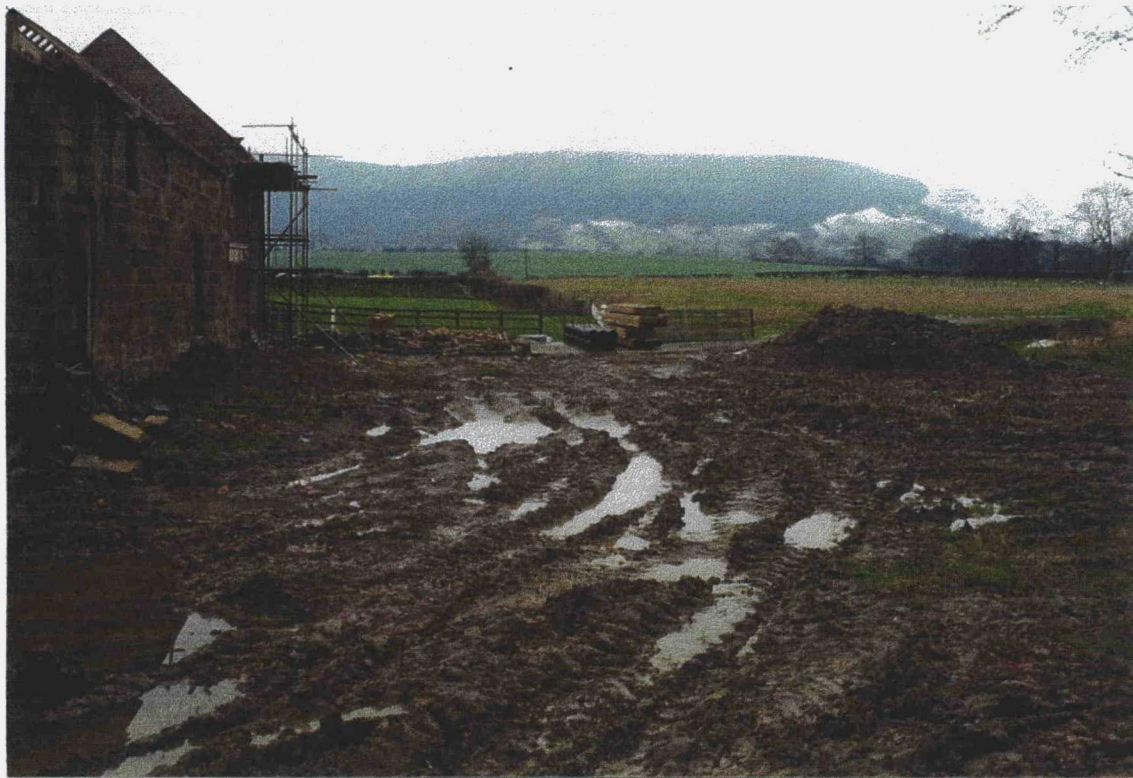
Plate 1. View of area to west of buildings 2 and 3. Facing north.

The Archaeological Watching Brief on the installation of the drains and septic tanks, and the construction of two garages during the redevelopment of existing agricultural buildings to residential units at Grange Farm, Great Broughton (NZ 5514 0550 . Figs. 1 & 2 Pls 1 & 2) was undertaken by MAP Archaeological Consultancy Ltd in February and March 2001

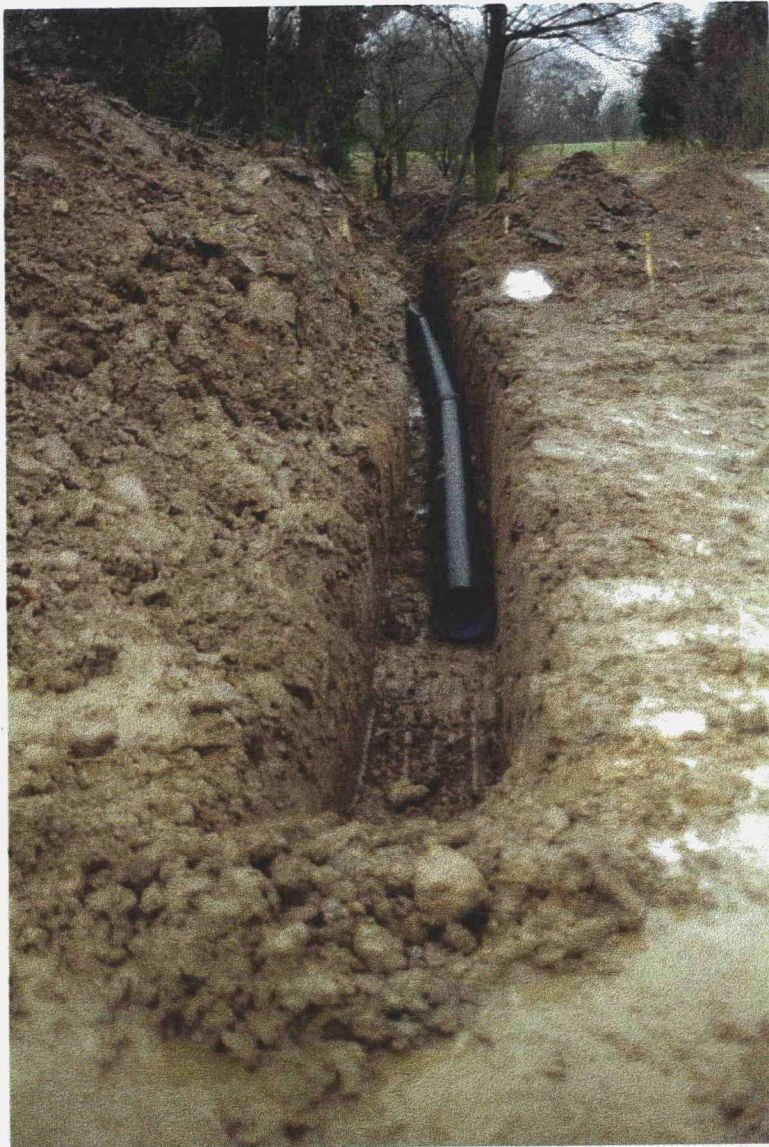
Plate 3. View of Drainage Run S1. Facing west.

Excavation of the main drain (S1 - Pl 3) was to a greater depth and illustrated the nature of deposits up to 1.75m below present ground level. Below the modern topsoil and rubble, measuring 0.30m - 0.04m in depth, was a light brown sandy clay (up to 0.35m deep) which sealed a grey brown clay with occasional sandstone fragments. There was no sign that these

deposits had been previously disturbed, in addition no finds were recovered from the excavation. Sections cut during the excavation of the septic tank pits were identical to the S1 drainage run.
