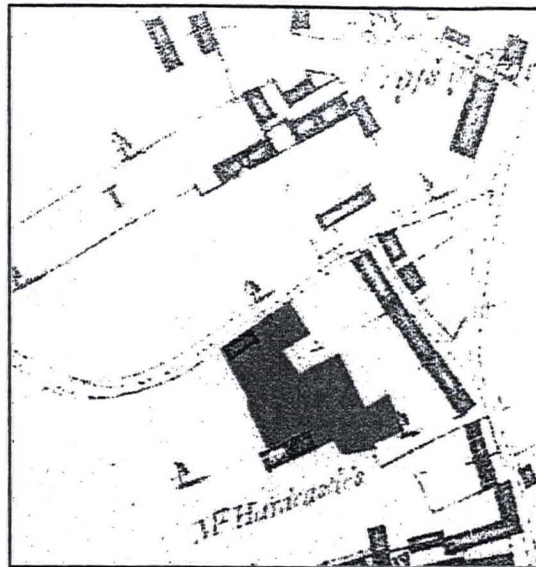
Figure 5. 1778: An actual survey of the glebe lands and copyhold houses &c in Masham

The present building behind the warehouse is also shown on the map from 1801. While the property boundaries are the same, the building on Leyburn Road is no longer shown. In general, this map seems to be fairly reliable and agrees with the 1778 map on many details, so the street front building is likely to have been no longer extant by this time.

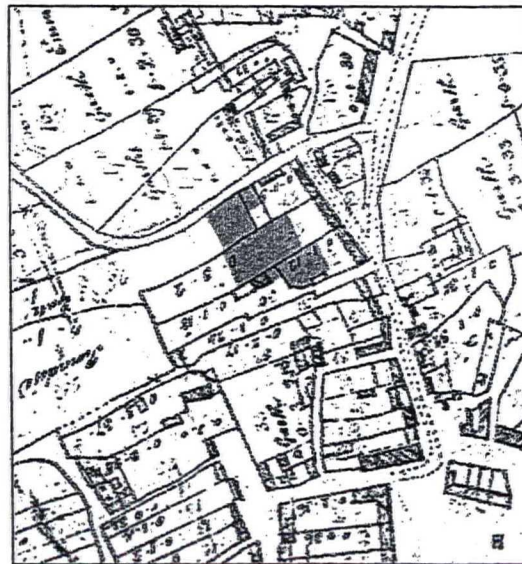
Figure 6. 1801: A plan of the old inclosed lands within the township of Masham

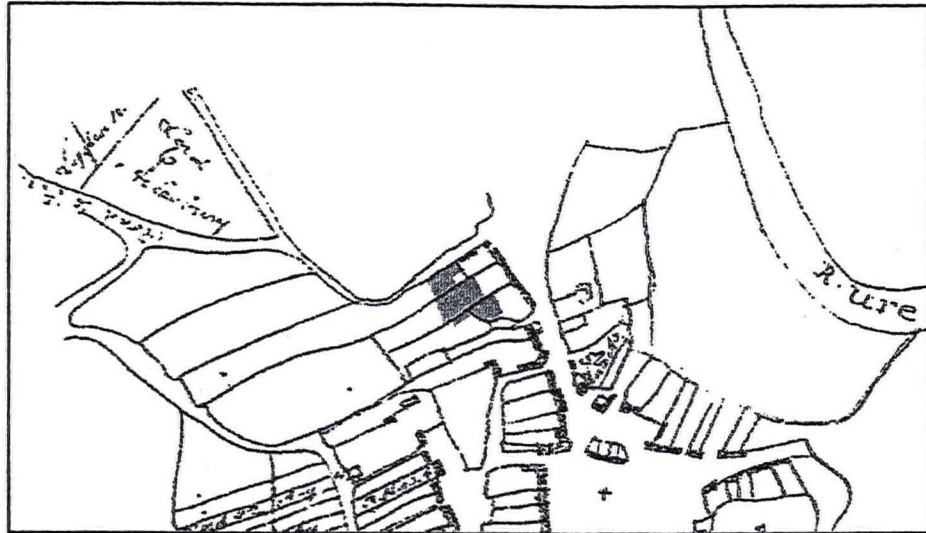
The undated map thought to be early nineteenth century does not show any buildings on the site. Comparison with the 1801 and 1778 maps reveals that, although it shows the buildings on the street frontages, it is much more selective in its coverage of the buildings known to be present in back-plot locations. The purpose or provenance of this plan is unknown, but a clue may lie in its title 'Masham: Plan of Some Properties', indicating that it was not intended to be an exhaustive survey of *all* the buildings in the town. Accordingly, while the lack of any building on the Leyburn Road frontage probably reflects reality, the lack of representation of the present building behind the existing warehouse (shown on the two earlier maps) should not be taken as definitive evidence of absence in this period.

Figure 7. Early nineteenth century: Masham, plan of some properties

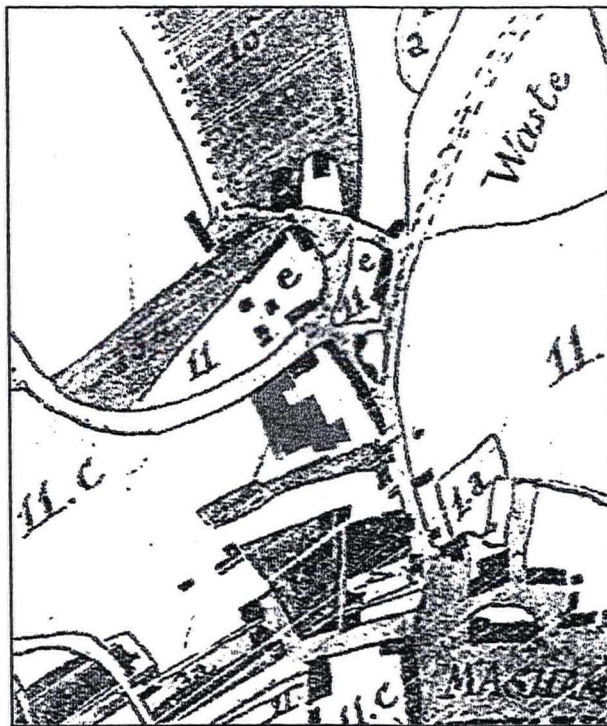
A similar story emerges from the Tithe Map of 1839. Again, no buildings are shown on the site and as with the early nineteenth century map discussed above, this is probably an accurate reflection of the lack of building on the street front, but is less conclusive for the building behind the warehouse. The primary concern of the tithe map was the valuation of land in accordance with the Commutation of Tithes Act of 1836, which converted tithes from payment in kind to a monetary payment. Thus it is not surprising that – compared with the map of 1801 and the Ordnance Survey first edition of 1856 – the depiction of buildings on the Tithe Map is somewhat perfunctory, and therefore a degree of caution is needed. However, the cottages of Quaker Terrace are shown for the first time on this map indicating that at least some effort was put into surveying buildings in non-frontage positions.

Figure 8. 1839 tithe map

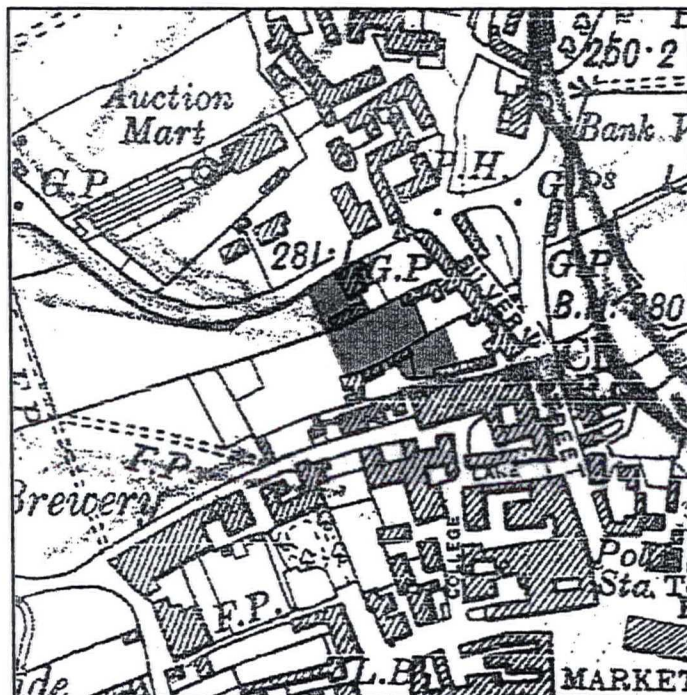
Figure 13. 1930 OS 6" map

The three OS maps show that the site underwent a series of small changes, but no major new development during this period. The only new additions are a small building at the eastern end of the middle of the site – possibly a workshop or similar – and the expansion of the small building to the east of the building at the rear of the present warehouse. Depicted in 1892 as one small building, this expanded in 1912 to two small buildings and two probable animal pens, in 1929 a third small building was added and in 1930 these had merged to become one building (although this may be the result of a lack of definition in this smaller-scale map). The existence of animal pens means that the buildings are almost certainly to do with livestock management.

Between 1930 and the present day, the site has been largely wiped clean and redeveloped. The only building remaining from the 1930 map is the old building to the rear of the present
