*AN ARCHAEOLOGICAL EVALUATION
AT 80 ST THOMAS STREET,
SCARBOROUGH*

SCARBOROUGH ARCHAEOLOGICAL AND HISTORICAL SOCIETY

INTERIM REPORT 29: 1997

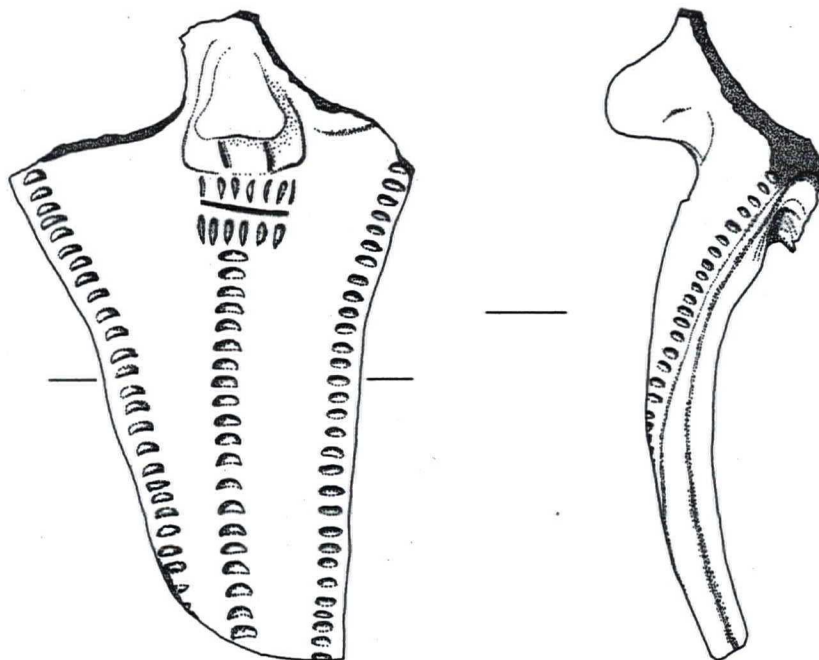
A handle fragment from a medieval "Scarborough Ware" pot
decorated with a human face.
Found in Trench One.

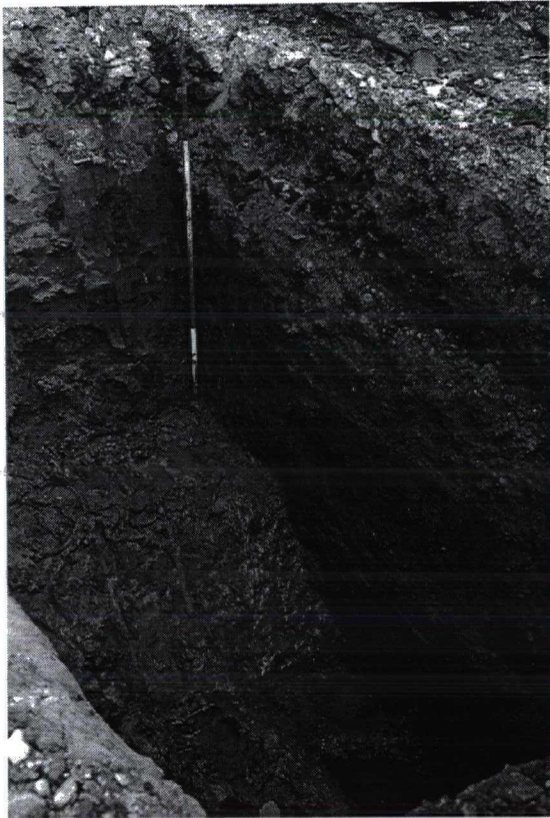
Plate 1: Trench One looking north-east showing ditch F107.

Natural red-brown clay was found at a depth of 2m from the surface (33.6m OD) at the north end of the trench increasing to a depth of 2.8m at the south end. The difference in depth across the trench was because the natural clay was cut by a feature F107 running approximately east-west (plate one). The north side of this feature sloped down at an angle of between 30 and 45 degrees and at its base were a number of rounded stones (F111) set into the clay.

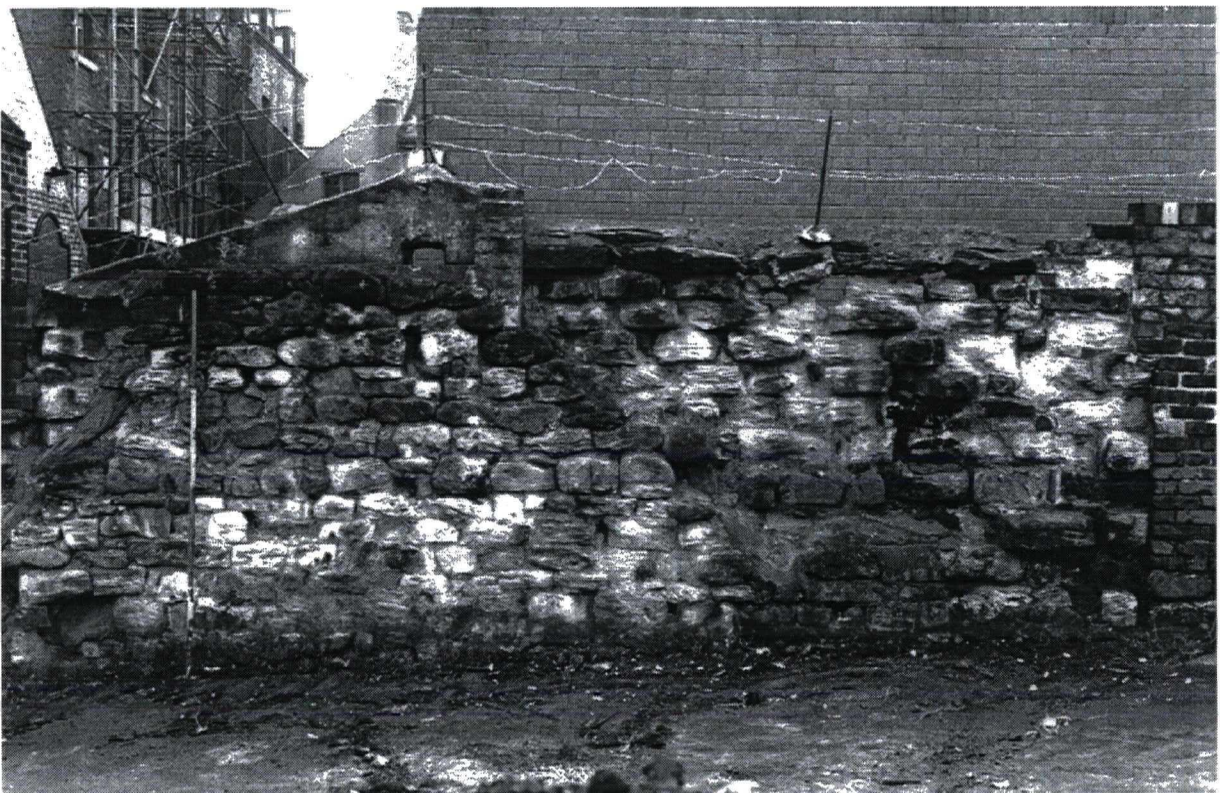
Plate 3: Stone wall forming part of the south boundary of the site

The site is approximately rectangular in outline and measures 45m north-south and 35m east-west. To the east of the site are a range of shops fronting St Thomas Street, whilst to the west is a low brick wall bordering North Street car park. Further shop units border the site to the north and to the south is the Equestrian public house and an electricity substation. The boundary wall between the site and the substation is partially constructed of re-used stone (plate three). At the time of excavation the site was covered in concrete.
