# AN ARCHAEOLOGICAL EVALUATION OF A SITE AT GLOBE STREET AND EASTBOROUGH SCARBOROUGH

SCARBOROUGH ARCHAEOLOGICAL AND HISTORICAL SOCIETY  
INTERIM REPORT 20

1994

**BY TREVOR PEARSON**

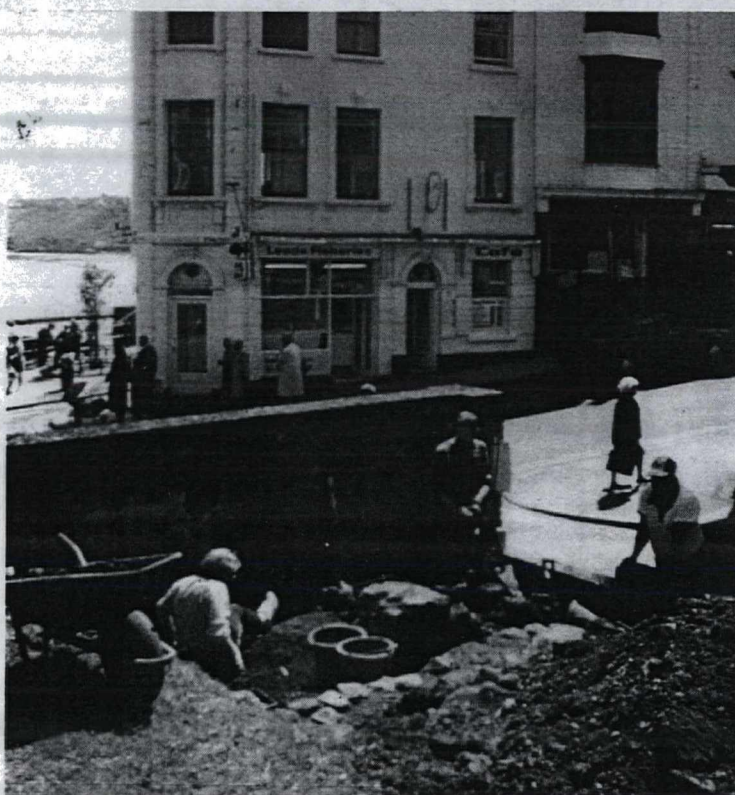
Plate 1 View of Trench One looking south-west

The excavation of Trench One was begun with a JCB excavator and completed by hand. The trench was excavated in two portions. The northern half was excavated first and exposed little of archaeological interest apart from a massive stone wall along the southern section of the trench. It was therefore decided to extend the trench southwards to expose the remainder of the stone wall and the deposits to its south whilst at the same time backfilling the northern half of the trench (Plate 1). In total an area 4m x 4m was investigated. A sequence of deposits from the medieval period to the 20th century came to light from which six phases of activity were identified. These six phases are described in chronological order below, beginning with the earliest; phase one.

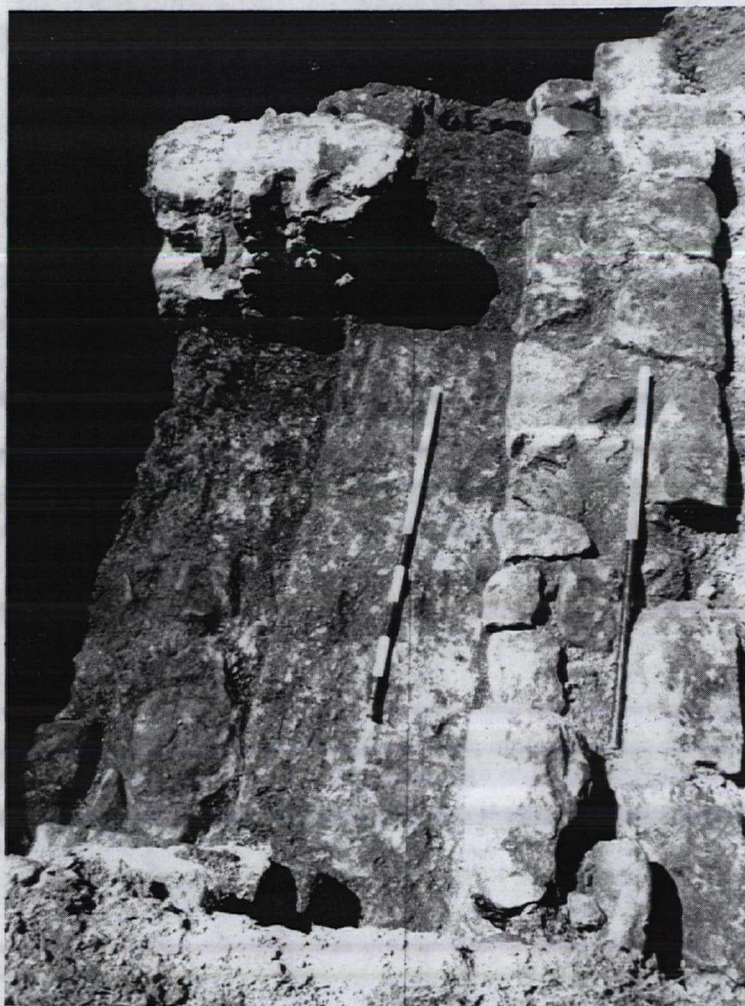
This phase saw the construction of a building on the site. A 50cm wide stone wall was built at right angles to Globe St (F1006). It survived to a height of one metre and cut through the underlying levelling deposits to allow the bottom course to rest on the natural surface. The northern, exterior face of the wall demonstrated the method of construction most clearly (Plate 3). The upper two courses were constructed of close fitting squared stone blocks and rested on between two and four courses of smaller and more irregularly shaped stones which were presumably the foundation. The wall was clay bonded although traces of mortar adhered to the upper surface of the top course of stones suggesting the overlying courses which have now disappeared may have been bonded with mortar. Associated with the wall and butting up to its southern face was a layer of stone rubble in a matrix of burnt soil and charcoal (layer 1008) overlain by a 10cm thick deposit of compacted clay (layer 1007). The clay layer 1007 is interpreted as a floor within the building and the underlying stony deposit 1008 as the make up layer below the floor.

**Plate 2** Trench One looking west showing stone wall F1006 with clay floor 1007 to its south

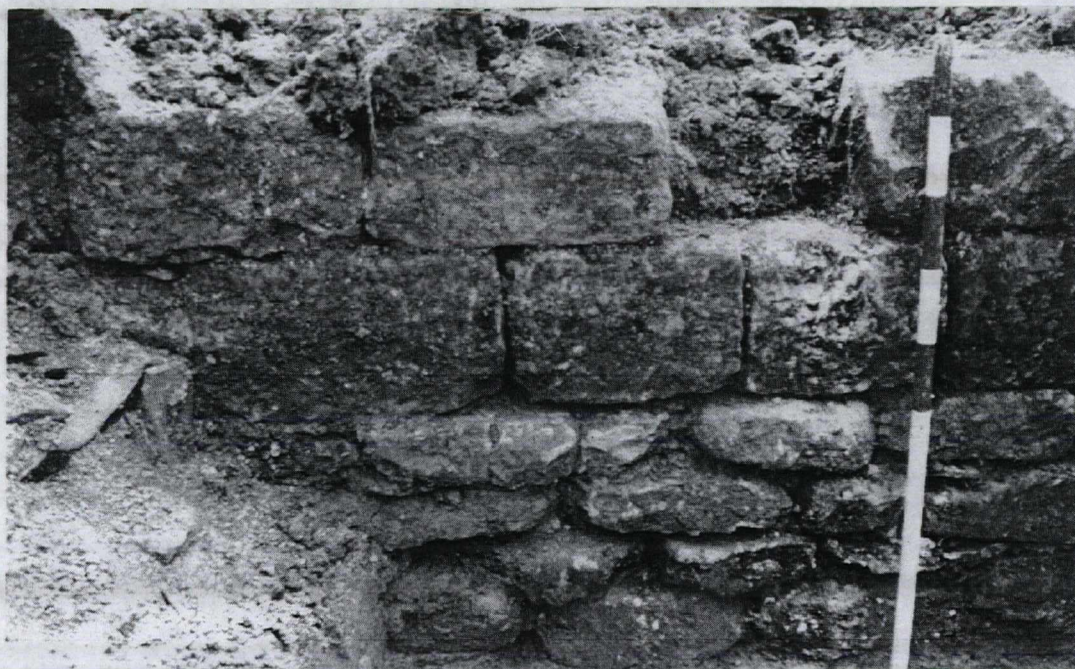
Fragments of plaster adhering to the inner face of two of the stones indicate the wall was rendered on the inside. Several fragments of green-glazed floor tile were also recovered from within the building suggesting it may have possessed other floors more sophisticated than the beaten clay floor revealed in the excavation. The only indication of an associated wall were two courses of stonework at the eastern edge of the trench (F1016). This stonework might be the end of a wall running eastwards parallel with F1006 or possibly part of a wall at right angles to F1006. Later activity described below had destroyed contemporary deposits to the north of wall F1006.

**Plate 3** Trench One. Northern face of wall F1006 showing the method of its construction
