**SCALBY LODGE FARM, CLOUGHTON ESTATE,
SCALBY, NORTH YORKSHIRE**

BUILDING RECORDING REPORT

REPORT NUMBER 2007/36

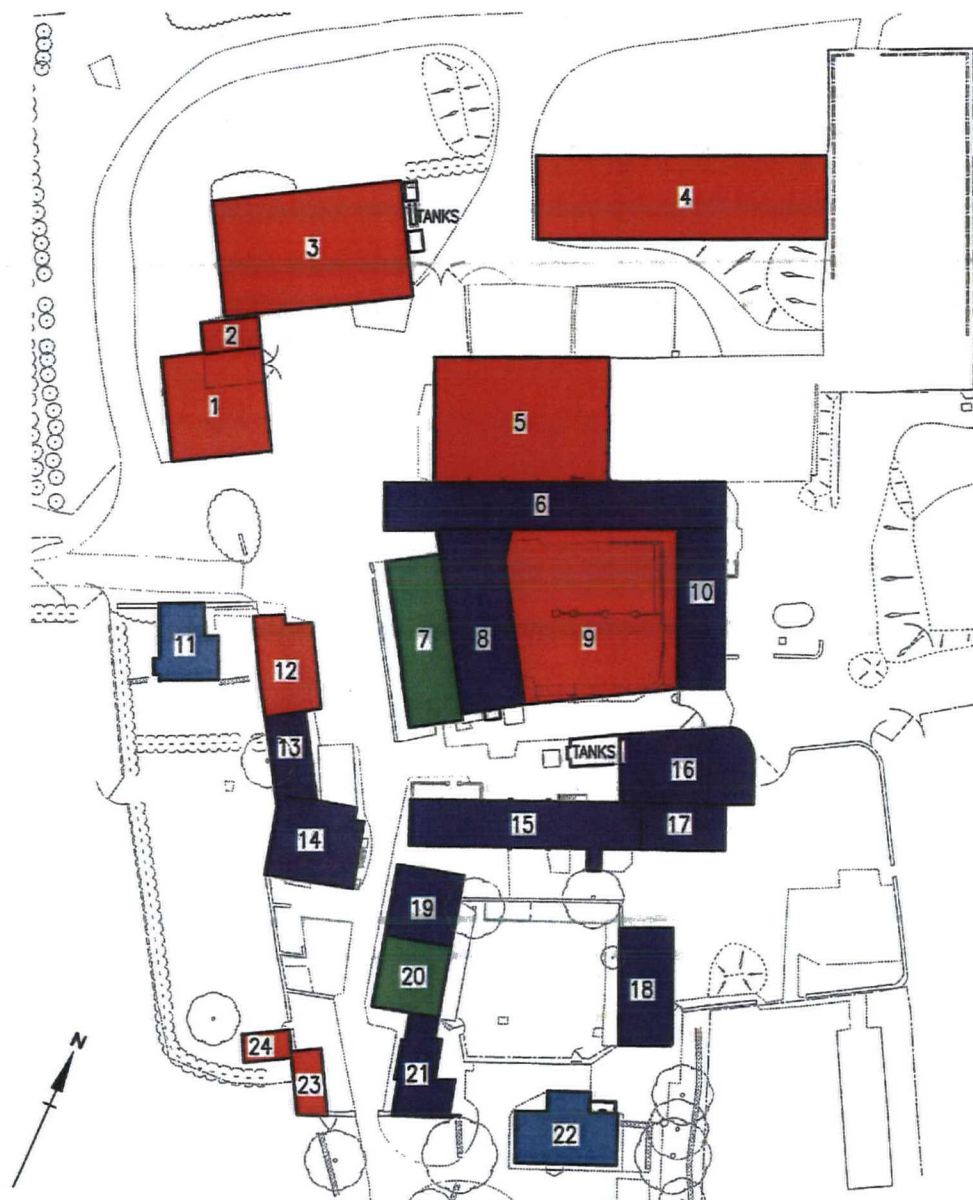
Figure 2 Building location plan (not to scale)

Note: colours denote usage and suitability for proposed usage These are NOT indicators of archaeological status

Red = 'not suitable for conversion' – these buildings mostly modern though 23 and parts of 12 pre-date the 1850's.

Dark Blue = 'suitable for conversion' – with the exception of 8, 16, 17, 18, these buildings are 19th century, or earlier, and of some significance.

Green = 'already converted to holiday homes' – both buildings are of some interest.

Light Blue = 'mid 20th century dwellings.
