SCARBOROUGH ARCHAEOLOGICAL AND HISTORICAL SOCIETYWATCHING BRIEF. MANOR FARM. OSGODBY. SCARBOROUGH. MAYby DANIEL FERGUSON B.A.Site code MF97. National Grid reference TA 053846 (At trench 2).

MANOR FARM. OSGODBY. SCARBOROUGH. WATCHING BRIEF 1997.

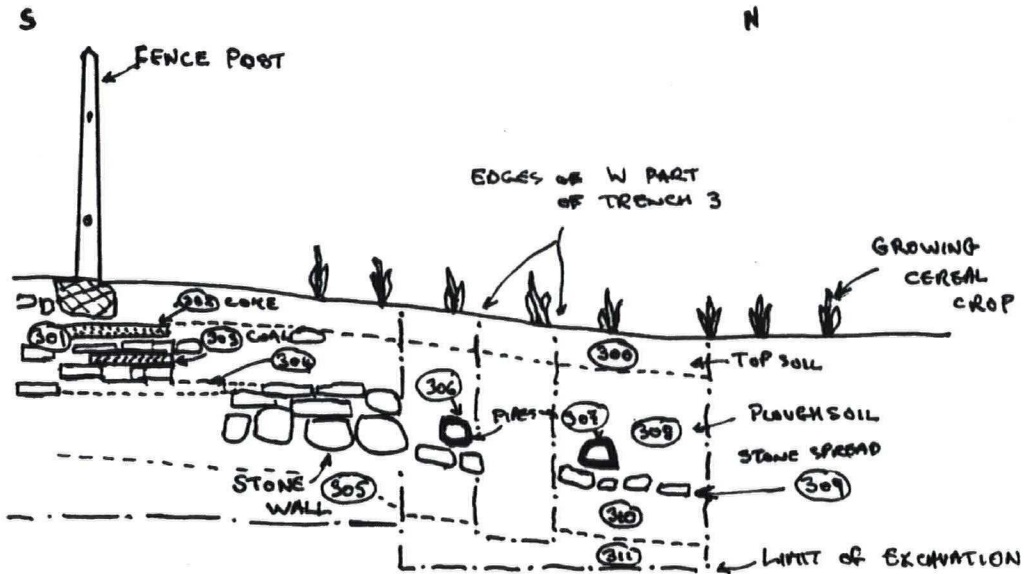
DRAWING MF 97/04

At the change of direction trench 3 becomes a box some 2M square, and about 2M deep. This lies at 2M N of the E/W boundary fence and footpath. In this area a similar series of field drains (MF306/307) cross the trench, but run E-W rather than N-S, indicating that the present play area belonged in a different field, and that the boundary continues from that period. Also indicative of the age of the E-W boundary are the remains of a buried stone wall (MF305), below a distinct hump lying along the line, on the crest of which runs the present fence. This consists of a layer of heavy stones, laid in courses, of which 3 to 4 survive, some 40-50cm thick, and some 50cm below the present surface, and beneath the field drains. It is also beneath the brick feature, separated from it by a band of mid-brown sandy soil 3cm thick (MF304), and elsewhere by a layer of clay up to 30cm thick (MF308). This stone feature extends from about 2M N of the fence, some 1.5-2M to N, and a further spread of a single layer of stones (MF309) extends beyond the limit of the trench, so represents probable spill from the wall, as it dips to N like the present surface. This spread lies at 1M below surface at N limit of trench box, but at only some 70cm at the S where lies beside the coursed wall stones. Below these stone layers is one of 40-50cm, of mottled grey and yellow clay (MF310), with few stones, and much iron panning, upon the natural red clay (MF311). This trench box is c 1.8M deep at S/W to 1.5M at N/W corners, with the BOTTOM level, so the present surface, and earlier stone spread, dip to the N by this much, this slope represents the burial of the old field wall, and the spilling of some of it's stones in an earlier stage of the bank makeup. At the W end of the pipe trench this again has been expanded into a box of some 2M in each direction. However this displays far less stone than the other, being mostly red clay, plough soil on natural. The difference may be because the line of the new cut is not the same as the previous field boundary, and so has missed these features further W.

SECTION W SIDE OF BOX AT N END OF TRENCH 3.

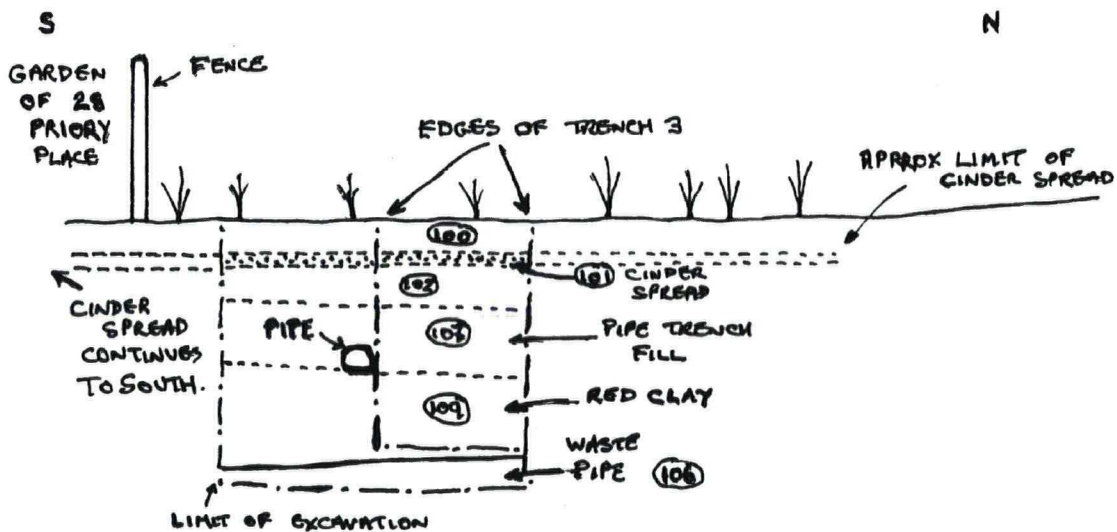
The box trench behind Priory Place, dug to locate the existing drain at the point where the new sewer was to be joined to it was designated as our Trench 1. It s west side is 4M from the paddock fence. This trench was measured at 3m E-W, by 2m N-S, and was about 2m deep. The site was rough grass. The soil was red-brown clayey loam, with pieces of sandstone and other rocks, some coal/charcoal, and grey clay silt where the earlier pipeline had been laid down. The west side of the trench maximum depth was 1.7M.

Top-soil (MF100) dark rich loam 20cm deep.

Compact cinder/ash c 8cm (MF101). This contains much metallic, mostly iron slag, as if from a forge. It continues to the north some 4M, and right round the opened area quite level and compact, and also across the garden and under the house extention (house-holders comment). Pieces of similar material are visible in the garden soil surface, and some iron objects seen in keeping of owner, a horse-shoe, a tanged tool, file or similar, and part of the closing mechanism from a gate. These all seem quite recent, as does the cinder spread itself, which may represent a laid hard surface, possibly of a yard or other working area.

Light silty subsoil (MF102) c 20cm. Field drains c 12cm red ceramic (MF103), in cut [MF104] cross trench in this layer, (modern).

Red clay (MF109) c 70cm below surface (natural).

These cut through N-S by large pipe trench [MF106] 70cm wide, in which sewer line top (MF108) lies at c 1.6M depth.

SECTION W SIDE OF TRENCH 1 AT S END OF TRENCH 3.

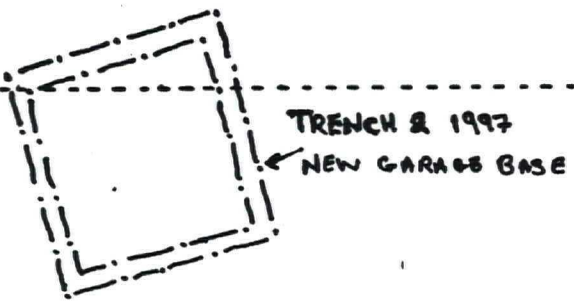
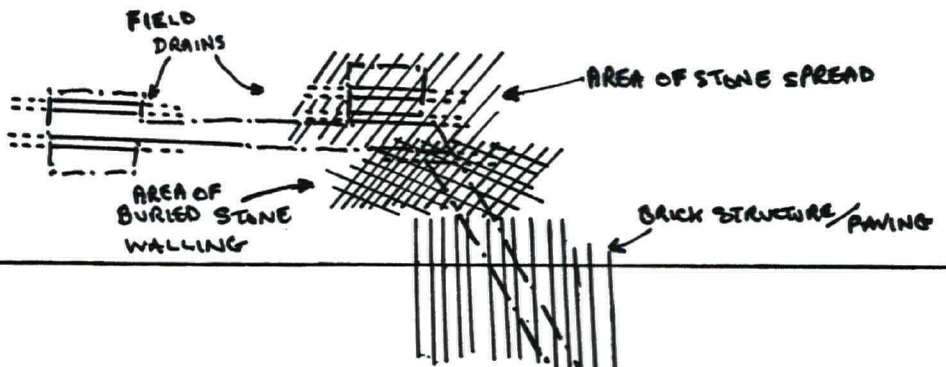
DRAWING MF 97/01 PLAN, NORTHERN PART OF SITE

This consisted of a pipe trench, some 78M long by 60cm wide, and up 1.8M deep, lying between the other two trenches, across the grassed play area. The diagonal length from trench 1 to the north fence is some 64M, with a further 4M to the turn to an E/W line. This is 9.5M long and lies 3M N of the boundary fence, and 13M from S/E corner of trench 2.

TRENCH 3 1997 (PIPE TRENCH)

FIELD DRAINS

CONTINUES ON DRAWING MF 97/02 TO TRENCH 1 AT 60M
