Landscape Research Centre Ltd.

Archaeological Report

West Heslerton, North Yorkshire

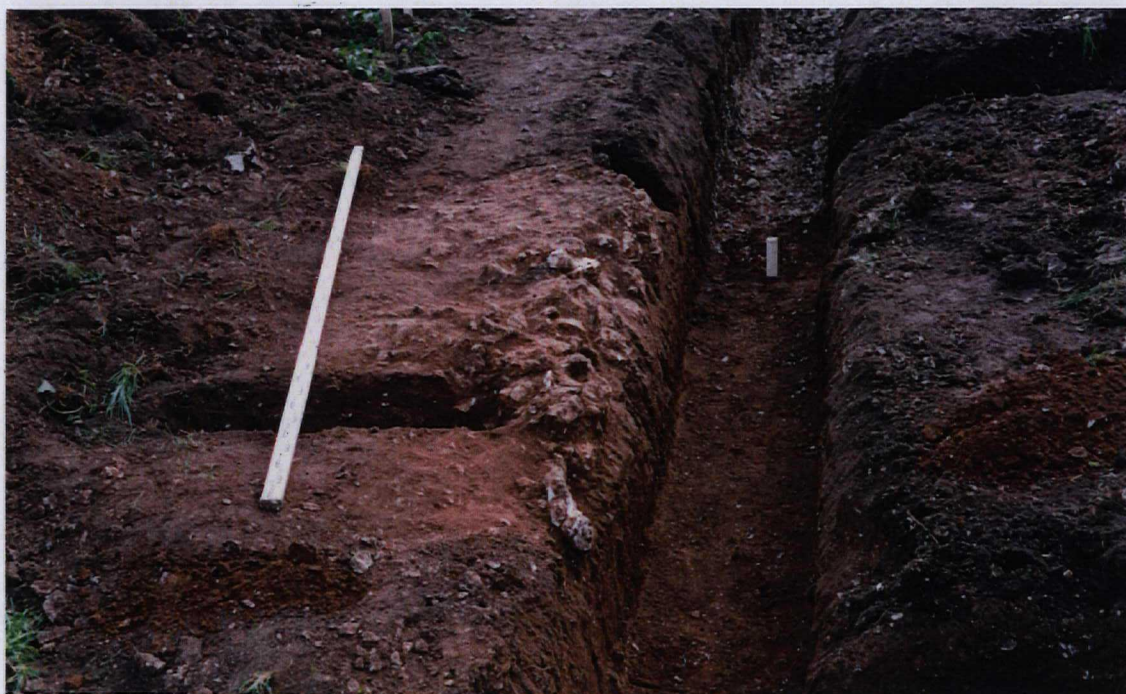
Photograph One

The photograph shows the wall footing (Context eight) from the west. The scale bar is three metres long.

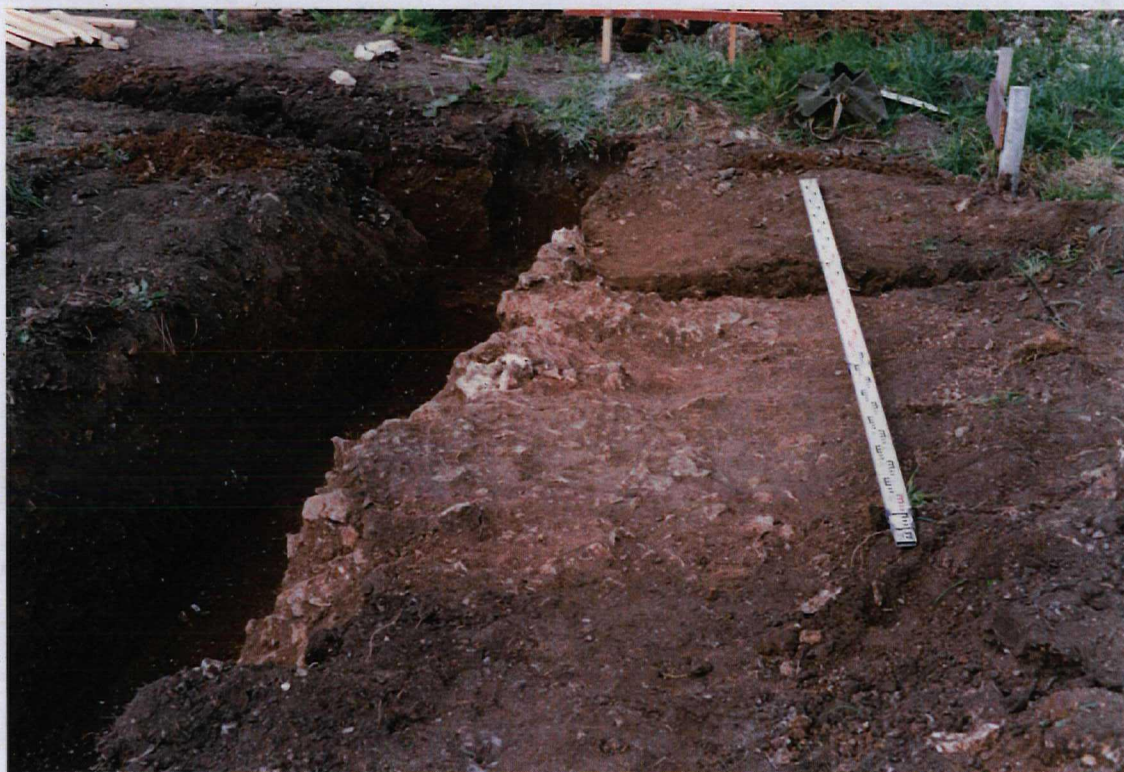
Photograph Two

The photograph shows the wall footing (Context eight) from the east. The scale bar is three metres long. Note the remains of a tree hole in the left foreground and the wall sighting to the north (right centre) of the photograph.

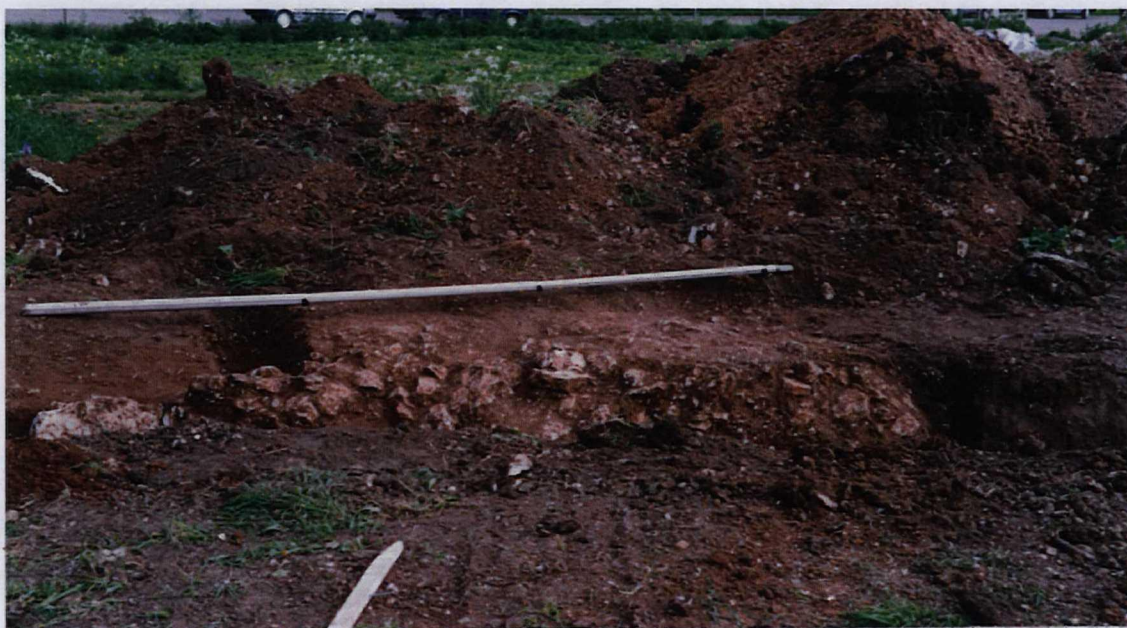
Photograph Three

The photograph shows the wall footing (Context eight) from the south. The scale bar is three metres long. Note in the centre right (east) how even the partial remains of the footing have been totally removed by the later planting of trees, themselves recently uprooted

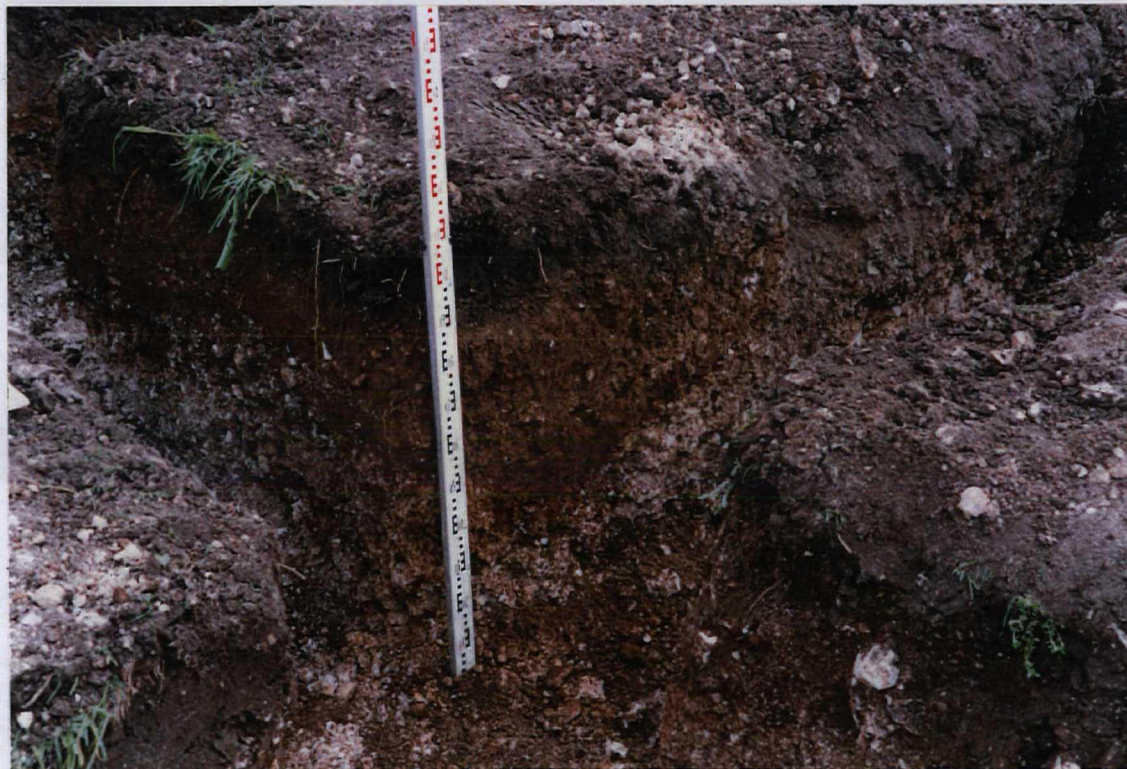
Photograph Four

The photograph shows the remains of a tree hole (Context seven) from the south west. The scale bar is three metres long. This is an example of the number of tree holes which were visible during the construction of the modern footings, caused by the recent uprooting of a number of oak trees.

Context:	00007
Type:	NATURAL
Shape:	ROUND
Profile:	V
Length:	109
Breadth:	82
Depth:	78
Soiltype:	SANDY LOAM
Soil_textr:	MEDIUM SANDY
Munsell:	10 YR 4/3
Notes:	NATURAL FEATURE. ALMOST CERTAINLY A TREE HOLE.
Context:	00008
Type:	WALL FOOTING
Shape:	LINEAR
Profile:	WIDE V
Length:	333
Breadth:	35
Depth:	31
Soiltype:	SANDY CLAY
Soil_textr:	FRIABLE
Munsell:	10 YR 5/3
Notes:	MORE SUBSTANTIAL REMAINS OF WALL FOOTING. SLIGHTED CHALK FRAGMENTS TO THE NORTH.

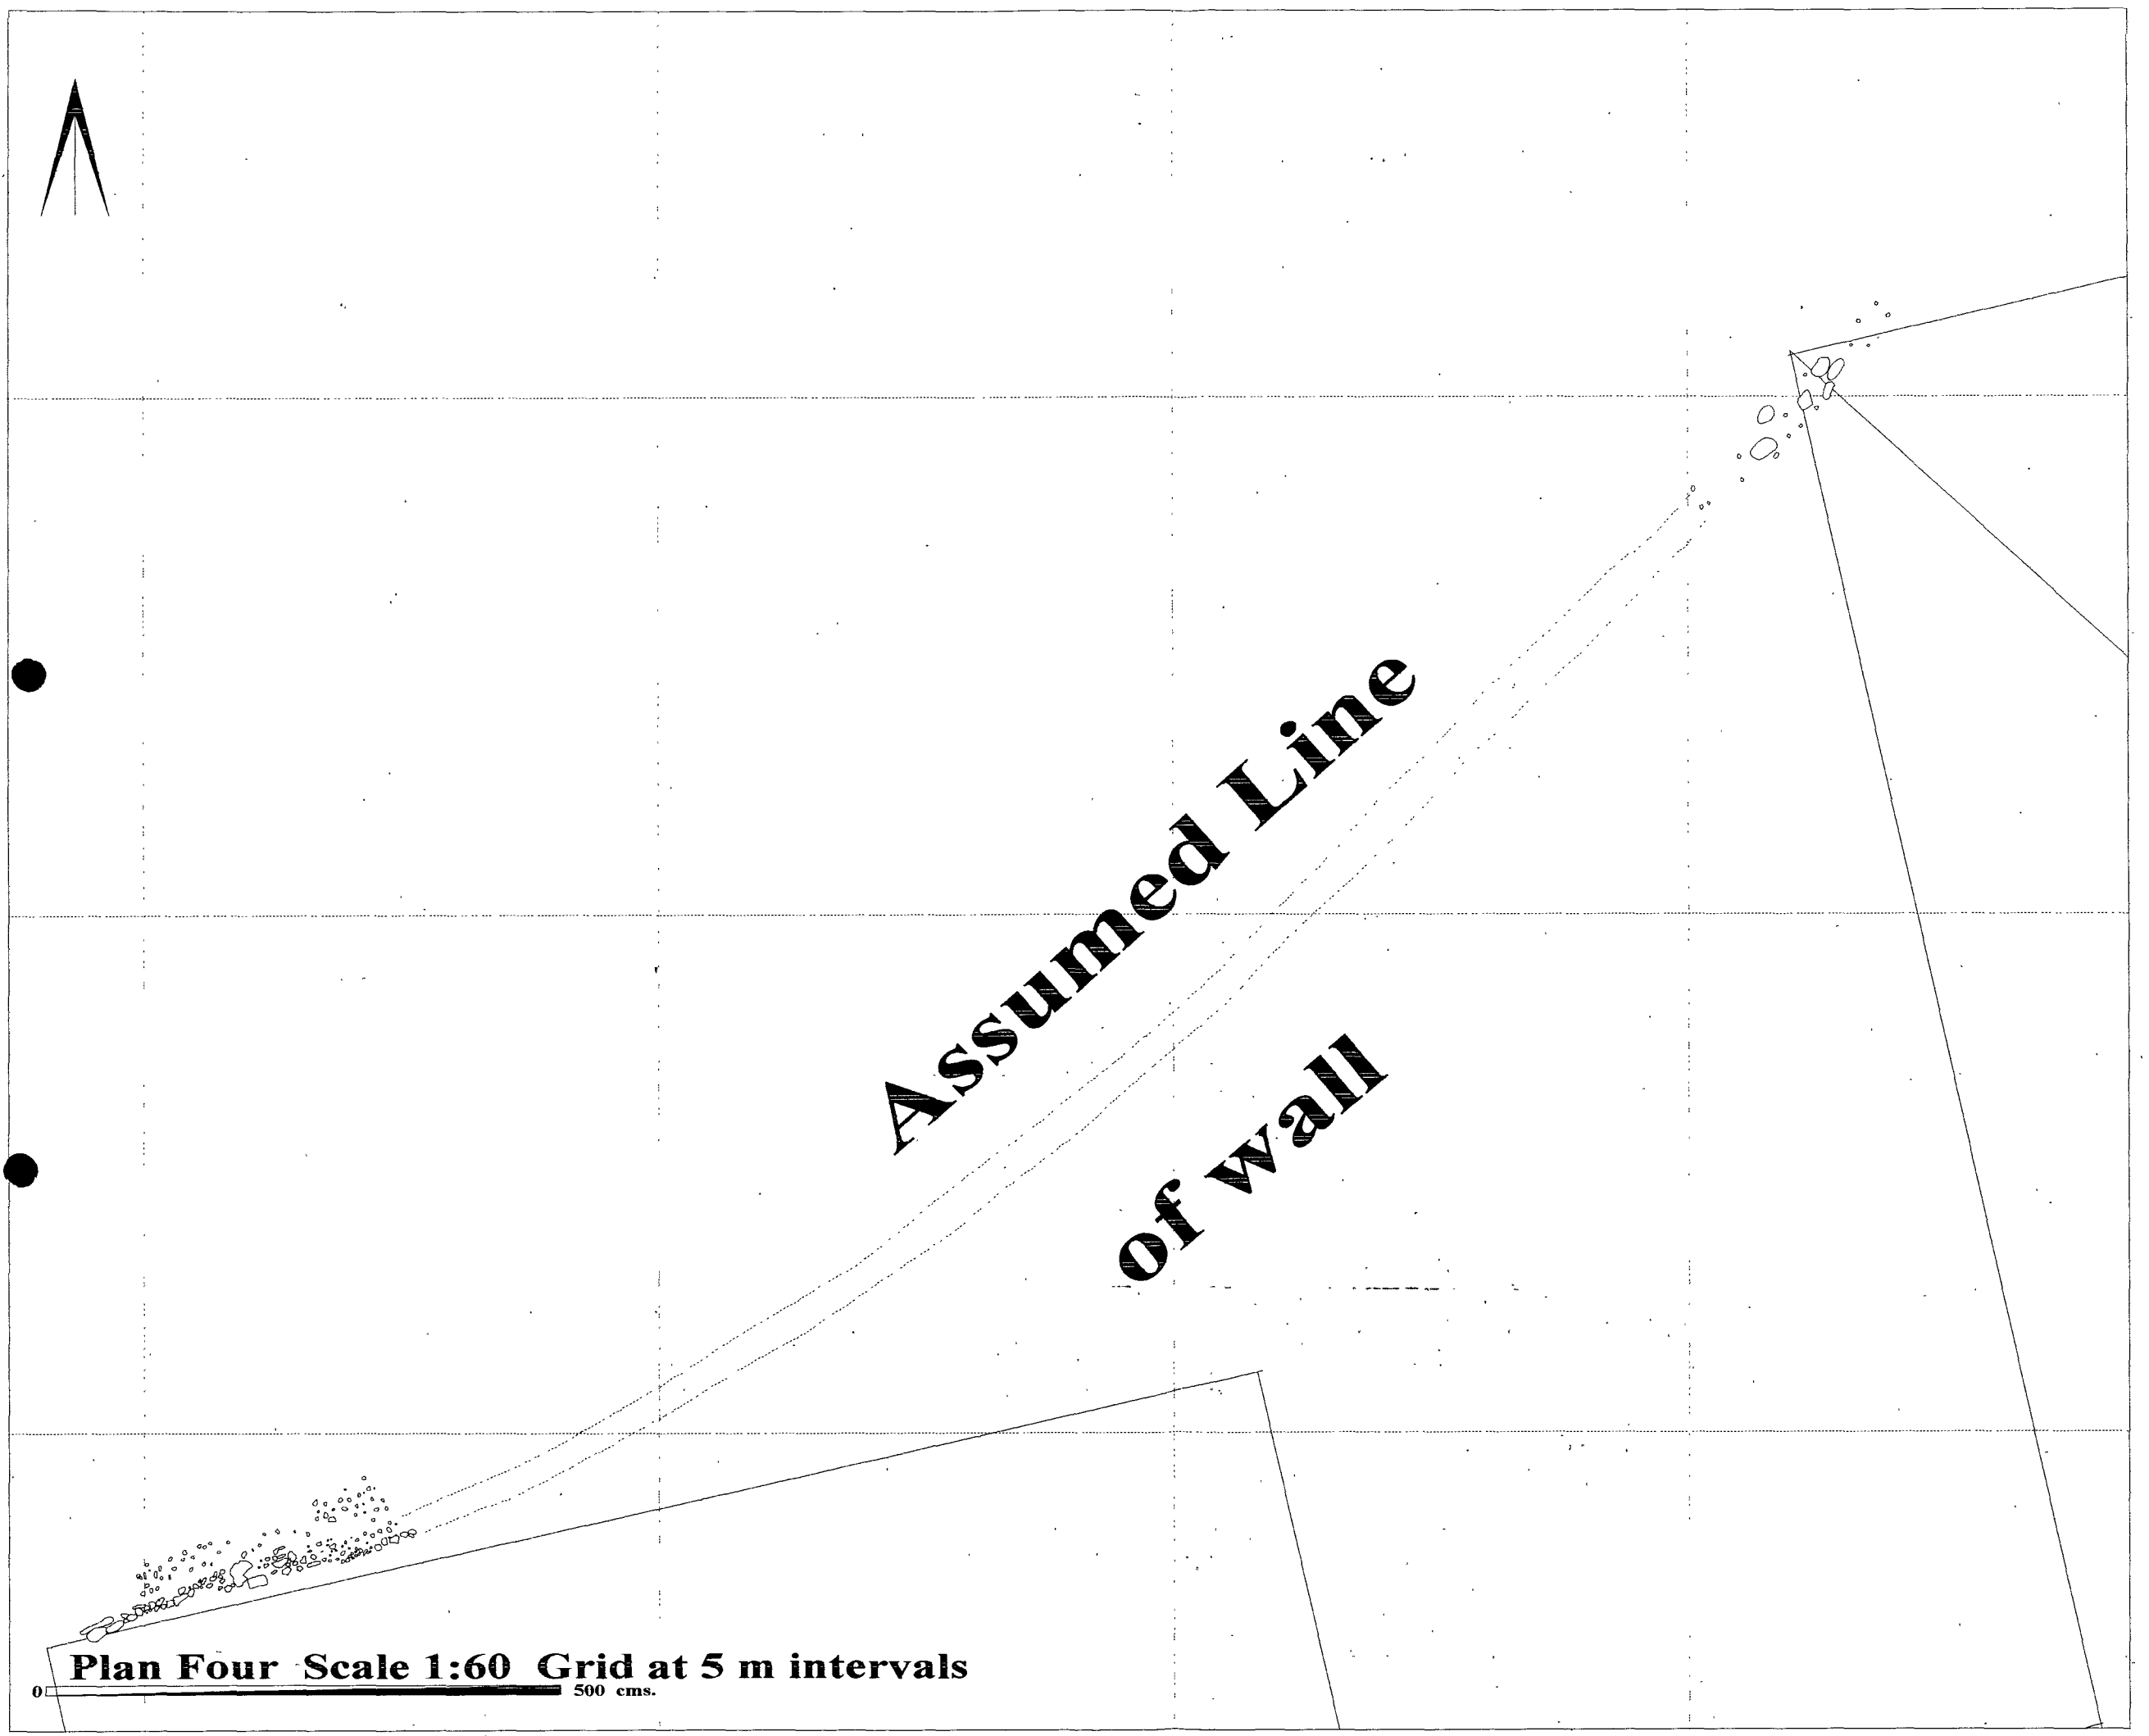
Plan Four Scale 1:60 Grid at 5 m intervals

**Assumed Line
of wall**
