Bridge Farm, Catterick, North Yorkshire

Conveyor Corridor and Aggregate Crushing Site

Archaeological Watching Brief

WYAS R506, 1 September 1997

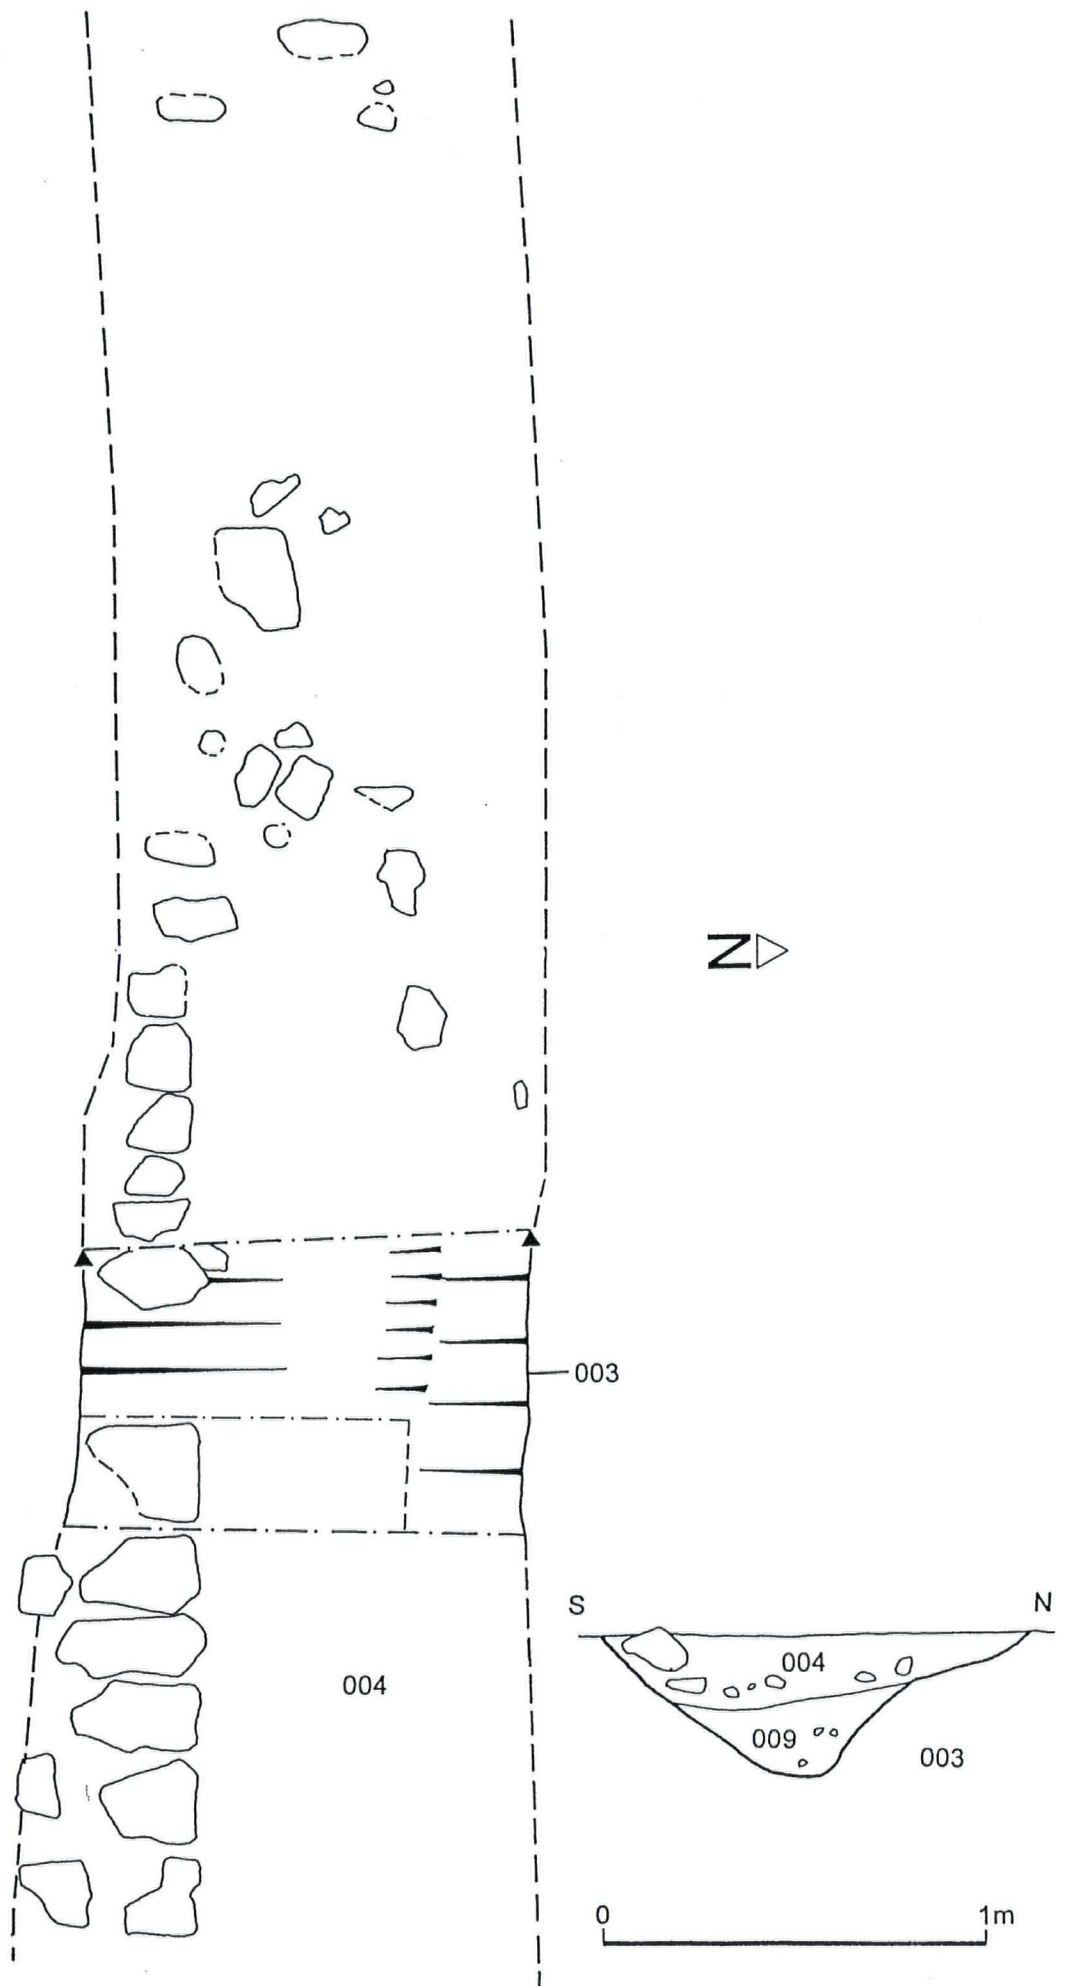
Fig. 3. Plan and section of ditch 003

3.2.1 Ditch 003 was aligned east-west, and was visible across most of the exposed area (some 50m), albeit interrupted by machinery trackways and spoil heaps. It survived to a depth of 0.39m and was visible immediately below the ploughsoil. A series of large cobbles had been deliberately arranged along the southern edge of the ditch, within the upper fill (Fig. 3). The cobbles directly the lower clay fill, sealing a number of sherds of post-medieval green glazed pottery. It is possible that these stones performed some stabilising function along the southern edge of the ditch, which was cut through the subsoil and into the soft underlying clay silt.

5.2 Ditches 003 and 007 corresponded to field boundaries marked on the OS 1st Edition map, dated 1857 (Fig. 9). This map indicated a Draw Well situated halfway between Leeming Lane and the now redundant Lover Lane, along the line of Ditch 003, which would suggest a watering point for horses and draught animals.

5.3 It should be noted, however, that the documentary evidence only provides a *terminus ante quem* for this field boundary, and there is every reason to suppose that the ditch had been in existence for some time prior to the Ordnance Survey mapping of the area. It is likely that the ditches fossilised the boundaries of older field systems in use prior to the enclosures of the late sixteenth century, and more extensively during the eighteenth century. The pottery retrieved from within the fill of 003 supports the suggestion that this ditch was in use during the late sixteenth century.

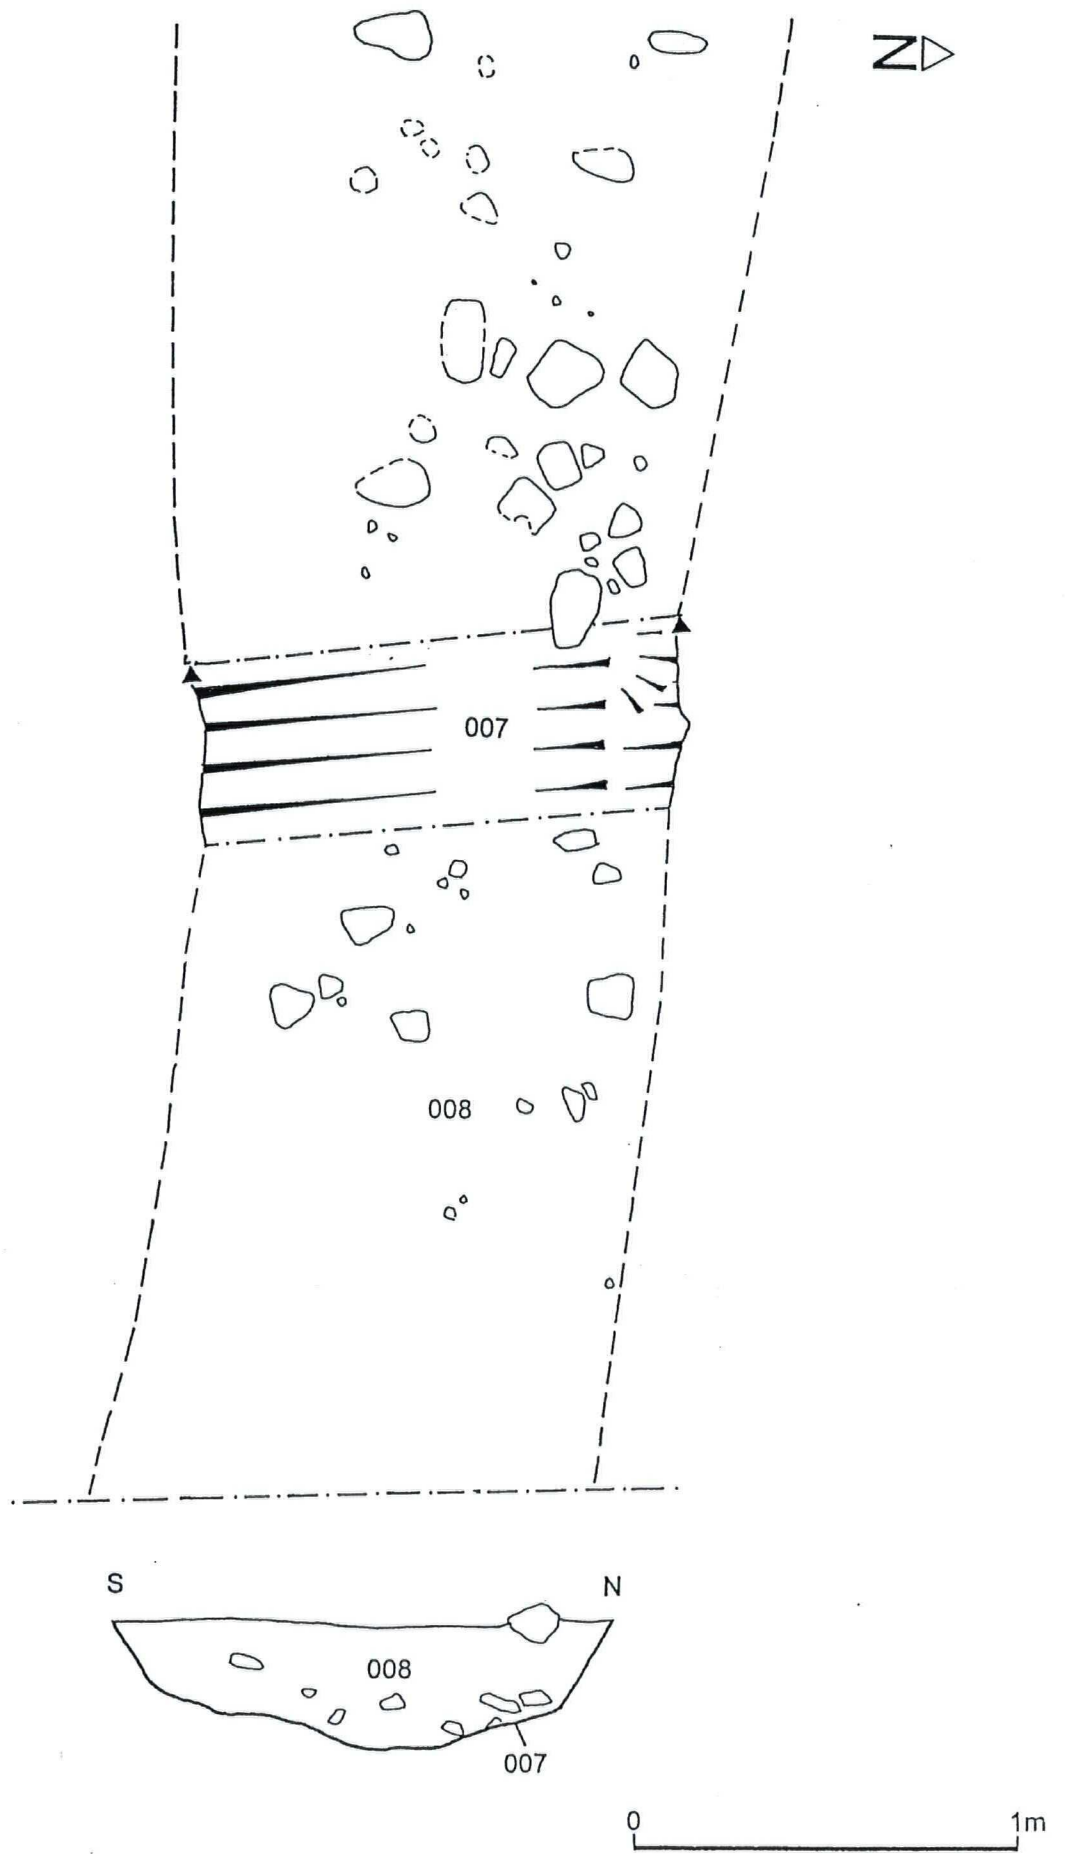
Fig. 4. Plan and section of ditch 007

3.2.2 Ditch 007, also aligned east-west, was located some 38m to the south of Ditch 003. It was first observed immediately below the ploughsoil towards the western edge of the stripped area, and latterly farther to the east (following further stages of stripping). An excavated revealed a regular, concave profile of 0.35m depth, that had been truncated by modern ploughing activity (Fig. 4). No dating evidence was recovered from this feature. Some 3m to the north of Ditch 007, a shallow linear feature (005) was identified. This proved, on investigation, to possess an irregular profile, filled with a deposit very similar to the surrounding natural alluvial silt.

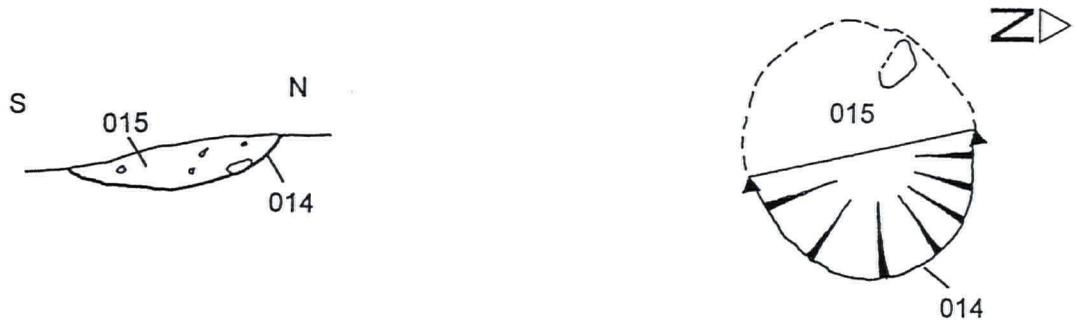
Fig. 6. Plan and section of feature 014

3.3.1 Towards the southern end of the conveyor corridor, two features containing burnt material were identified. Neither could be phased stratigraphically, as they had been obscured by machine trample prior to the final subsoil spit being removed. Feature 014 survived only as a shallow scoop in the top of the gravel, containing a charcoal-bearing silt clay fill (Fig. 6). Small grit inclusions in the fill (015) appeared to be heat-reddened, but as the surrounding gravel was unaffected in any way, it was concluded that the burning had not occurred *in situ*.

5.6 The two features 014 and 016, located towards the southern extent of the conveyor corridor, were both associated with episodes of burning, although only one (016) indicated burning *in situ*. Neither 014 nor 016 yielded any artefactual evidence of date or function. Some indication of function may be gained from the results of processing the environmental samples, though the usefulness of any information so gained would be hampered by the lack of relative stratigraphic relationships.

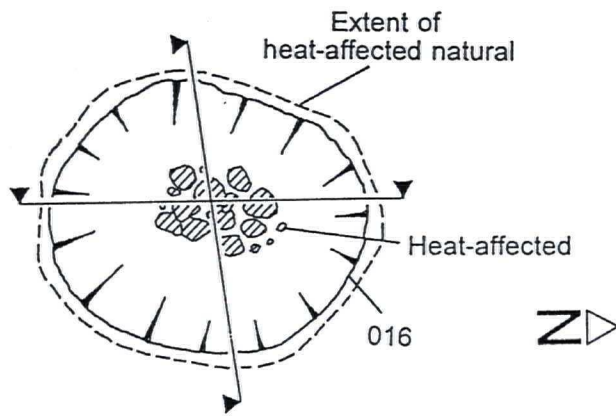
Fig. 7. Post-excavation plan and sections of feature 016

3.3.2 Feature 016, although heavily truncated, survived as a shallow sub-rectangular depression 0.84m by 0.68m in plan, which had been cut through the natural silty clay onto the underlying gravel (Fig. 7). Within the cut, several deposits (017 to 019) were observed, bearing varying quantities of charcoal. Due to their high charcoal content, these deposits were sampled. The thin band of heat-scorched natural describing the outer extent of the feature and the scorched gravel

at its base indicate that burning occurred *in situ*, and not elsewhere, as supposed for Feature 014. The precise function of the feature could not be established.

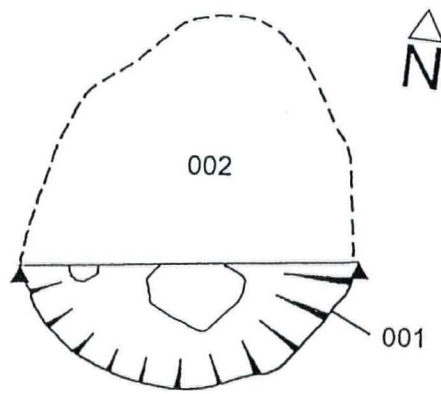
Fig. 8. Plan and section of pit 001

3.3.3 An isolated pit (001) was revealed following the stripping of the ploughsoil and subsoil in preparation of a soil holding area to the north-east of the aggregate crushing site. The feature was sub-circular in shape, with a regular concave profile 0.88m wide by 0.30m deep, and was cut into the natural gravel (Fig.8). The single fill (002) was a homogenous sand silt loam, which yielded fragments of bone and brick/tile along with a small quantity of charcoal.

5.5 None of the three small pits encountered during the watching brief produced evidence for their date or function. Although the isolated pit 001 yielded a small quantity of bone and brick/tile, it is possible that these were present in the pit fill only as a result of bioturbation, rather than having been incorporated into the material at the time of filling. The lack of context and the very fragmentary nature of both bone and brick/tile rules out the possibility of further analysis. Perhaps more light will be shed on the nature of this feature following the stripping of adjacent Phases 5-8.
