COPT HEWICK HALL, NEAR RIPON, NORTH YORKSHIRE

REPORT ON AN ARCHAEOLOGICAL EVALUATION

OSA REPORT No: OSA12EV23

October 2012

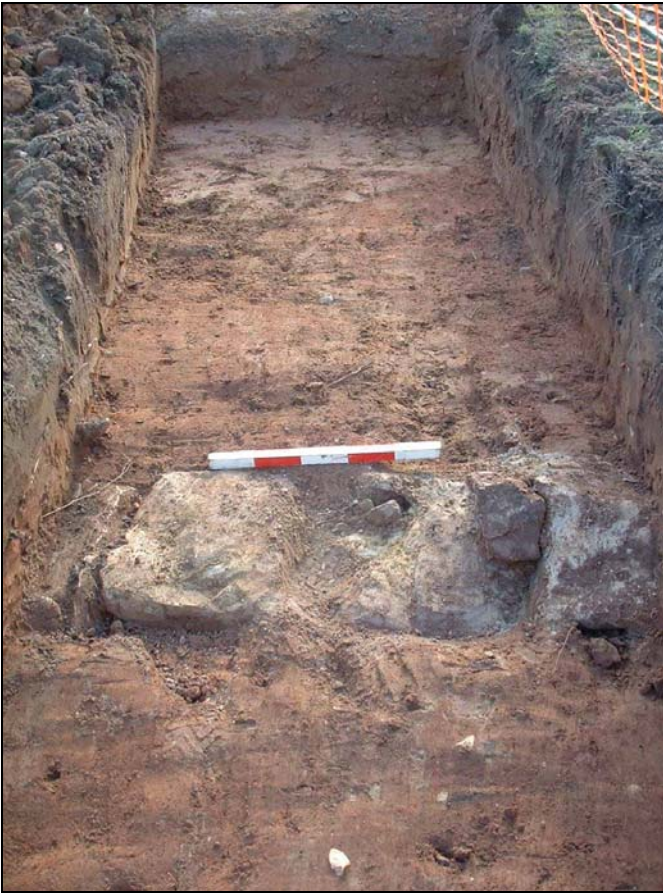
Plate 1. Trench 1 looking north.

This trench measured 5m by 1.40m and was located at the northern end of road 8 where it joined the southern end of road 7 (Figure 2; Plate 1). As a result of the fact that road 8 had, at the time of investigation, been partially installed and for the need to alter the radius of its curve in order to match the existing road to the north, the trench was excavated to the east of the road line.

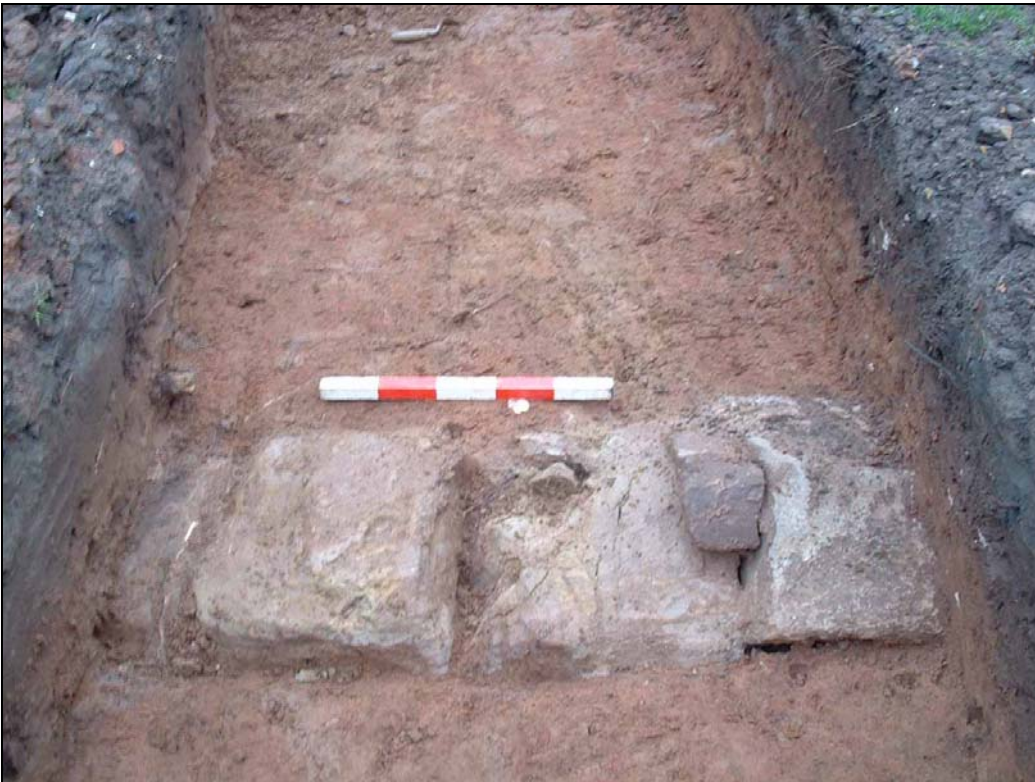
The earliest deposit encountered was the natural pinkish yellow clayey sand (105) at 53.55m AOD (See Figure 3). This was present throughout the entire trench save for the centre where its surface was cut by east to west aligned linear [104]. This 0.55m wide cut ran across the full width of the trench and contained sandstone structure (103). This comprised of four large square block of sandstone averaging 0.50m by 0.55m by 0.15m in size (Figure 3 and 4; Plate 2). These had been set with flat upper surfaces and all were fairly well dressed. To the western end there remained a segment of upper coursing comprising of two smaller blocks that were chamfered to create a coping course atop the structure. This structure was initially thought to be a wall but the removal of one of the large blocks revealed a long silted culvert, with a channel formed by straddling the slabs over sides formed from a single course of cobbles. The culvert sat within a narrow cut [104] backfilled with yellow brown clay (102). The top of the culvert was present at 53.65m.

Plate 2. Trench 1 sandstone structure (103). looking north.

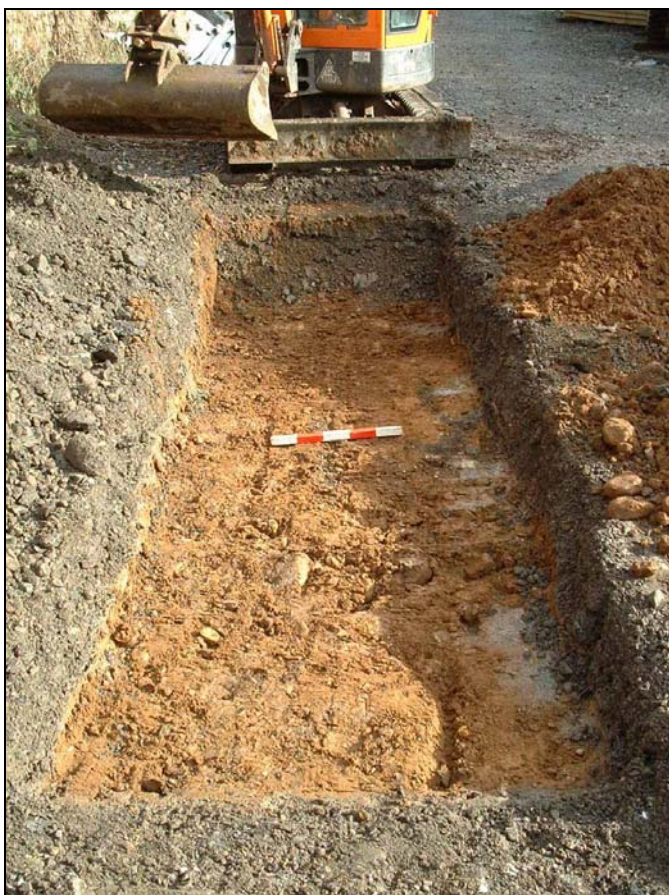
Plate 3. Trench 2 looking northeast.

This 5m by 1.30m trench was located along the route of road 3 to the north of site (Plate 3) inside the boundary wall in an area that for many years had been used to store spoil and garden waste. Excavated to a depth of just 0.20m below existing ground level (BGL) it revealed only hardcore (200) sealing a trench wide spread of natural coarse sand (201).

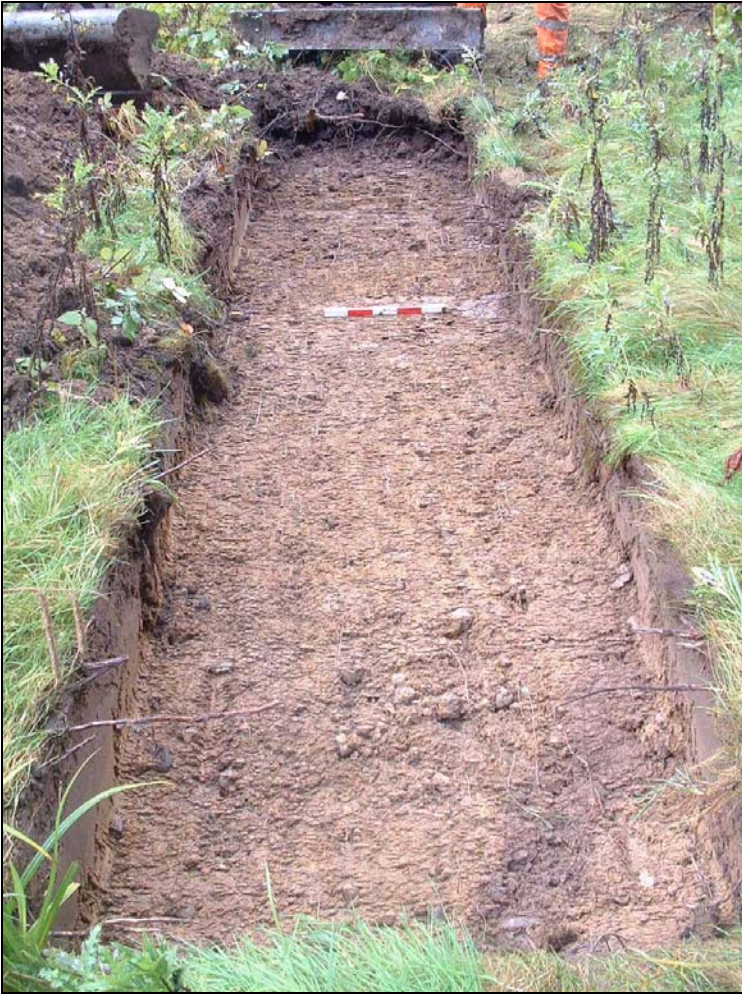
Plate 5. Trench 4 looking north.

This 5.30m by 1.30m trench was located along the route of road 2 within the plantation area (Figure 2; Plate 5). The overall depth of the trench was 0.40m BGL and excavation at this depth ceased as the natural sand and gravel (401) was revealed. The surface of this had been cut at the southern end by a northeast to southwest aligned land drain.

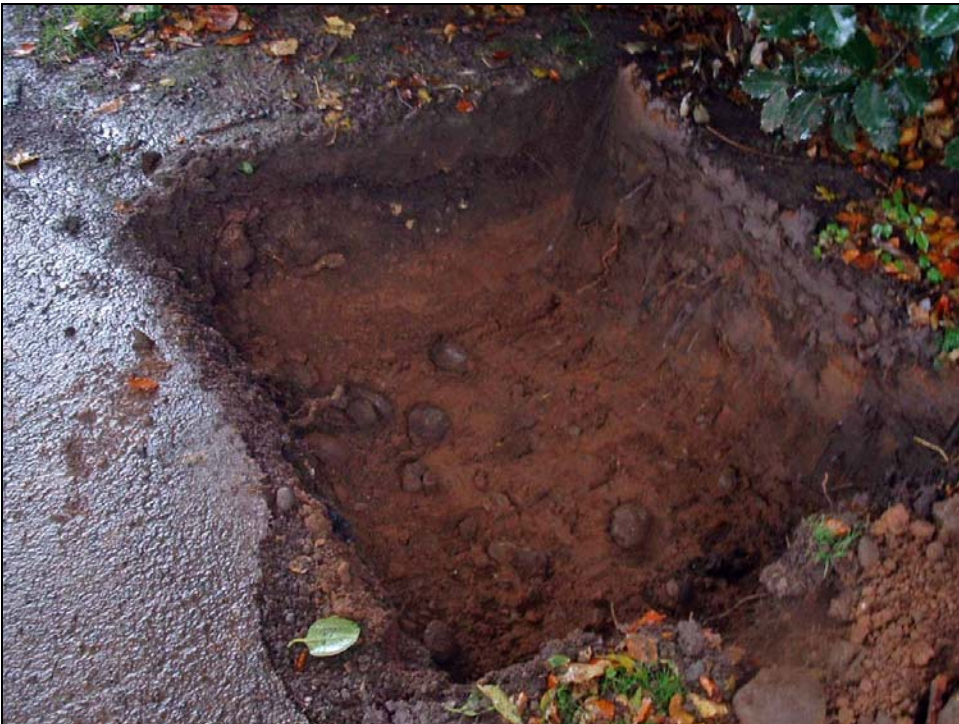
Plate 6. Trench 5 looking northeast.

This 1m by 1m trench was located by the northeastern most site entrance and was positioned behind the eastern most gate pillar (Figure 2; Plate 6). It was excavated to allow for an assessment of buried deposits prior to the insertion of a new gate pillar. In all 0.55m of topsoil (500) were removed revealing clean natural (501).

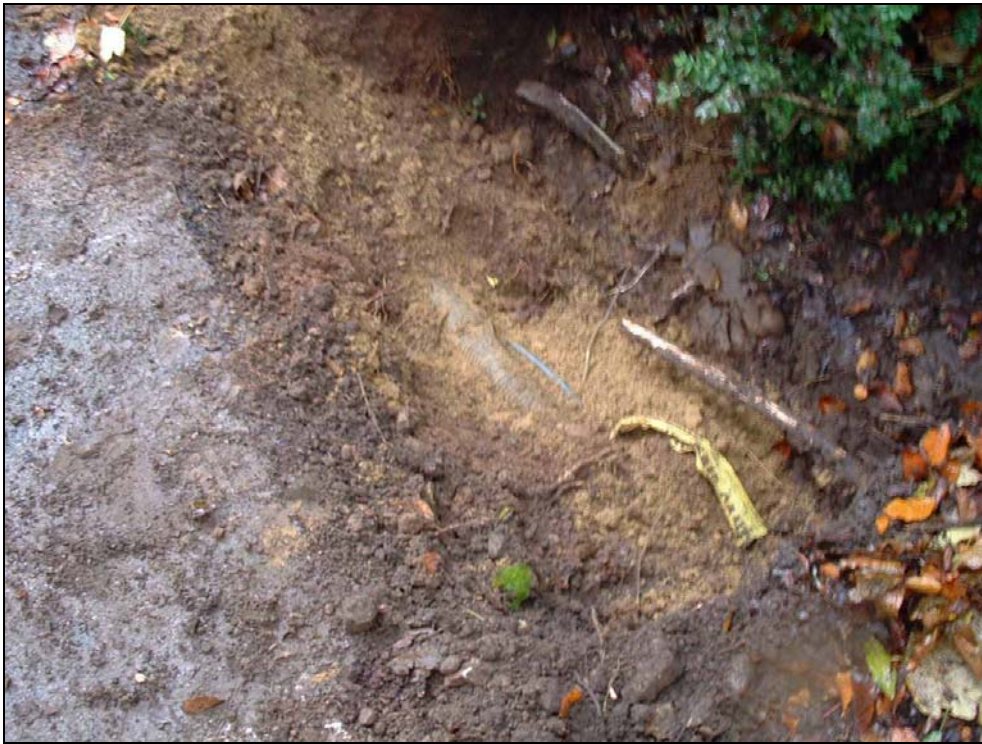
Plate 7. Trench 6 looking northeast.

This 1m by 1m trench was located behind the western most gate pillar across from Trench 5 (Figure 2; Plate 7). Here 0.50m of topsoil (600) were removed exposing natural (601).
