**Gladvic Farm
Main Street
Potter Brompton
Scarborough
North Yorkshire**

**SE 97032 76665
MAP 10.85.2012
Archaeological Watching Brief Report**

Report on Archaeology (Pre-Planning Requirement)

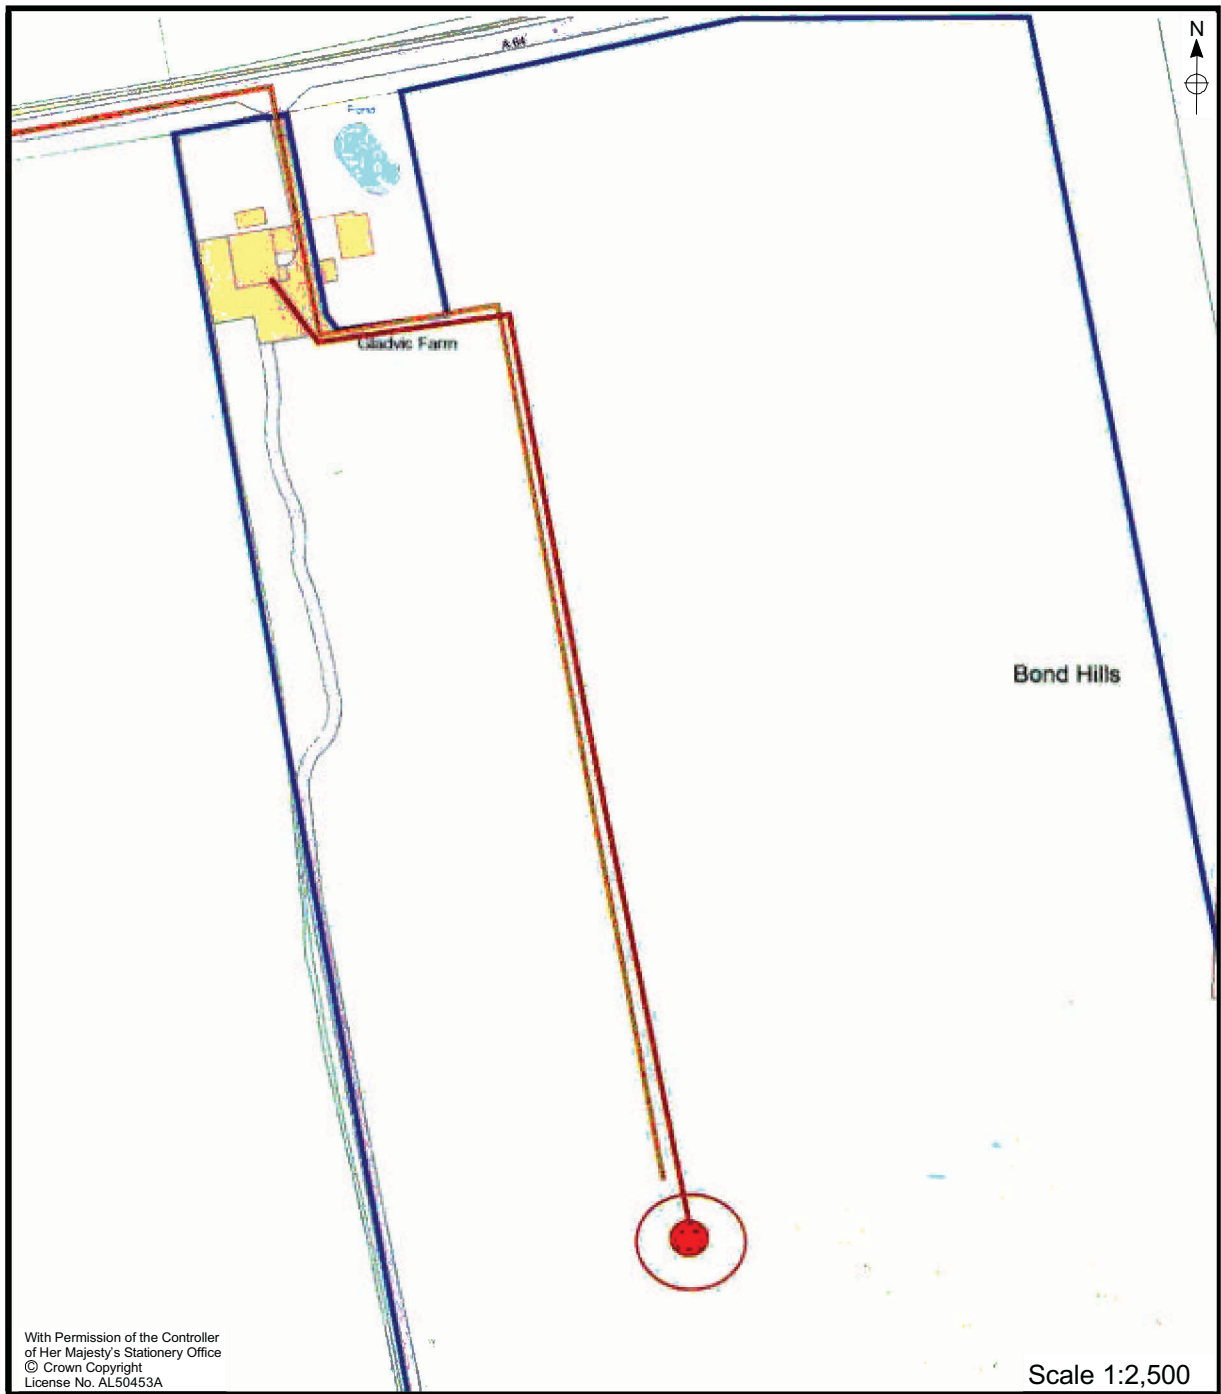
Figure 2. Location of Archaeological Strip and Record Area.

outdoor pig farming and the central area set aside for cropping of maize. The proposed turbine site is bounded by a 9 hole golf course to the west, the A64 to the north, an elongated tree belt to the east and a woodland area on Staxton Hill to the south. The Wolds Way public footpath runs across the site's south eastern boundary (Fig. 2: Pl. 1).

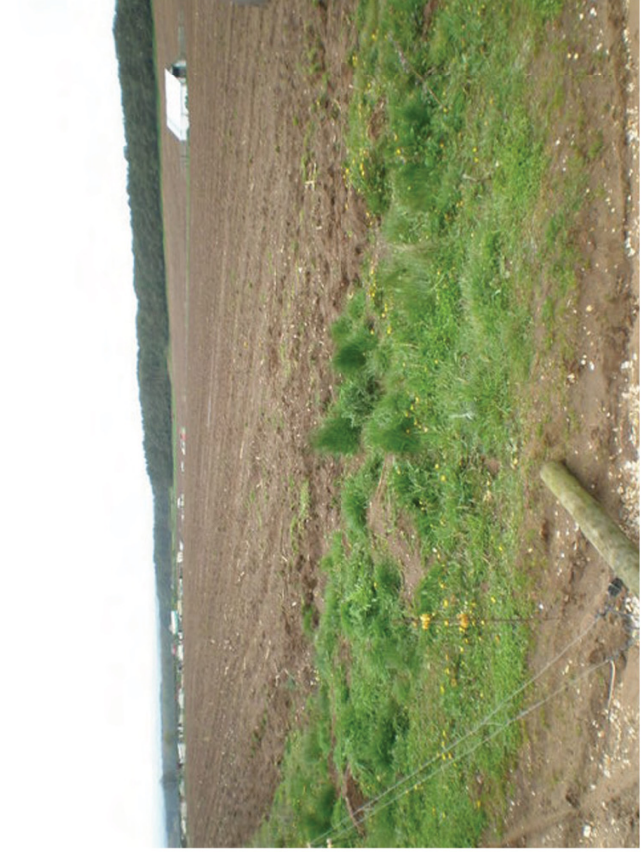
Plate 1. General View of Site. Facing North-east.

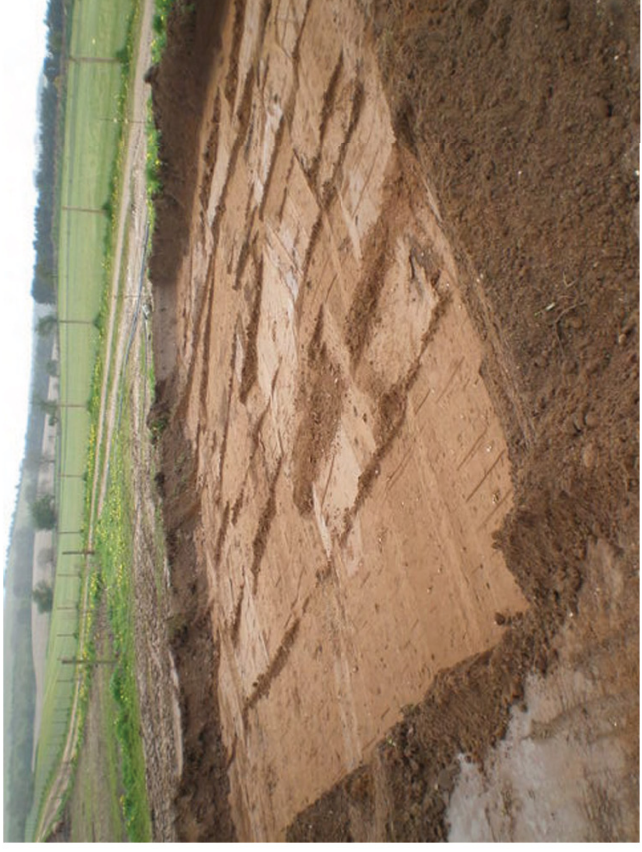
Plate 2. Wind Turbine Base after Topsoil removal. Facing South-west.

5.1 The initial groundwork stages of the wind turbine base installation involved the preliminary topsoil strip of an area c. 7m by 7m by a JCB excavator fitted with toothless ditching bucket. Machining initially ceased at the surface of the wind blown sand deposit (Pl. 2) revealing the absence of archaeological remains. Subsequently, the area was excavated by machine to formation level (1.40m below existing ground level), the course of the wind blown sand being levelled in shallow spits to enable the identification of archaeological features, deposits or finds

6.1 Natural deposits of sand with chalk gravel were encountered at the location of the wind turbine. Stratigraphy on the western side of the turbine base consisted of a brown silty sand topsoil deposit (1001) measuring up to 0.41m which sealed a very thick deposit (up to 0.55m) of very silty sand (1002) which represented the wind blown sand horizon/deposit which is characteristic to this area (Pl. 4). Towards the eastern end of the turbine base, where the land appeared to gradually slope down, the topsoil deposit had a maximum depth of 0.39m with the wind blow sand reaching depths of 1.01m.

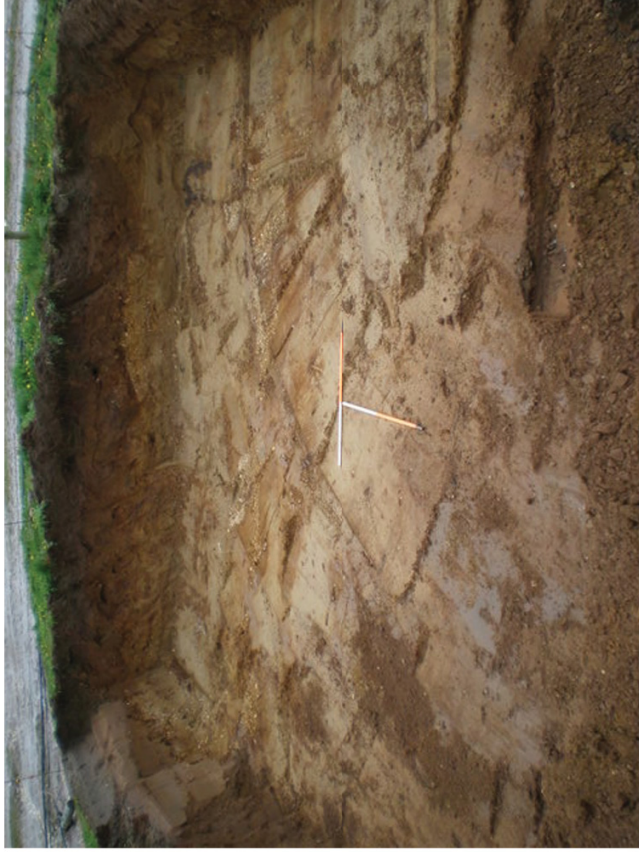
Plate 3. Wind Turbine Base at Formation Level. Facing West.

6.2 No archaeological features, deposit or finds were present within the proposed turbine base.

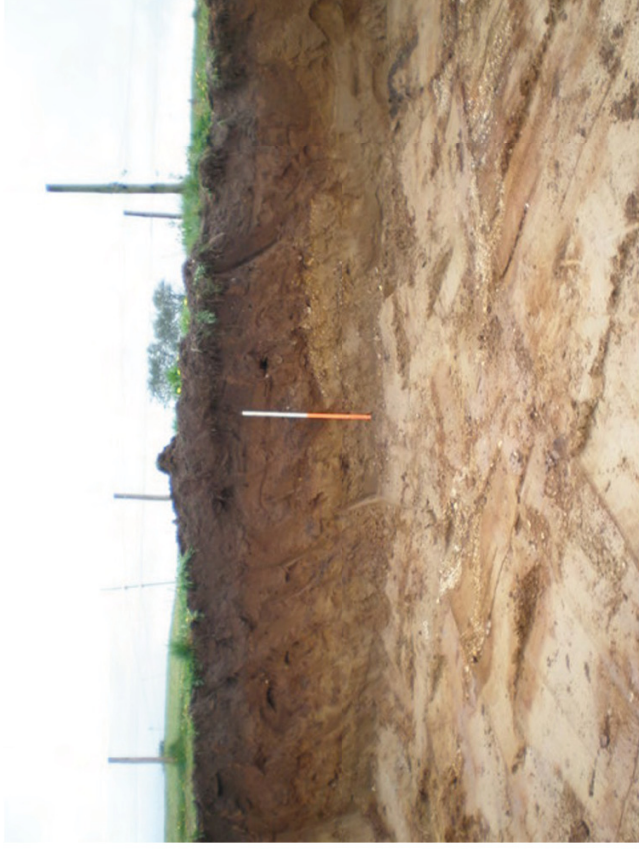
Plate 4. East Facing Section of Turbine Base. Facing West.
