6 STONEBRIDGATE
RIPON
NORTH YORKSHIRE

6 STONEBRIDGE GATE
RIPON
NORTH YORKSHIRE

ARCHAEOLOGICAL EVALUATION
APRIL 1992

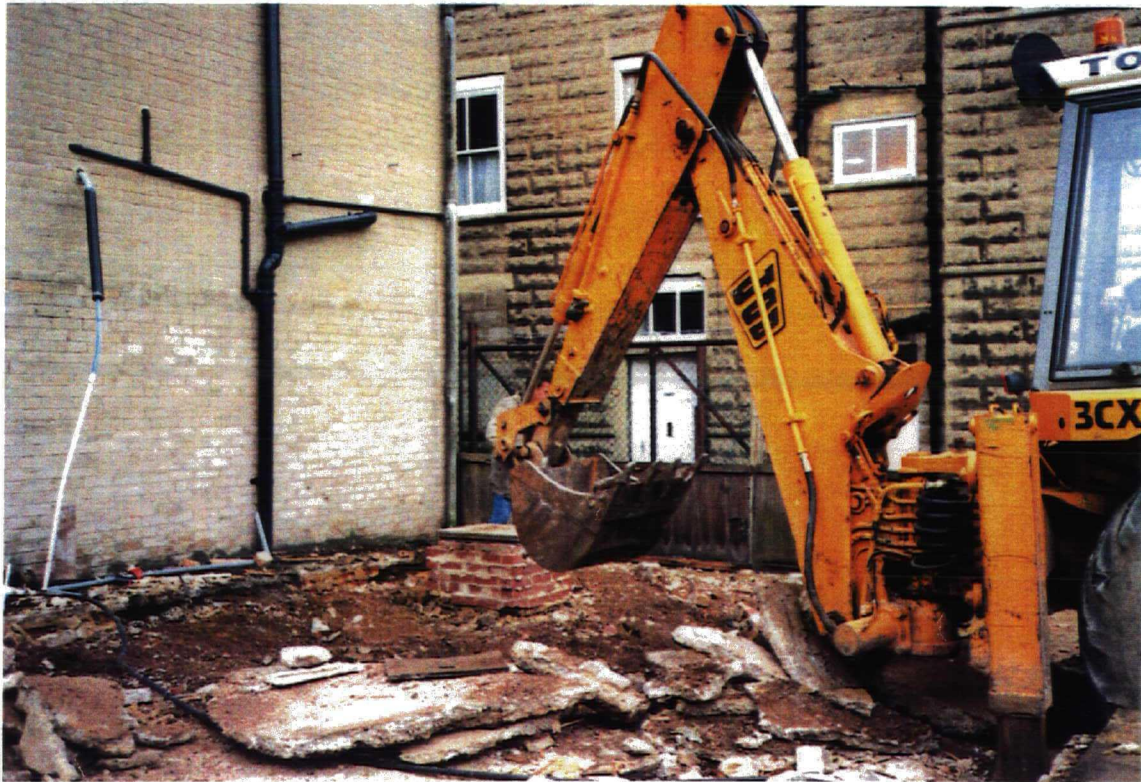
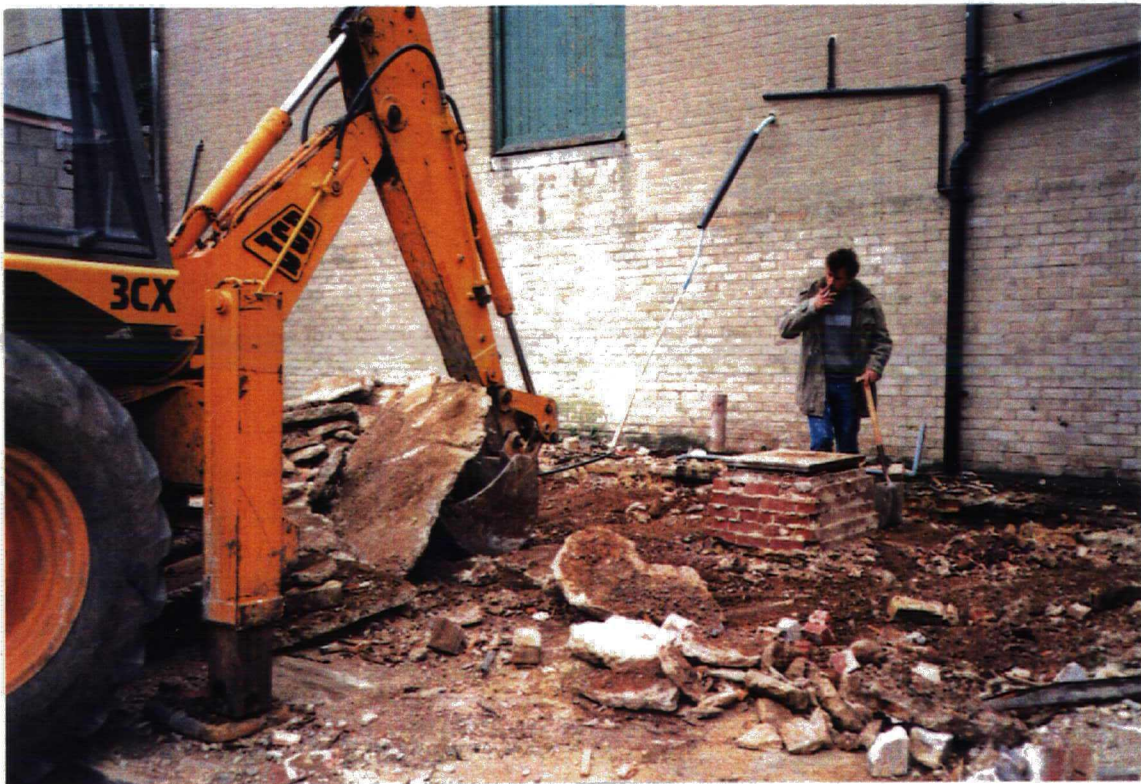
Removal of on site concrete

The concrete platform was broken up and removed by a machine, the underlying hardcore and gravels were cleaned back by hand to reveal a gently undulating surface of compacted sands and demolition rubble.

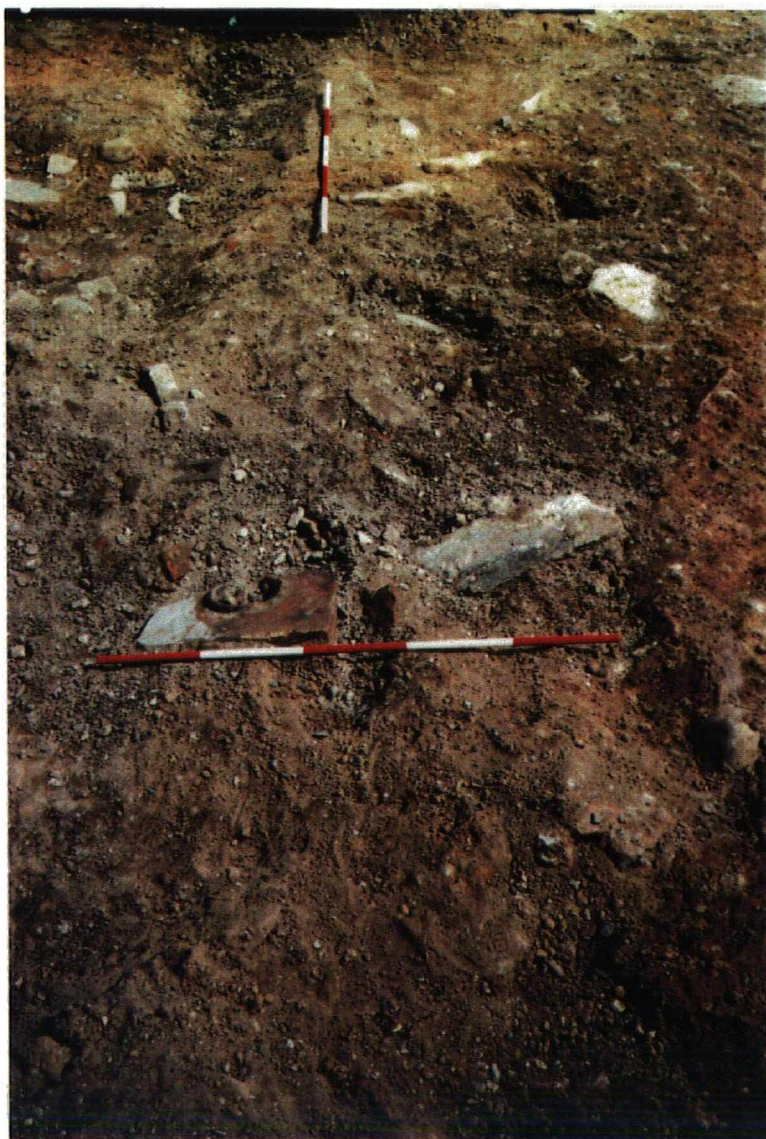
Demolition rubble

This surface had been cut by modern drainage features and shallow foundation trenches, some of which contained modern bricks and concrete fragments. This demolition layer also contained rectilinear brick features and the intermittent and fragmentary remains of a cobbled surface, these features were investigated and found to be shallow and insignificant. The layer was sealed in places by superficial spreads of dark brown loam.

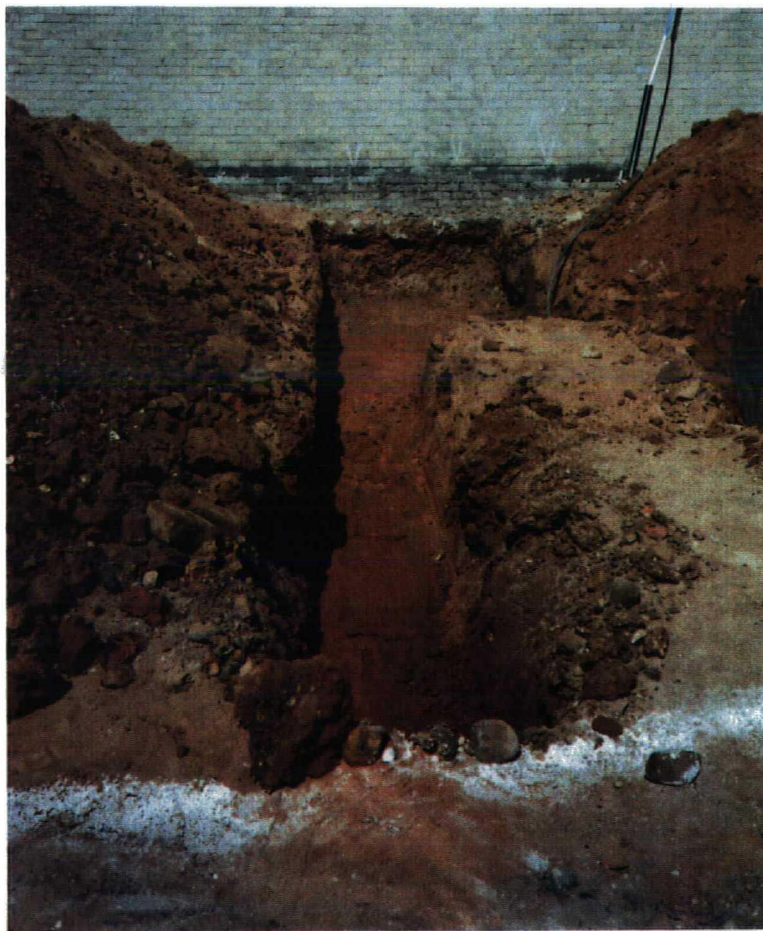
Machine trench

No archaeological features or deposits were identified within the four foundation trenches.
