**Oak Mount
Thirsk Road
Northallerton
North Yorkshire**

**SE 3710 9310
11/02264/FUL
MAP 5.53.2012
Building Survey and Photographic Survey**

Building Survey and Photographic Record

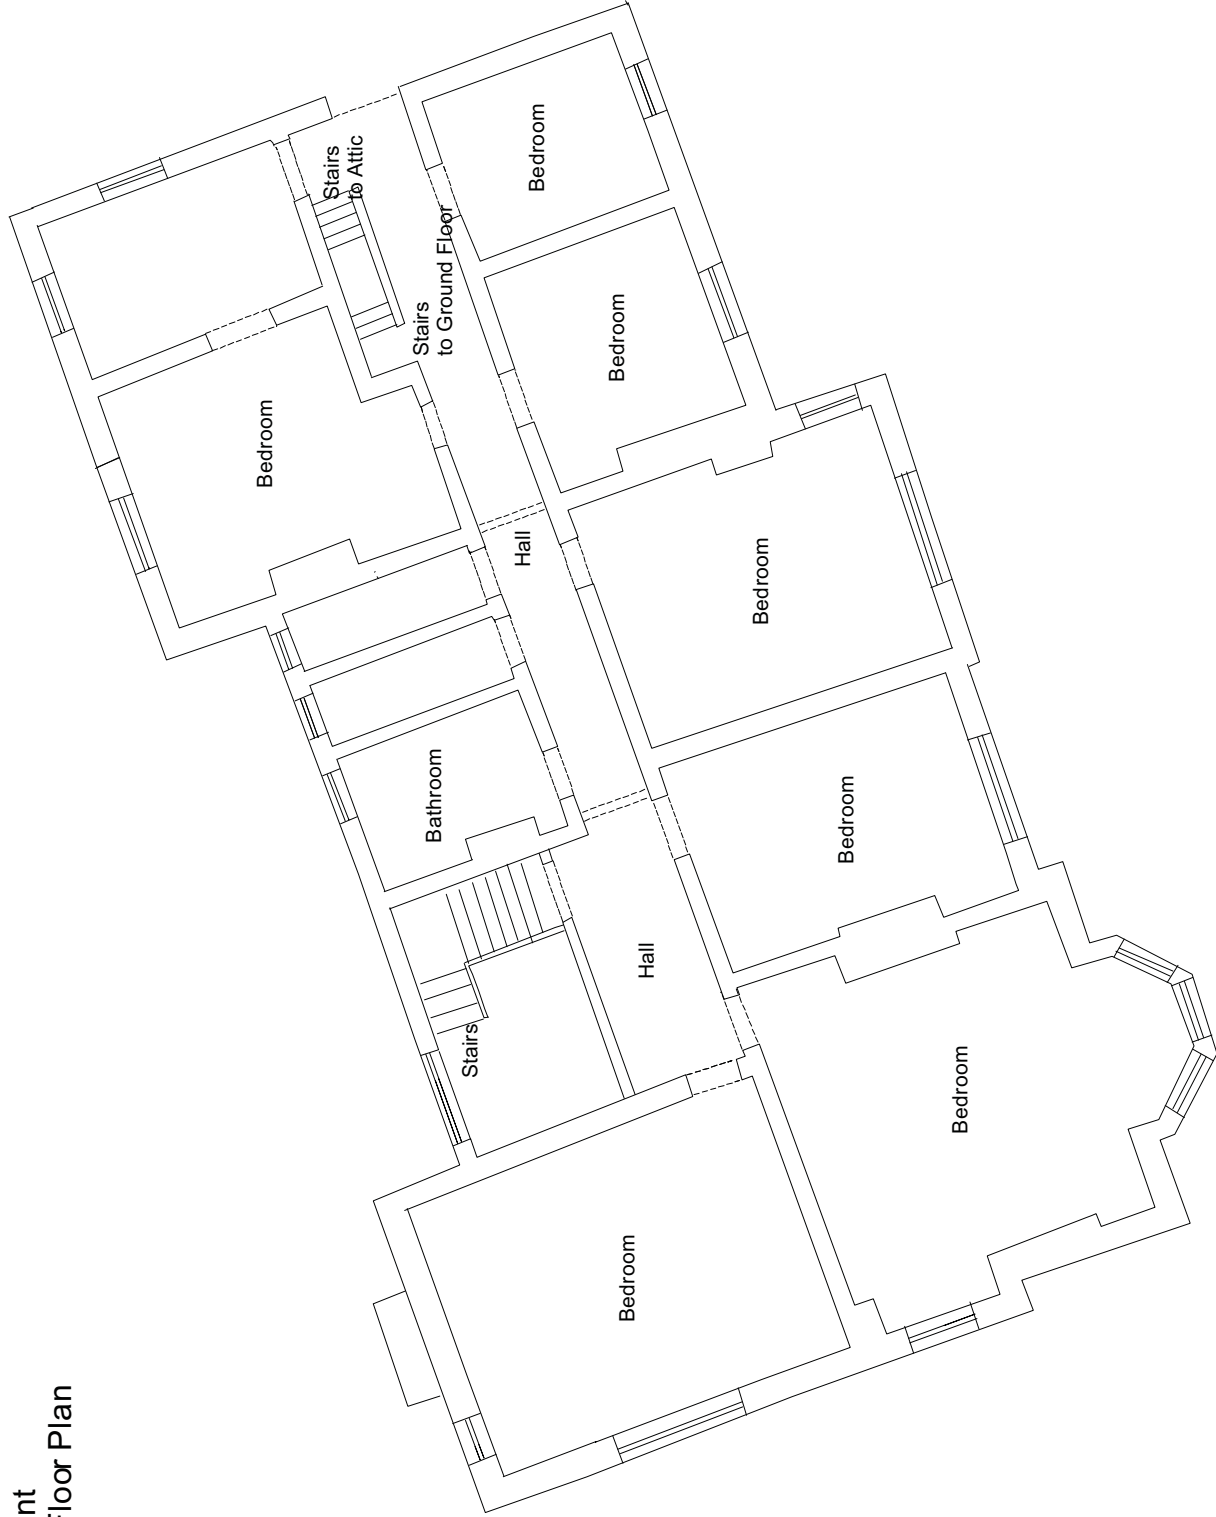
Figure 8. Oak Mount: First Floor Plan.

7.3.2 The main bedrooms are on the east and west side and on the south side of the house. There are a series of smaller rooms on the north side of the hall, now bathrooms. The eastern most room on the south side has a chimney across the south-western corner of the room. No fireplaces survive on the first floor. There is modern glass divide at the top of the main hall.
