# Police House, Main Street, Sheriff Hutton: Watching Brief Report

Planning Application Ref: 12/00482/HOUSE  
National Grid Reference Number: SE 65373 66381

AOC Project No: 51143

Date: January 2013

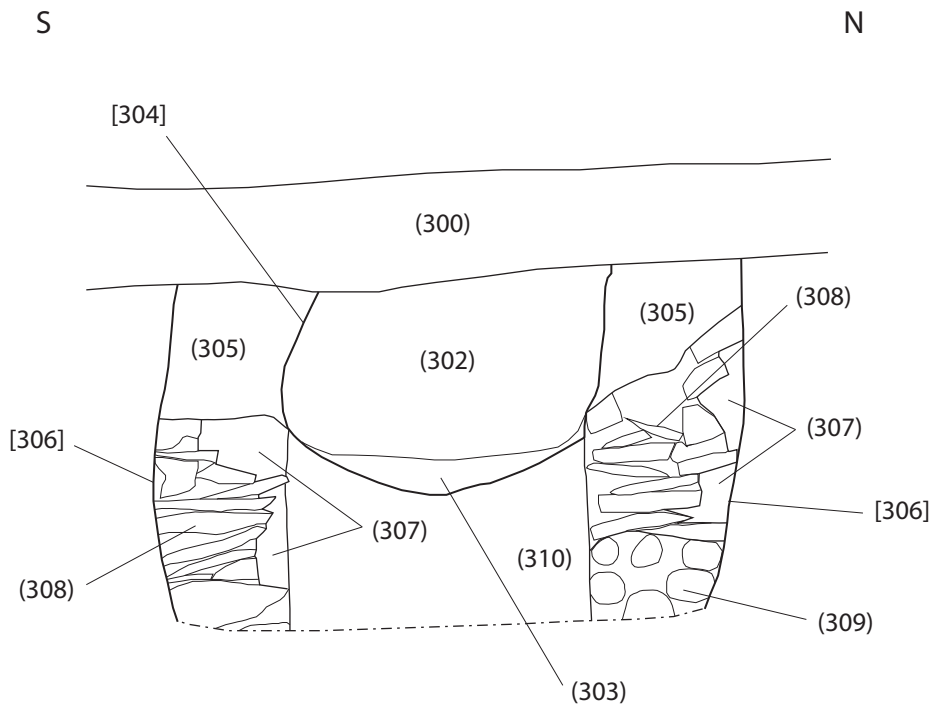
East-facing section through features {306} and {304}

- 7.5.2 At the southern end of the westernmost strip foundation, the made-ground deposits described above petered out and two intercutting features were encountered. The earliest was a stone-lined pit which cut through the natural subsoil; it was sub-rectangular in plan with vertical sides (context 306, 1.5 m wide and greater than 0.9m deep; **Plate 1**). This feature was excavated to a depth of 1.2 m below ground level (deeper than the required depth of the foundation trench) but it was not possible to excavate further than this as the trench sides became unstable. The stone lining appeared to consist of two deposits. The earlier comprised river cobbles (context 309); these were sealed by roughly

arranged sandstone slabs (context 308). The slabs were roughly hewn, laid irregularly and bonded with stiff mid greyish brown silty clay (context 307). They extended below the limit of excavation. The pit had been backfilled with firm dark greyish brown silty clay with frequent charcoal inclusions (context 310, 0.46 m deep). Two sherds of pottery were recovered from this deposit. One was undiagnostic as to date, the other had a broad date range beginning in the latter part of the 16<sup>th</sup> century and continuing until c. 1900 (Appendix 2). The upper parts of the stone lining of the pit were sealed by re-deposited natural clay (context 305, 0.35 m deep). This appeared to represent an attempt to cap or seal the pit and the dumped material within it.

- 7.5.4 Feature 306 was truncated by a later, sub-rectangular pit (context 304; 0.77 m wide and 0.56 m deep with vertical sides and a rounded base). The pit had a shallow primary silting deposit (context 303, 0.20 m deep). This was sealed by a dumped deposit of dark blackish grey silty sand containing charcoal and CBM flecks and four sherds of post-medieval pottery (context 302, 0.46 m deep). Three of the pottery sherds were of 18<sup>th</sup> century date; the fourth spans the late 16<sup>th</sup> century to the end of the 19<sup>th</sup> century. An 18<sup>th</sup> / 19<sup>th</sup> century date seems most likely for this feature; it would appear to be a small refuse pit.

- 7.5.3 The function of feature 306 is unclear. Interpretation is hindered by the small amount of the feature exposed and the limited depth of excavation. It seems unlikely to be a well: the stone lining was crudely constructed and not water-tight. It is conceivable that it represents a garden feature or a refuse pit that had a roughly-built stone lining. The pottery within the backfill of the feature could belong to the 17<sup>th</sup>, 18<sup>th</sup> or 19<sup>th</sup> centuries. Given the dating evidence from the remainder of the site, this feature is perhaps most likely of 18<sup>th</sup> or 19<sup>th</sup> century date.
