**OSGOODBY HALL, OSGOODBY,
THIRSK, NORTH YORKSHIRE**

WATCHING BRIEF & BUILDING RECORDING REPORT

REPORT NUMBER 2012/55

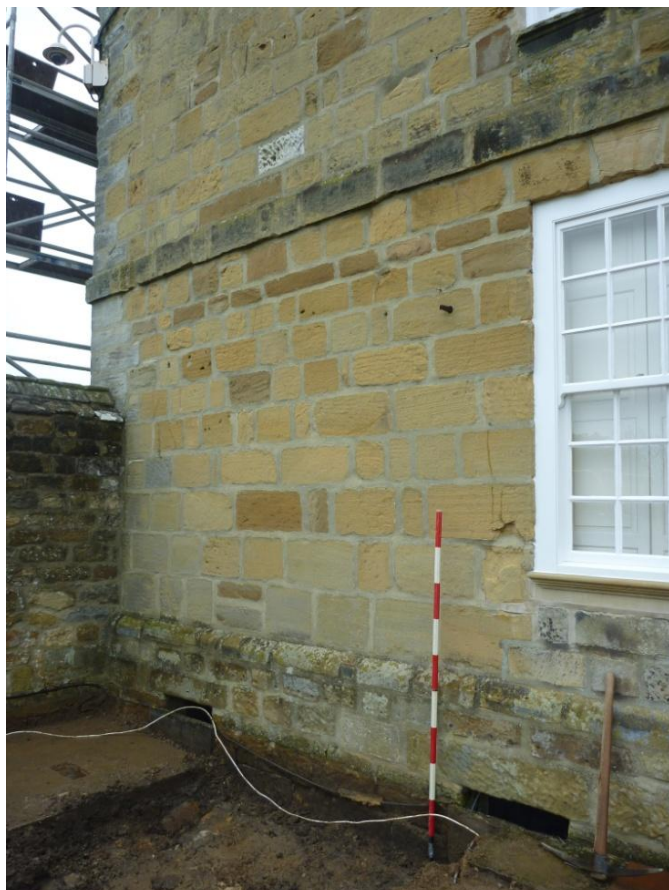
Plate 3 View of area of drawn walling, note the two basement windows.

The cutting through of the new doorway between the house and the new library was observed, see Plate 3. The walling was seen to be up to 0.67m in width, two courses wide with the coursed and dressed stone exterior not being matched by the stonework to the inner face of the wall. Instead this was generally of smaller stone that was often irregularly shaped and of somewhat rough appearance, seemingly so as to provide keying for the internal wall plaster. The stonework, particularly in the interior parts of the wall, was bonded with copious amounts of a creamy white coloured lime mortar.

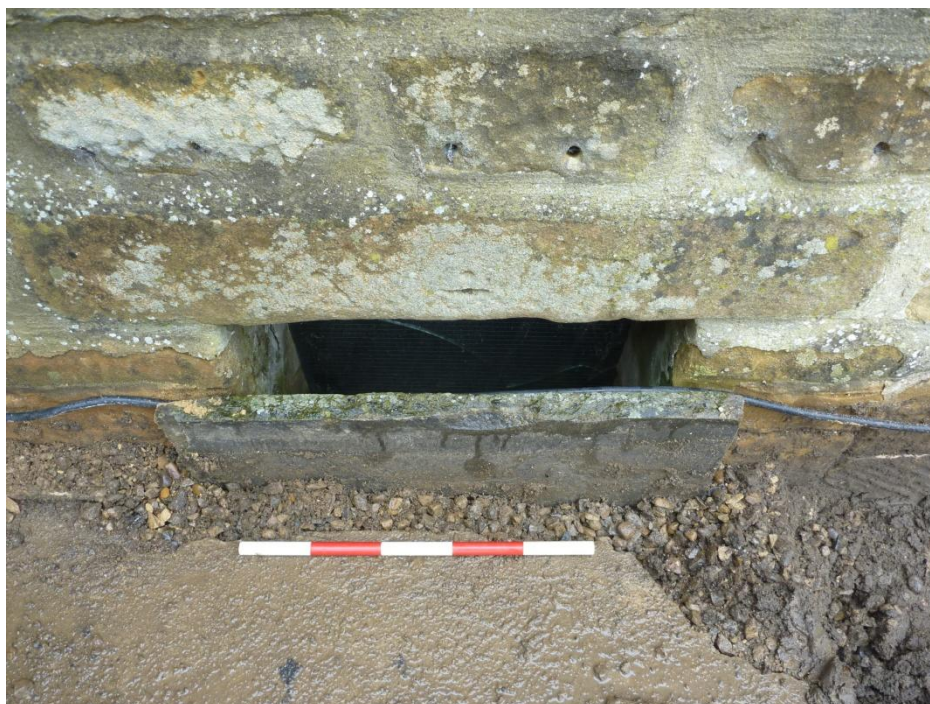
Plate 4 View of west basement window (to be blocked-up).

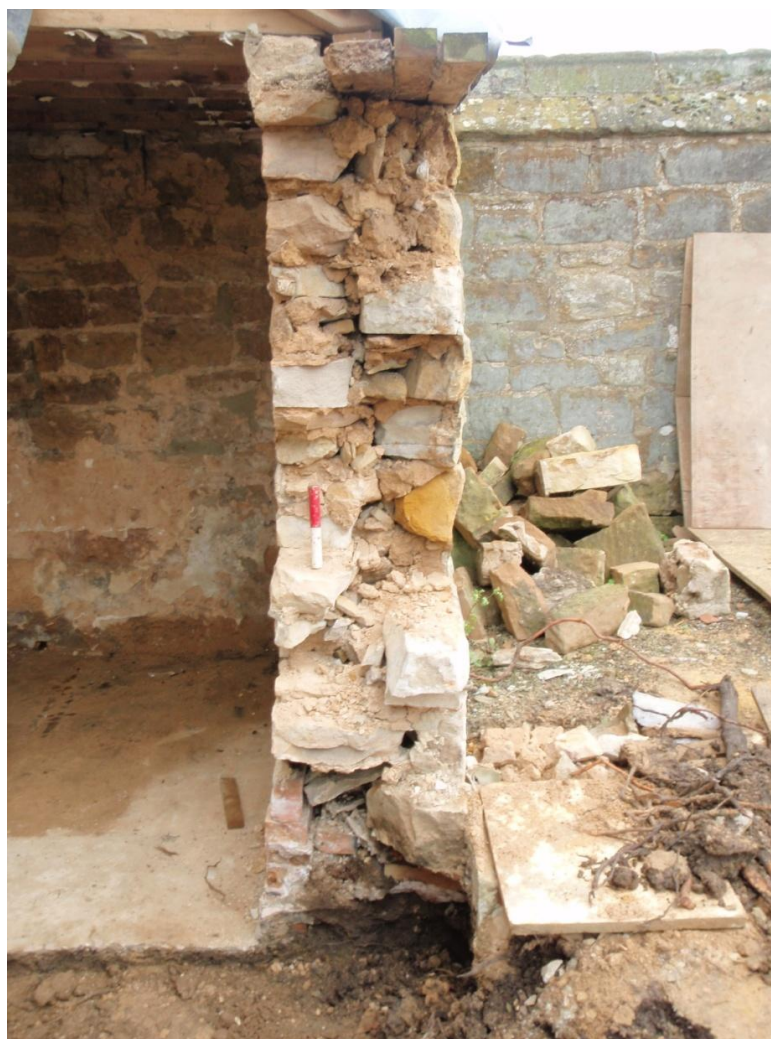
Plate 8 Cross section of store walling after removal of the east wall. Looking W.
