# Northallerton Flood Alleviation Scheme (FAS) Environmental Report

Final

This document forms the Environmental Report of the non-statutory Environmental Impact Assessment for the proposed flood alleviation scheme at Northallerton. The local planning authority, namely Hambleton District Council, have confirmed that the proposed scheme will require planning permission. However, a statutory EIA under the Town and Country Planning (Environmental Impact Assessment) (England and Wales) Regulations 1999 is not required as the total length of the proposed scheme would be less than the 2km threshold for linear flood defences contained within Circular 02/99<sup>1</sup>.

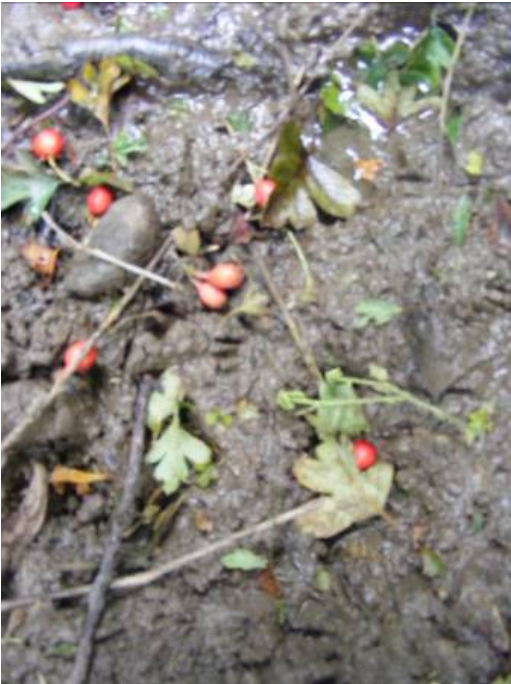
Photograph 1: Brown rat footprint within Turker Beck

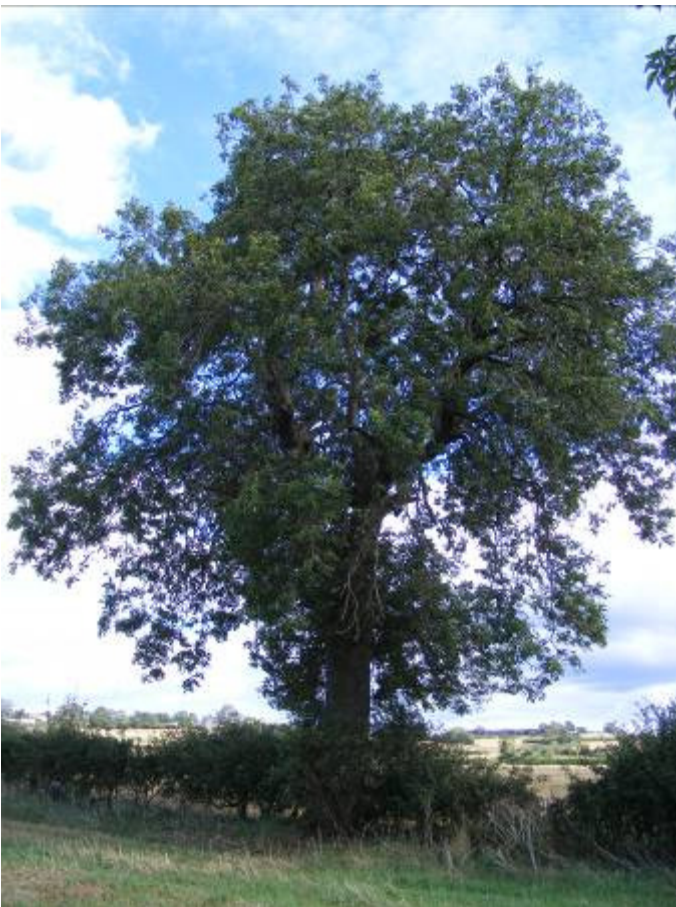
Photograph 2: Ash with bat roosting potential close to Sun Beck.

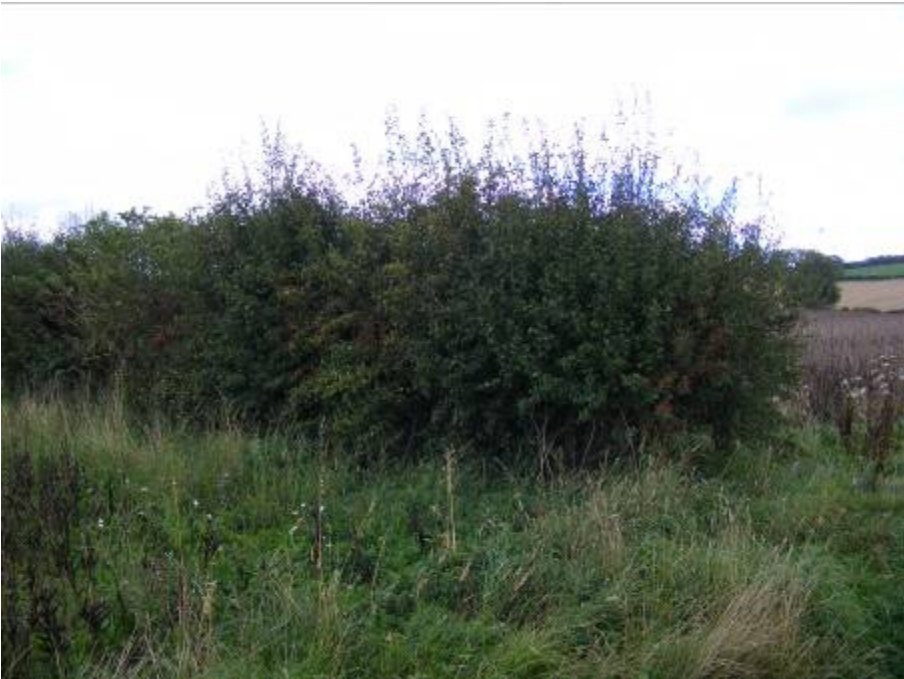
Photograph 4: Hedgerow 1 running perpendicular to Turker Beck

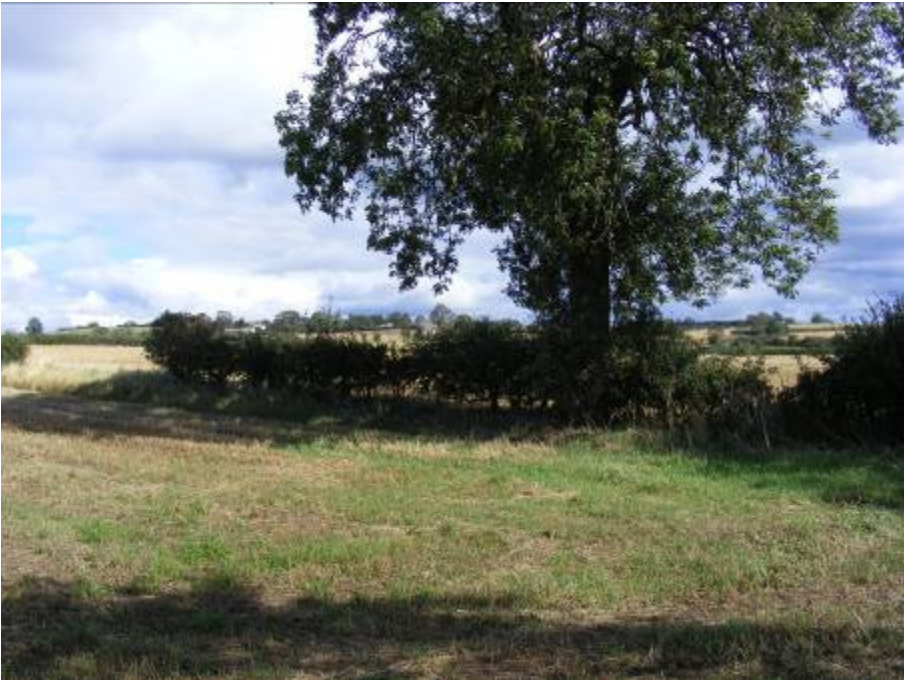
Photograph 5: Hedgerow 2 running perpendicular to Sun Beck

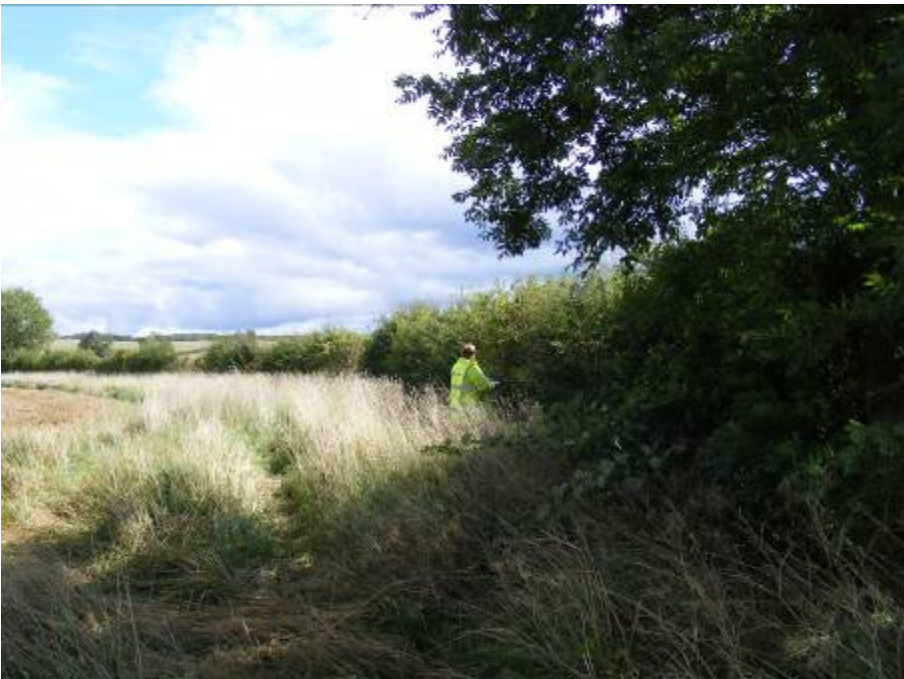
Photograph 6: Hedgerow 3 running parallel to Sun Beck – looking east

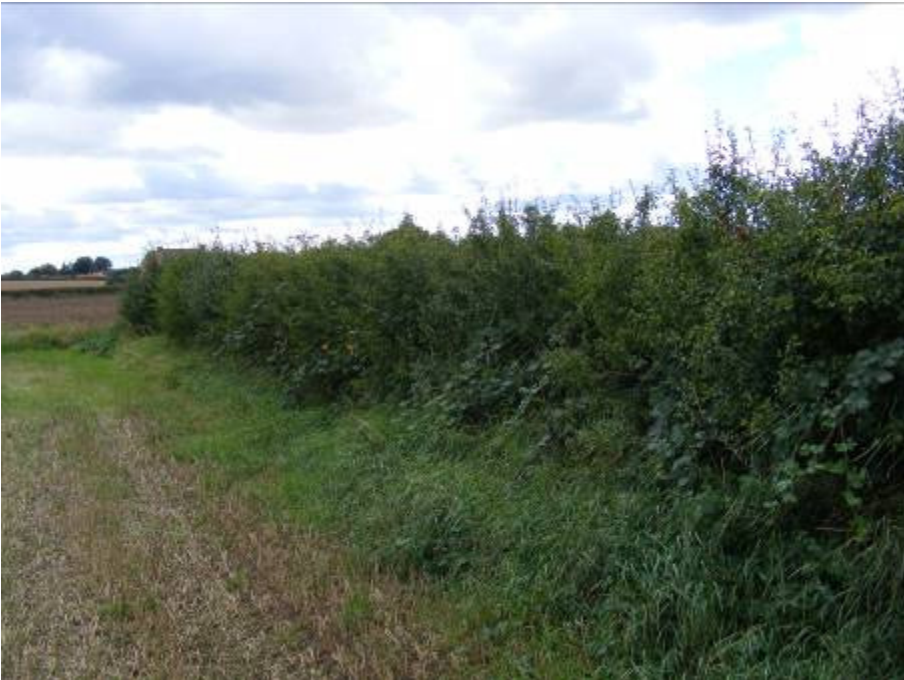
Photograph 7: Hedgerow 4 running perpendicular to Sun Beck – looking south

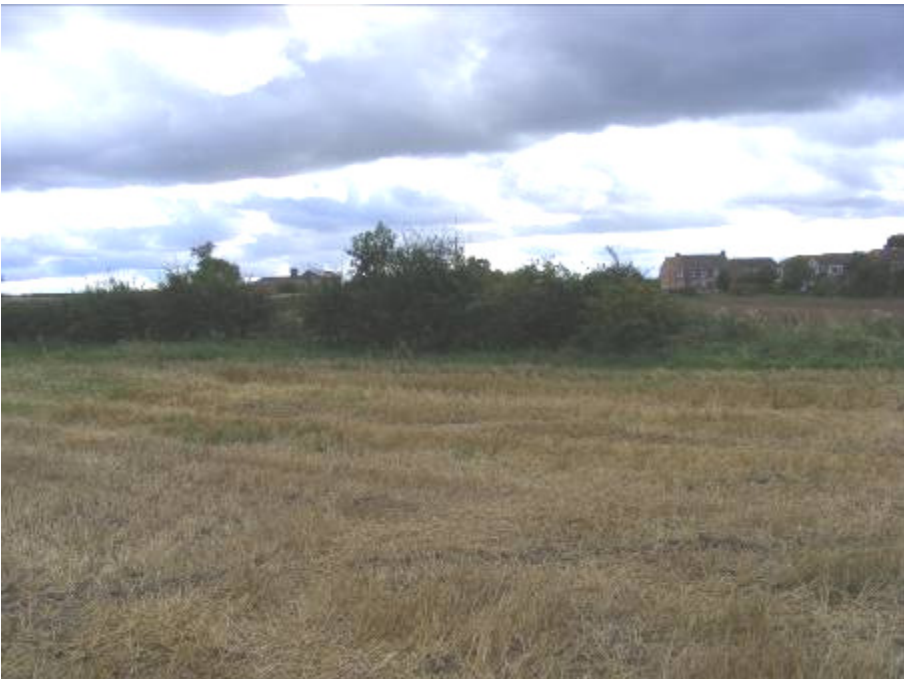
Photograph 8: Hedgerow 5 running parallel to Sun Beck – looking south

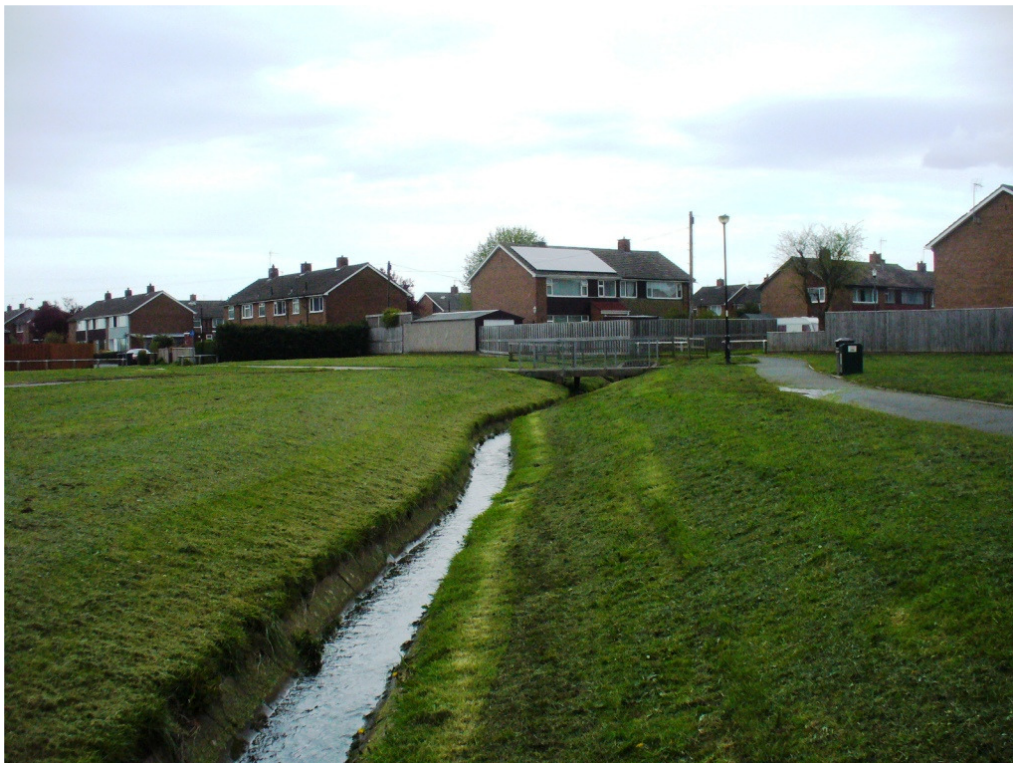
Plate 3: general view of Turker Beck in Bullamoor Park looking northeast towards Turker Close, showing the artificially graded banks

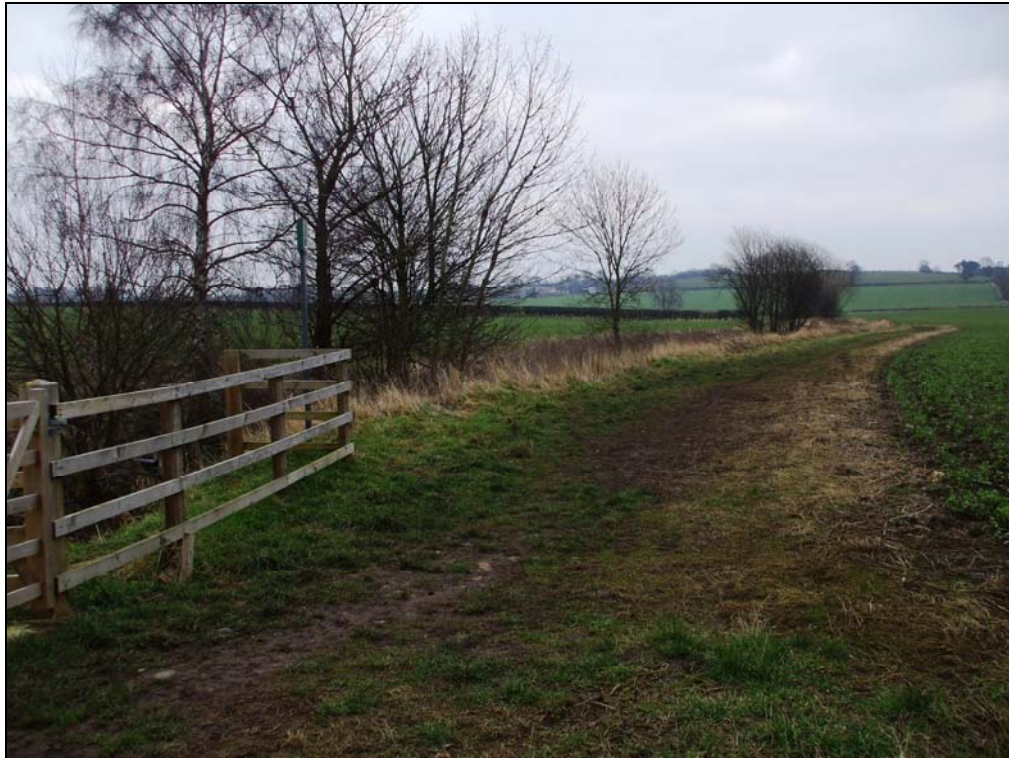
Figure 8: View looking northeast along the Turker Beck

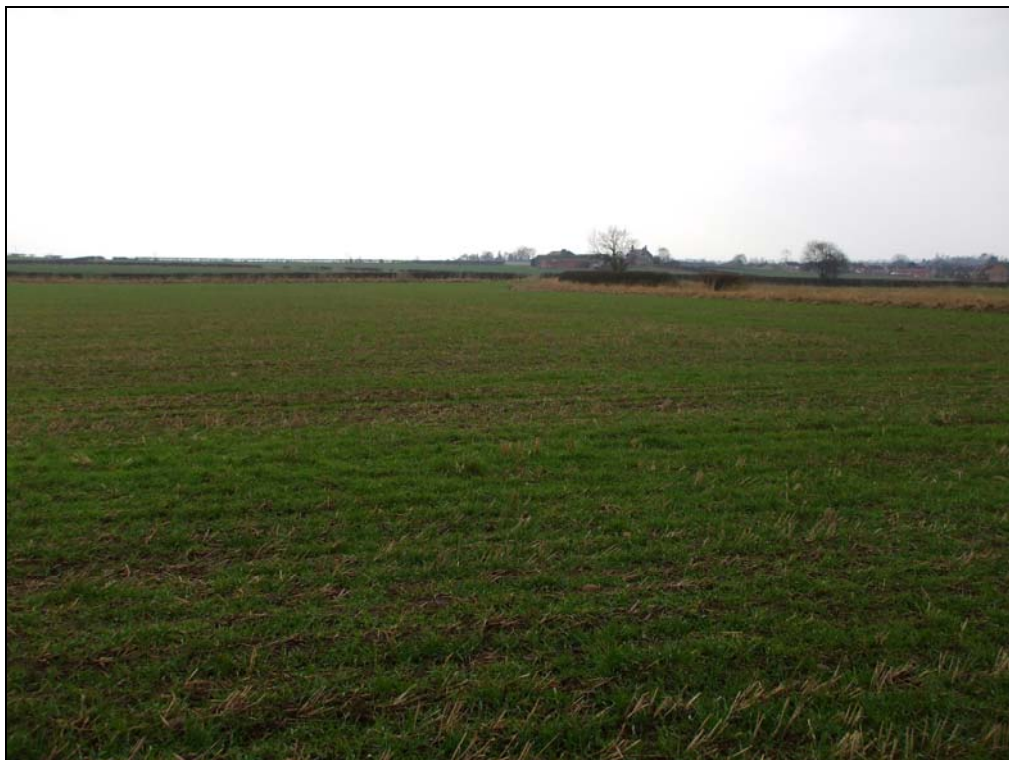
Figure 9: View south from Scholla Lane towards Sun Beck

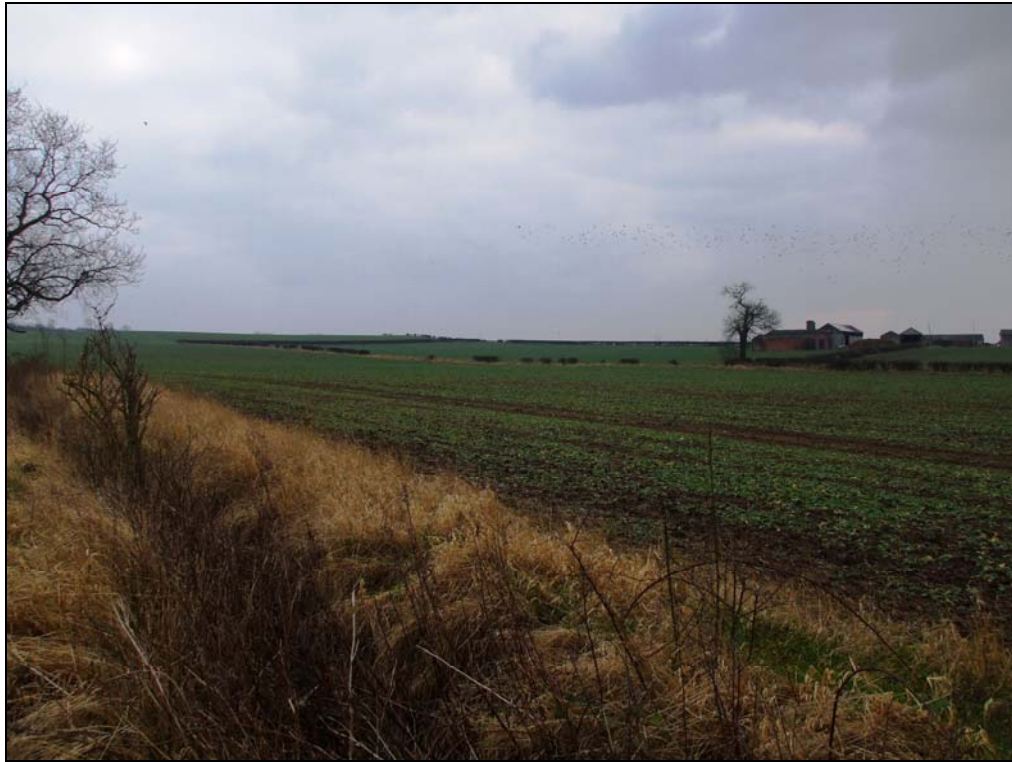
Figure 10: View south with Sun Beck in foreground

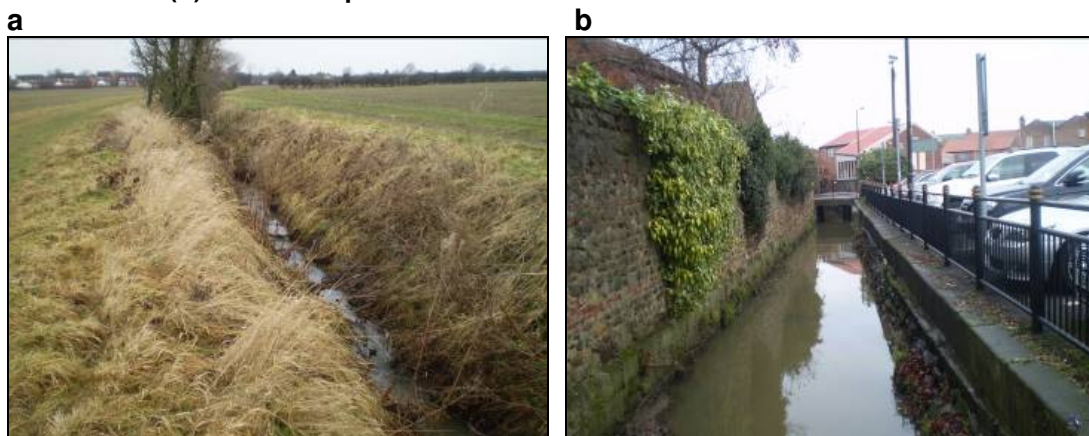
**Figure 2.1: Examples of channel modification, (a) re-sectioning and straightening – Turker Beck (b) hard bank protection – Sun Beck.**

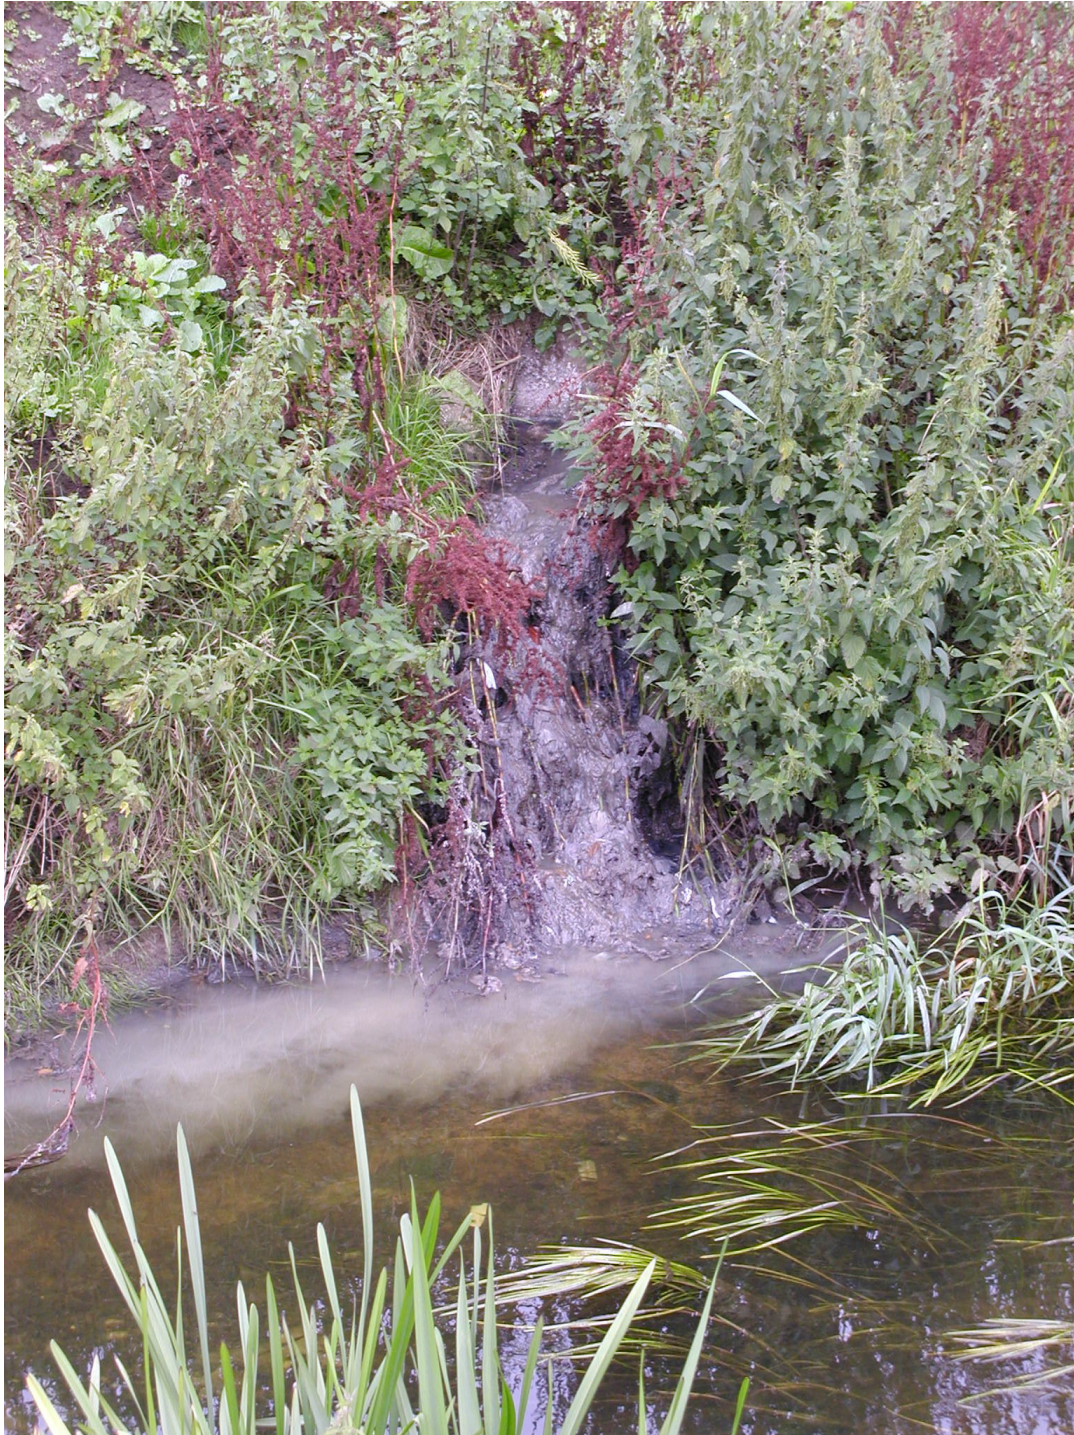
**Gross organic pollution c.100m upstream of Newby Wiske Bridge**

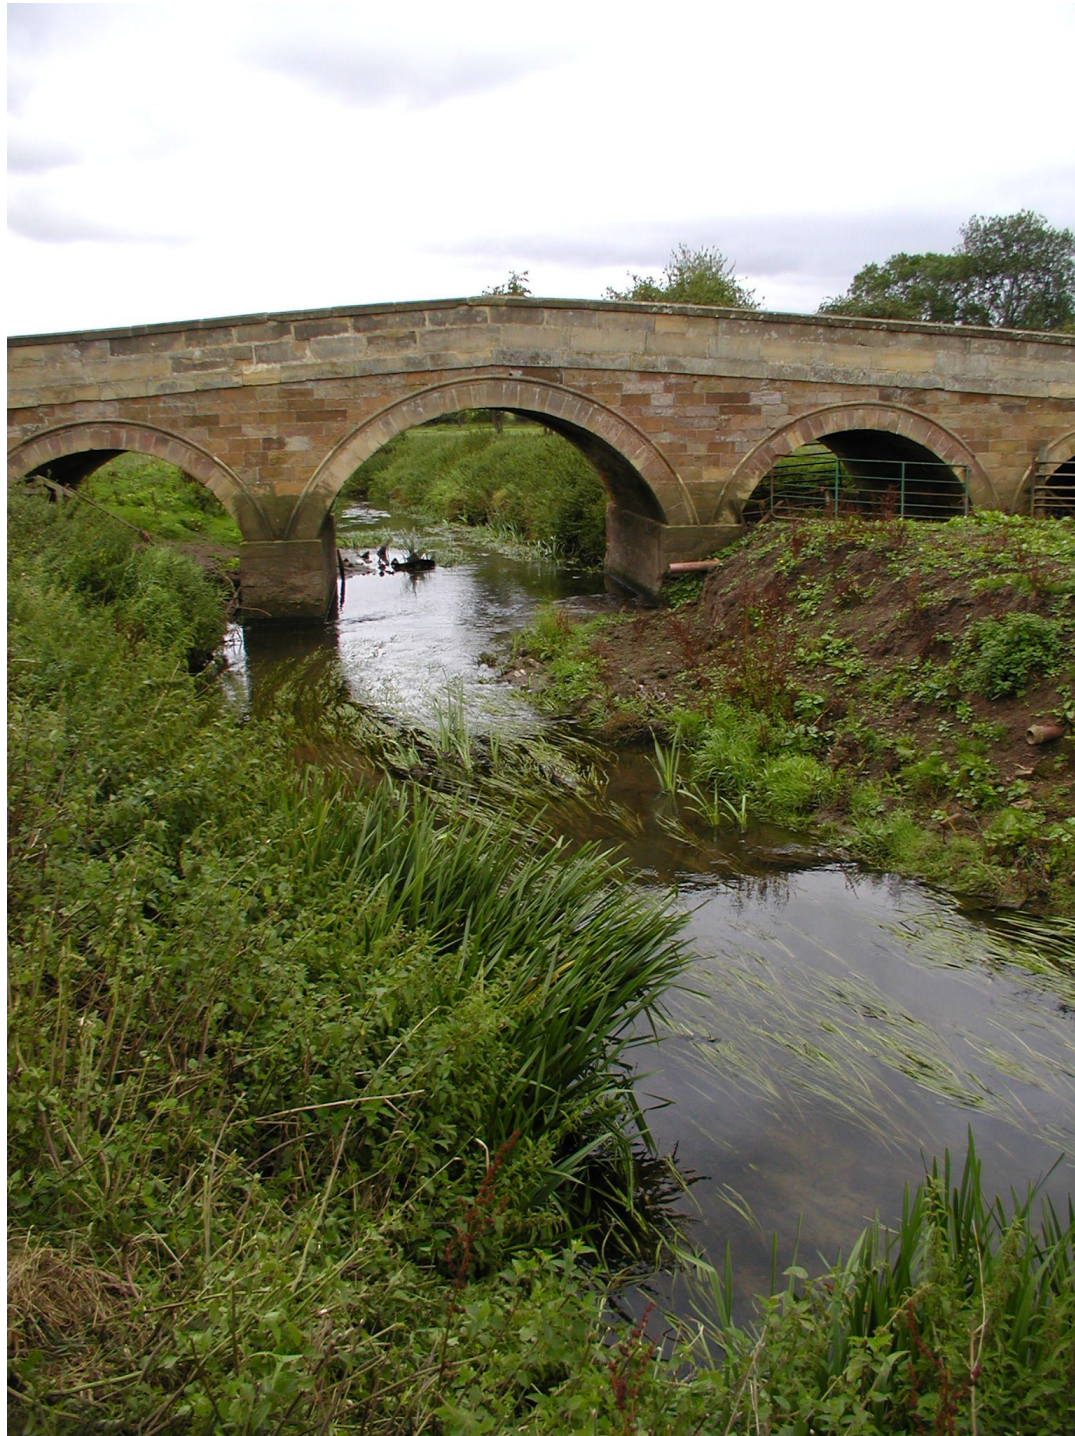
**Newby Wiske showing abundant macrophytes typical of the Wiske system.**

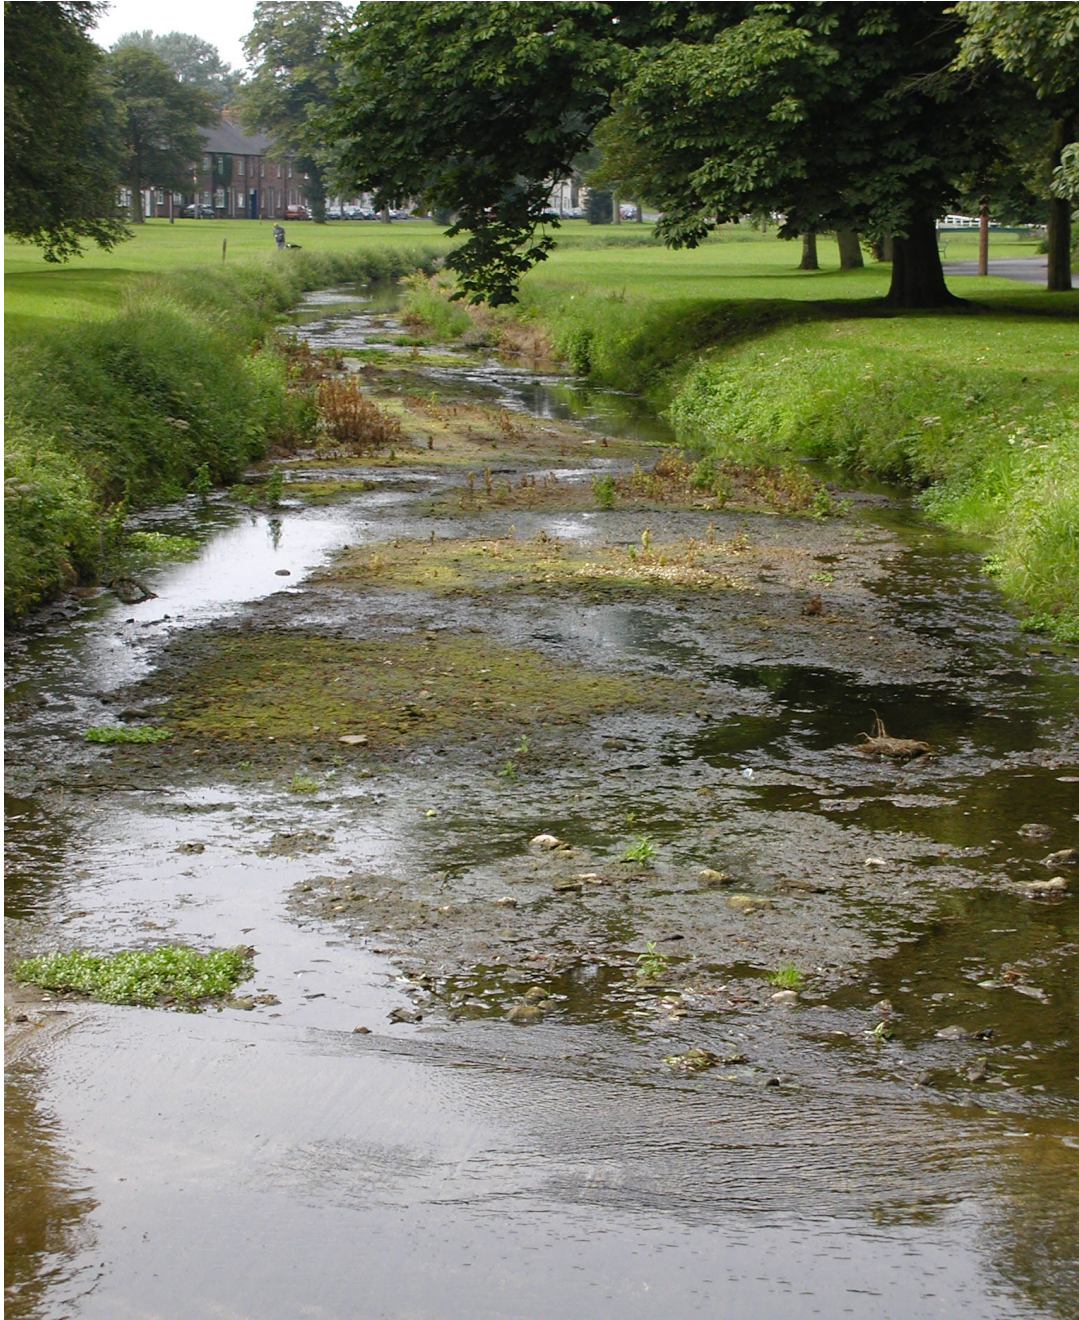
**Brompton Beck d/s ford in Brompton village showing acute low flows and abundant filamentous algae from over enrichment. NB. brown instream vegetation suggests treatment with herbicide.**

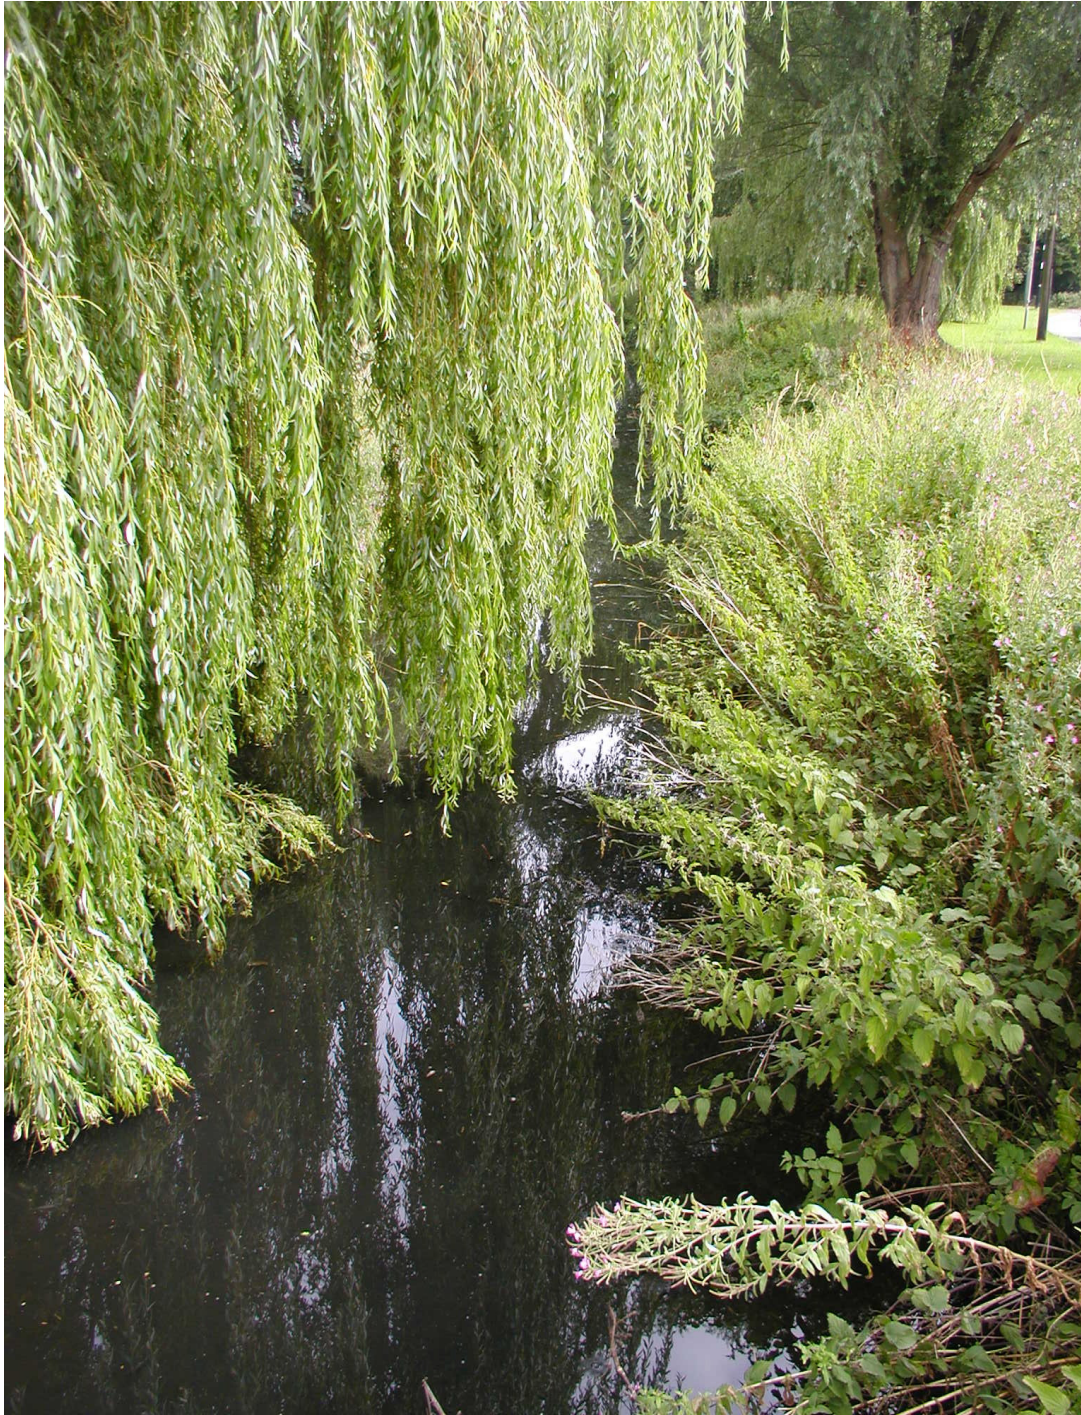
**Brompton Beck u/s ford in Brompton village. Substrate: extensive covering of black ,anoxic silt.**
