**RED HOUSE, PALACE ROAD, RIPON, NORTH YORKSHIRE**

**ARCHAEOLOGICAL DESK-BASED ASSESSMENT**

**Enterprise Developments**

March 2013

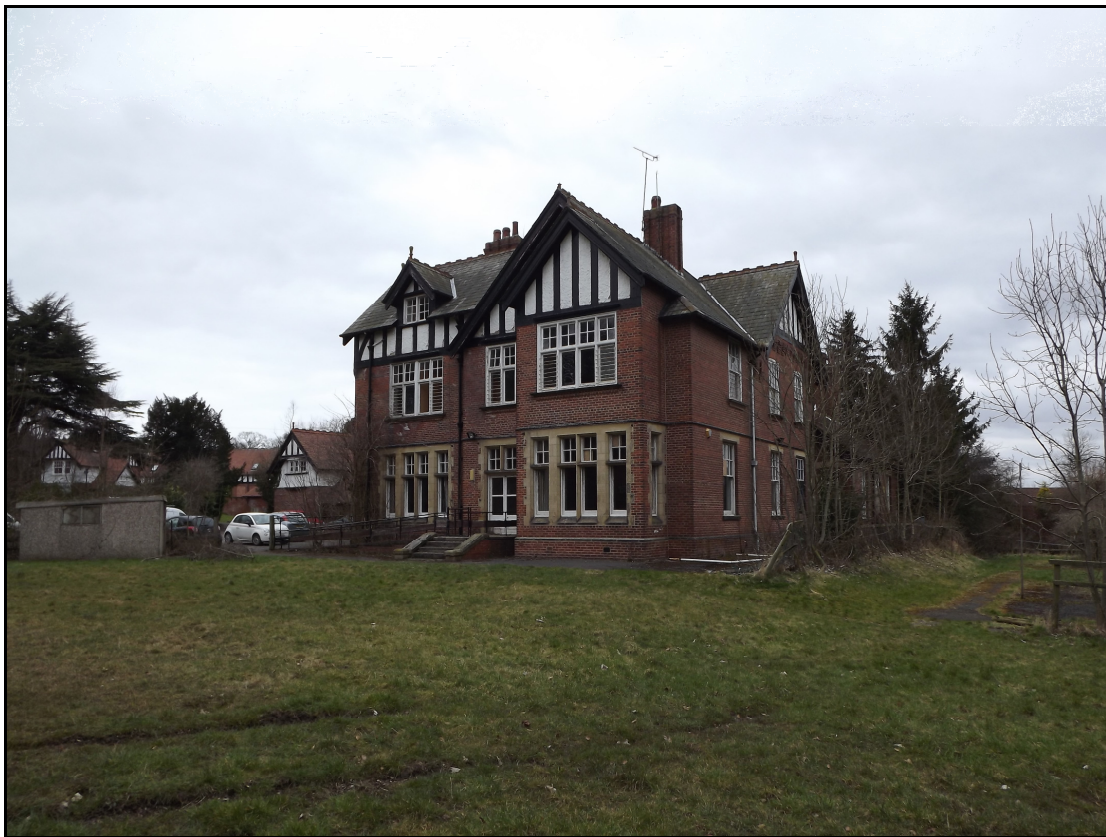
Plate 1. General view of Red House, looking north-east

- 2.3 The site lies on the eastern side of Palace Road at a height of *c.*44mOD and is surrounded by residential developments. The current 'Red House' stands towards the centre of an area of a mixture of grass and mature trees.

- 2.1 The proposed development site lies approximately 1km to the north of the centre of Ripon, on the eastern side of Palace Road (SE 30943 72311) (Plate 1). The southern, eastern and northern boundaries are all on to residential areas, whilst the western boundary is Palace Road. The site is in Ripon civil parish in Harrogate District, North Yorkshire (Figures 1 & 2).

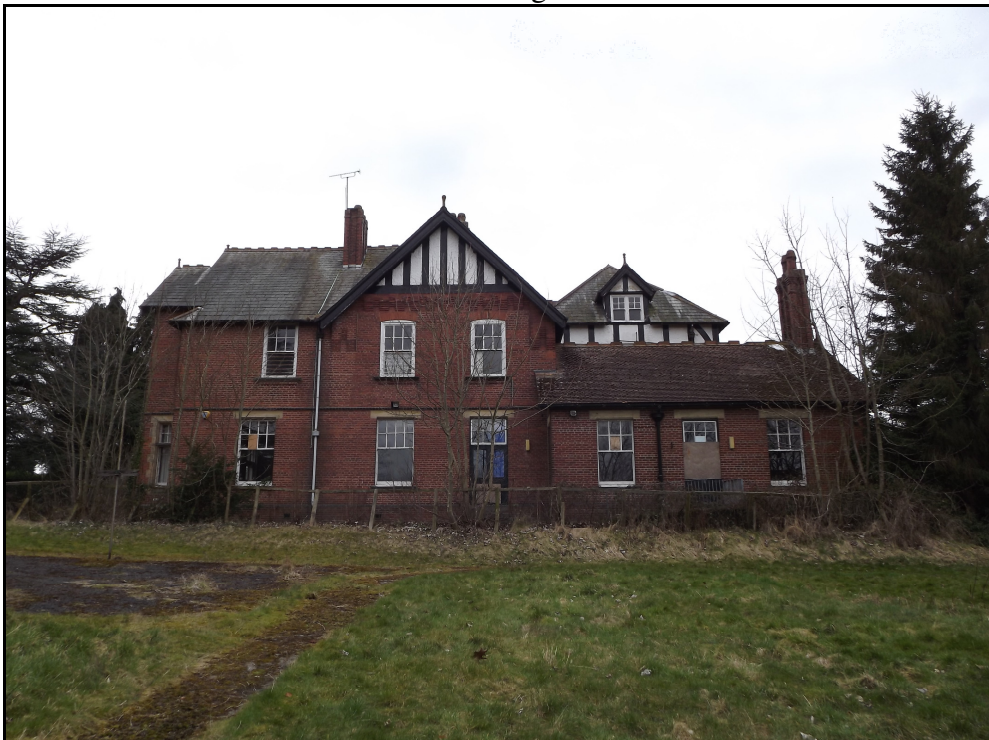
Plate 2. View of the rear (eastern) elevation of Red House.

- 5.3 The surviving historic structures all appear to date from the building of the current 'Red House' between 1890 and 1907 (Plates 1 & 2) and are typical of large domestic buildings of the era. As such, externally, they do not appear to have any particular architectural merit. One aspect of the group of building of minor significance is that they appear to survive as a good example of the range and layout of buildings (gate house, stables) and associated areas (formal and kitchen garden) typical of this date.

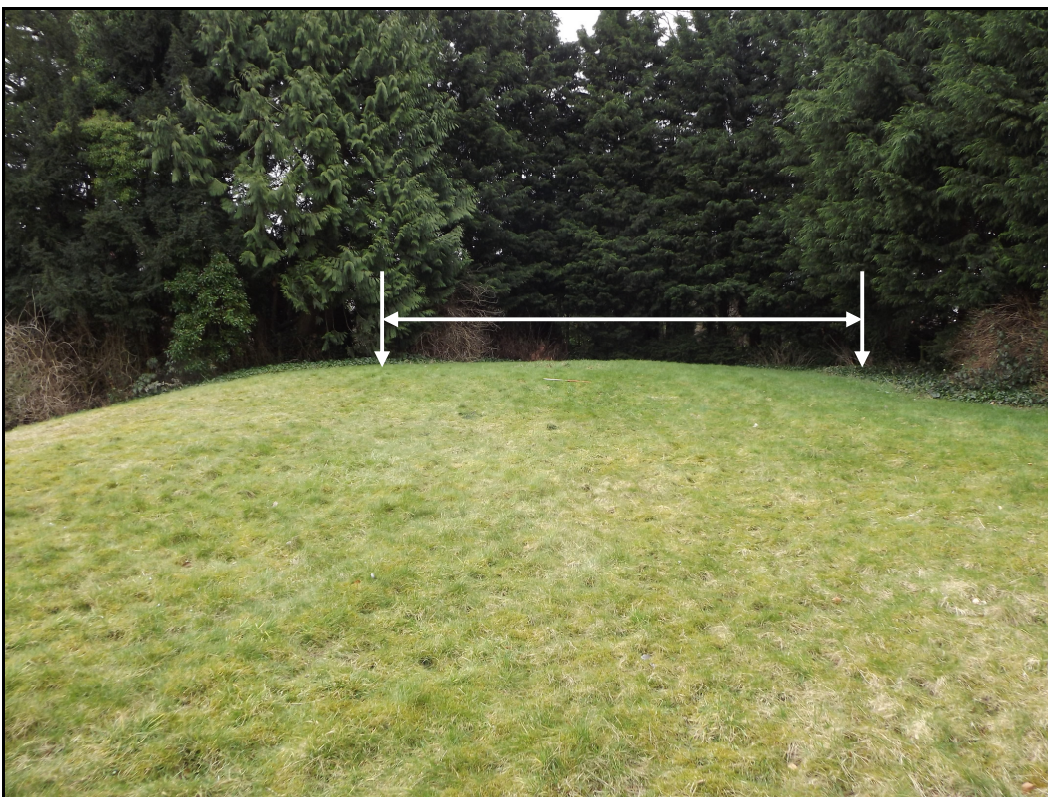
Plate 3. Top of building platform for Hope House, scale 1m looking south, showing area of probable buried remains

- 5.4 The site inspection recorded extensive evidence for the below ground survival of the remains of 'Hope House' towards the southern end of the site. This was in the form of a building platform to the east of Place Road which retained a distinctive, low mound. This appears to be in the location of 'Hope House' and probably represents demolition debris or similar remains (Plate 3).

- 7.2 Depending upon the extent and nature of the ground disturbance for the development (e.g. raft or strip foundations) along with associated services and any landscaping, there may be a low potential to encounter archaeological remains. Therefore, due to the large area of the site, it is recommended that an archaeological watching brief is considered for at least the initial site strip and any ground reduction. If no significant archaeological remains are encountered during this phase of the works then the remaining works would not require monitoring.

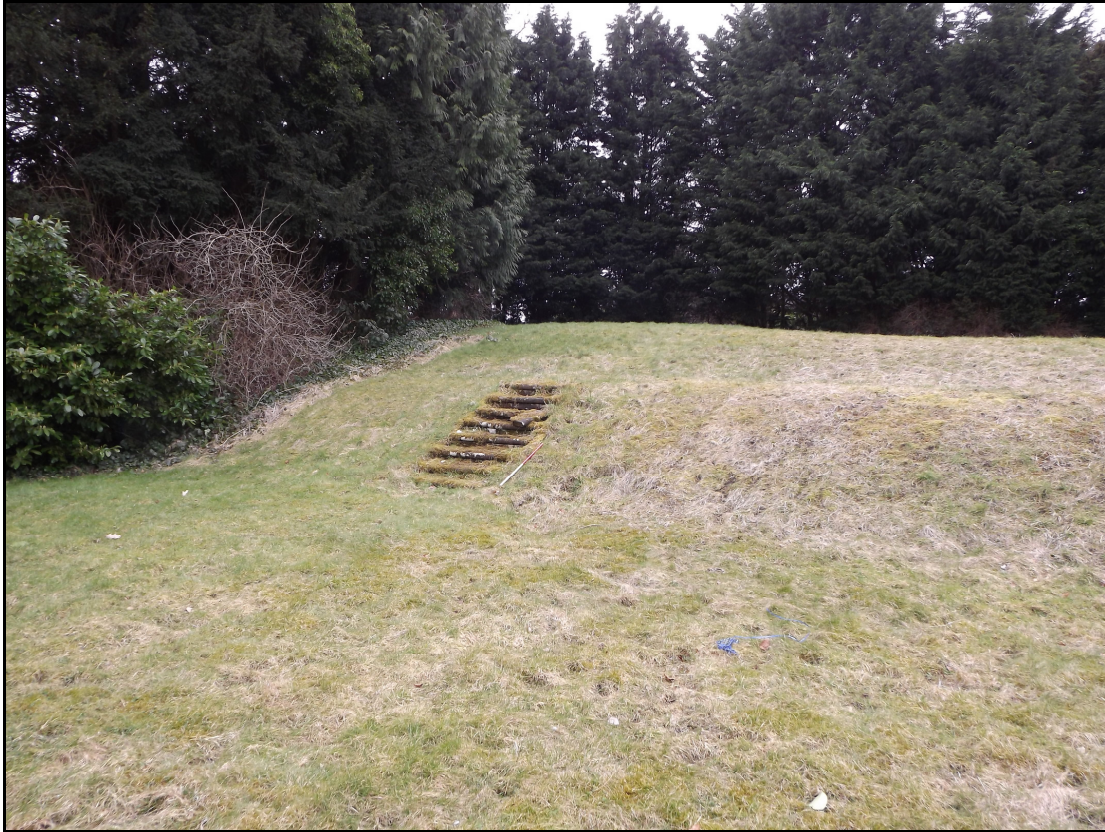
Plate 4. Stone steps leading down from 'Hope House', scale 1m, looking south-west

- 5.5 The eastern end of the building platform retained the remains of a set of stone steps which would have formerly led down into a garden area (Plate 4). The historic mapping shows a small building in this area but due to dense vegetation this area could not be investigated.
- 5.6 On the northern edge of the building platform two small areas of disturbance were noted. These both appear to be as a result of the ground settling into buried; stone built structures (Plate 5). It is possible that these are the remains of cellars or similar associated with 'Hope House'.

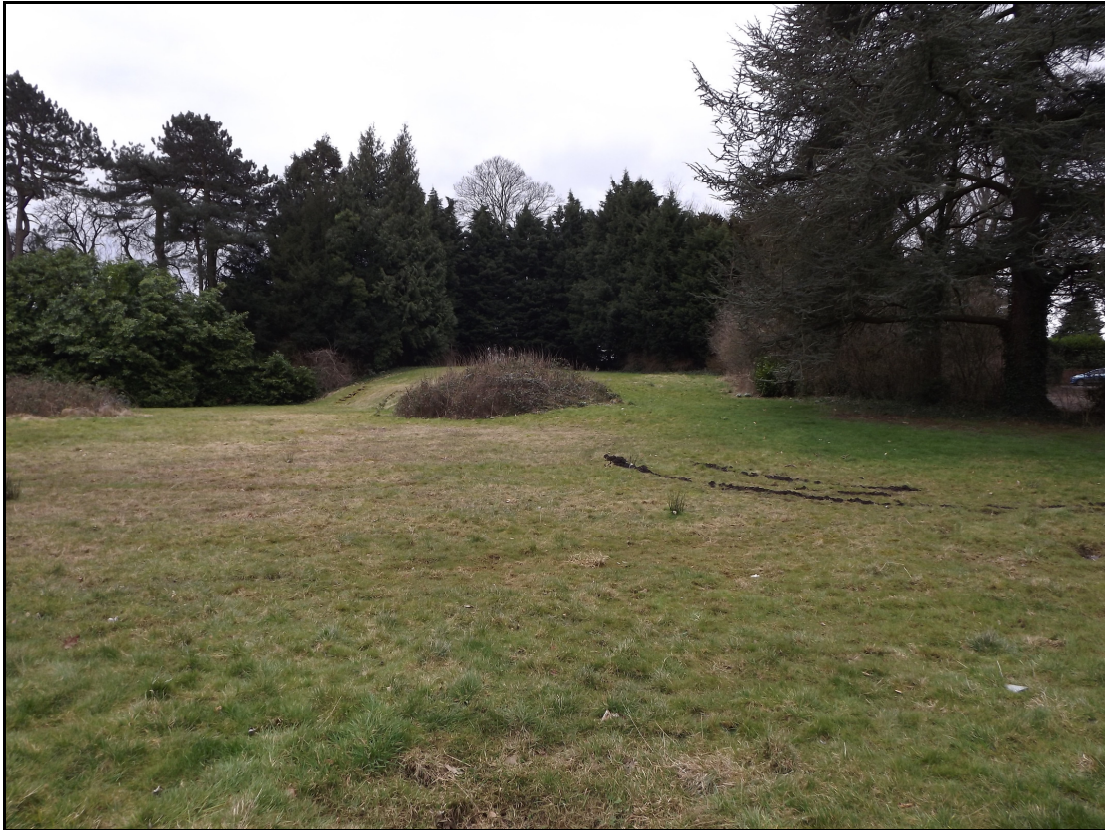
Plate 6. General view looking south of the 'Hope House' building platform.

- 5.7 Overall the site inspection only noted various changes in levels and elements of landscaping which all appear to be associated with the grounds and gardens of both 'Hope House' and 'Red House'. From the visual inspection there did not appear to be any particular features that could be considered indicative of a potential for buried archaeology.
