**Eskdale Park  
Larpool Lane  
Whitby  
North Yorkshire**

**NZ 9012 9045  
11/00213/FL  
MAP 5.17.2013**

**Archaeological Evaluation by Trial Trenching**

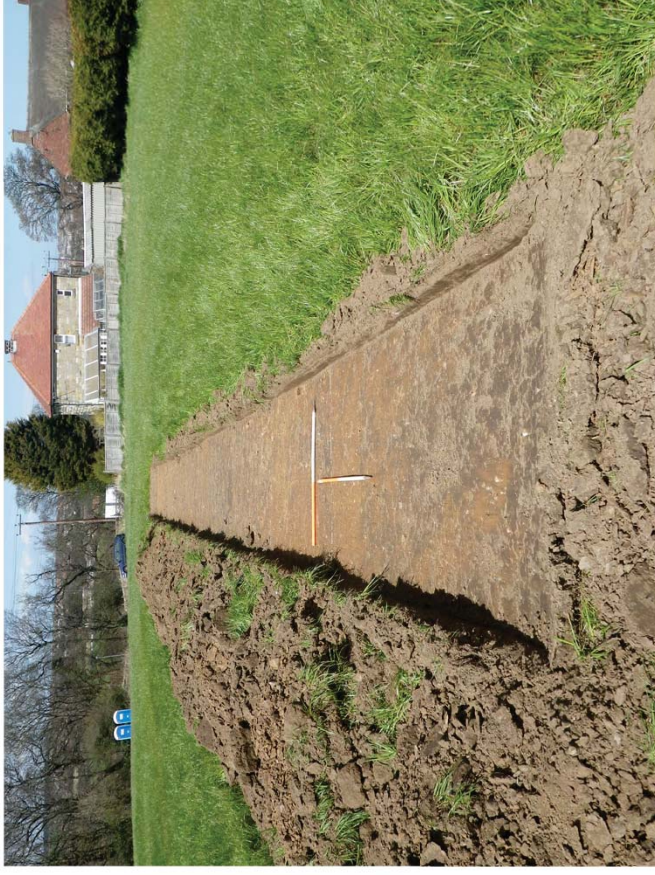
Plate 8. Evaluation Trench 1. Facing North.

- 6.1.1 There were no archaeological features noted in Evaluation Trench 1. Existing ground level was at a height of 58.10m AOD – 58.40m AOD. The topsoil was c. 0.23m deep, and was a clay loam (context 1001). Natural Clay was revealed in the base of the trench at depths between 57.87m AOD and 58.15m AOD.

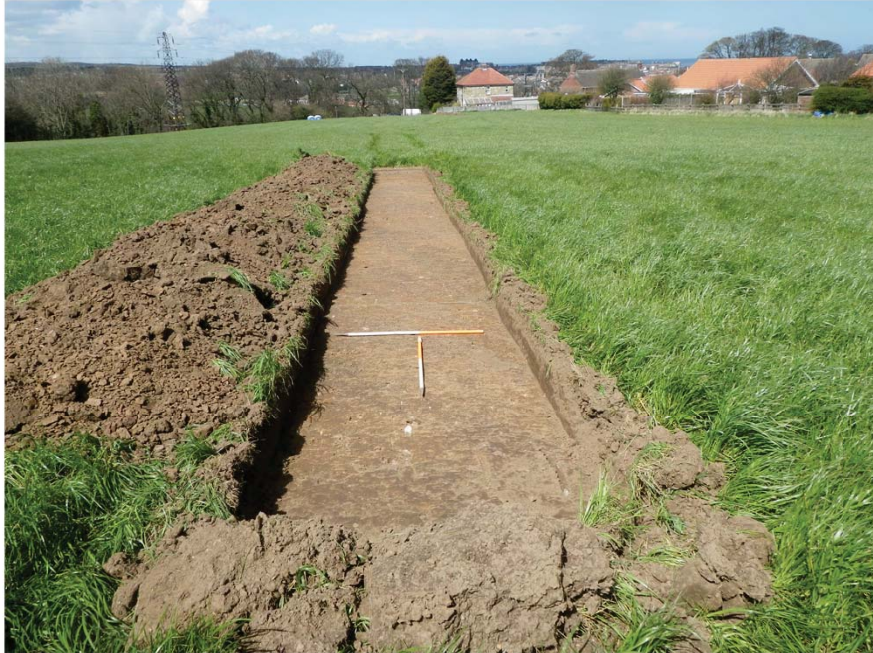
Plate 9. Evaluation Trench 2. Facing North.

- 6.2.1 No archaeological activity was revealed in Evaluation Trench 2, Existing ground level was at a height of between 62.43m AOD and 63.07m AOD. The topsoil deposit (context 2001) was 0.25m deep and was a clay loam. Natural clay was encountered in the base of Evaluation Trench 2 at a depths between 62.18m AOD and 62.82m AOD.

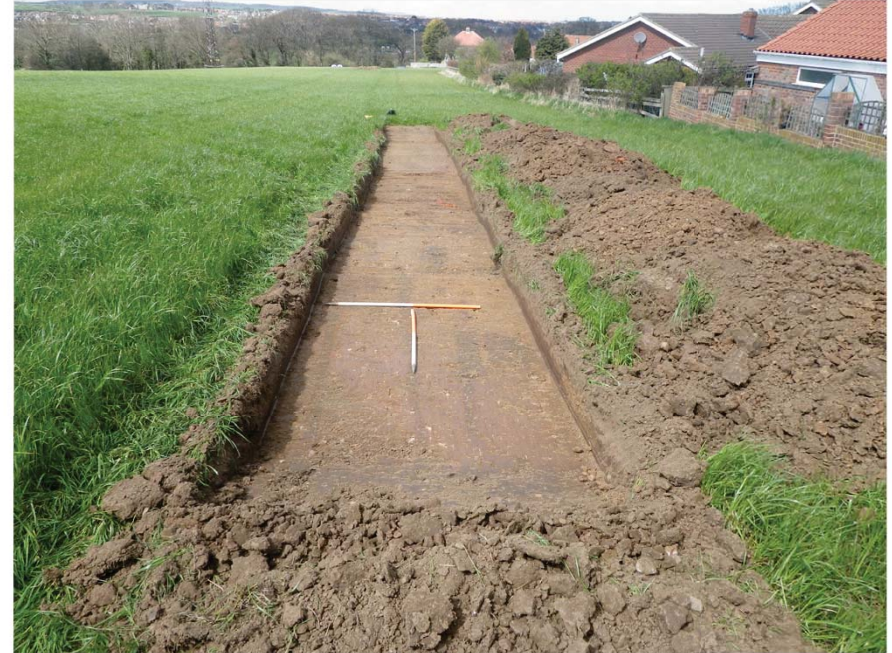
Plate 10. Evaluation Trench 3. Facing North-west.

- 6.3.1 No archaeological activity was revealed in Evaluation Trench 3. Existing ground level was at a height of between 64.00m AOD and 64.67m AOD. The topsoil deposit was c. 0.25m deep and was a clay loam (context 3001). A modern land drain aligned east-west was encountered in the centre of this trench. Natural clay was encountered

in the base of Evaluation Trench 3 at a depth of circa 63.75m AOD and 64.42m AOD.

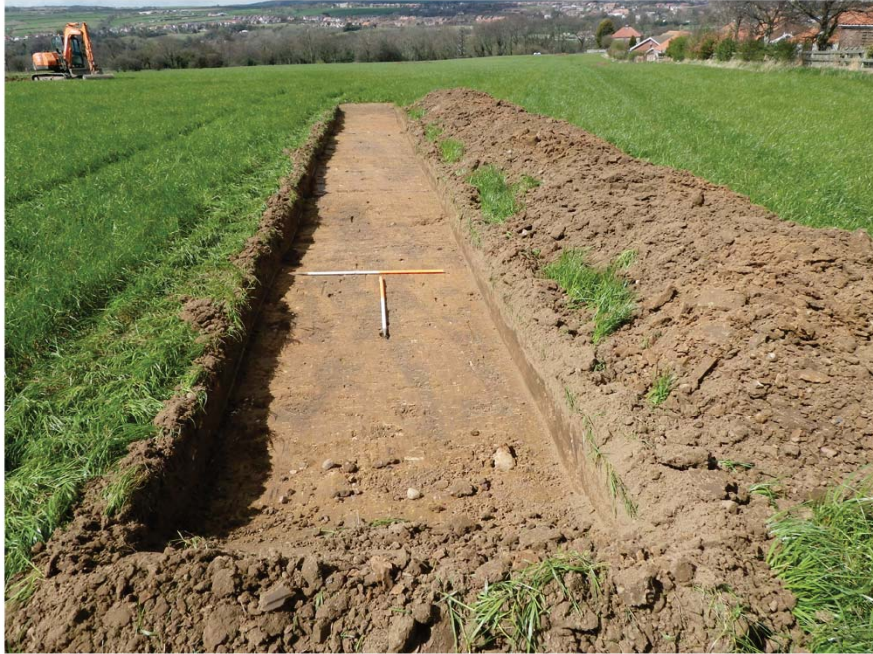
Plate 11. Evaluation Trench 4. Facing West.

6.4.1 No archaeological activity was revealed in Evaluation Trench 4. Existing ground level was at a height of between 71.22m AOD and 71.89m AOD. The topsoil deposit was c. 0.25m deep and was a clay loam (context 4001). Natural clay was encountered in the base of Evaluation Trench 4 at a depth of circa 70.95m AOD and 71.74m AOD.

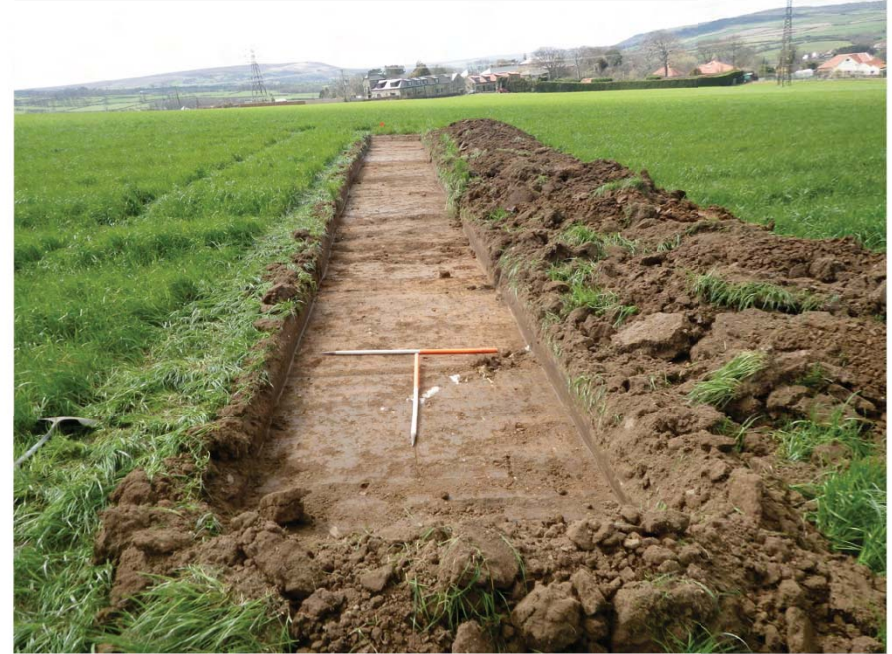
Plate 12. Evaluation Trench 5. Facing South.

6.5.1 No archaeological activity was revealed in Evaluation Trench 5, Existing ground level was at a height of between 11.76m AOD and 11.58m AOD. The topsoil deposit (context 5001) was 0.30m deep and was a sandy loam. A modern French drain aligned east-west was encountered in the east end of this trench. Natural clay was encountered in the base of Evaluation Trench 5 at a depths between 11.36m AOD and 11.20m AOD.

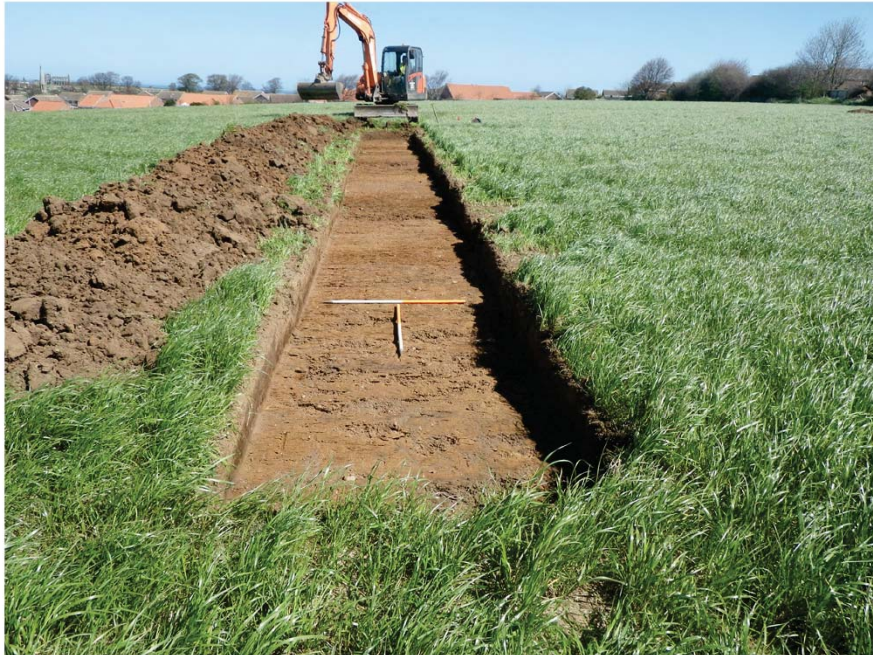
Plate 13. Evaluation Trench 6. Facing North.

6.6.1 No archaeological activity was revealed in Evaluation Trench 6, Existing ground level was at a height of between 69.17m AOD and 69.61m AOD. The topsoil deposit (context 6001) was 0.30m deep and was a clay loam. Natural clay was encountered in the base of Evaluation Trench 6 at a depths between 68.87m AOD and 69.35m AOD.

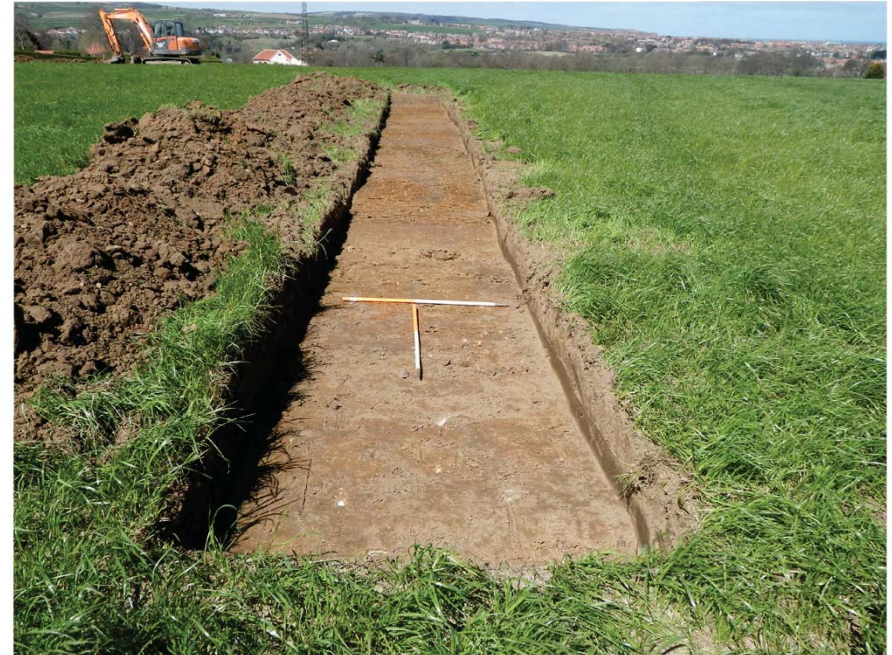
Plate 14. Evaluation Trench 7. Facing West.

6.7.1 No archaeological activity was revealed in Evaluation Trench 7, Existing ground level was at a height of between 73.04m AOD and 11.58m AOD. The topsoil deposit (context 7001) was 0.30m deep and was a clay loam. Natural clay was encountered in the base of Evaluation Trench 7 at a depths between 11.36m AOD and 11.20m AOD.

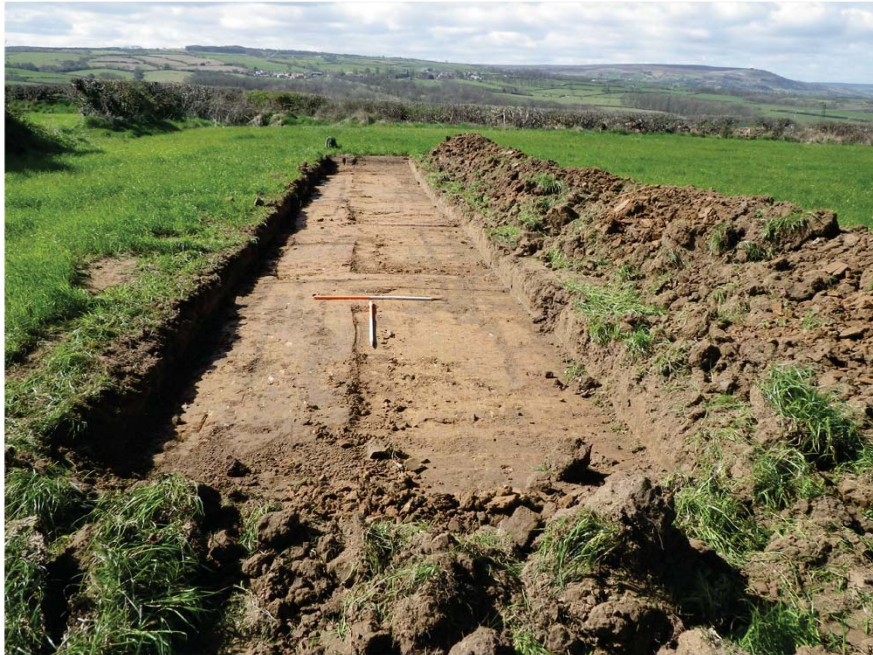
Plate 15. Evaluation Trench 8. Facing South.

6.8.1 No archaeological activity was revealed in Evaluation Trench 8, Existing ground level was at a height of between 72.20m AOD and 72.16m AOD. The topsoil deposit (context 8001) was 0.30m deep and was a clay loam. Natural clay was encountered in the base of Evaluation Trench 8 at a depths between 71.90m AOD and 71.96m AOD.

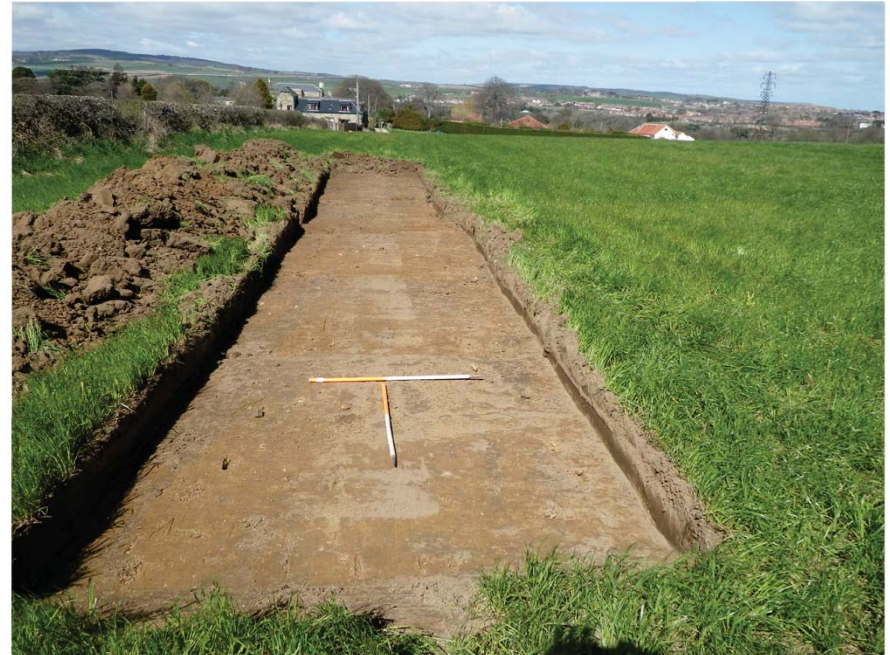
Plate 16. Evaluation Trench 9. Facing East.

6.9.1 No archaeological activity was revealed in Evaluation Trench 9, Existing ground level was at a height of between 70.65m AOD and 71.03m AOD. The topsoil deposit (context 9001) was 0.30m deep and was a clay loam. Natural clay was encountered in the base of Evaluation Trench 5 at a depths between 70.35m AOD and 70.73m AOD.

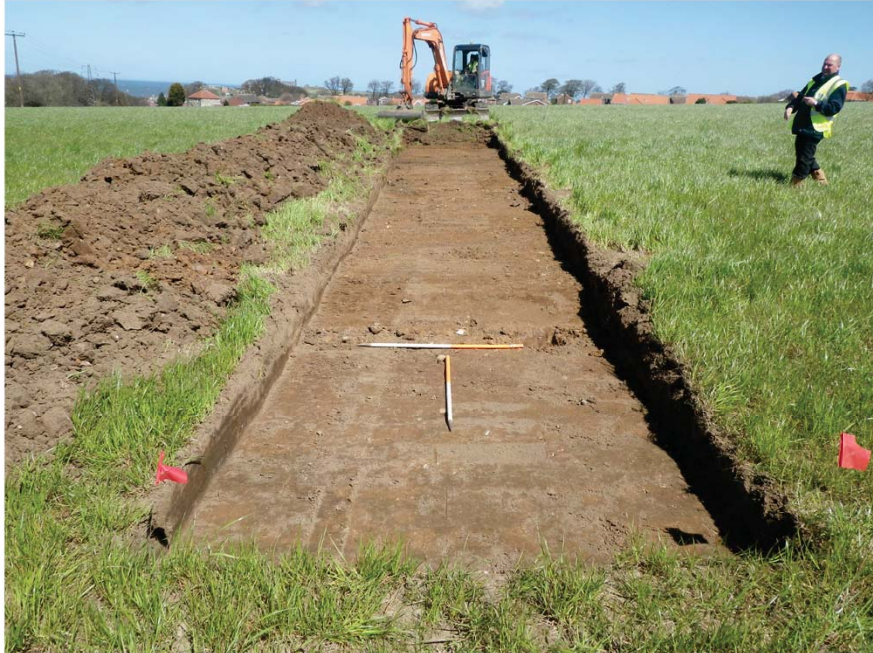
Plate 17. Evaluation Trench 10. Facing North.

6.10.1 No archaeological activity was revealed in Evaluation Trench 10, Existing ground level was at a height of between 66.71m AOD and 66.92m AOD. Two modern land drains, aligned east-west, were encountered in this trench. The topsoil deposit (context 10001) was 0.30m deep and was a clay loam. Natural clay was encountered in the base of Evaluation Trench 10 at a depths between 66.21m AOD and 66.62m AOD.

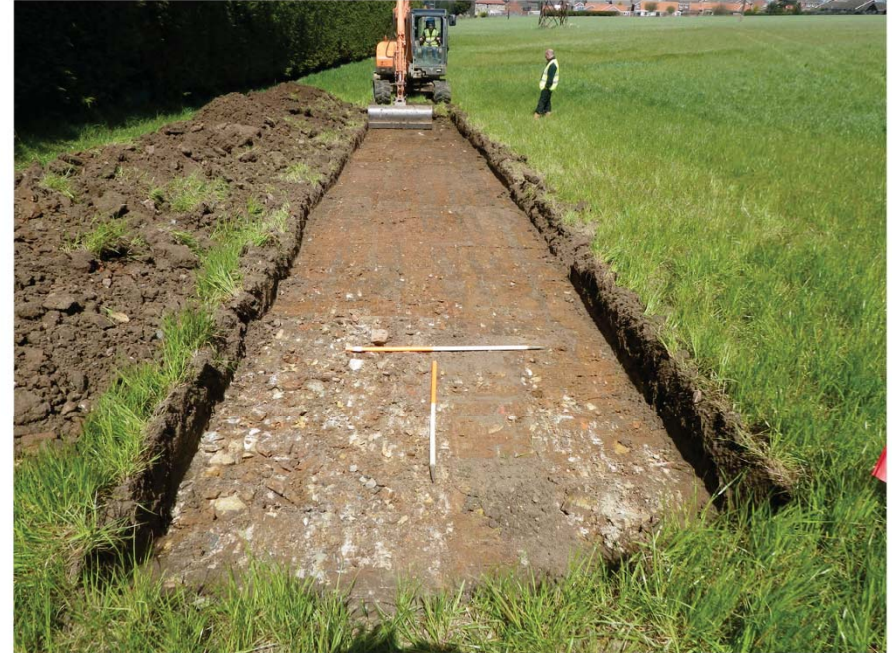
Plate 18. Evaluation Trench 11. Facing North.

6.11.1 No archaeological activity was revealed in Evaluation Trench 11, Existing ground level was at a height of between 63.38m AOD and 63.58m AOD. The topsoil deposit (context 11001) was 0.30m deep and was a clay loam. Natural clay was encountered in the base of Evaluation Trench 11 at a depths between 63.28m AOD and 63.28m AOD.
