DOBPARK LODGE, WESTON,  
NORTH YORKSHIRE

ARCHITECTURAL AND  
ARCHAEOLOGICAL SURVEY (PHASE 1)

Report no: 2011/406.R01  
Version: Final  
Date: April 2013  
Author: Shaun Richardson & Ed Dennison

Rural Estate Management Ltd  
21 Throstle Nest Close  
Otley  
West Yorkshire  
LS21 2RR

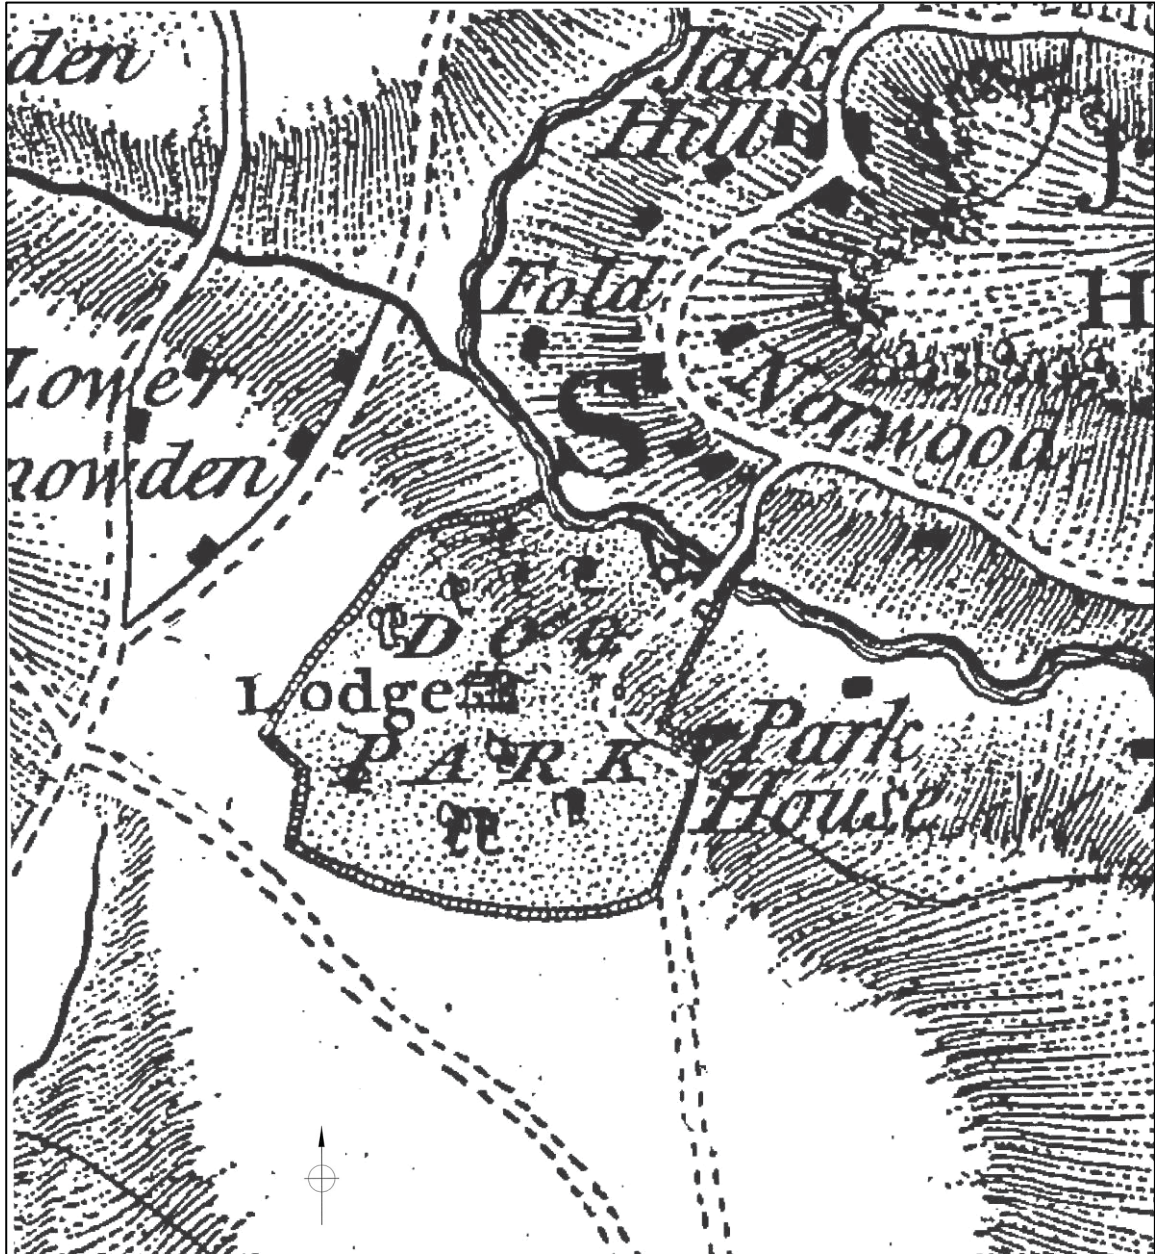
PROJECT		DOBPARK LODGE	
TITLE		JEFFERYS' 1775 MAP	
SCALE	NTS	DATE	APR 2013
EDAS		FIGURE	4

Section of Jefferys' 1775 map of Yorkshire (sheet 12).

- 3.5 In terms of the wider park, the lodge is placed in the approximate centre of the park as it is depicted in 1775 and 1781 (see figures 4 and 5). At the latter date, the enclosed parkland had a broadly sub-square plan form, the boundaries in the northern half being far more curvilinear than those to the southern half, which were generally very straight; comparison with modern maps suggests that the park had maximum dimensions of c.1.2km north-south by 1.1km east-west (see figure 6). It

later 18th century. The township boundary and the park boundary follow the beck as far as the river Washburn; the deep, steep-sided natural gully cut by the beck would have formed an effective pale line. Jefferys' depiction of the west side of the park does not include this projection and it is possible that he is showing an alignment to either the east or west. Depending on which line is taken, Midge Hall Farm lies in or out of the park (see figure 4). The later 1781 plans clearly show that the farm lies outside the park (see figure 5).

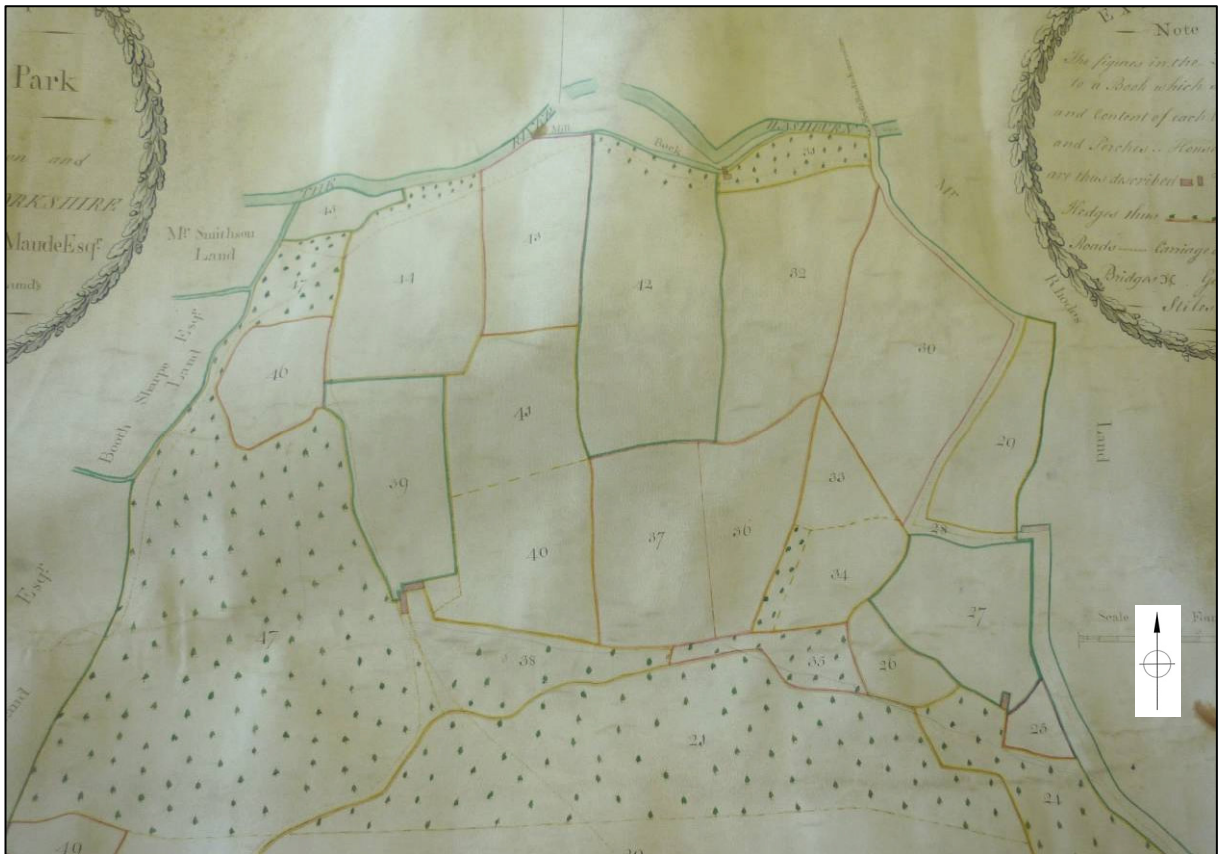
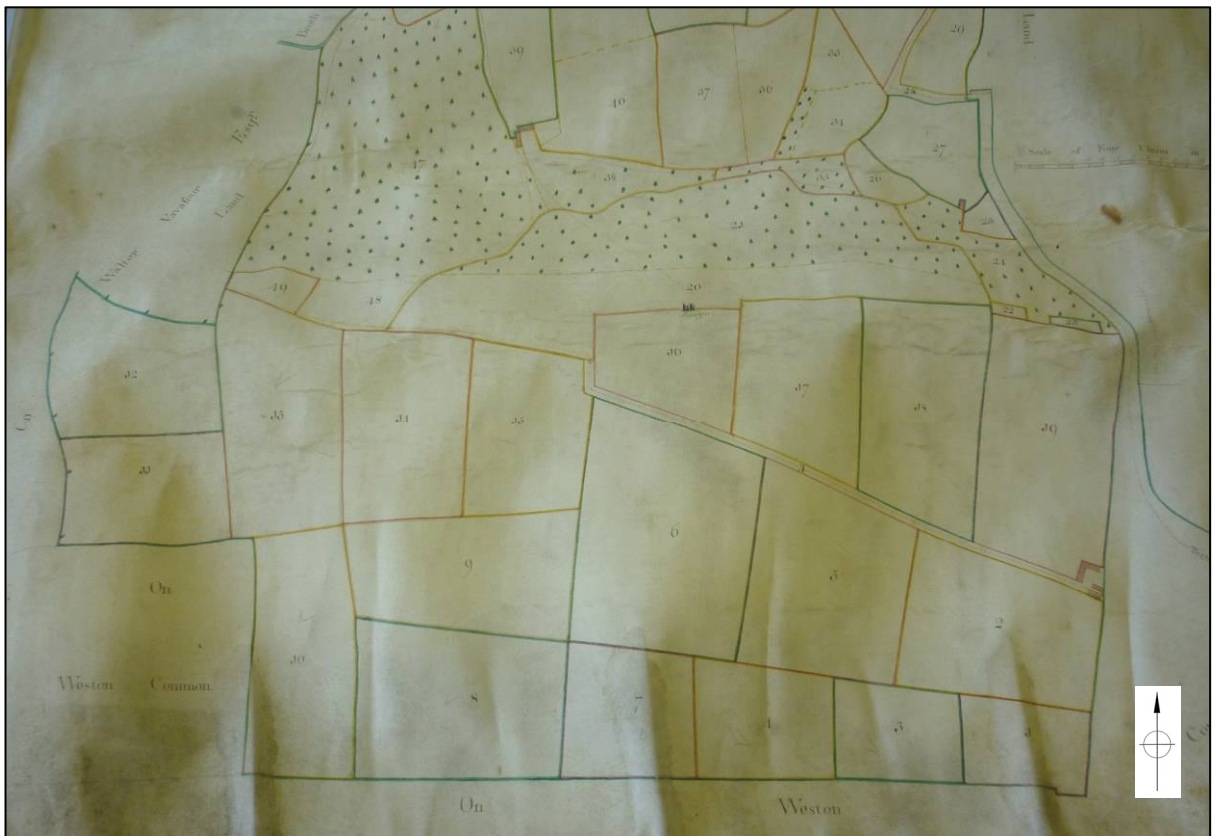
PROJECT		DOBPARK LODGE	
TITLE			
		1781 PLAN OF DOB PARK	
SCALE	NTS	DATE	APR 2013
EDAS		FIGURE	5

Source: 1781 Map of Dobb or Dog Park in the Lordship of Weston, property of Francis Maude, surveyed by Messrs Lunds (WYAS WYL 639/351). Note: different halves shown at different scales for clarity.

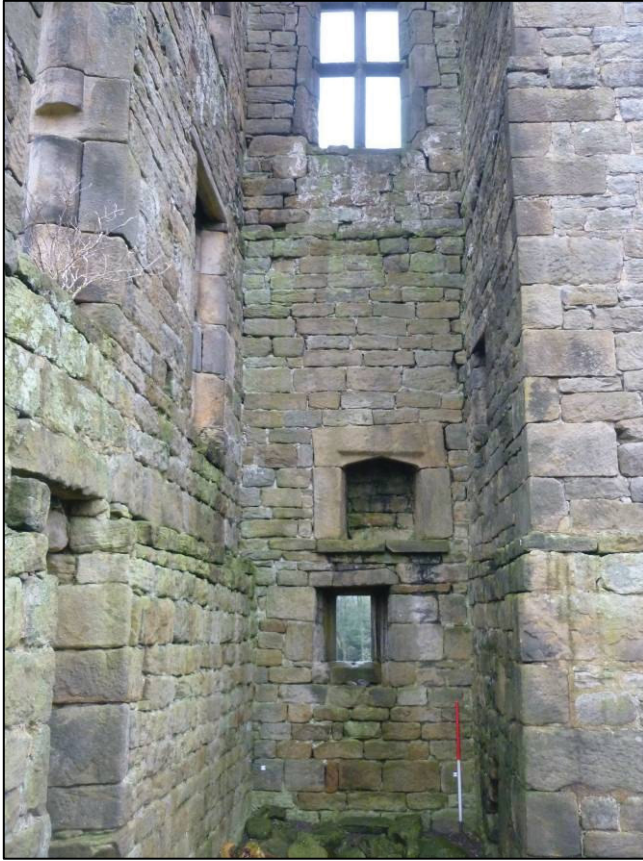
Plate 21: Elevation 25, looking NW (photo 2/539).

- 4.53 The west internal elevation comprises three co-joined wall faces (Elevations 25 to 27), essentially the former south-west corner of the building. At the south end, the west side (Elevation 25 - see plate 21) has a small window (W10) to the ground floor, and above, to the first floor, a fireplace (FP3) which has a Tudor arched head, chamfered lintel and chamfered jambs, which are stopped at approximately one-half of their height. The fireplace flue slopes backwards slightly as it rises but from ground level it is difficult to see how it avoids the windows on the floors above. At 5.50m above ground level, a slight set back to the wall face marks the position

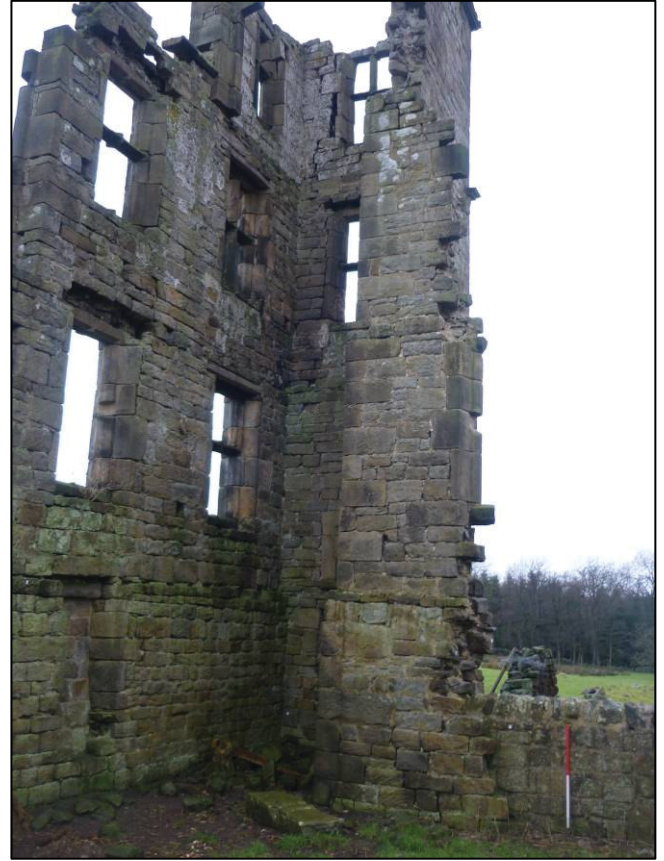
Plate 22: Elevations 24, 25 and 27, looking W (photo 2/537).

- 4.55 Where the elevation returns to the north (Elevation 27), only a short section survives to any height, and this contains the remains of the window (W8) described externally (Elevation 8) (see plate 22). The remainder of the elevation is formed by a low modern wall, incorporating a sheep creep with a timber lintel.

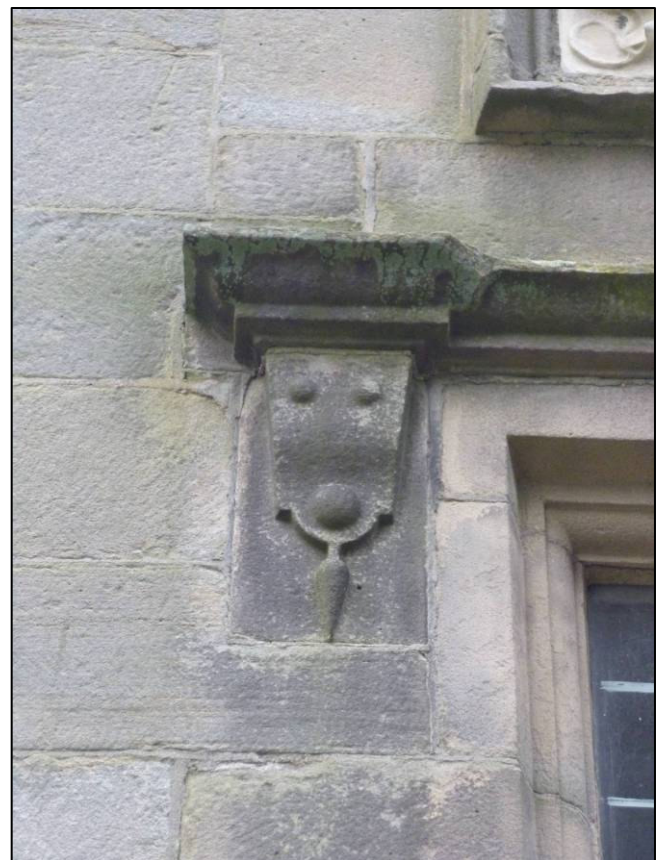
Plate 27: Weston Hall Banqueting House, first floor window detail on west elevation, looking E.
