**FORMER DAWKINS MOTORCYCLE GARAGE**

**BEDALE, NORTH YORKSHIRE**

**AN ARCHAEOLOGICAL WATCHING BRIEF**

**Planning Reference 12/00432/FUL**

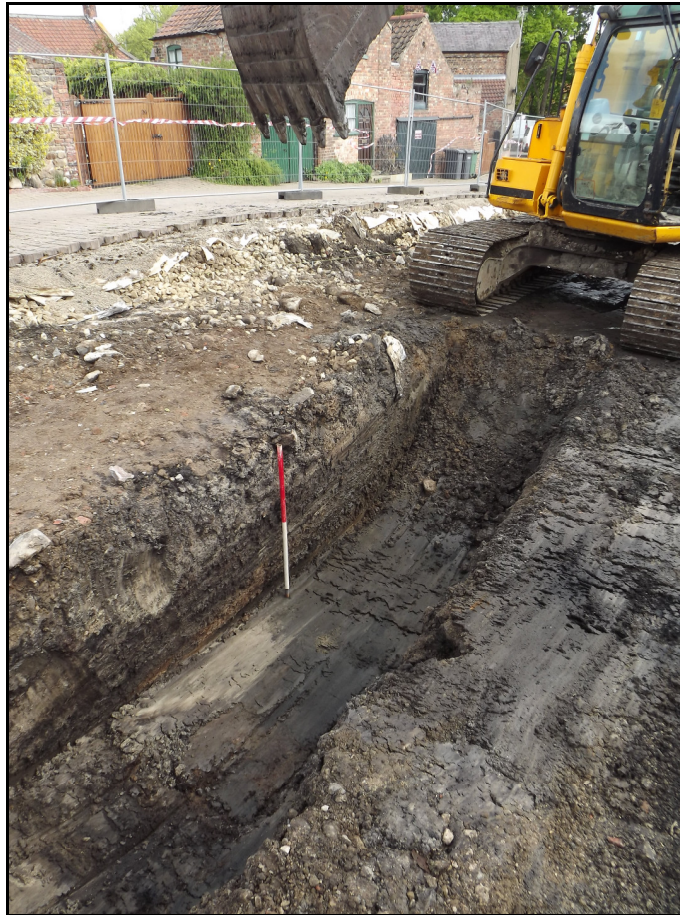
Plate 1. General view of peat deposit, looking north-east, scale 1m

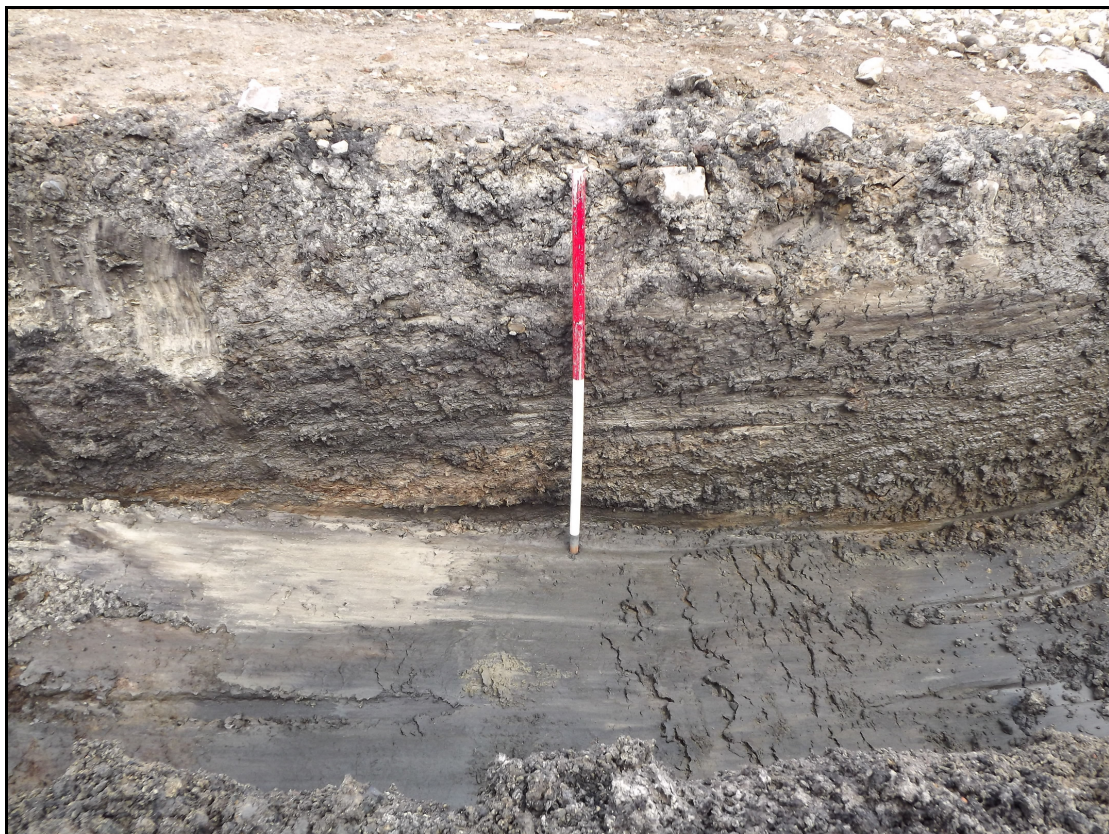
5.2 The peat deposit was found to be up to 1.1m thick in its centre (base at *c.*33.5mOD) and appeared to be the infill of a natural pond type feature. Due to the use of a raft foundation on this part of the site it was not possible to investigate the feature beyond the formation level of the raft. The peat itself was very fibrous with occasional thin lenses of fine, grey silt which appear to represent periodic flooding episodes. No artefactual material was recovered from within the peat though a small amount of 18/19<sup>th</sup> century material was observed on its surface, possibly derived from the deposit above. A sample of the peat was examined by John Carrot of Palaeoecological Research Services and found to contain very little material that could be subject to a more detailed analysis. This combined with its highly fibrous nature means that it was considered to be of a relatively modern origin and as such was not subject to any further analysis.

Plate 2. Peat deposit, looking north, scale 1m

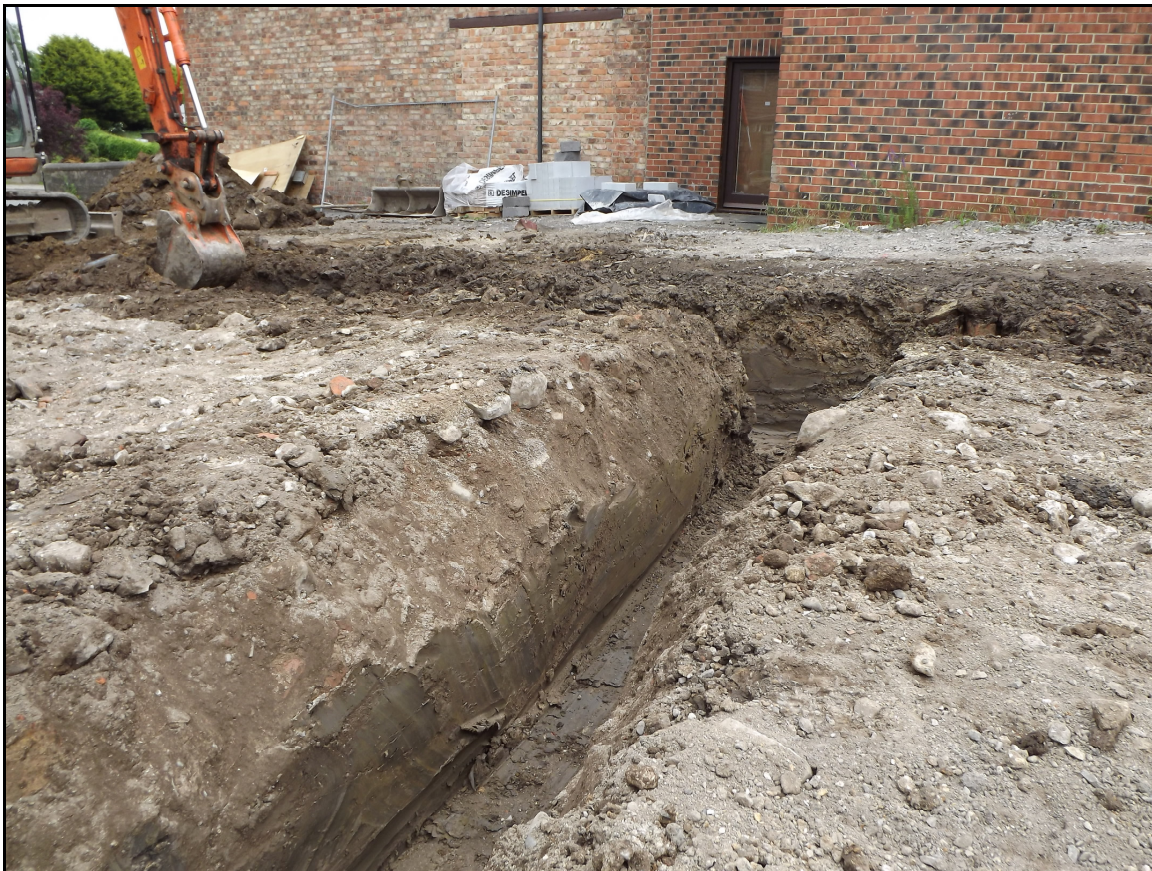
- 5.3 During the monitoring of the second set of foundations in the centre of the site it could be clearly seen that the overlying made ground covered the whole of the site and had been dumped directly onto the underlying natural clay stratigraphy. It could also be seen that the overlying made ground was much thinner at the eastern end of the site and was practically the modern ground level adjacent to the roadside. It was therefore considered, in consultation with the Heritage Section of NYCC, that it was highly unlikely that there were any archaeological remains in the remainder of the site. Therefore the watching brief was halted at this point with the caveat that should any possible features be encountered the project archaeologist would be contacted immediately.
- 5.4 No other archaeological features or artefacts were encountered during the ground works.

Plate 3. Made ground overlying natural clay, looking south-east
