# The Landscape Research Centre

Report covering an Archaeological Watching Brief undertaken ahead of  
the installation of two wind turbines at Woodhouse Farm, Flixton,  
North Yorkshire. August 2012

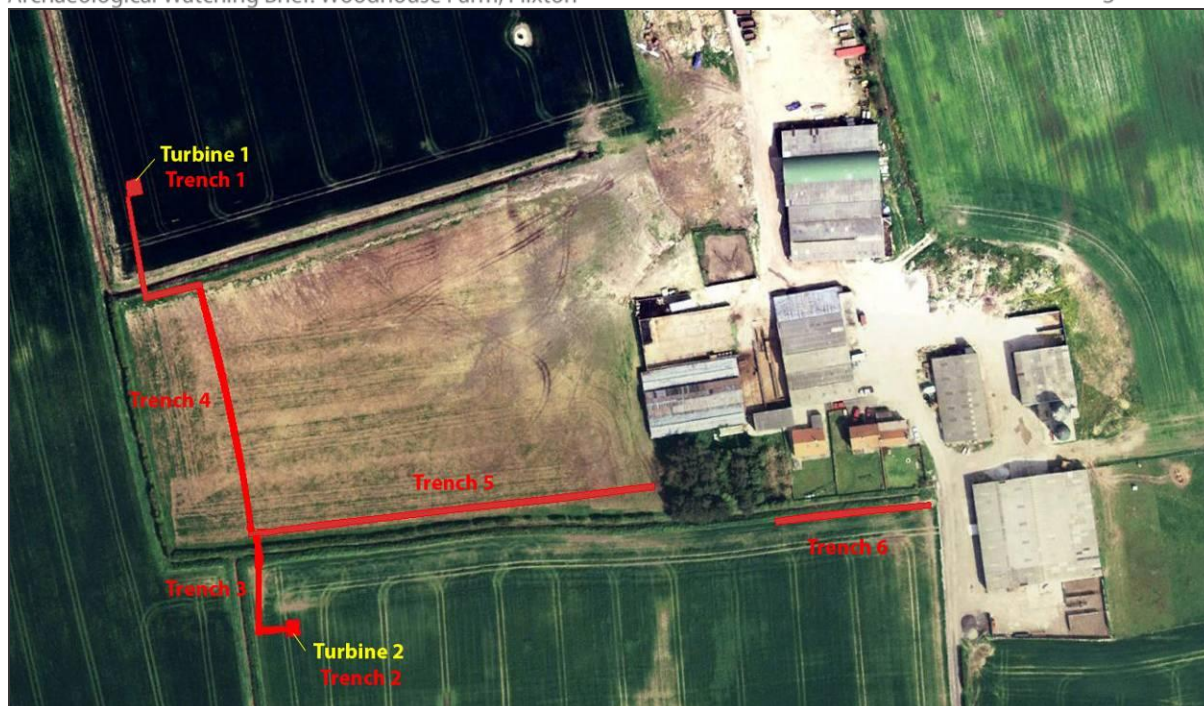
**Figure 3: Location of the two turbines and related cabling trenches**

A total of six trenches were excavated. Two trenches measuring 5m by 5m covered the area impacted by the turbines (trench 1 and 2), whereas four other trenches measuring 1.6m in width were excavated to cover the areas impacted by the cabling. The location of these areas is shown in Figure 3.

It was not possible to monitor the trench linking trenches 5 and 6 as it was cut through a small wooded area located to the south west of Woodhouse Farm. Due to the density of the vegetation a narrow trench was to be excavated using a mechanical mini excavator fitted with a 0.30m wide toothless bucket minimising any subsurface archaeological impact (Figure 3).

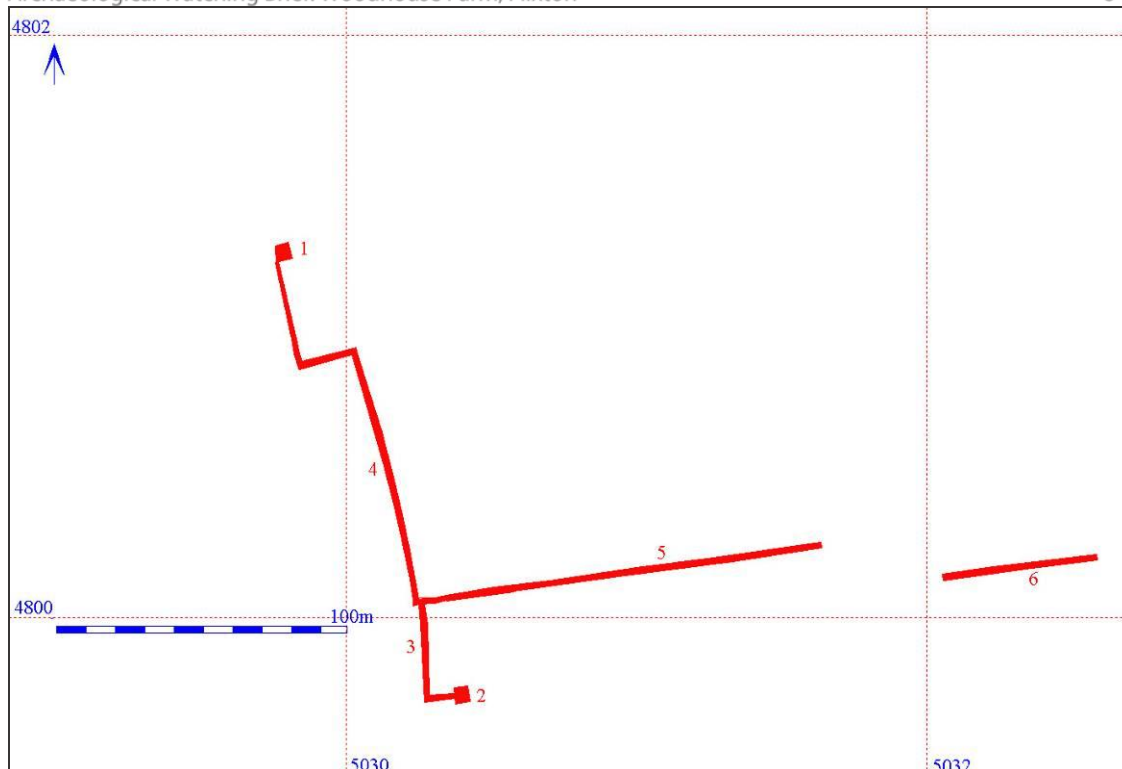
**Figure 4: Layout of the turbine areas (1 and 2), and related service trenches**

The area required for the positioning of the cable which links Turbine 1 and Turbine 2 was covered by trenches 3 and 4. These two trenches measuring about 200m in length and 1.5m in width were excavated to a depth of 0.40m (Figure 4).

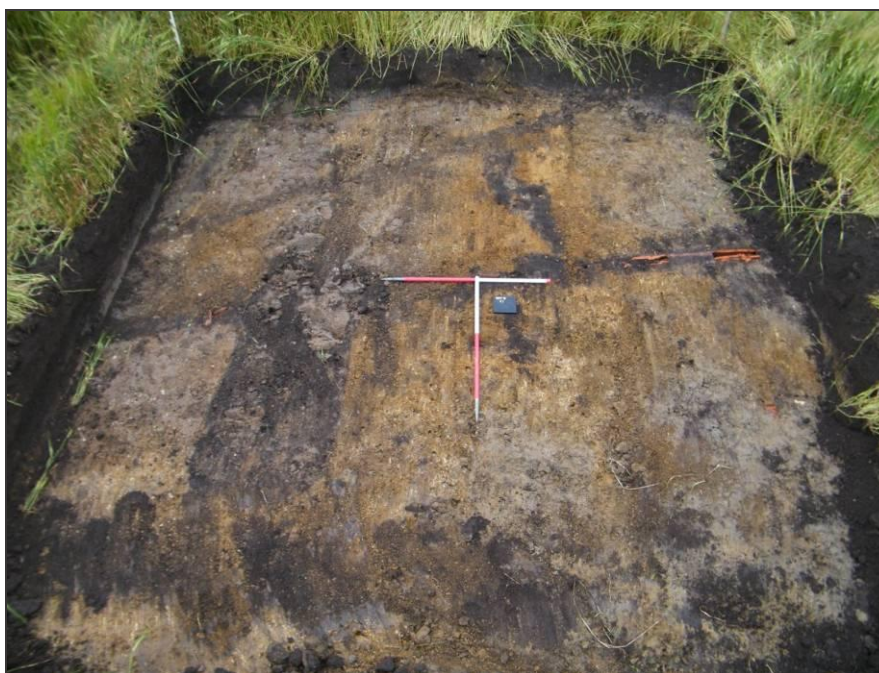
**Figure 5: Trench 1 (Turbine 1) area looking north**

Trench 1 measuring approximately 25m<sup>2</sup> and located at the north of the development it is on a flat arable land. This is to be the location of Turbine 1.

Pit 102, a sub-rectangular feature, measuring 0.80m in width and 2.10m in length, was seen in plan cutting one of the field drain, therefore making it of a very modern origin. This feature was backfilled by a mixture of topsoil and orange clay sandy natural deposit (context 101) which also contained un-decayed grass indicating that it was very recent perhaps a sondage designed to test the subsoil (Figure 5, Figure 7).

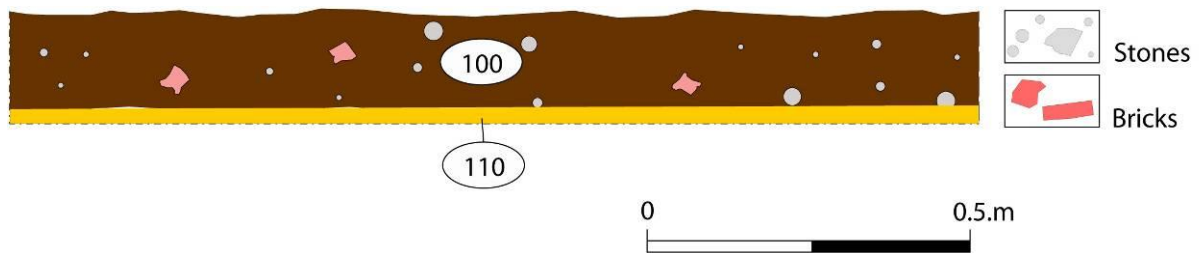
**Figure 6: East facing section, in trench 1 (Turbine 1)**

The upper deposit (top soil, context 100) a 0.40m thick layer of very dark brown sandy silt, containing sporadic fragments of bricks and small stones, has been interpreted as the

modern plough soil. The brick fragments may derive from night soiling or distribution of modern domestic waste in the fields.

The natural subsoil (110) was recorded at a depth of 0.40m below current ground level (Figure 7). It comprised a deposit of firm orange brown clay sandy material.

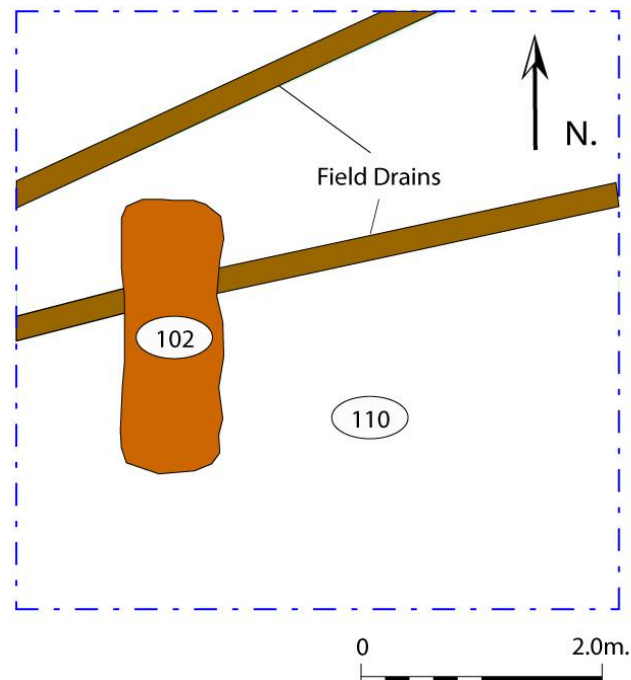
**Figure 7: Plan of trench 1**

The removal of top soil within trench 1 revealed the presence of three modern features; two field drains and an oval feature(102) which was very recent.

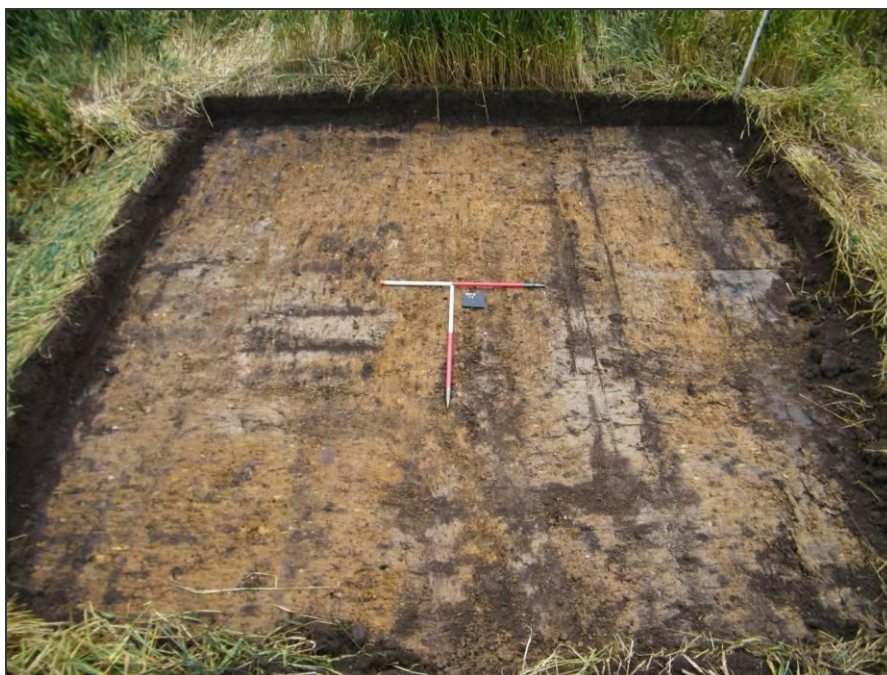
**Figure 8: Trench 2 (Turbine 2) area looking north**

In trench 2 the natural deposit (context 110) was reached at a depth of 0.40m immediately below the plough soil (context 100).

No archaeology was recorded within the limits of this trench.

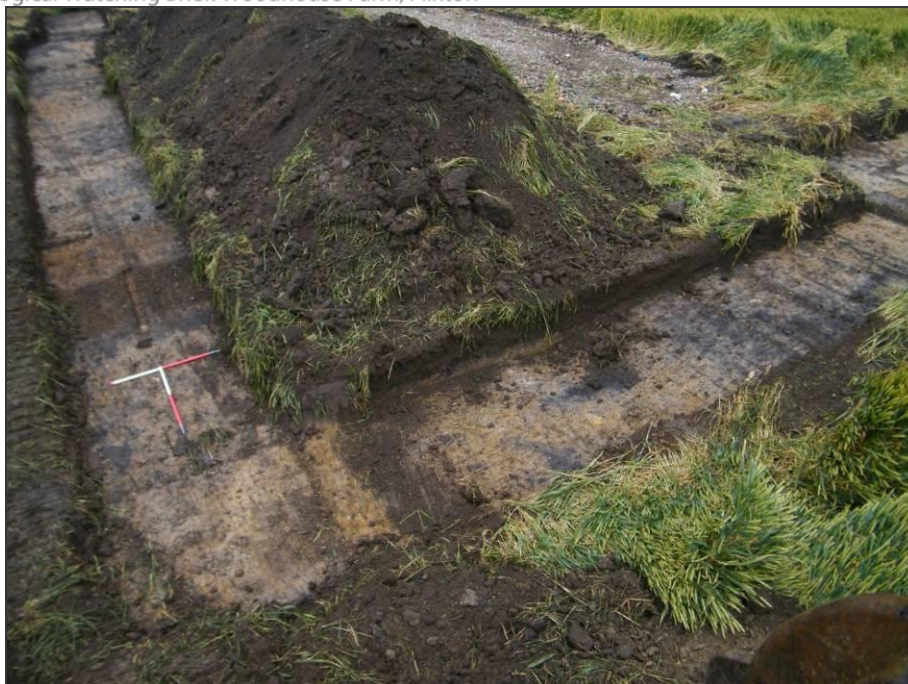
**Figure 9: Trench 3 looking north east**

The natural deposit (context 110) was directly sealed by the plough soil (context 100). Trenches 3 and 4 combined, covered an area of 382m<sup>2</sup>. The natural sandy clay subsoils were marked by modern plough scars showing that the subsoil had been truncated by plough damage and was cut by modern land drains. No peat deposits or other archaeological features were encountered within the trenches.

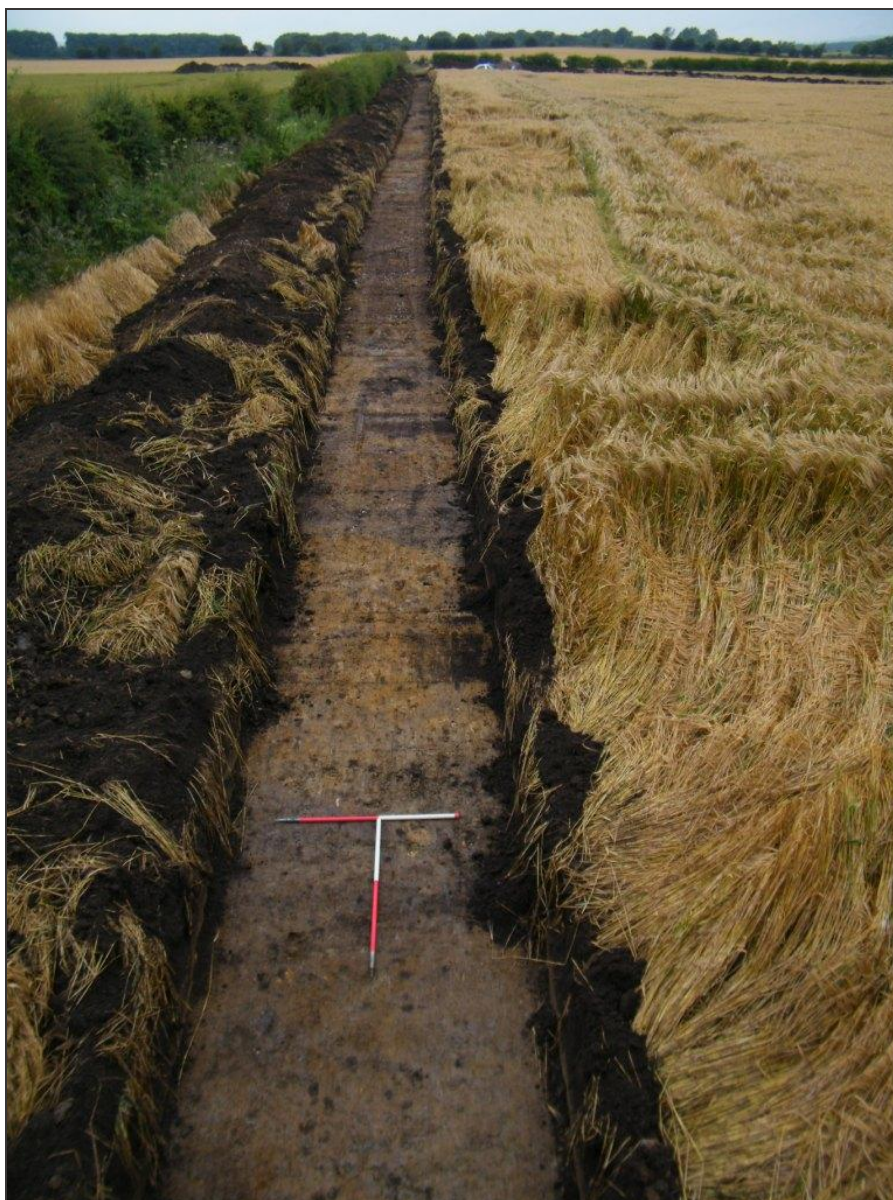
**Figure 11: Trench 5 looking west**

These service trenches running on an east to west direction will carry the cabling that links the turbines (via trenches 3 and 4) with the meter / transformer. Trenches 5 and 6 measuring 1.50m in width were excavated to a depth of 0.40m where the natural deposit (context 110) was exposed. Both trenches cover a combined area of 420m<sup>2</sup>.
