ARCHAEOLOGICAL INVESTIGATIONS AT
AYTON CASTLE, WEST AYTON,
NORTH YORKSHIRE
MARCH 2013

NGR SE 98765 85091
SAHS SITE CODE AC13

Scarborough Archaeological and Historical Society
Report 45

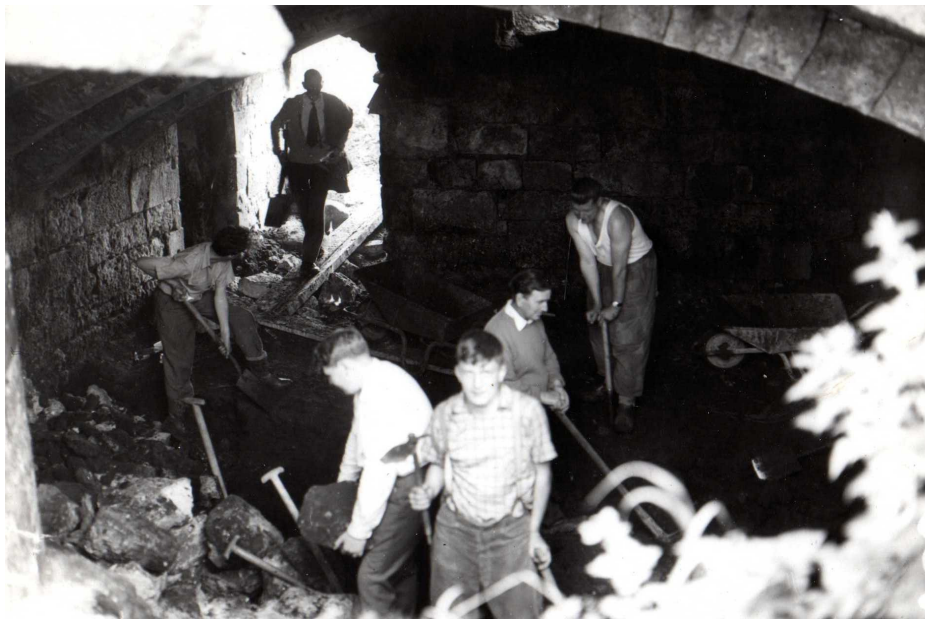
Figure: 1. Photograph dated 1958 from the SAHS archives where it is captioned 'cleaning out tons of cow dung from cellar or buttery'

- 2.1 The site has already been the focus of extensive study. Excavations were carried out by Scarborough & District Archaeological Society (as SAHS was then called) between 1958 and 1961. Although the Society cleared out the vaulted chamber it is thought that they did not excavate into the archaeology. Archaeological and architectural surveys were carried out by BHWB in 1996, by Ed Denison Associates in 2008 and a Conservation Management Plan prepared by Purcell, Miller, Tritton in 2008. It is therefore not proposed to rehearse the history and development of the site here. However all these studies helped to inform the archaeological investigations.

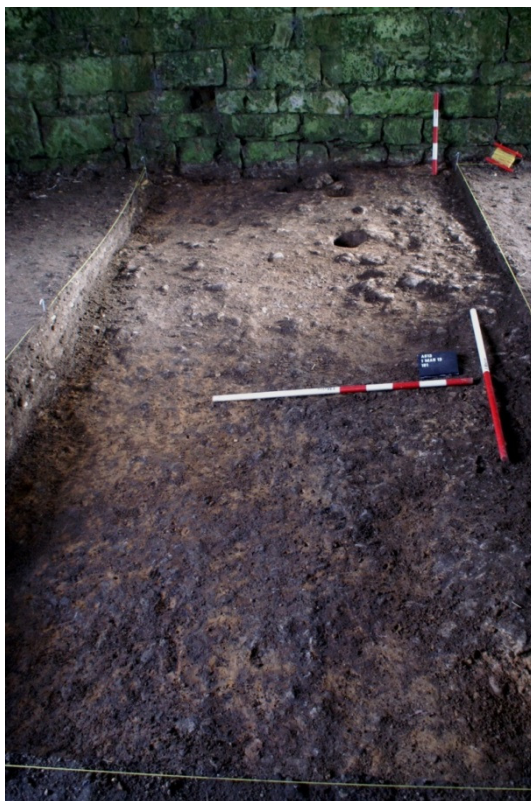
Figure 6:Trench 1 looking towards the cross wall. Natural in the foreground

- 4.7 It was noticed that the cross wall appeared to have been built directly off either the natural material or surface 103. In order to test this a small sondage was excavated in the south-east corner of the trench. The wall was confirmed to have been built directly off clay which was at this point much more stony than usual (Figure 7). The suggestion is put forward that surface 103 predates the building of the tower and that the tower was built directly off both the natural and this pre-existing surface resulting in the weight of the wall pushing the stones of the surface into the clay. This was possibly a yard associated with the earlier buildings.

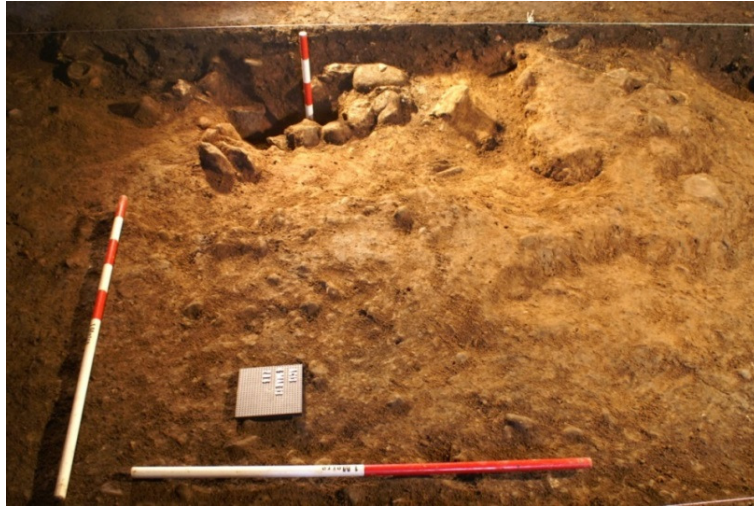
Figure 9: Detail of Trench 2 showing F208 cut into the natural

- 4.10 The natural clay was penetrated by three features. F207 was an oval cut 400mm long by 250mm wide and 300mm deep. Its dark loamy fill (202) contained two sherds of post 19th century pottery and the bones of a small animal – it may have been dug for the burial of these bones.
- 4.11 F208 was larger bowl shaped feature 800mm by 400mm by 320mm deep. It was flanked by a series of stones set vertically. Its fill, 205 was a dark ashy material which contained 2 sherds of modern bottle glass and 1 sherd of post 19th century pottery.

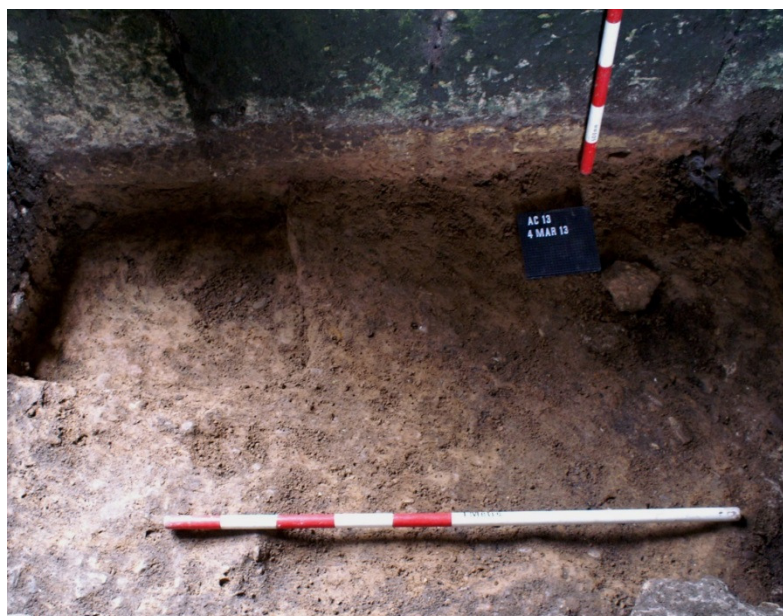
Figure 11: Trench 3 looking toward the cross wall

4.15 This small trench measuring 1.5 metres by 1.0 metre and was designed to test the foundations of the main wall and in particular whether there was a foundation cut, or whether, like the cross wall it was built directly off the natural clay. It was therefore excavated alongside the north-east wall of the chamber.

4.16 It was confirmed that as with the cross wall, there was no foundation cut and that the main outer wall was also built directly off the natural clay (Figure 11)

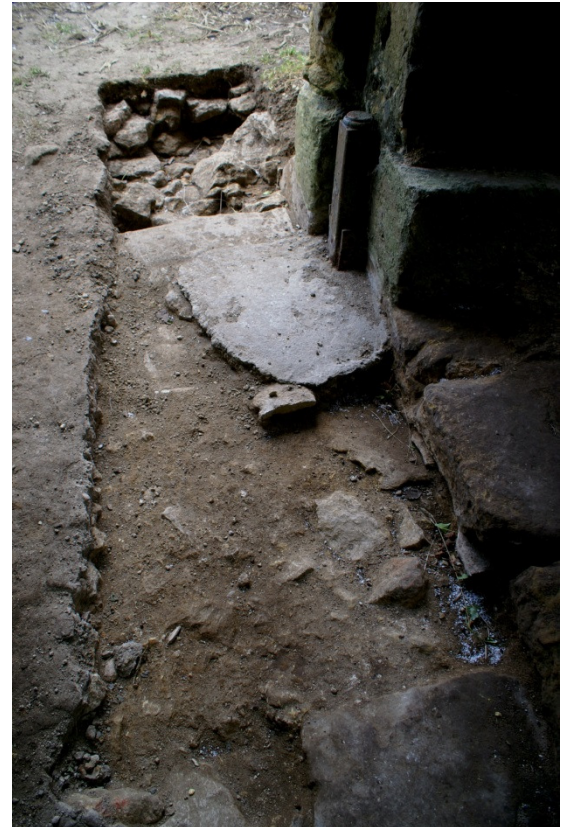
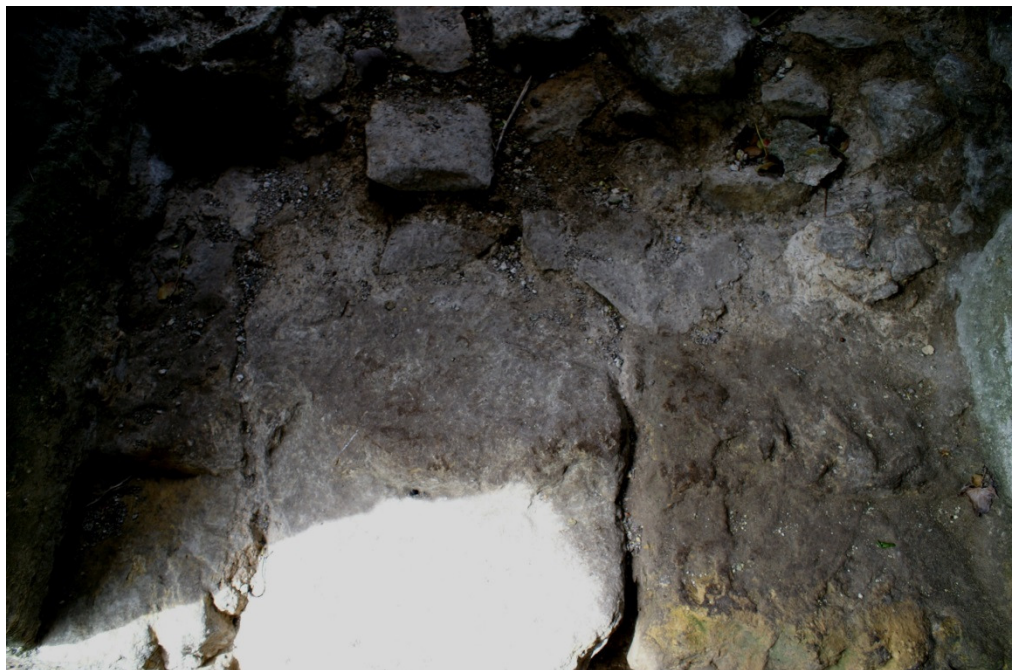
Annex 3 Photographs of the staircase

5.1 The staircase was cleared archaeologically of all debris and loose rubble. Annex 3 is a series of photographs showing the cleared staircase, the bottom step and the passage of the main entrance which was also cleared. No residual steps were found under the debris although the packing underneath the possible step positions was seen.
