**FISH POND WOOD & BEWERLEY GRANGE CHAPEL,
BEWERLEY, NIDDERDALE, NORTH YORKSHIRE**

HISTORIC ENVIRONMENT SURVEY

JB Archaeological Services

NIDDERDALE AONB

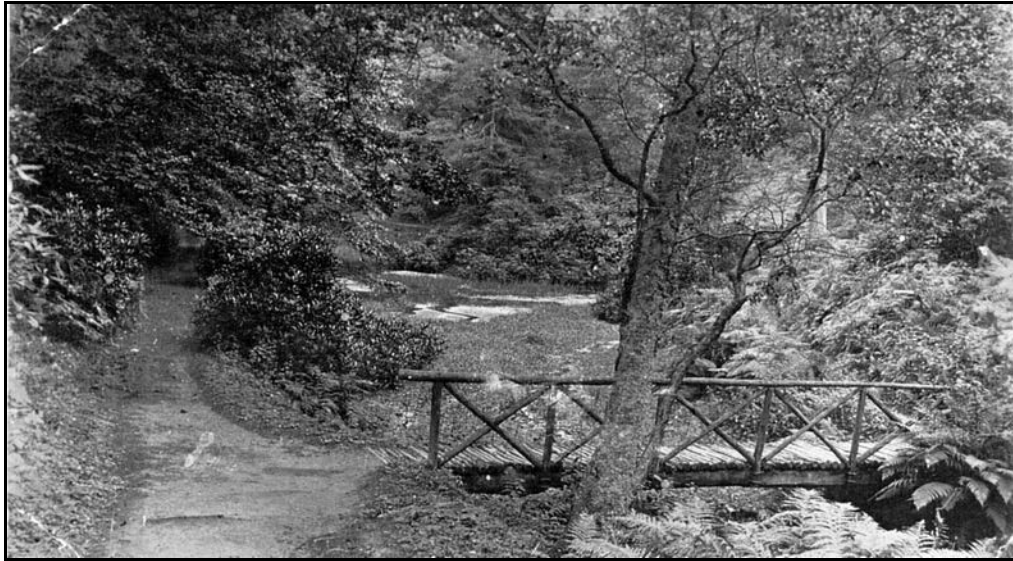
the northern end of the pond and from the site visit the wide, levelled path runs on the western side of the pond. Therefore, from the width of path on the western side of the water in the photograph below it must have been taken looking north. In addition the width of the water beyond the bridge is too great for it to be the simple inlet stream as it would have been according to the mapping. Hence the only other logical place for a footbridge would be to access the island. Interestingly, the site visit identified a discrete pile of stones on the pond edge opposite the approximate location of the island based on the historic mapping. It is possible that this could be the remains of the support of the end of the bridge described above.

Figure 4. Historic image of bridge, probably to the island, looking NNE

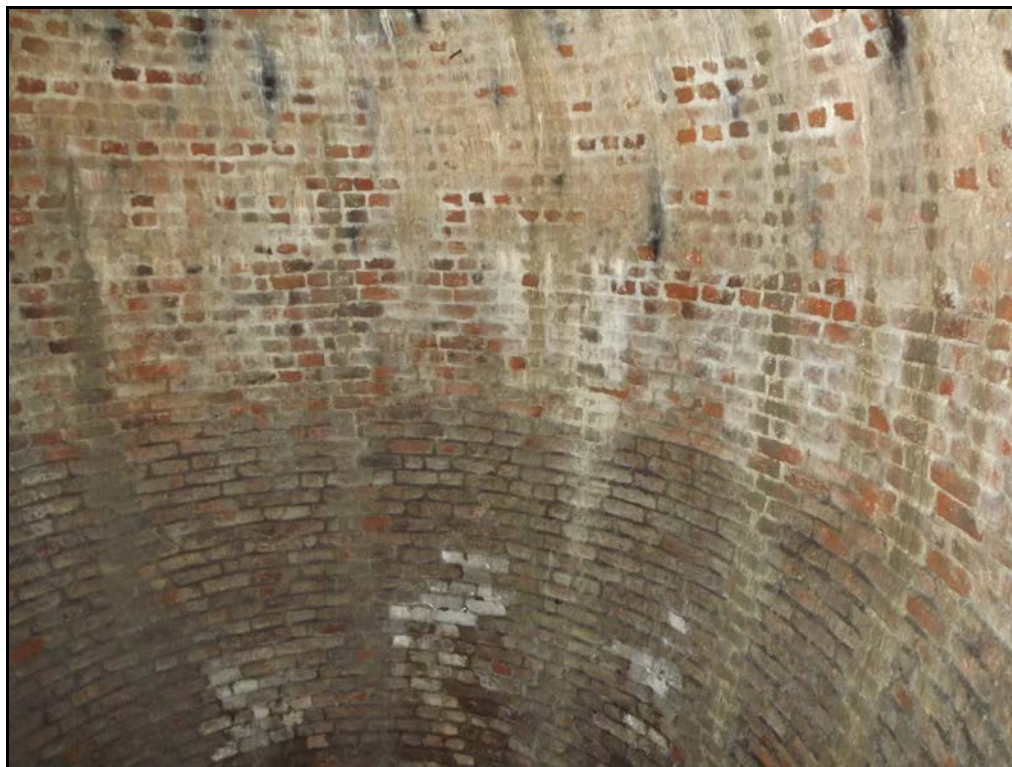
- 5.2 Ice houses first start to make an appearance in Britain around the 1660s for the provision of ice to help preserve perishable items and then from the later 18th century for the production of ice cream. The ice house is linked by a path marked on the historic OS to the pond, which would seem to show that (unsurprisingly) this was the main source of the ice for it. The ice house is a large brick built, tapering cylinder set deep into the ground (Figure 5) with a stone built access tunnel at ground level (Figure 6) on the southern side and adjacent to the path to the pond. The bricks are 230x100x60mm (9x4x2½ins) and appear to have been laid in a stretcher bond with an occasional header course. Bricks of this size are set by statute in 1725 (with various changes in size set in 1729 and 1776*). The ice-house at Raywell, East Yorkshire, with the same size bricks, has been dated to 1803 and the Skipsea brickworks (also in East Yorkshire) where manufacturing bricks of this size and were in operation by 1855 and closed by 1892 so the ice house could be either 18th or 19th century in date. However, it is suggested that bricks of this size or close to it typically range in date between 1687-1767. Overall this would seem to suggest that the elder John Yorke was responsible for the brick ice house, with his nephew possibly adding the stone entrance at a later date, perhaps to improve its setting (John Tibbles *pers comm*). The access to the ice house on the southern side could be considered to be slightly unusual as this would be facing into the sun and therefore allow warm air into the chamber. The rapid examination of the ice house noted that the stone access chamber appears to be butt joined to the main brick structure (Figure 7). This would seem to suggest that it could be a later addition – both from the fact it is stone and not brick built, the existence of a butt join, and that the two elements of construction are not keyed to each other. In addition the dressing on the masonry blocks varies, which could suggested that it has been re-used from more than one source.

* Brick fixed sizes by statutes:- 9"x4¼"x2½" – 1725; 8¾"x4⅛"x2½" – 1729; 8½"x4"x2½" - 1776
Bricks were only supposed to be a set size by law, an ice-house is an ideal situation for re-used and sub-standard bricks i.e. not visible above ground in most cases (J Tibbles *pers comm*).

Figure 5. Part of brick lining of ice house

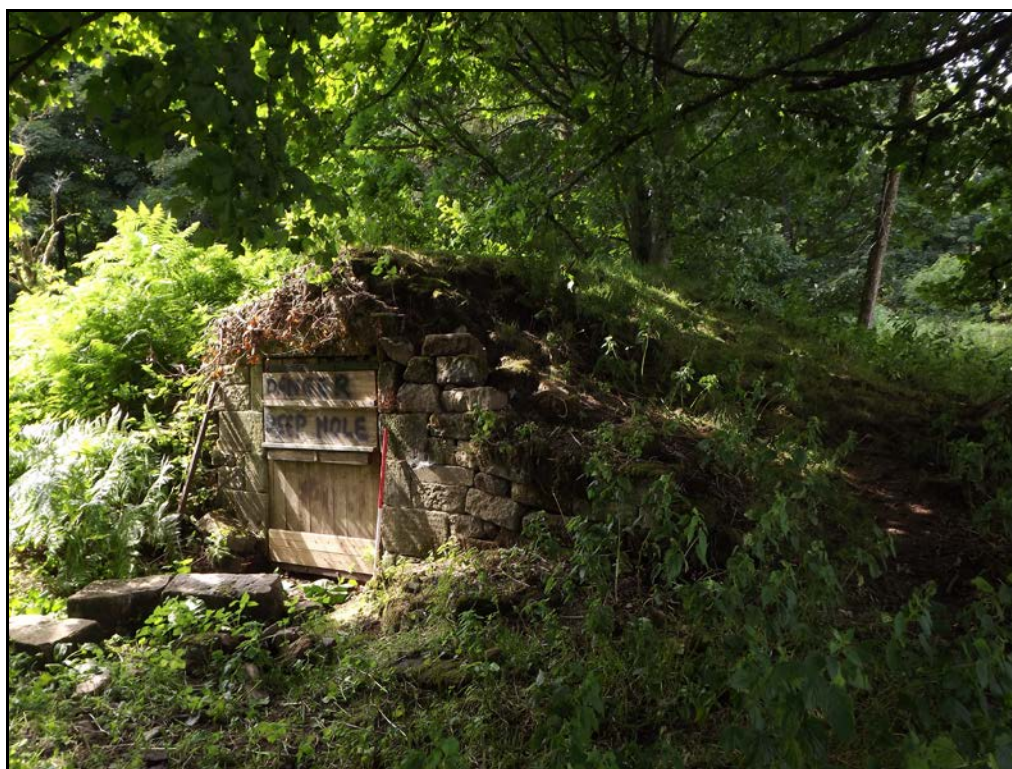
Figure 6. Stone built entrance to ice house, looking NW, scale 1m

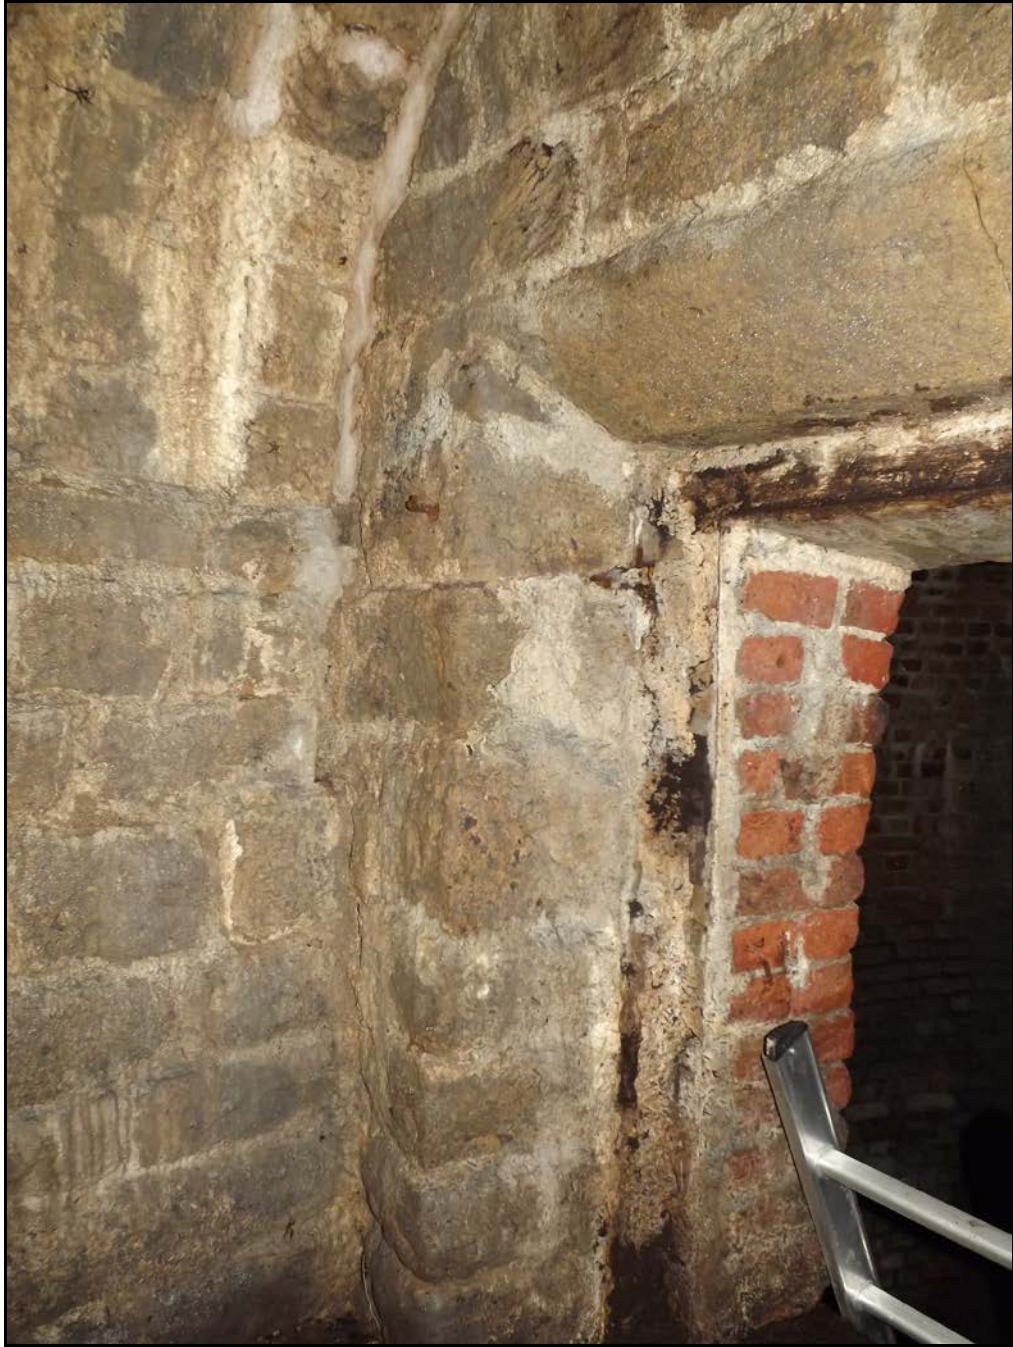
Figure 7. Detail of butt joint between stone and brick work, looking NW

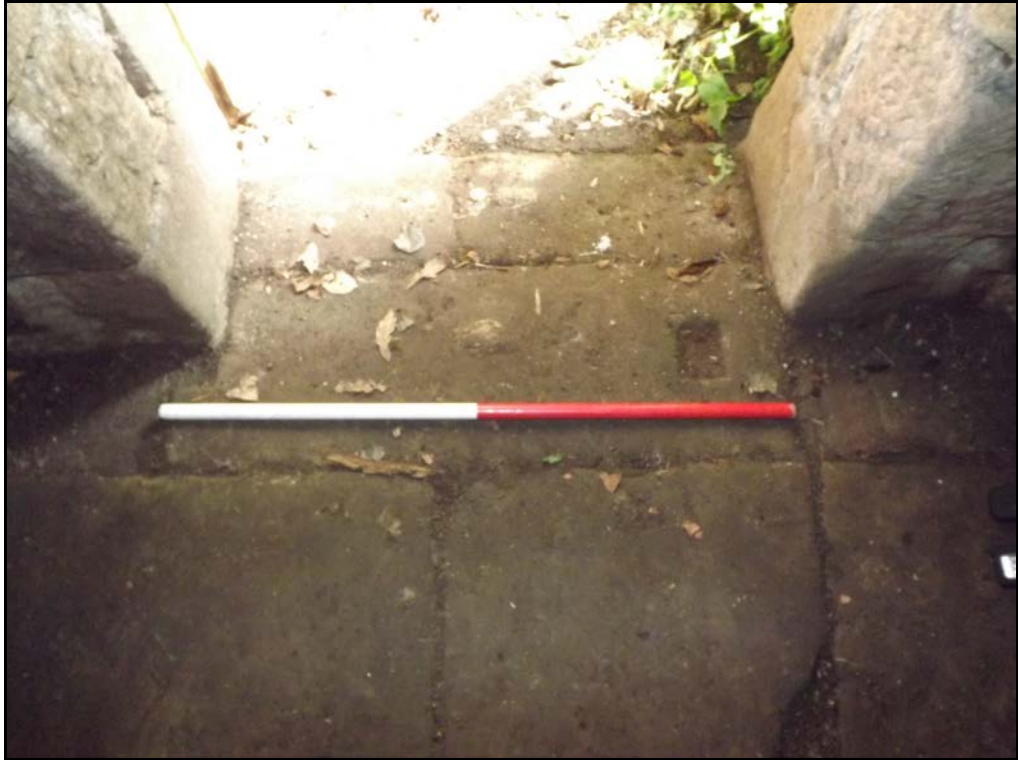
- 5.3 At the entrance to the stone chamber the flagged floor could be seen to have two square recesses cut into them – one on each side of the doorway (Figure 8). This suggests that there was once a different configuration of the doorway and/or door surround. This is further supported by an additional recess cut into the top right (southern) corner of the lintel of the doorway.

Figure 8. Remains of earlier door frame in flags, scale 1m

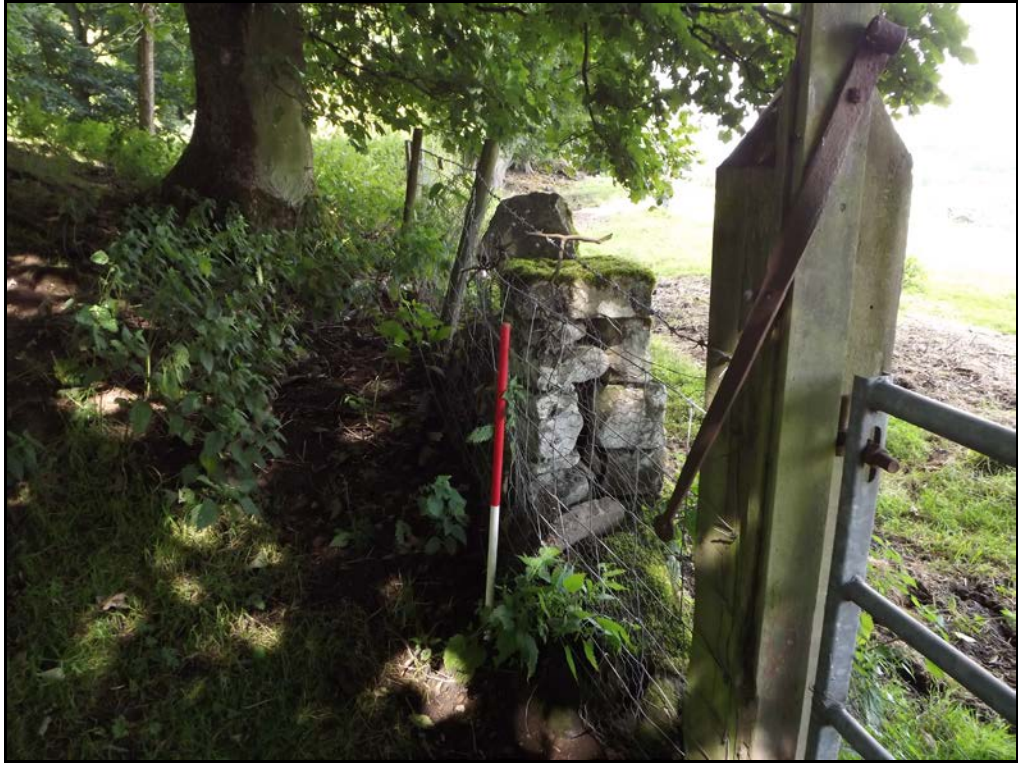
Figure 9. Possible wall end adjacent to ice house, note re-used iron strap hinge of possible 17/18th century date.

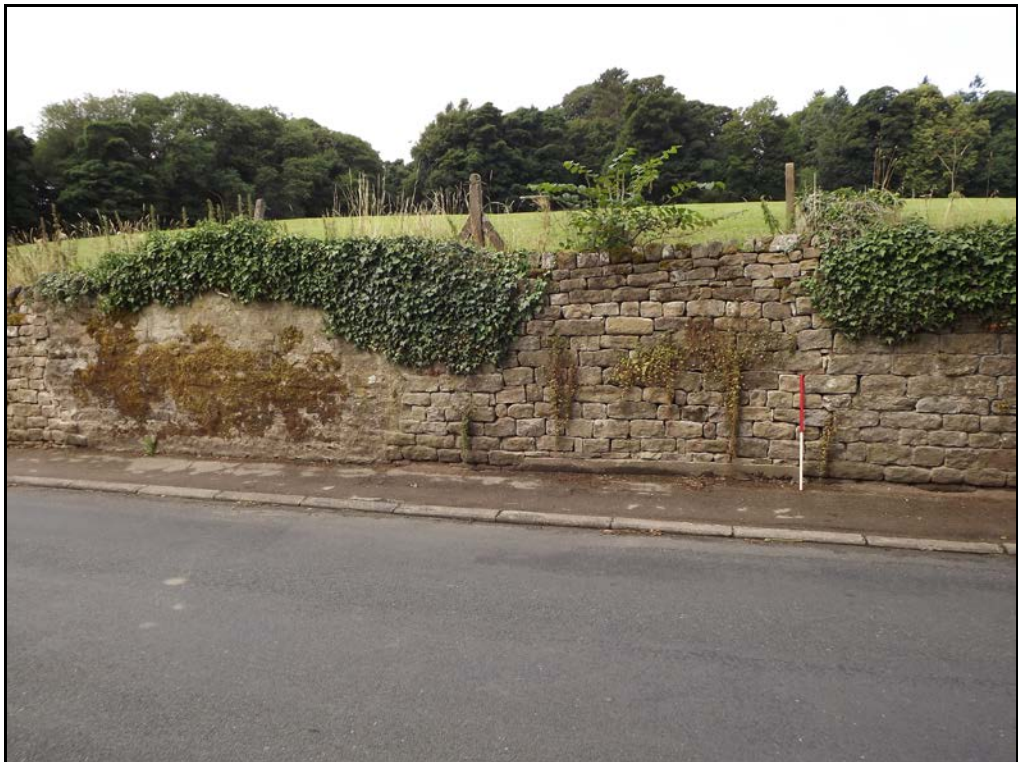
- 5.4 It is interesting to note that the historic mapping only records one path to and from the ice house which leads to the pond (Figure 2). It would have been expected that there was a path from the ice house to the hall, or more probably to the service wing of the hall. No path towards the hall is shown on any of the currently available mapping, nor is there one visible in the field to the east of the ice house even though there is what appears to be the finished end to the wall along the adjacent field (Figure 9) for a gateway. There is also an iron strap hinge reused on one of the modern gate posts that may have come from an earlier gate. Stylistically it can be dated to the 17th century (Alycock & Hall, 1994, 21). In addition an inspection of the roadside wall in line with the ice house and Beverley Hall noted a section of irregular construction (Figure 10). Also, on the ice house side of the roadside wall, the field can be seen to drop sharply into a dip which may represent the remains of steps that lead into the field to cross it to get to the ice house. Alternatively this could just be the collapse of the wall due to the pressure of the soil behind it - only further investigation would help resolve this. A little to the south of this irregular build part of the wall has collapsed and what appears to be an earlier wall is partially visible behind it.

Figure 10. Possible rebuilt gateway for path to ice house (Site 5), scale 1m, looking NW

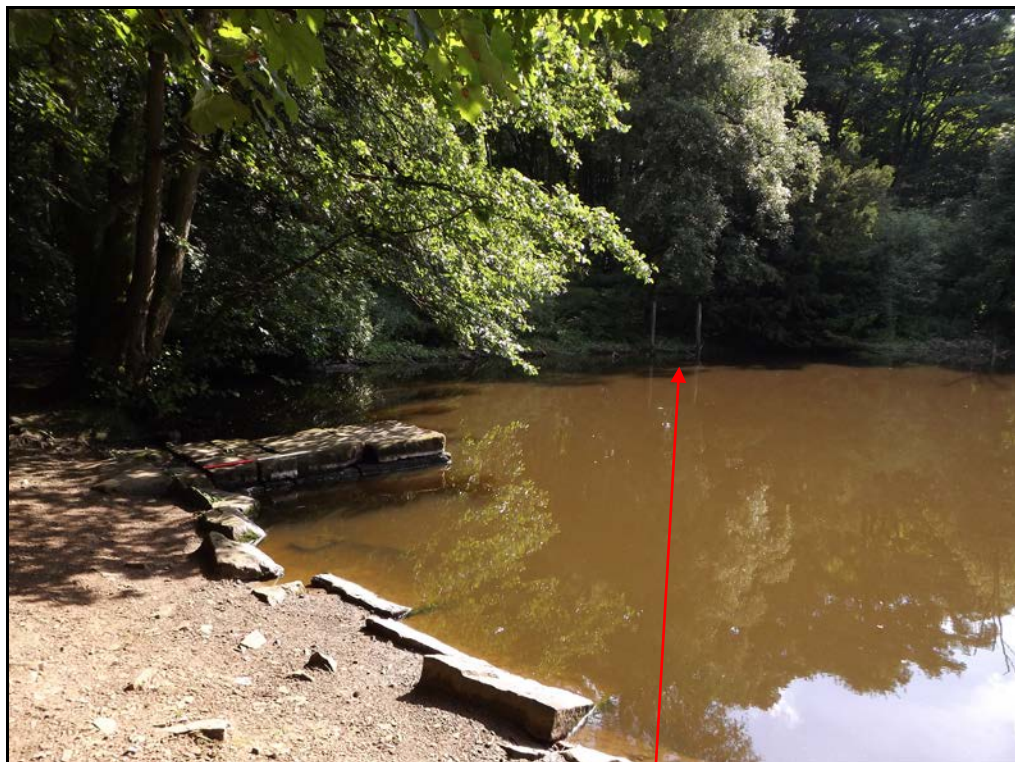
Figure 13. Edge of dam, jetty and remains of boat house

- 5.7 The simple nature of the boat house and its location close to the small jetty near the southern end of the dam would all seem to point to its use to keeping the weather off a small rowing boat or skiff type vessel that could be taken over to the jetty to collect passengers/fishermen for a trip on the pond.

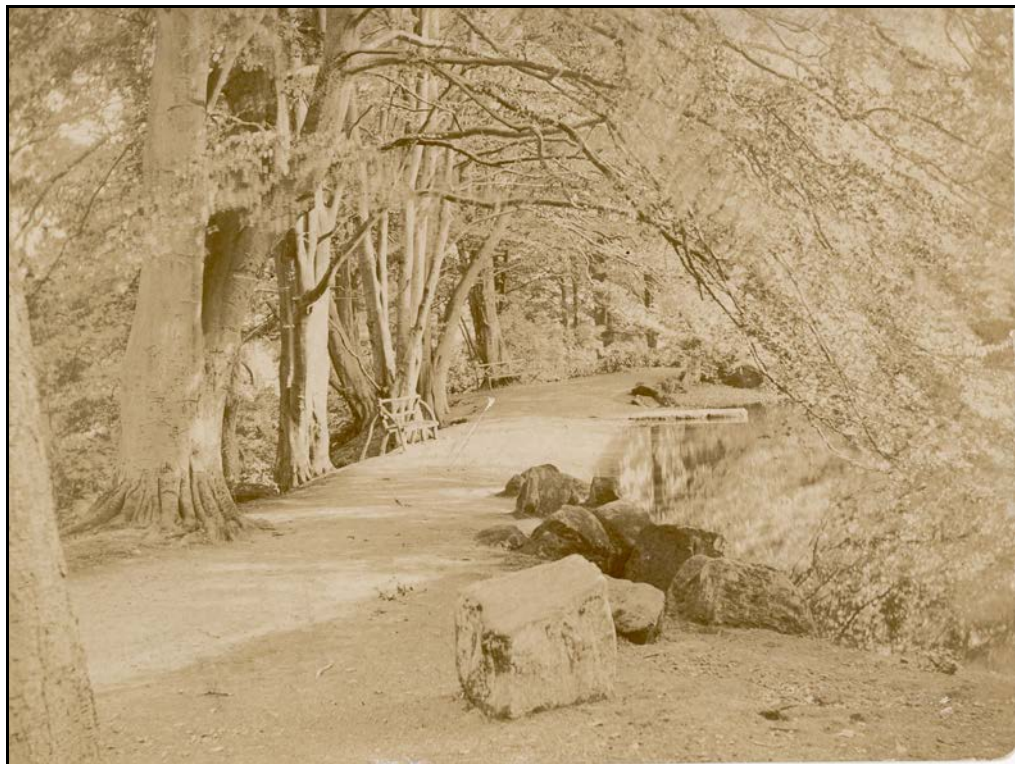
Figure 14. Historic image of the dam, looking SSW

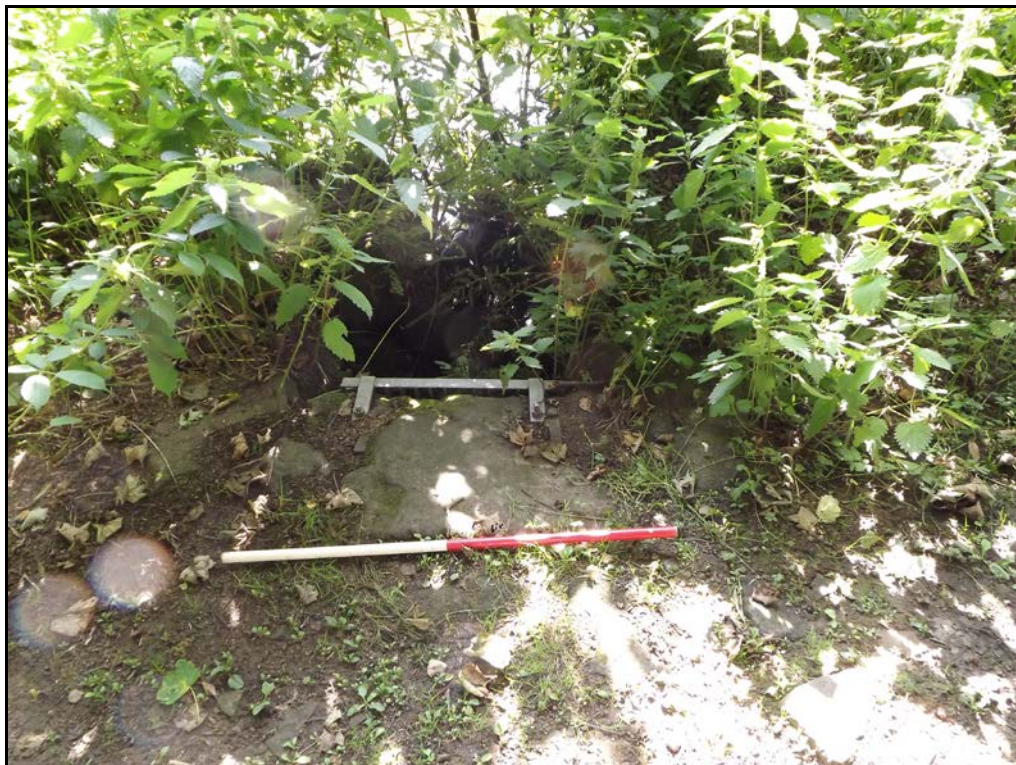
- 5.11 The site visit recorded the presence of a small sluice like structure towards the southern end of the dam (Figure 15) which did not seem to have a downstream exit on the east side of the dam. This appears to be the outflow shown on the northern shoulder of the dam in the historic mapping of 1867. The marked dip in the level of the earthwork at the northern end appears to be the result of erosion. If the pond was medieval in origin, in addition to there being an outflow, it would also be expected to find some evidence for a bypass leat to channel off excess flood water. No sign of this was seen during the current site visit nor during an inspection in 1998 (Cale, 1998, 18). However there is still extensive vegetation cover at the pond edge in several areas.

Figure 15. Outflow at southern end of dam, scale 1m

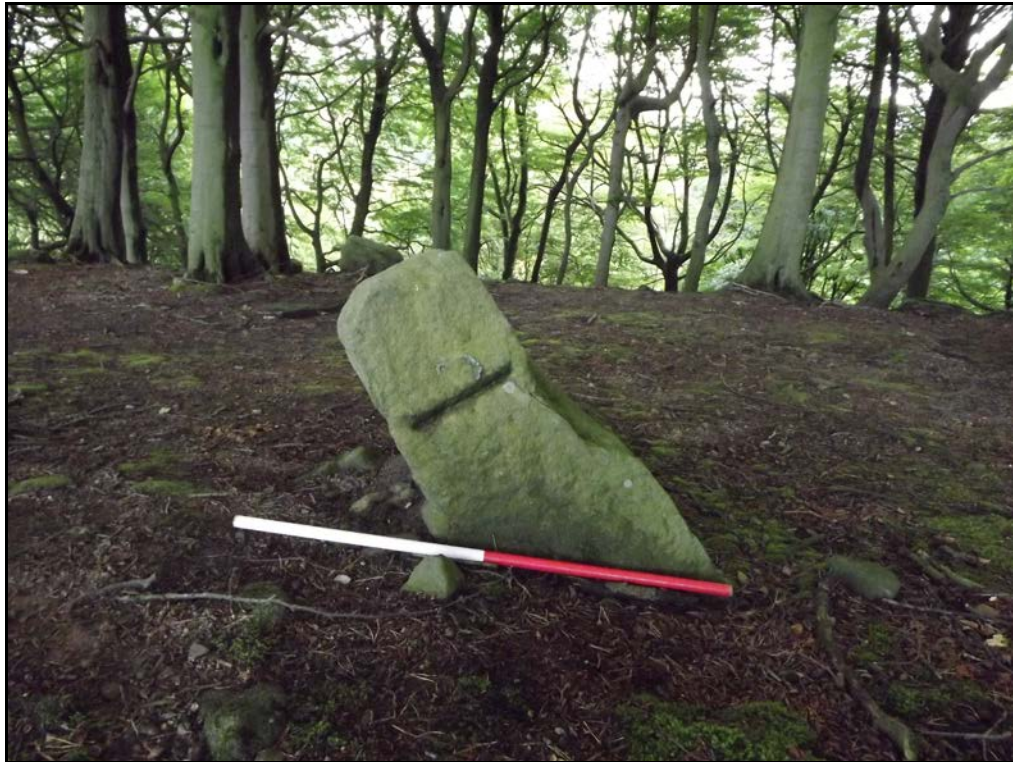
- 5.13 There are at least three areas of stone extraction identifiable within the woods. The first of these (Site 17) is to the north-west of the pond where, in a large area under the beech wood, there are clear signs that a lot of stone has been ‘quarried’ out across a wide area, with tool marks visible on several earthfast blocks (Figure 16). This is particularly noticeable on a large outcrop (at SE1532 6457) where it has been worked on two faces. It appears that in conjunction with the stone extraction here, there is an extensive network of paths surviving along the hillside here (including one hollow-way that contours around the hillside up towards the top) which could well be the remains of haul-ways for moving the stone safely down slope. Although partially covered with woodland debris, some areas of the hillside have the appearance of having been worked in benches.

Figure 16. Slot cut in block prior to splitting, scale 1m

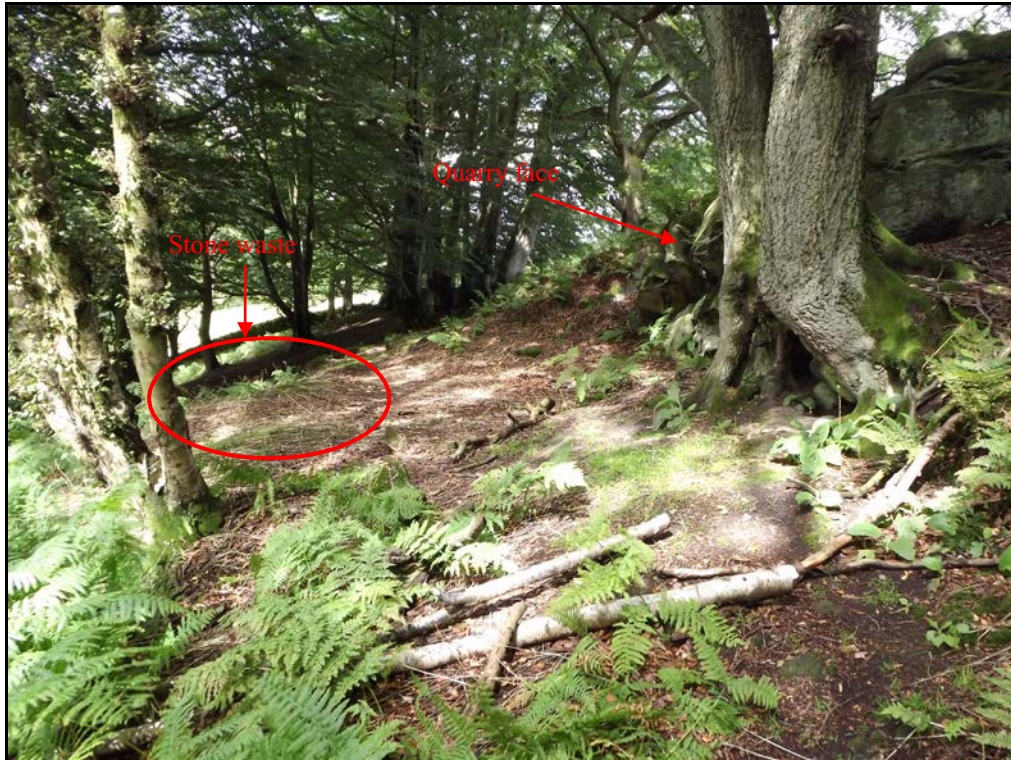
- 5.14 The second area of stone extraction (Site 2) lies on the eastern side of the woods on the hillside above the feeder stream to the pond (Figure 17). Here, as on the opposite side, stone appears to have been removed from rocky outcrops rather than from specifically dug quarries and tool marks can be seen on at least one earth fast stone. From an initial inspection the areas seems to be much smaller than the one on the western side. This however may due to the covering of summer vegetation and it would seem quite likely that it could actually cover the whole of the valley side along the eastern side of the pond.

Figure 17. Stone extraction on the eastern side of the woods. Looking NW

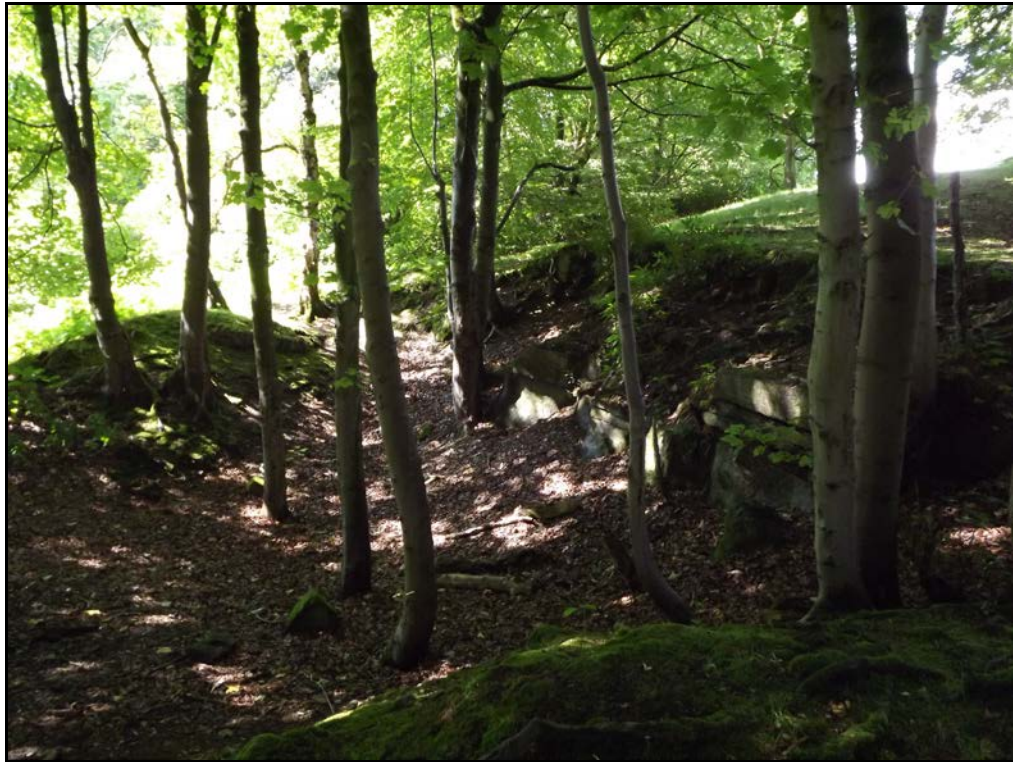
- 5.15 A third, smaller, quarry (Site 15) is located to the north-west of the ice house where it has been cut into the hillside (rather than surface extraction over a wide area) (Figure 18). A rapid inspection of the quarry face did not reveal any evidence for tool marks or quarrying techniques which would have helped in dating. Its location away from the pond would seem to rule it out as a source for the dam construction. This material would probably have come from the sides of where the pond was going to be. The quarry faces towards Bewerley Hall and, although too small to have been the source of stone for its construction, it may well have figured in the various additions and alterations carried out by John Yorke (c.1780s) and his nephew also John in 1832 (see Cooper, 1988, 170 & 208 and Grainge, 1863, 53). On the northern side of the quarry there is a low, linear bank running approximately east-west. Set into the top of the bank and in line with the eastern end of the barn to the north there is a rectangular stone built feature with possible additional stonework features to the west and east (Figure 19). From their alignment they could be the remains of a base or support for small scale equipment used in the quarry. From the examination of the quarry face it can be seen that there is an upper layer of less well bedded stone. This would be easily removable for use in dry-stone walling with a much thicker, better bedded layer below which would make good building stone. Other possible uses for the material could be the entrance tunnel for the ice house and the nearby reservoirs.

Figure 18. Quarry face and floor of the small stone quarry, looking NW

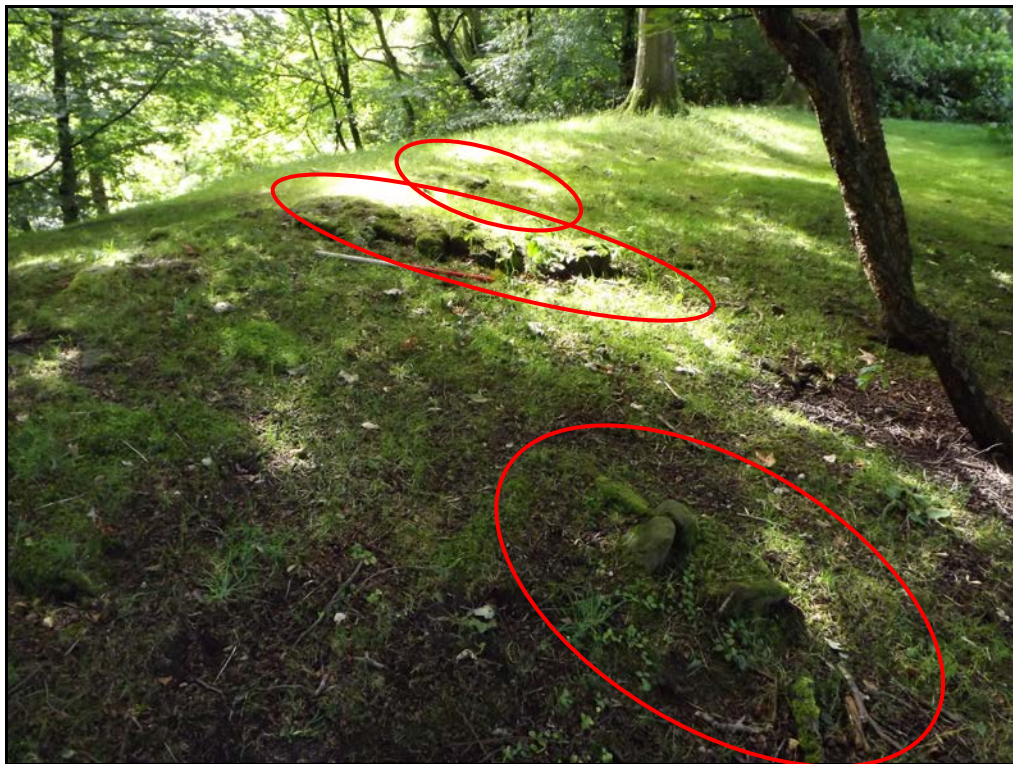
Figure 19. Bank with stone features to north of quarry, scale 1m, looking west

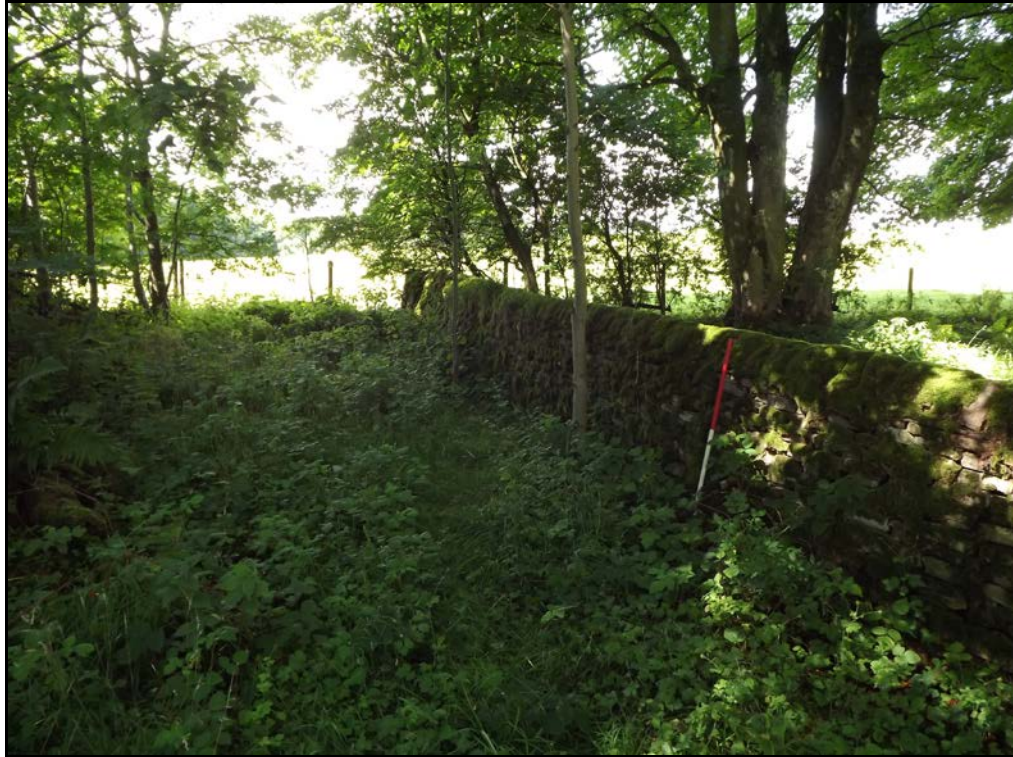
- 5.21 Clearly shown from the earliest OS mapping onwards is an elongate S shaped track running east-west through part of the woods to the north of the ice house. This track appears to be linking two fields (currently under pasture). The site visit recorded that the track was originally marked by well built dry-stone walls on either side, typical of an 'estate' style dating to the 18/19th century (Figure 20). The southern of the two walls is currently in a ruinous state but the northern one survives in a very good condition. The simplest interpretation for this is that it was used for moving livestock from field to field – though the good quality of the walls' construction would seem to argue against this. A more likely possibility is that it was built as part of the designed landscape by the elder John Yorke around the end of the 18th beginning of the 19th century as some form of ride or carriageway. The difficulty with this is that it does not appear to lead anywhere apart from one field to another, nor does it form part of a circular route for example. A further, more intriguing though unlikely, possibility does present itself. This is that it could have been used for moving deer through from the field to the west of the woods into the one to the east for the purpose of the final part of the hunt. This would allow the kill to be seen from the east (the Hall or possibly the earlier Grange). This could explain why

Figure 20. Northern wall of the track-way, scale 1m, looking west

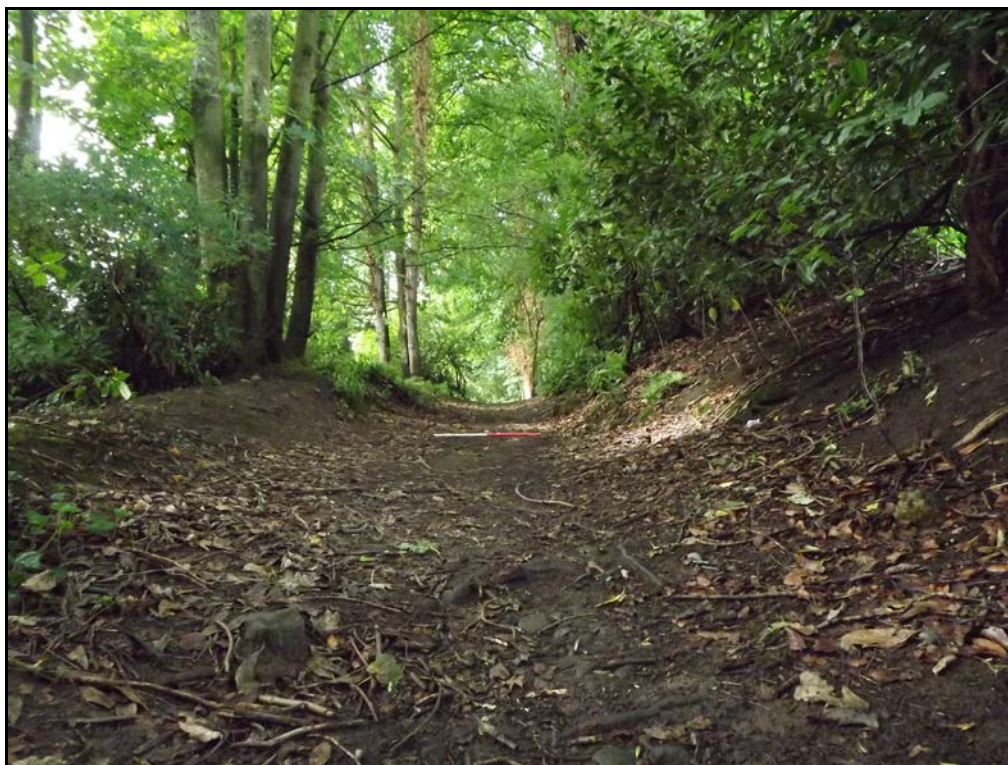
- 5.22 Three distinct hollow ways were noted during the walk over survey. The first of these (Site 20, Figure 21) was in the south-eastern corner, where the current access to the woods starts. Here the current path starts at a pair of 19th century stone gate posts (Figure 22), climbs a set of stone steps and heads north-west. About 100m into the woods on the left hand side there is a distinct earthen ridge which marks the southern side of the path. This ridge can be seen to turn southwards away from the track and head towards the junction of Peat Lane with Bewerley Road. Although the vegetation here is quite dense it is possible to make out a shallow hollow way running down slope. Looking north-west along the path, the remains of the hollow way are very distinct. This would seem to indicate that this has been the main route into the woods for a long period of time. A second stone gateway is located on the south-western corner (Site 31, Figure 23).

Figure 21. Hollow-way leading from gates to pond, scale 1m, looking WNW

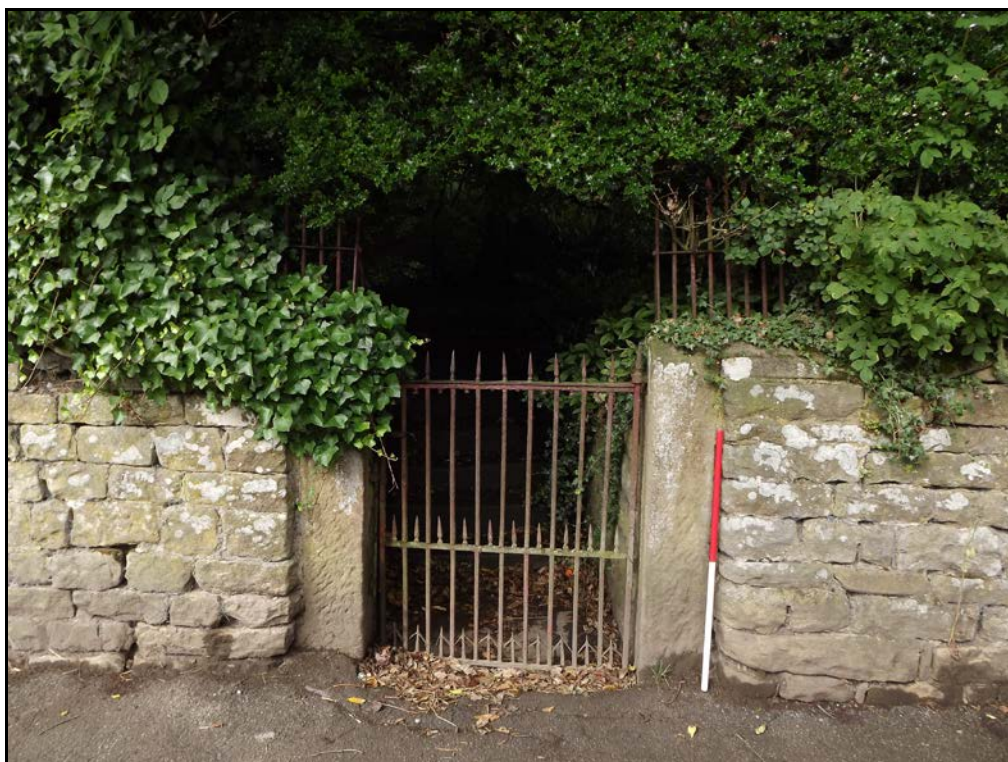
Figure 22. Stone gateway, probably dates to c.1832, scale 1m, looking west

- 5.28 Closely associated with the various paths are the two 19th century gateways into the woods (Figures 22 & 23). These are built from ‘rustically’ finished stone piers with wrought iron gates. The entrance at the eastern end of the woods being closest to the hall is much more elaborate and still retains its curved coping stones running from either side along with fine examples of twisted wrought iron railings. The wrought iron gates survive in good condition with the eastern gate again being much more elaborate in its detail. Although a small amount of damage has occurred to parts of the gate, it is still largely complete with only a small amount of detail missing. It is felt that it would be worth undertaking any necessary repair and replacement of missing details to return this to close to its original state.

- Remove vegetation to expose surrounding stone and wrought iron work
- Undertake necessary repair and restoration work on the gate details

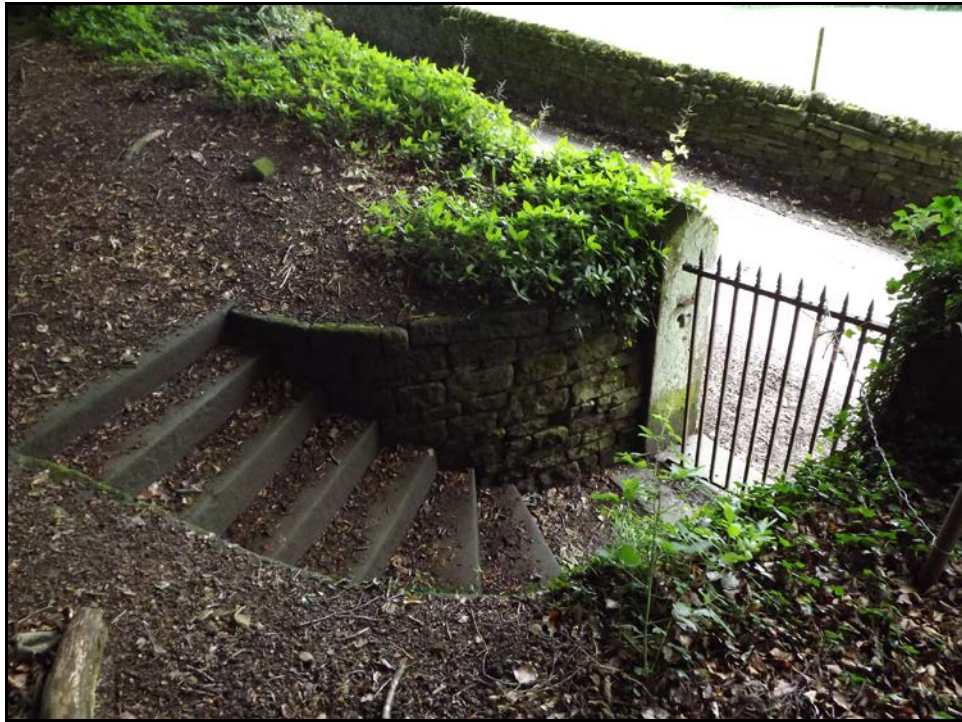
Figure 23. Stone gateway (?1832) at the south-western end of the woods

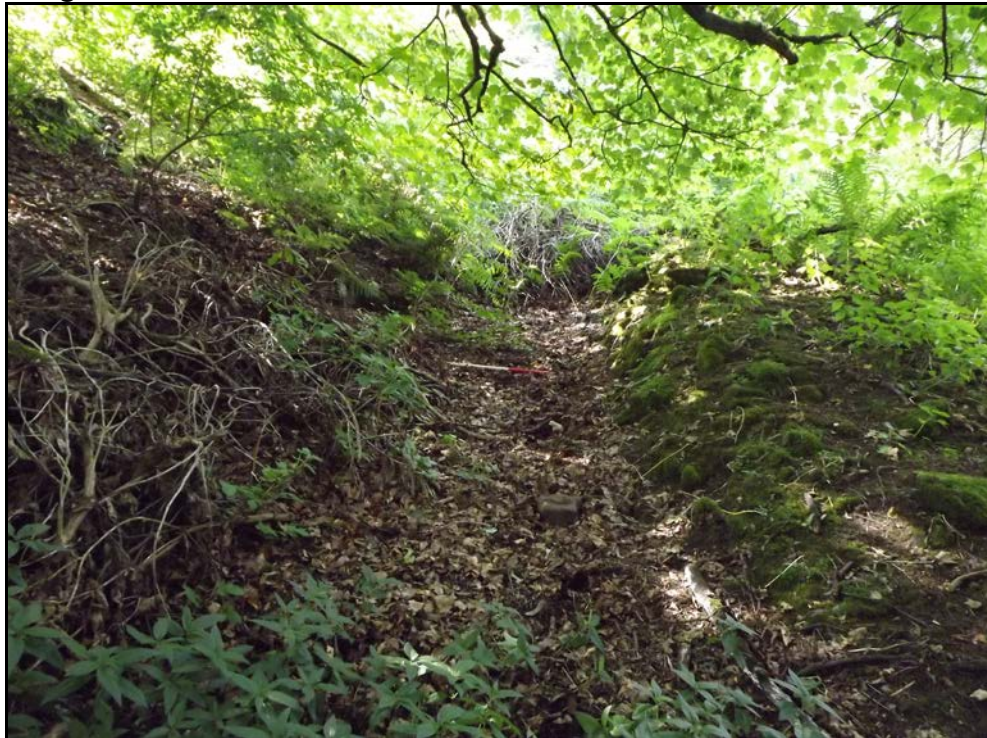
- 5.23 The second hollow way (Site 27, Figure 24) was noted to the west of the pond almost at the top of the western side of the valley. Although only part of its course was visible due to the vegetation, it could clearly be seen to run from close to the modern entrance to the woods northwards. From here it contoured around the valley side and headed up towards the stone extraction area under the beech woods. This would appear to represent the remains of the route along which stone was removed for use elsewhere.

Figure 24. Hollow-way leading to stone extraction area, scale 1m, looking NW

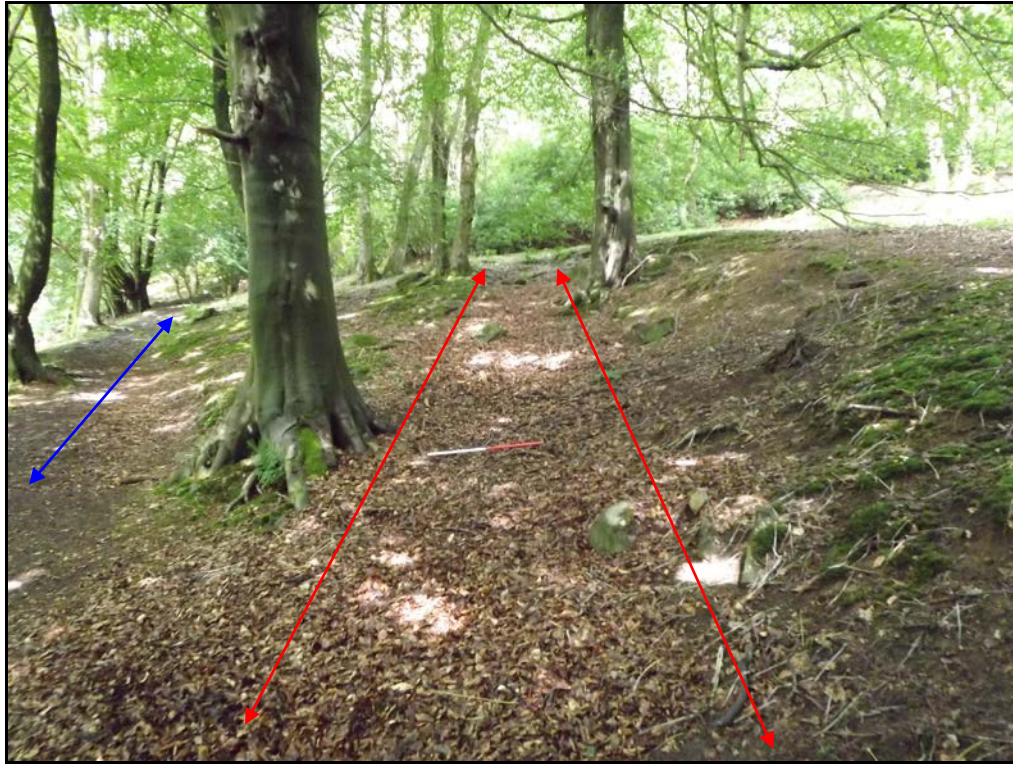
- 5.24 The third hollow-way (Site 29, Figure 25) was recorded zig-zagging up the hillside from the direction of Paradise Farm. As with the second hollow-way described above, this one also appears to be heading towards the area of stone extraction in the beech woods.

Figure 25. Hollow-way (in red) above Paradise Farm with later Yorke path (in blue) to west, scale 1m, looking north

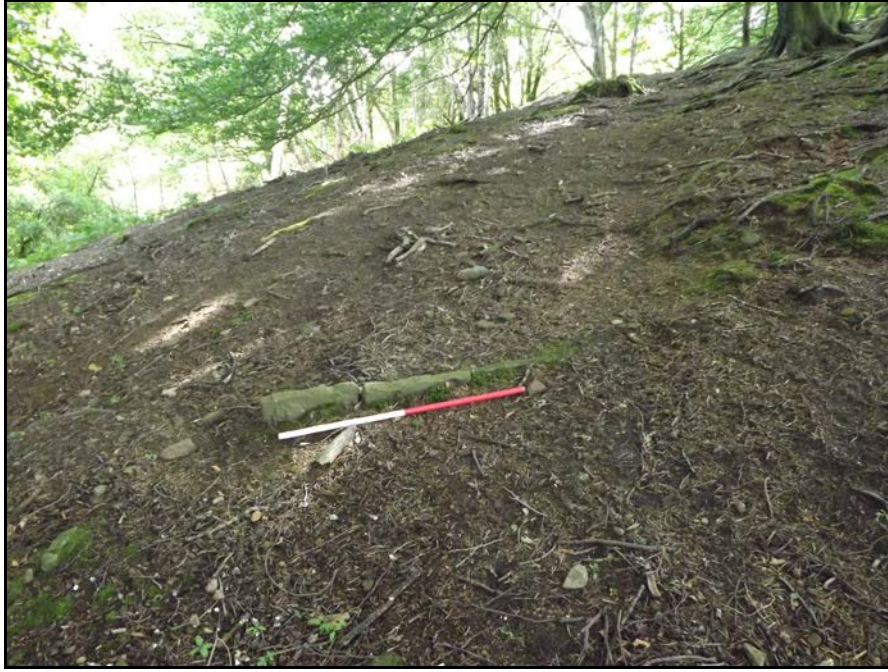
Figure 26. One of two sets of stone on edge marking a path in the area of stone extraction, scale 1m, looking SW

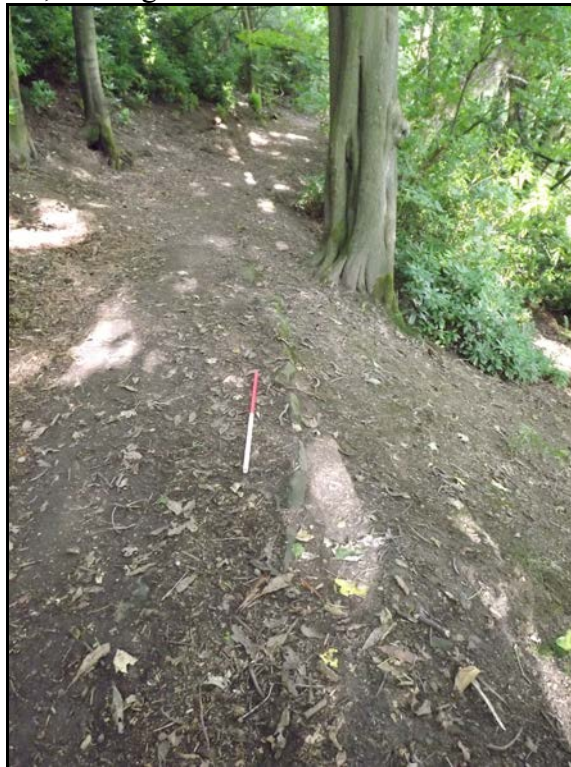
still retain some of the edging stones on their downslope side (Figure 27). It is this feature that could be used in other areas to possibly help trace the route of the now lost or overgrown paths. If the suggestions of Loudon had been followed in the woods here, it may be possible to identify/confirm the 19th century paths by trial excavation as he suggested the use of gravel or sand as a covering. However the ready availability of stone from the surrounding hillside would make a simple solution for path construction in any era.

Figure 27. Remains of edging stones on path to pond, scale 1m, looking east

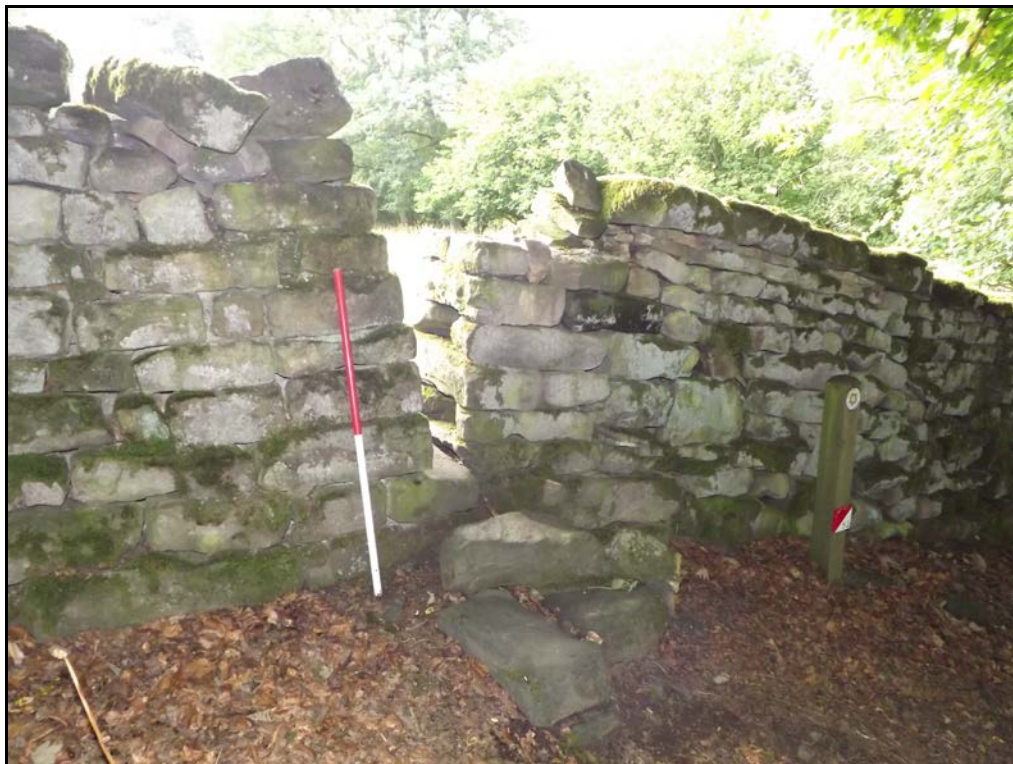
- 5.27 One path which cuts through a small part of the woods is shown on both the earliest OS map and the 1867 estate map (Figure 3). These maps show a well defined path running eastwards from the direction of Wood Head through a stone stile (Figure 28). The path, which appears to have been reduced in width, travels across the northern tip of the woods to the boundary where it turns and then runs almost due north up a flight of stone steps (Site 1) and on towards Calf Haugh. As this is the only path that is shown on the earliest mapping, it is possible that this may have originated in the medieval period as a route to link the scattered farmstead in the area. The stone steps are of a very simple construction and several are worn, though apparently none on both upper and lower faces. At the top end of the steps they appear to run under the adjacent dry stone wall which, if this is the case, would suggest they are older than the wall.

Figure 28. Stone stile along western boundary, showing narrowing of opening, scale 1m, looking NW
