**FISH POND WOOD & BEWERLEY GRANGE CHAPEL,
BEWERLEY, NIDDERDALE, NORTH YORKSHIRE**

HISTORIC ENVIRONMENT SURVEY

JB Archaeological Services

NIDDERDALE AONB

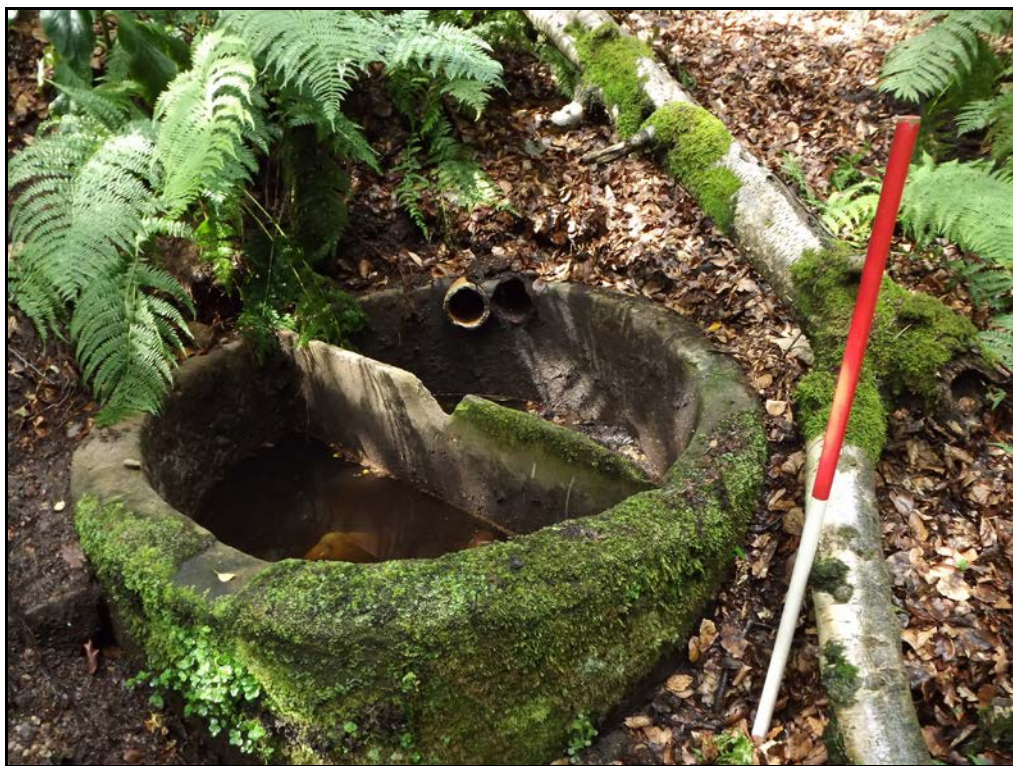
- 5.29 The remains of the well (Figure 29) recorded do not appear to show a well as such, rather they appear to be more of a collection cistern fed by a spring. In Figure 29 two inlet pipes can be seen on the northern side. It is assumed that the iron one on the right is the earlier and the ceramic one is a later replacement when the iron one corroded. These then feed the water into the northern chamber, where any sediment is allowed to settle before the water overflows into the southern chamber where it can be collected. There is also a small overflow cut into the southern side to take away excess water. The presence of the well would seem somewhat at odds with there being a stream and pond nearby. But with the simple settling system it would appear that it was probably created to obtain fresh water, rather than collecting water that had drained through several pastures.

Figure 29. Stone 'well' to the west of the inlet stream, scale 1m, looking north

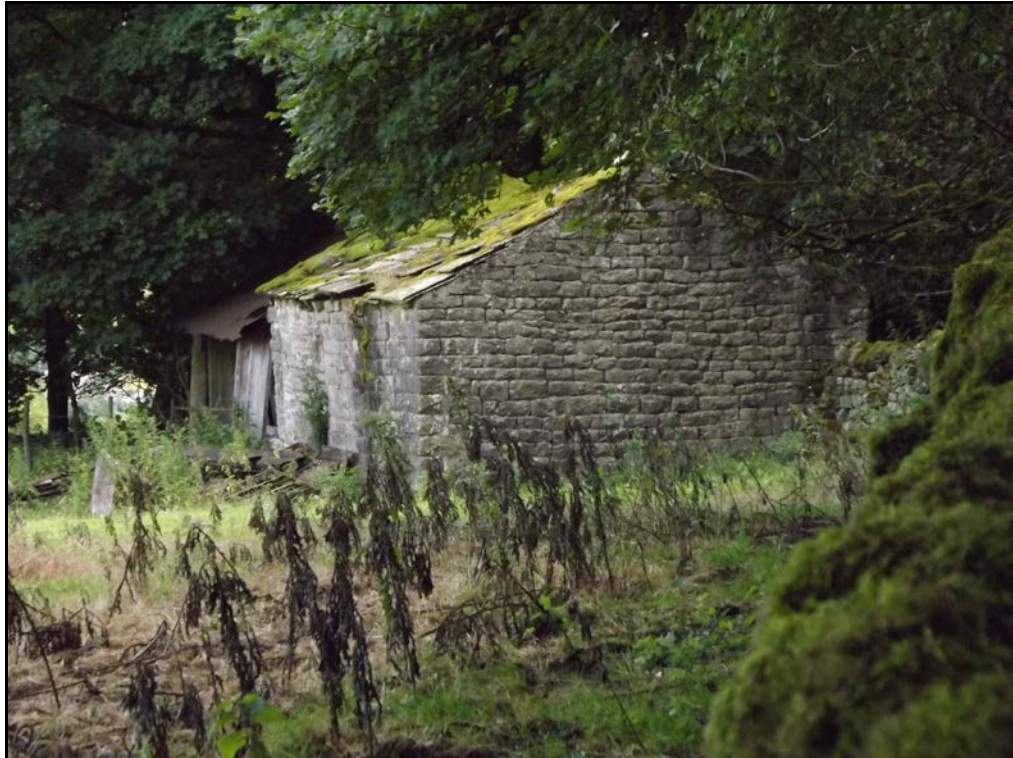
- 5.30 The remains of a small stone-built barn are located on the northern boundary of the woods. The barn is of a very simple construction of coursed, roughly finished stone blocks under a stone tile roof (Figure 30). The building appears to be marked on the first editions of the OS and so would date to the 1840s or before. The barn lies outside the holding of Fish Pond Wood and as such would seem to be a simple field barn. However as one of the quarries lies *c.*20m or so to the south, it may be that the barn was used as a tool store or canteen.

Figure 30. Stone built barn on the northern boundary, looking east

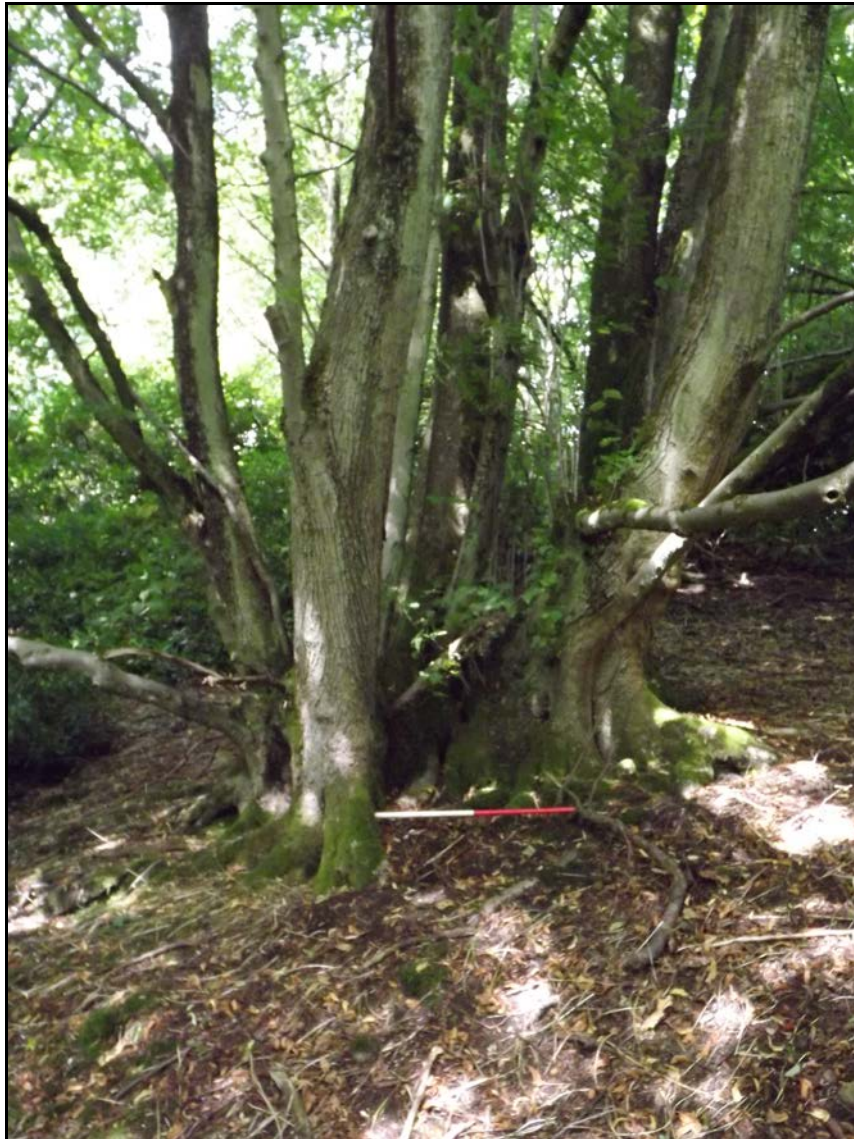
Figure 31. Possible coppice stump, scale 1m, looking north

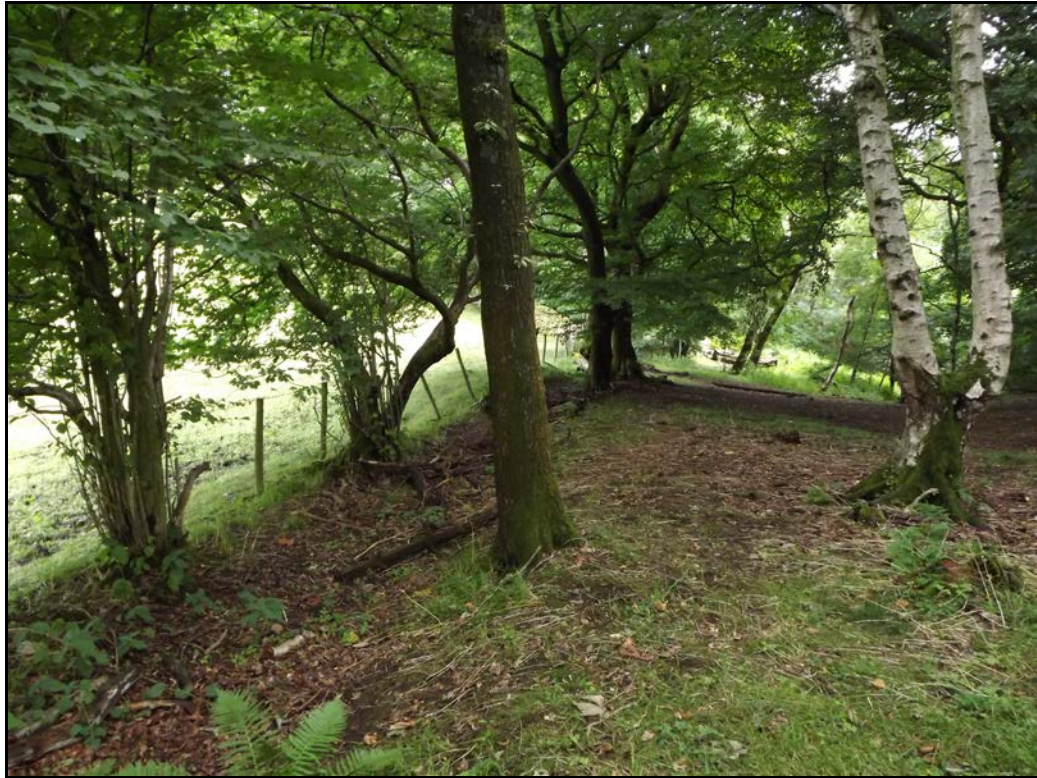
- 5.32 Part of the northern boundary of the woods (Site 6) is formed not by the usual dry stone wall but by the remains of a hedge bank and ditch which from the early OS formed the course of the feeder stream to the pond (Figure 32). Examination of the earliest OS map appears to show this feeder stream running along the boundary and then turning north-west following the field boundaries. It may be due to pollution from the pasture that the stream appears to have been piped into an iron pipe which emerges a short distance inside the boundary of the woods. The 1867 estate map shows an unusual configuration for this north-western corner for which some evidence survived in the current field boundaries. One possible interpretation for this is that it was some form of sheep fold.

Figure 32. Remains of bank and ditch for feeder stream to pond, looking SE

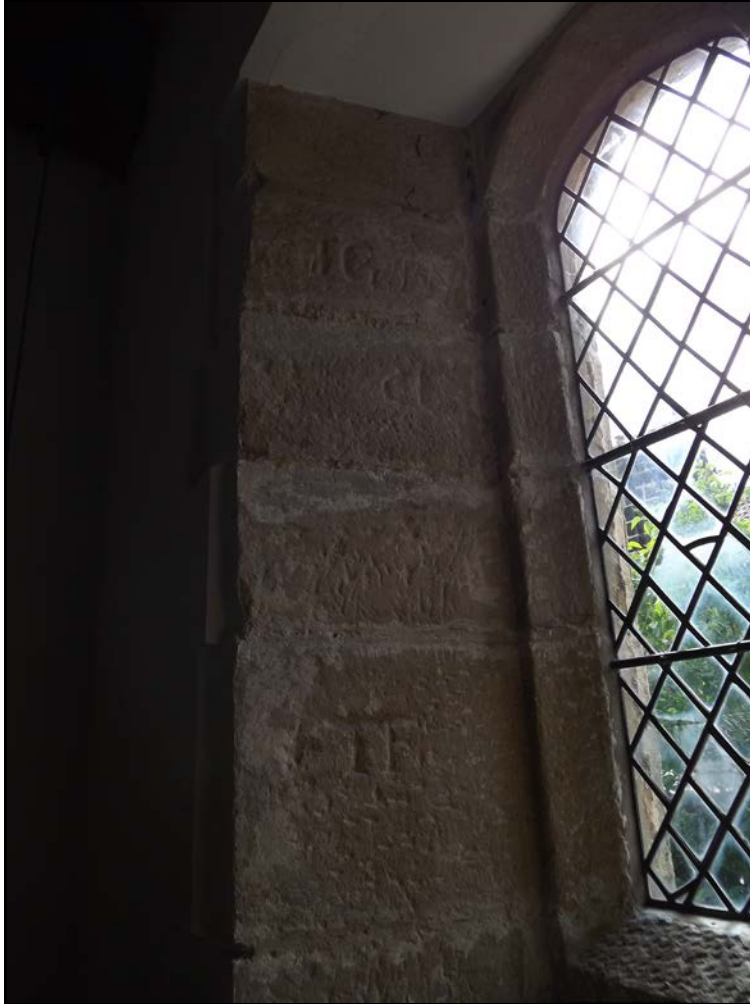
5.34 The assessment of the chapel found that the details recorded in the buildings listing and scheduling descriptions were at a detail that could not be added to at this level of investigation. However the site visit did record two particular items. The first of these was a number of graffiti in the east side of the window reveal of the eastern most window on the south side of the chapel (Figure 33). Starting at the top these read IG?; CL; several overlapping W; and TF. Graffiti was not obvious in any of the other exposed areas of the chapel but a more detailed investigation was not part of the report for this assessment. The second was that on the western gable end of the chapel there were a number of cracks in the stonework which could indicate that the eaves of the building may be spreading (Robert Thorniley-Walker *pers comm*). From the site visit it

Figure 33. Graffiti in the window reveal on the south side of the chapel

is felt that additional detail into the construction and use of the chapel could be obtained by a systematic examination of the fabric of the building to record such evidence as tool marks in both stone and timber, construction methods, graffiti etc.
