PROPOSED ALDI STORE, NORTON ON DERWENT, NORTH  
YORKSHIRE.

REPORT ON AN ARCHAEOLOGICAL EVALUATION.  
OSA REPORT No: OSA09EV08

July 2009.

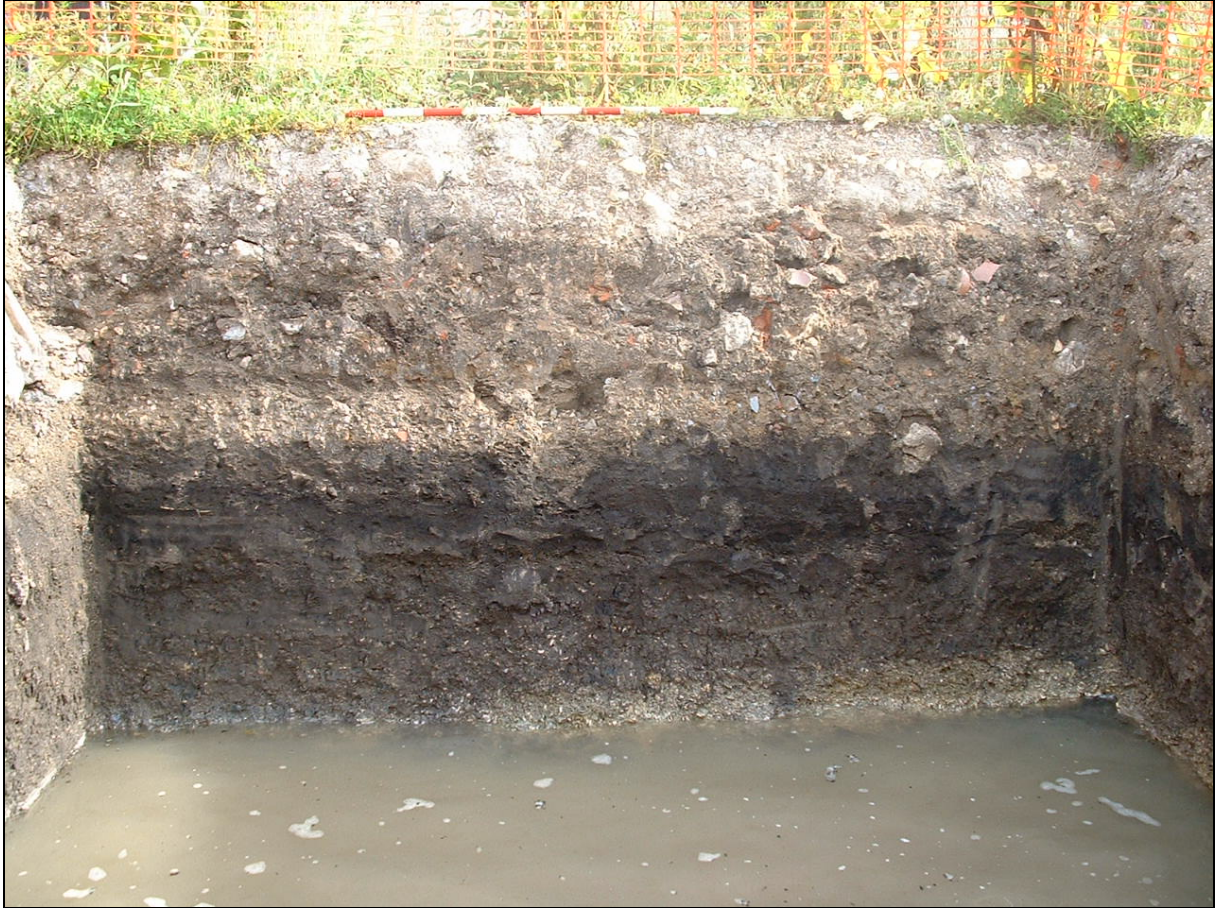
*Plate 1. Trench 1 section looking north*

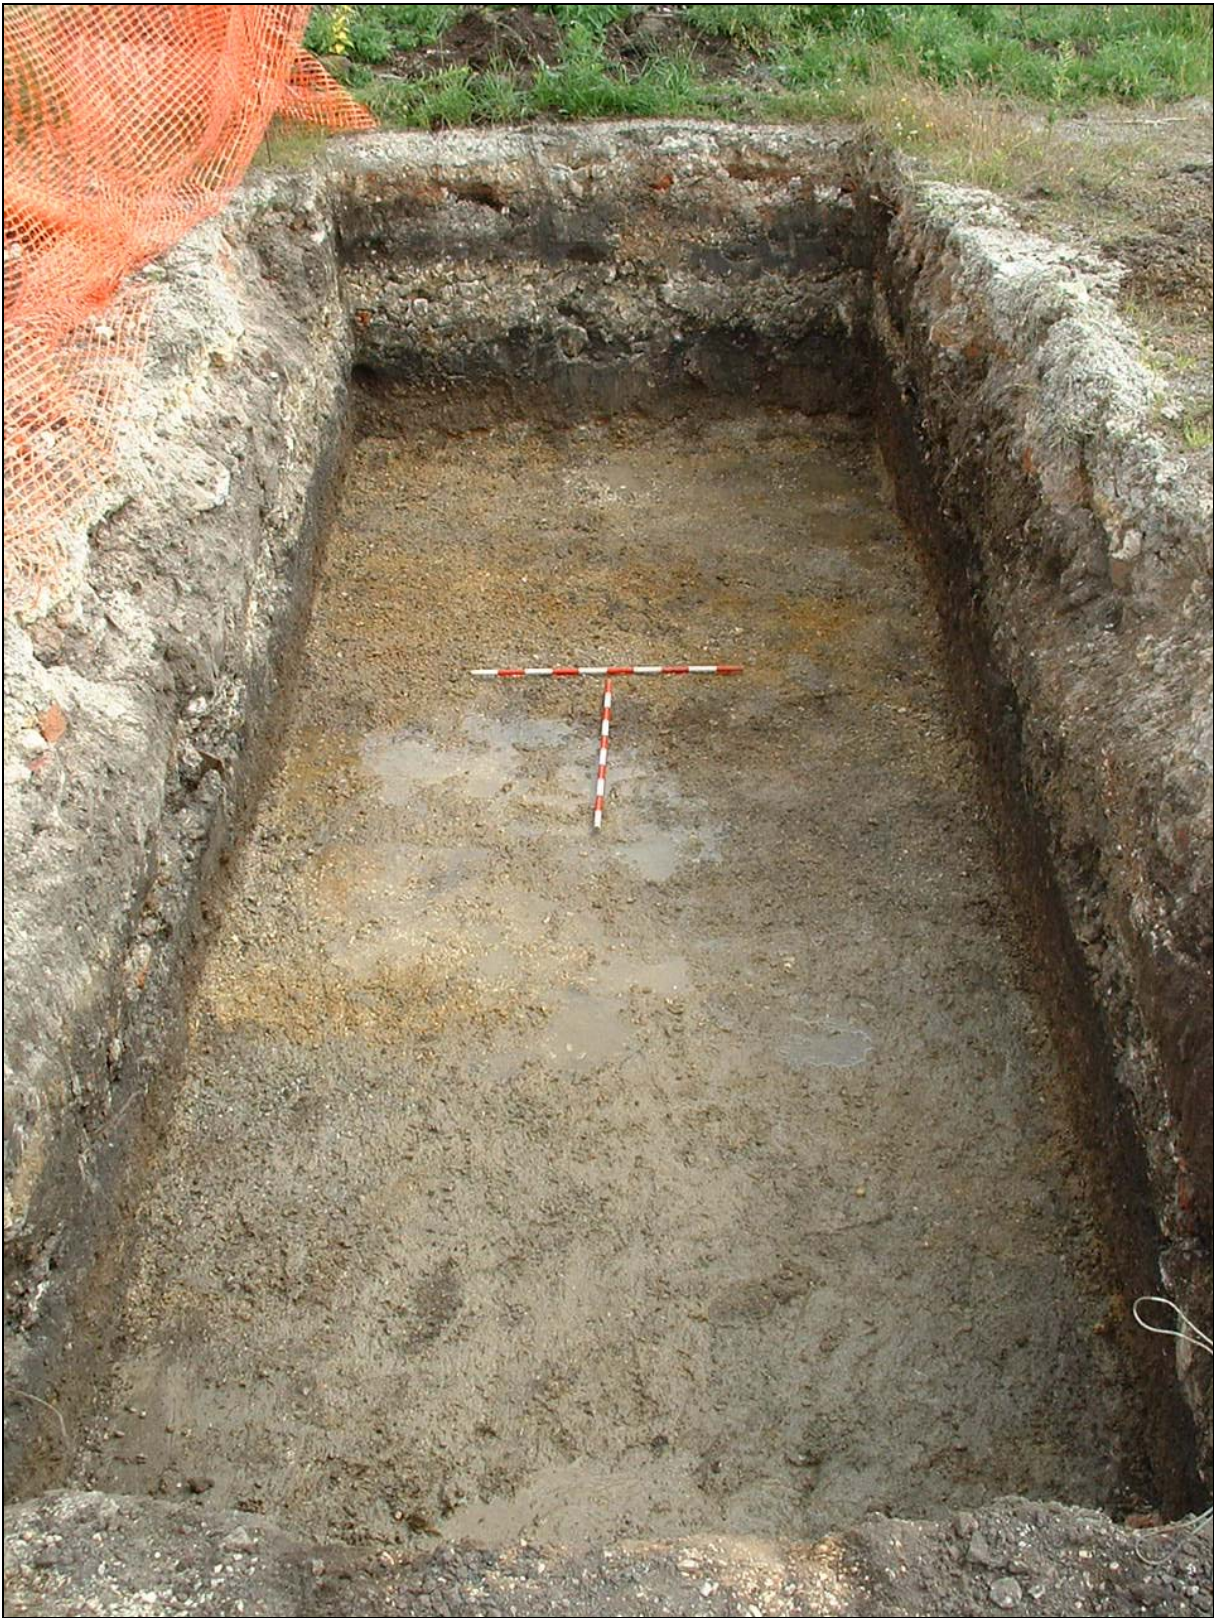
*Plate 2. Trench 2 looking north-east*

This trench was situated south-east of Trench 1, measuring 8m by 3m and orientated on a north-east to south-west alignment, (Figure 2; Plate 2). The trench was excavated to a maximum depth of 1.5m BGL where the natural deposits were identified at 17.03mAOD.

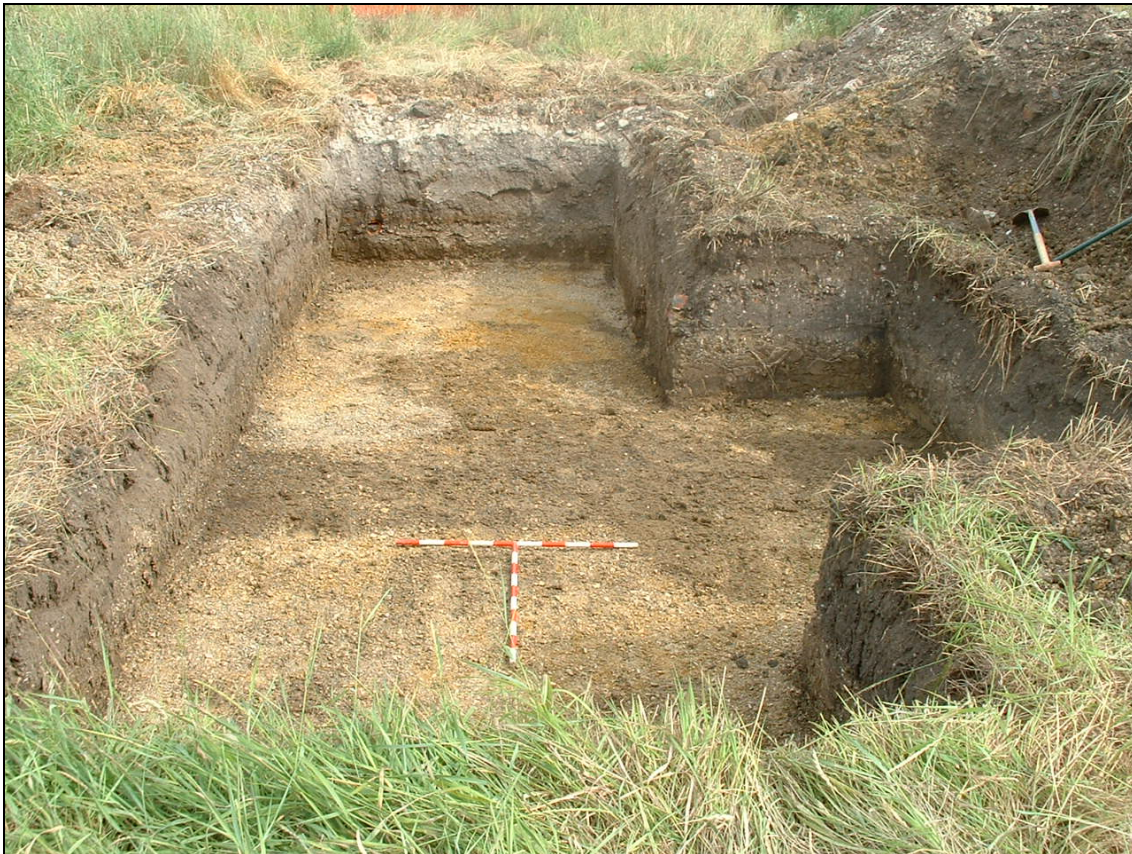
*Plate 3. Trench 3 looking north*

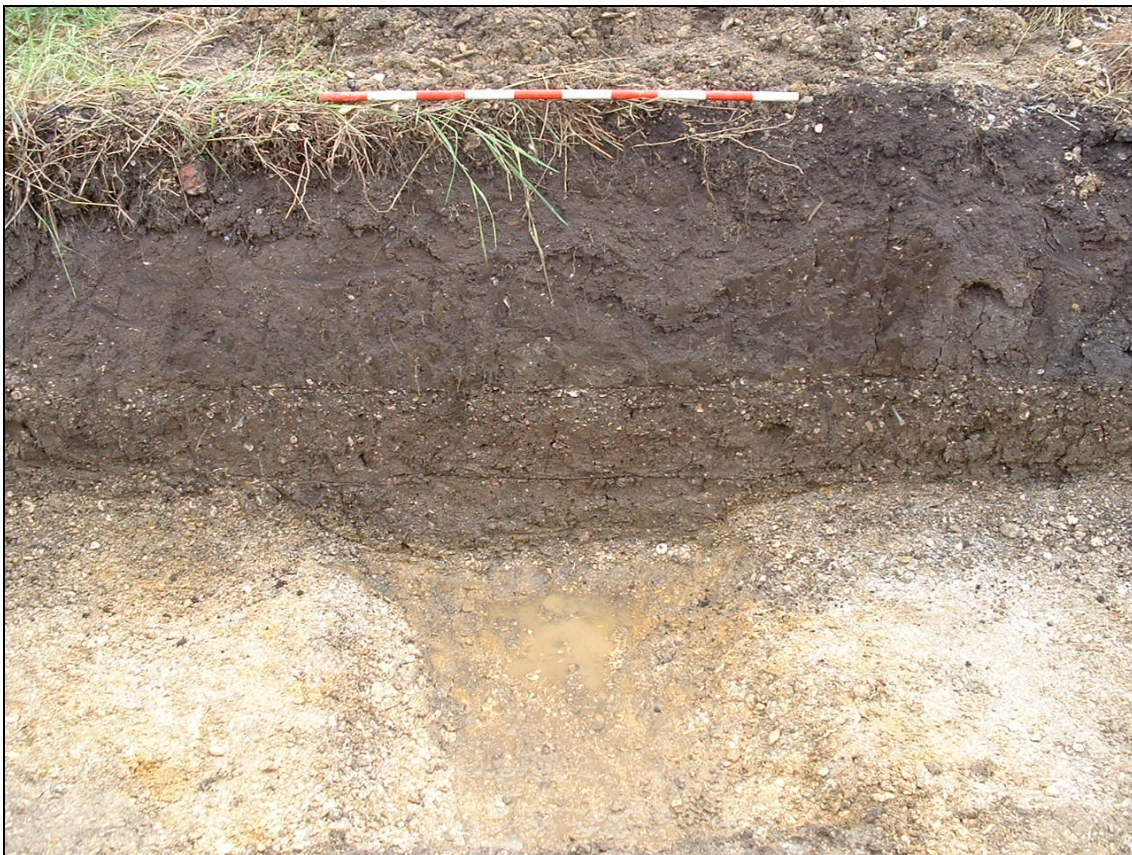
The earliest deposit detected within this Trench 3 was natural a deposit (304) consisting of mid-brown chalk gravel. The natural (304) was cut by an east to west aligned ditch [303] (Figure 5). The ditch had a U-shaped profile with shallow sloping sides and a flat base measuring 1.21m in width and 0.25m in depth (Figure 6; Plate 4). Ditch [303] contained a single silting fill (302) consisting of light-brown clayey-silt containing moderate chalk gravel and occasional charcoal fleck inclusions. No finds were recovered from this deposit. Ditch [303] probably represents a drainage ditch of unknown date.

*Plate 4. East-facing section ditch [303]*

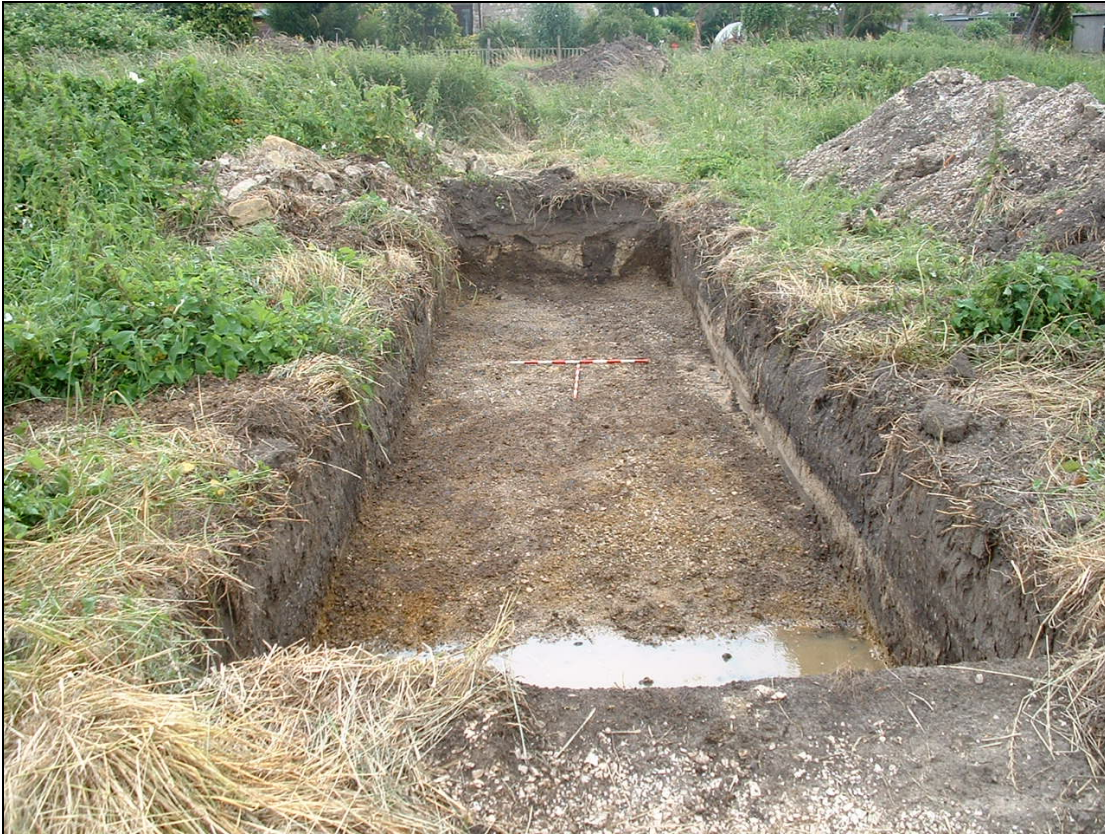
*Plate 5. Trench 4 looking east*

This trench was situated to the south-west of Trench 3, measuring 10m by 2m and orientated on an east to west alignment (Figure 2; Plate 5). The trench was excavated to a maximum depth of 0.9m BGL where the natural deposits were identified at 17.3mAOD. The natural deposits (404) consisted of mid-brown chalk gravel and was cut by a ditch [403], and five post holes [406], [408], [410], [412] and [414] (Figure 7).

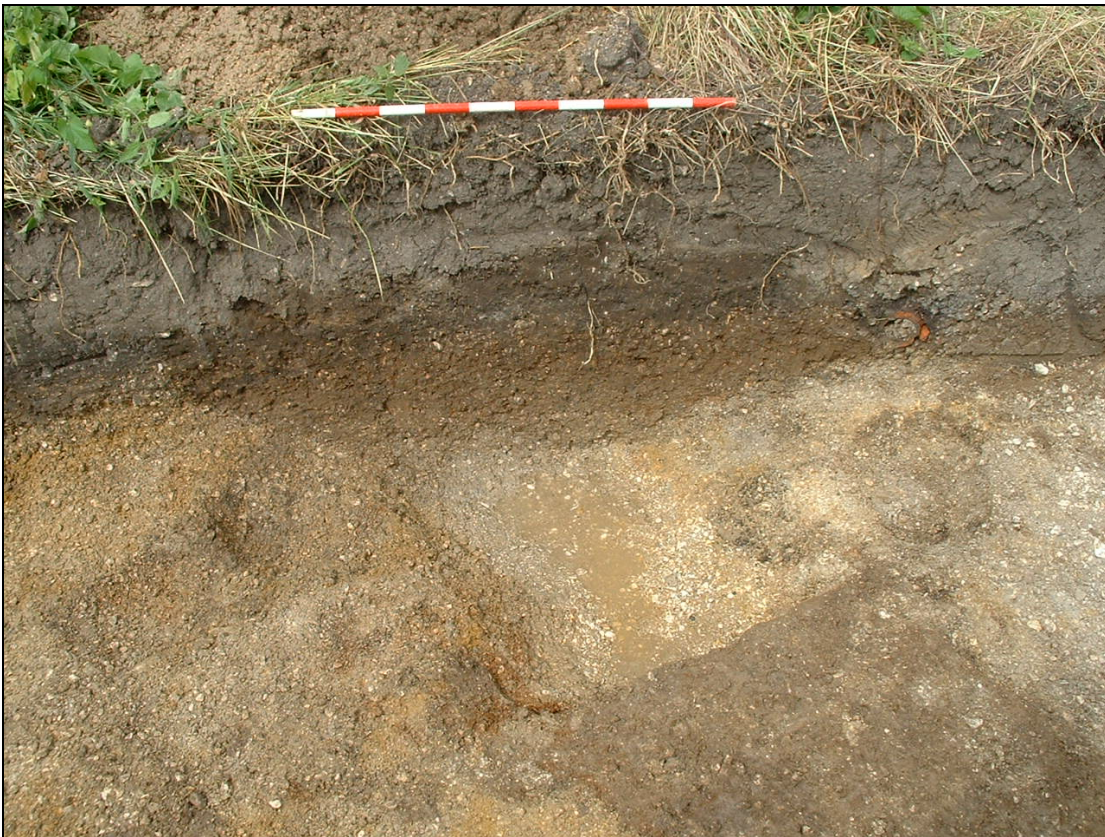
Ditch [403] was aligned north-west to south-east and had a U-shaped profile with moderate sloping sides and a concave base measuring 1.55m in width and 0.37m in depth (Figure 8; Plate 6). The ditch contained a single silting fill (402) consisting of greyish-brown clayey-silt containing occasional chalk gravel and charcoal flecks. No finds were recovered from fill (402). Ditch [403] probably represents a drainage ditch of unknown date.

*Plate 6. South-facing section (oblique) ditch [403]*

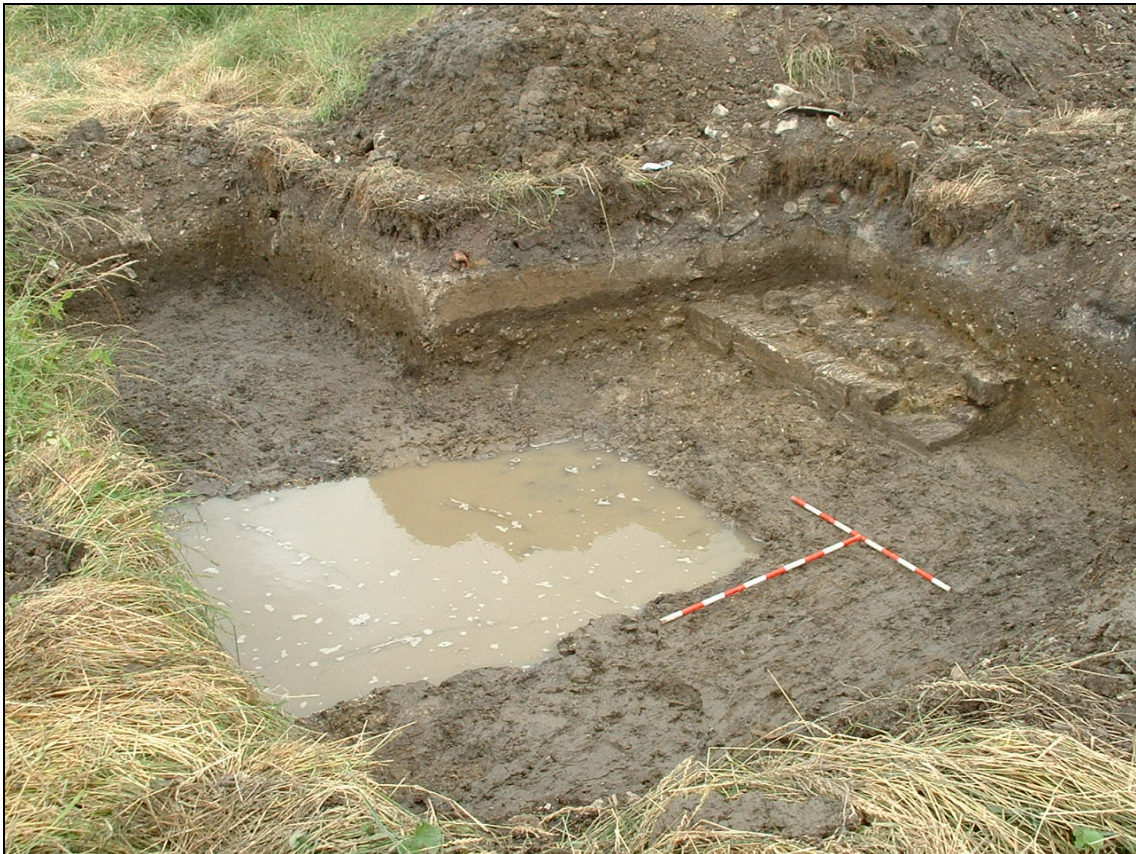
*Plate 7. Trench 5 looking north-east*

Trench 5 was located to the east of Trench 4, with maximum measurements of 6m by 4.7m (extended to the east by 4m by 2.4m to avoid services to the north and south of the trench), orientated on a north to south alignment (Figure 2; Plate 7). The trench was excavated to a maximum depth of 0.9m BGL where the natural deposits were identified at 17.25m AOD. The natural deposits (513) consisted of mid-brown chalk gravel.

Truncating pit [512] was the construction cut [510] for a wall (508). The construction cut was near vertical and measured 0.5m in depth (Figure 10). Set within the construction cut was wall (508) that was partly exposed within the north-eastern corner of the trench (Plate 7). It was exposed for 2m in length, 0.6m in width and 0.9m in depth. The wall had a foundation constructed from roughly hewn limestone blocks two courses deep measuring 0.24m in depth that extended out from the wall face by approximately 0.14m (Plate 9). The west and south facing walls were 3 courses deep measuring 0.48m in depth and constructed from smooth chiselled faced limestone blocks with average dimensions of 0.3m by 0.25m by 0.15m (Plate 10). The wall core was constructed from roughly hewn and fragmented limestone. Butting up to wall (508) and within the construction cut [510] was a backfill (509) consisting of a dark greyish-brown clayey-silt with occasional chalk gravel inclusions. No finds were recovered from the backfill. Wall [508] most likely represents the south-western corner of a structure that extends towards the north and east. Wall (508) is probably of a mid-medieval date and its function remains inconclusive as so little of it was exposed by trench excavation.

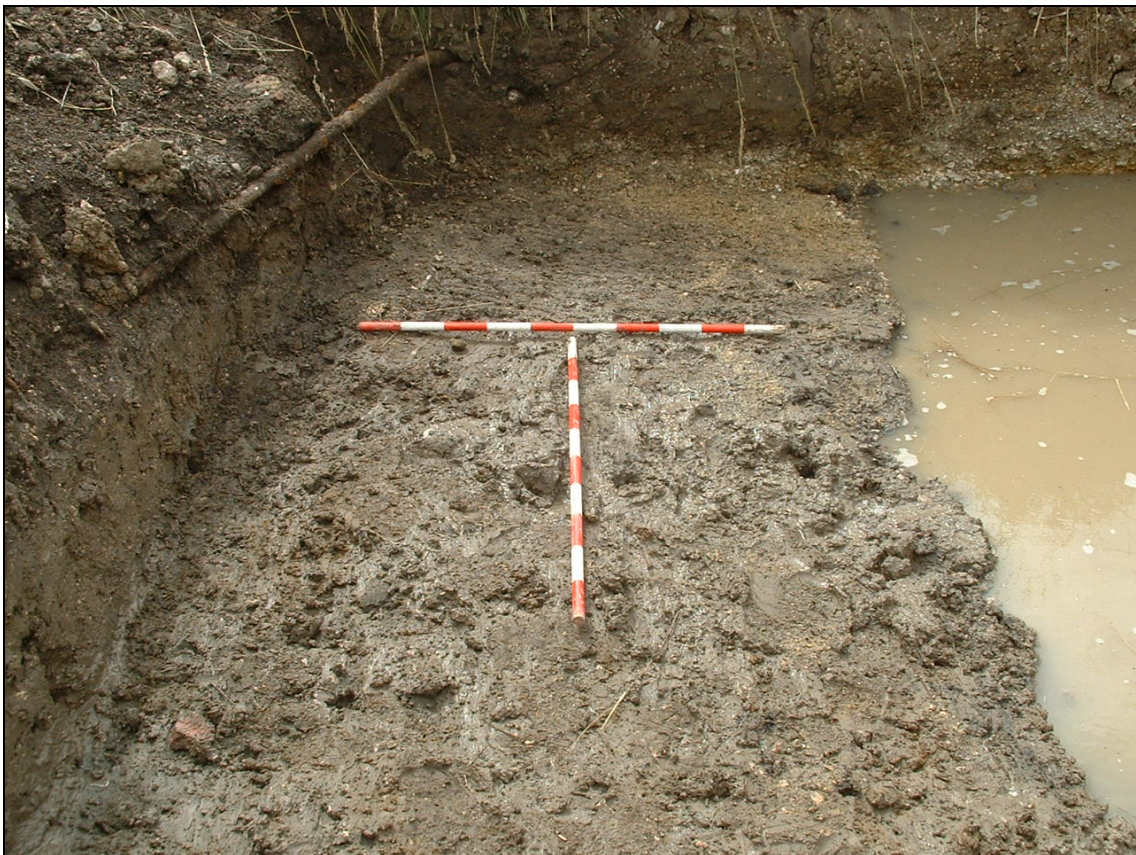
The earliest archaeological feature detected truncating the natural (513) within Trench 5 was a large pit [512] (Figure 9; Plate 8). The pit was detected within the southern half of the trench and extended beyond the trench limits to the south and east. Pit [512] appeared to be probably sub-circular in plan and had an exposed length of 4.2m and a width of 2.5m. Investigative slots excavated into the pit revealed it to have moderate sloping sides (base unexcavated), filled with a dark grey clayey-silt fill (511) containing occasional to moderate chalk gravel and charcoal inclusions. Two sherds of undiagnostic medieval pottery, a residual sherd of Roman pottery and fragments of animal bone were recovered from fill (511). The two investigative slots were excavated to a maximum depth of 16.8mAOD at a point where the water table was hindering further investigation, however, it was evident that the pit extended further in depth. Pit [512] probably represents a large domestic rubbish pit of a possible early medieval date.

*Plate 8. Pit [512] looking west*

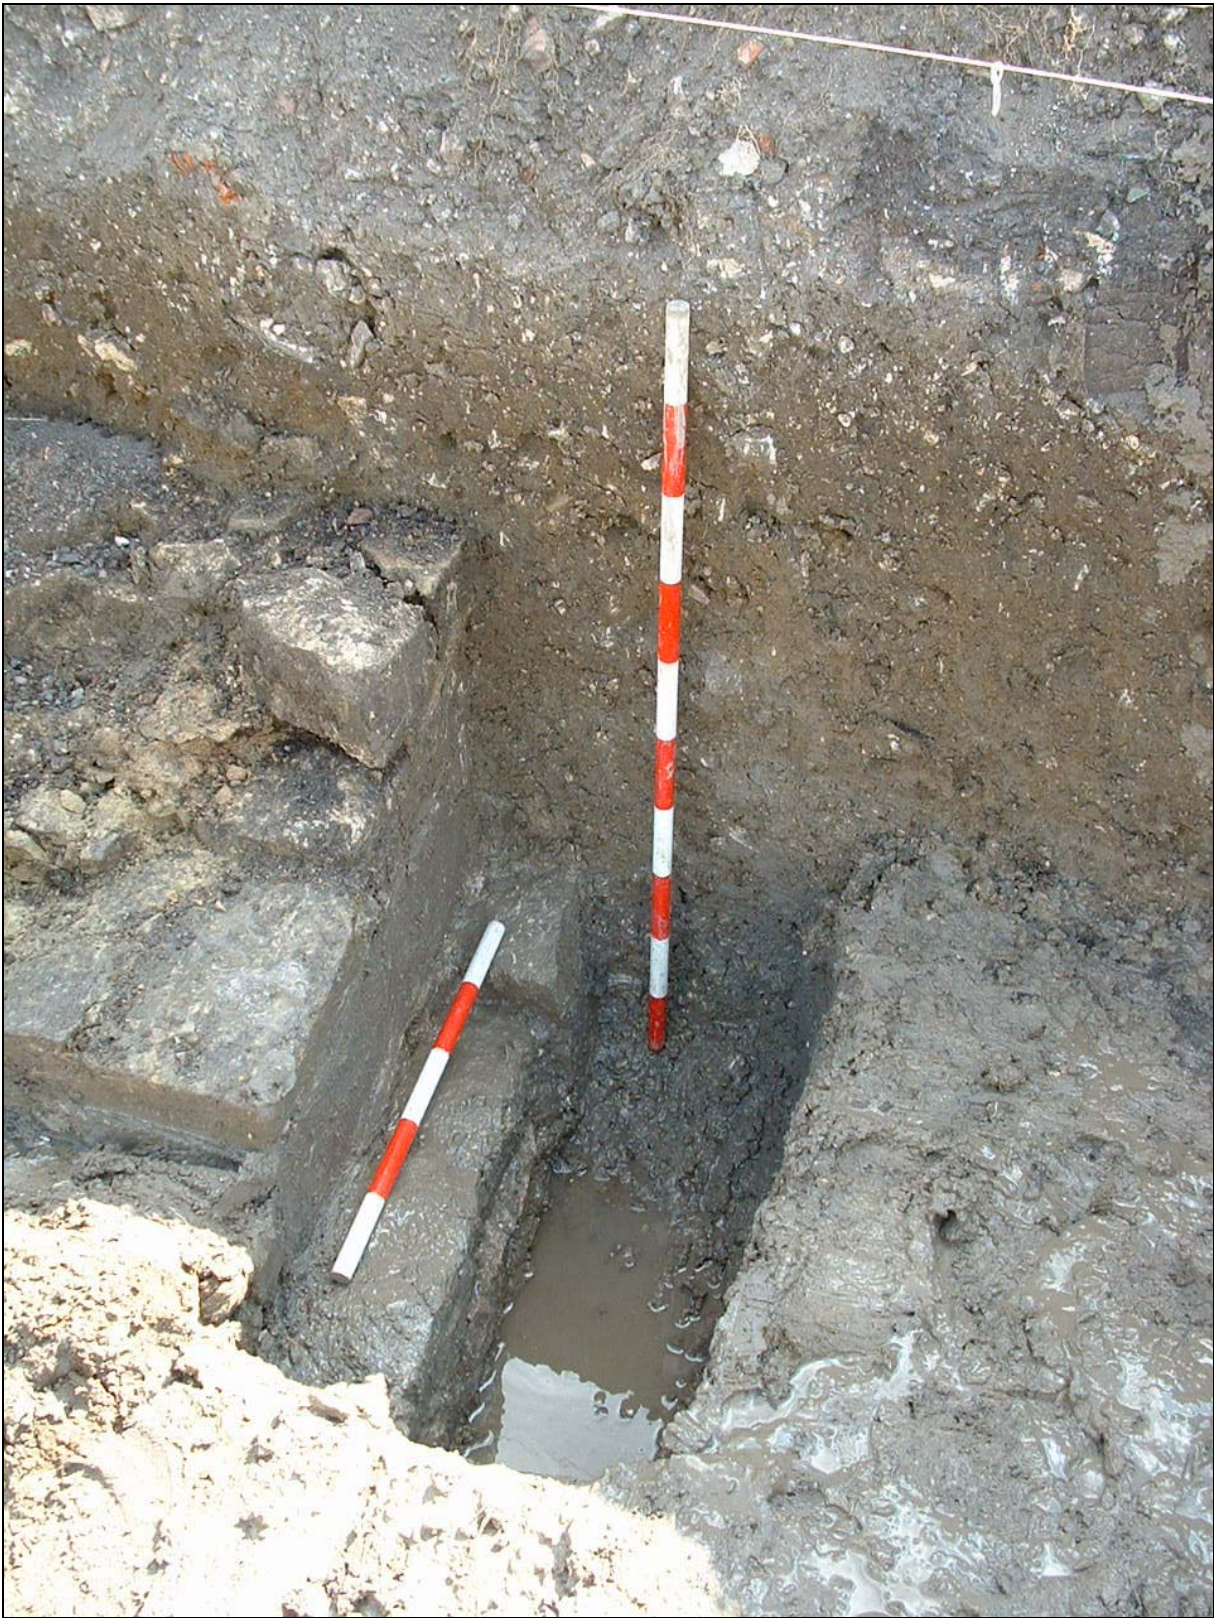
*Plate 9. Foundation course of wall (508) looking north-east*

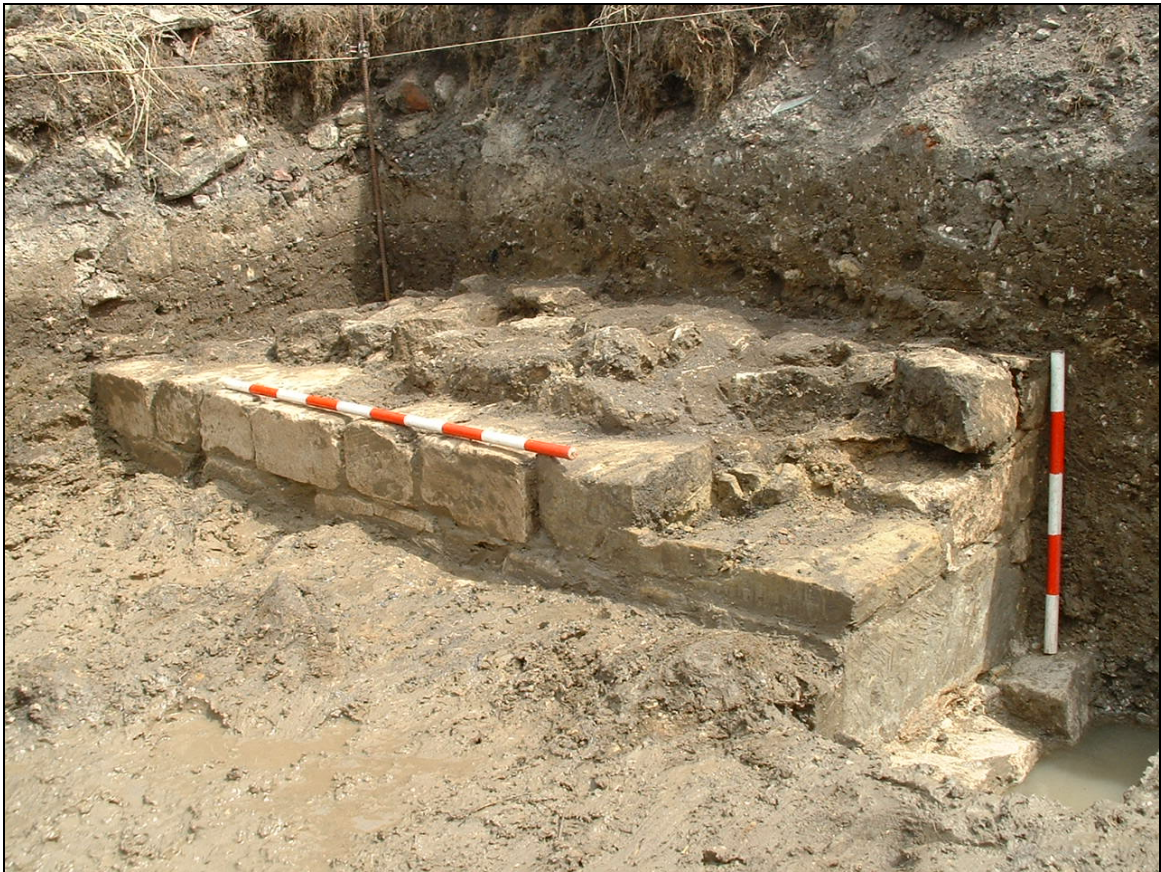
*Plate 10. Wall (508) looking north-east*

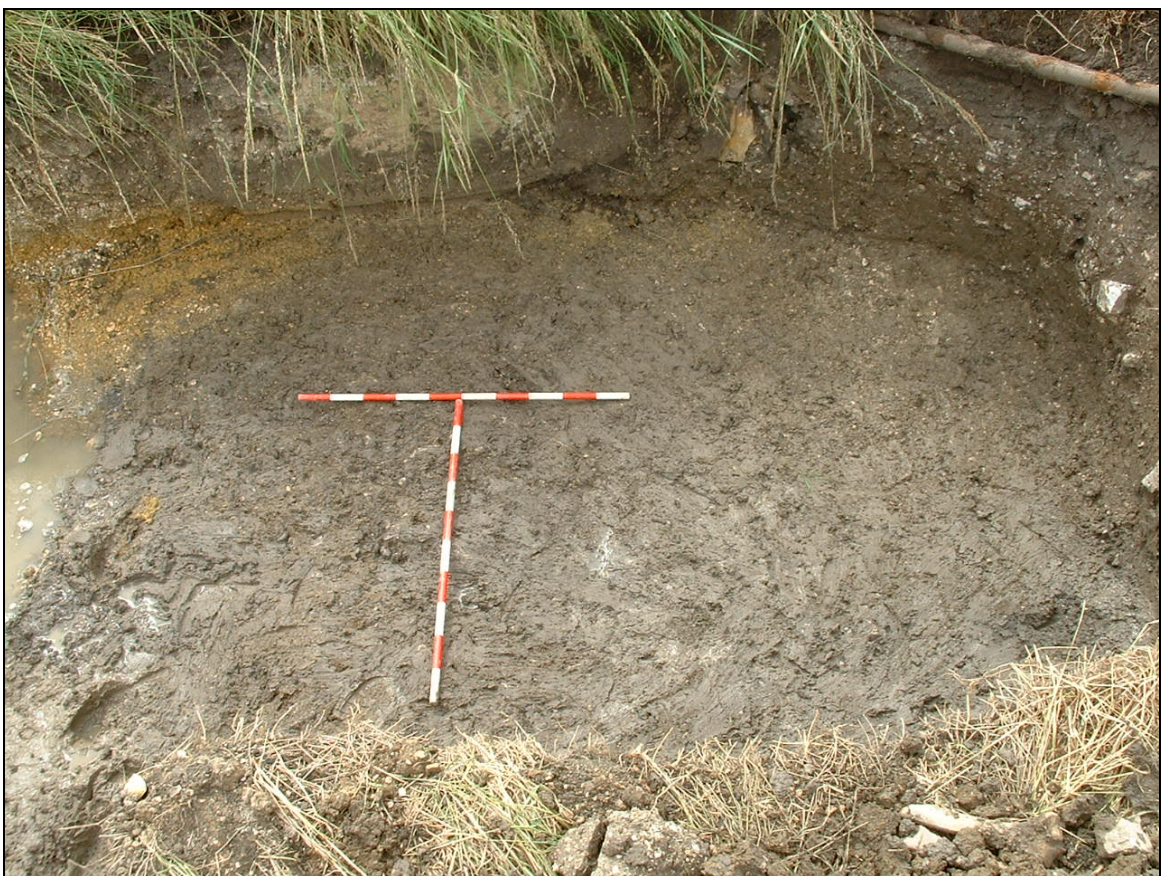
Cutting demolition layer (507) was a large pit [506] (Figures 9 & 11; Plate 11). The pit was detected within the northern half of the trench and extended beyond the trench limits to the north and east. The pit appeared to be sub-oval in plan with an exposed length of 4m and 2.7m in width. Investigative slots revealed the pit to have moderate sloping sides (base unexcavated), containing a fill (514) comprising of greenish-blue/grey silty-clay containing frequent chalk gravel and occasional charcoal inclusions. This was below an upper fill (505) consisting of dark grey clayey-silt containing moderate chalk gravel and occasional limestone fragments and charcoal inclusions (Figure 12). Pottery sherds were recovered from both fills (514) and (505) dated to the mid-13<sup>th</sup> to mid 14<sup>th</sup> century. Animal bone was also retrieved from both fills (514) and (505). Pit fill (514) extended further in depth beyond the excavated

*Plate 11. Pit [506] looking west*
