Skipton Flood Management Scheme
Skipton
North Yorkshire

Archaeological Watching Brief

Report No. 2160

**Skipton Flood Management Scheme,
Skipton,
North Yorkshire**

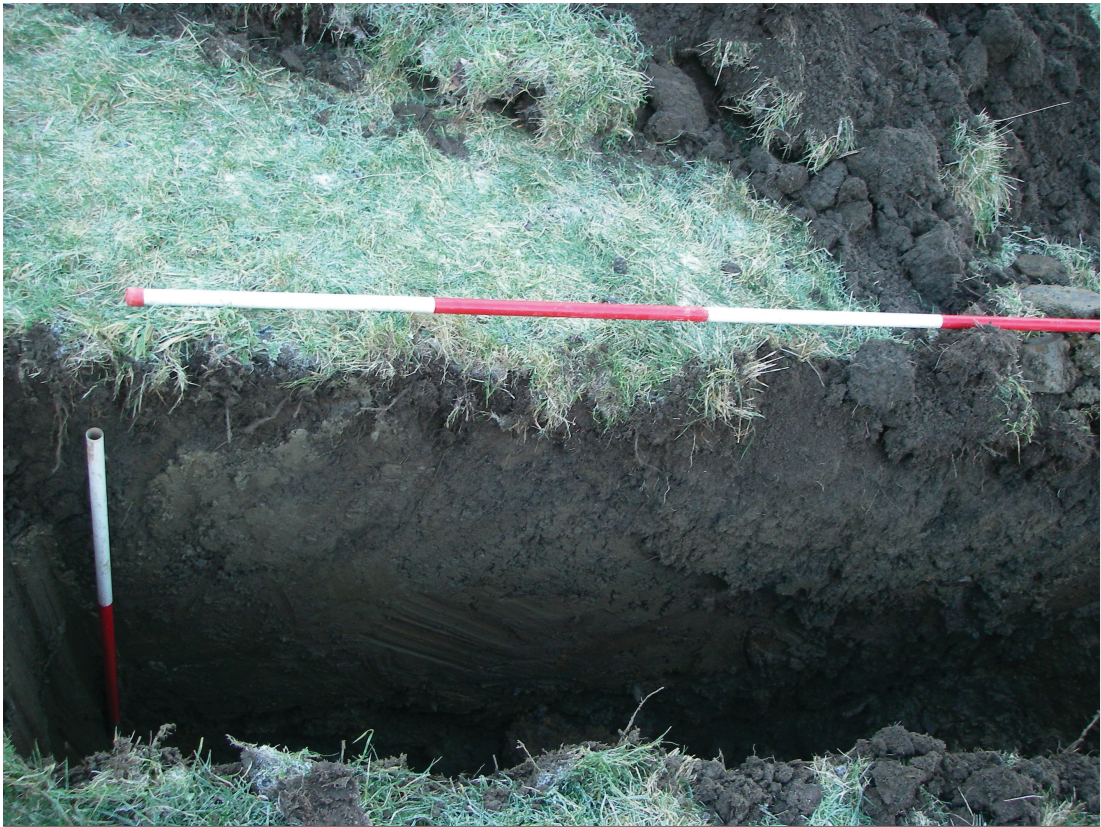
TP 1 was excavated to a maximum depth of approximately 2m at which point limestone bedrock was encountered and excavations stopped. Two distinct deposits were observed to overlie the bedrock within the confines of the test pit, both of a natural origin and devoid of archaeological material. The uppermost layer consisted of a dark brown silty clay extending to a depth of 0.7m and obviously deriving from the deposition of fluvial sediments (Plate 1). Beneath this was a medium brown clay deposit with variable inclusions of bedrock boulders, increasing in quantity and size with depth, probably indicative of a natural weathering and fragmentation of the bedrock.

Plate 1. The east facing section of Test Pit 1 after initial exposure of the upper natural layers, viewed facing west.

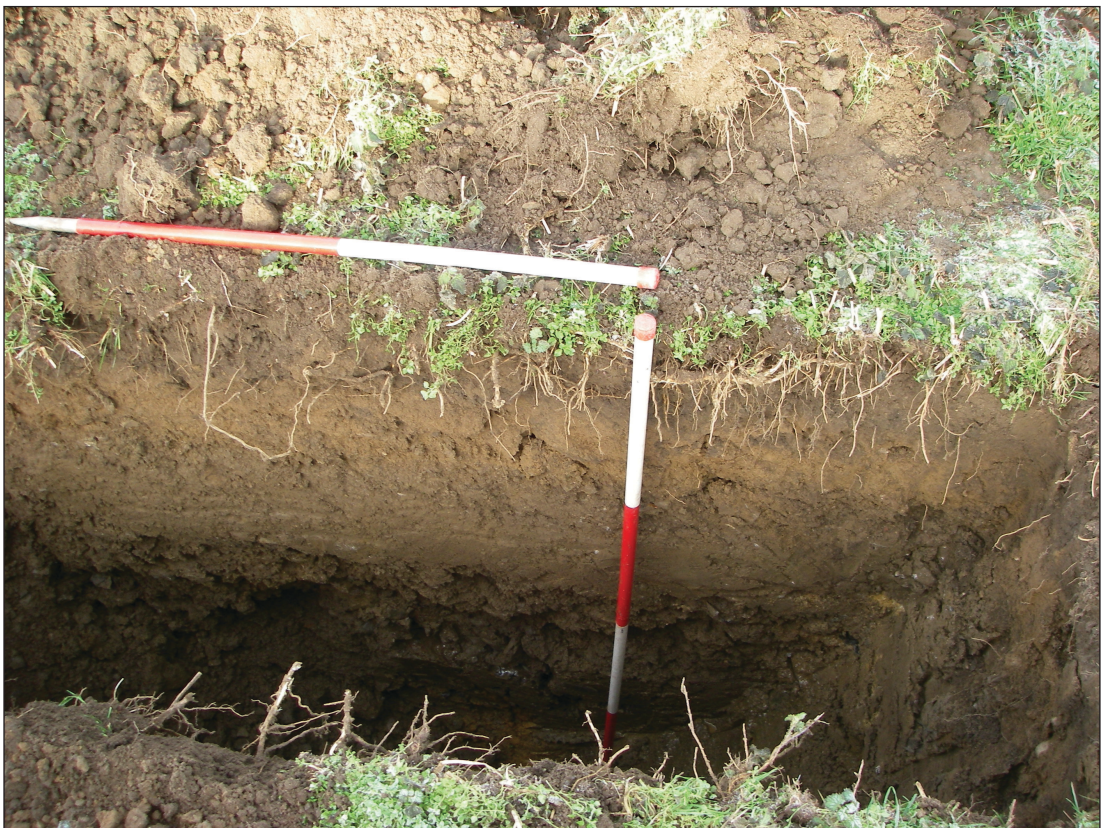
TP 5 extended to a maximum depth of 3.1m where excavations ceased, this being the maximum depth that could be reached by the machine. A slightly different stratigraphic sequence was recorded within this pit, with a dark brown silty clay topsoil deposit extending to a depth of 0.3m below the ground surface, overlying a sandy clay subsoil with clay bands extending to between approximately 0.9m and 1.1m. Below this the ground primarily

consisted of sandy gravel layers extending to a depth of approximately 2.4m (Plate 2) above a boulder clay layer extending to the limit of excavation. Again no archaeological deposits were observed.

Plate 2. The east facing section of Test Pit 5 after excavation to a depth of 2.4m, viewed facing west.
