Figure 6. Ground Plan of Church Farm,

Figure 7. Elevation of Church Farmhouse.

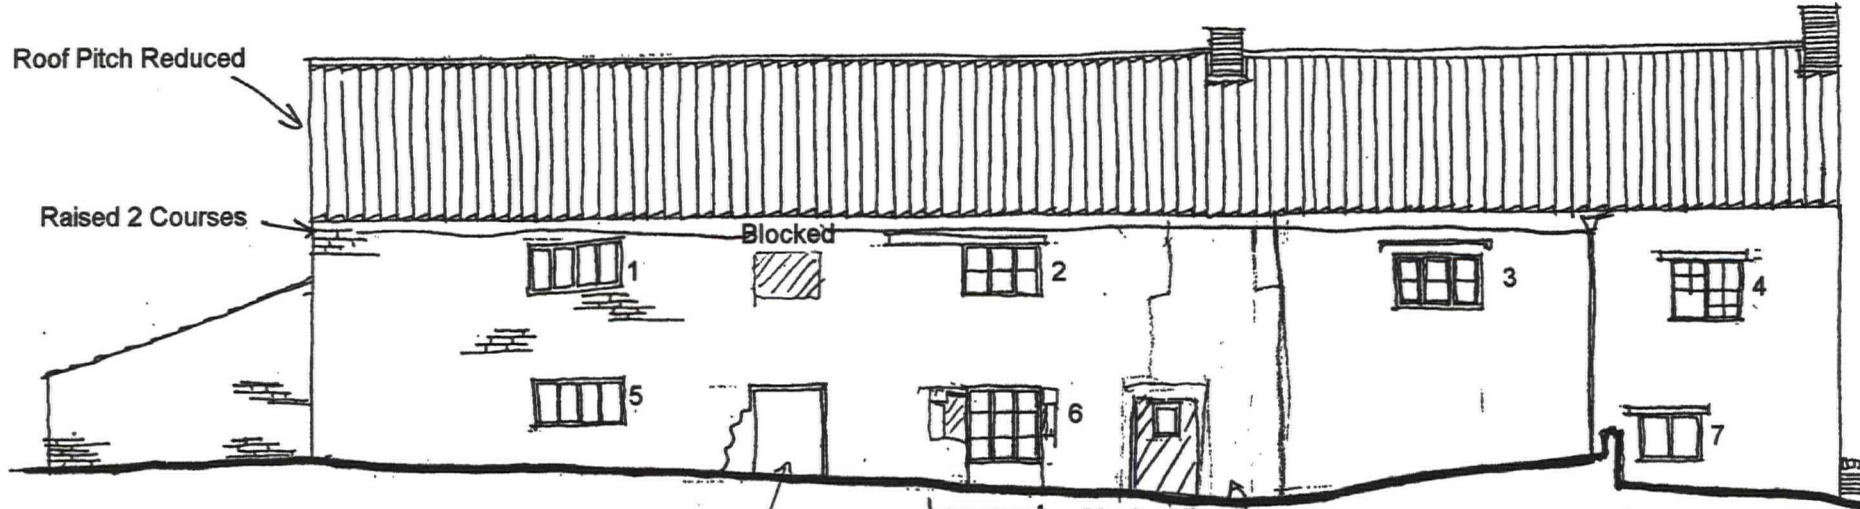
WEST ELEVATION.

Chimney in North Gable collapsed & rebuilt

1 to 2 Bays Added

4 Courses Added

Drip Mould with Stop/ String Course respects Fire Place

Butt Joint

EAST ELEVATION.

Blocked Doorway

Rebate (Build Scar)  
2nd Storey Only
