OCT 2002
NYE 888
NYS 482

Overview of Archaeological Deposits at 11 - 13 Wheelgate, Malton, North. Yorks

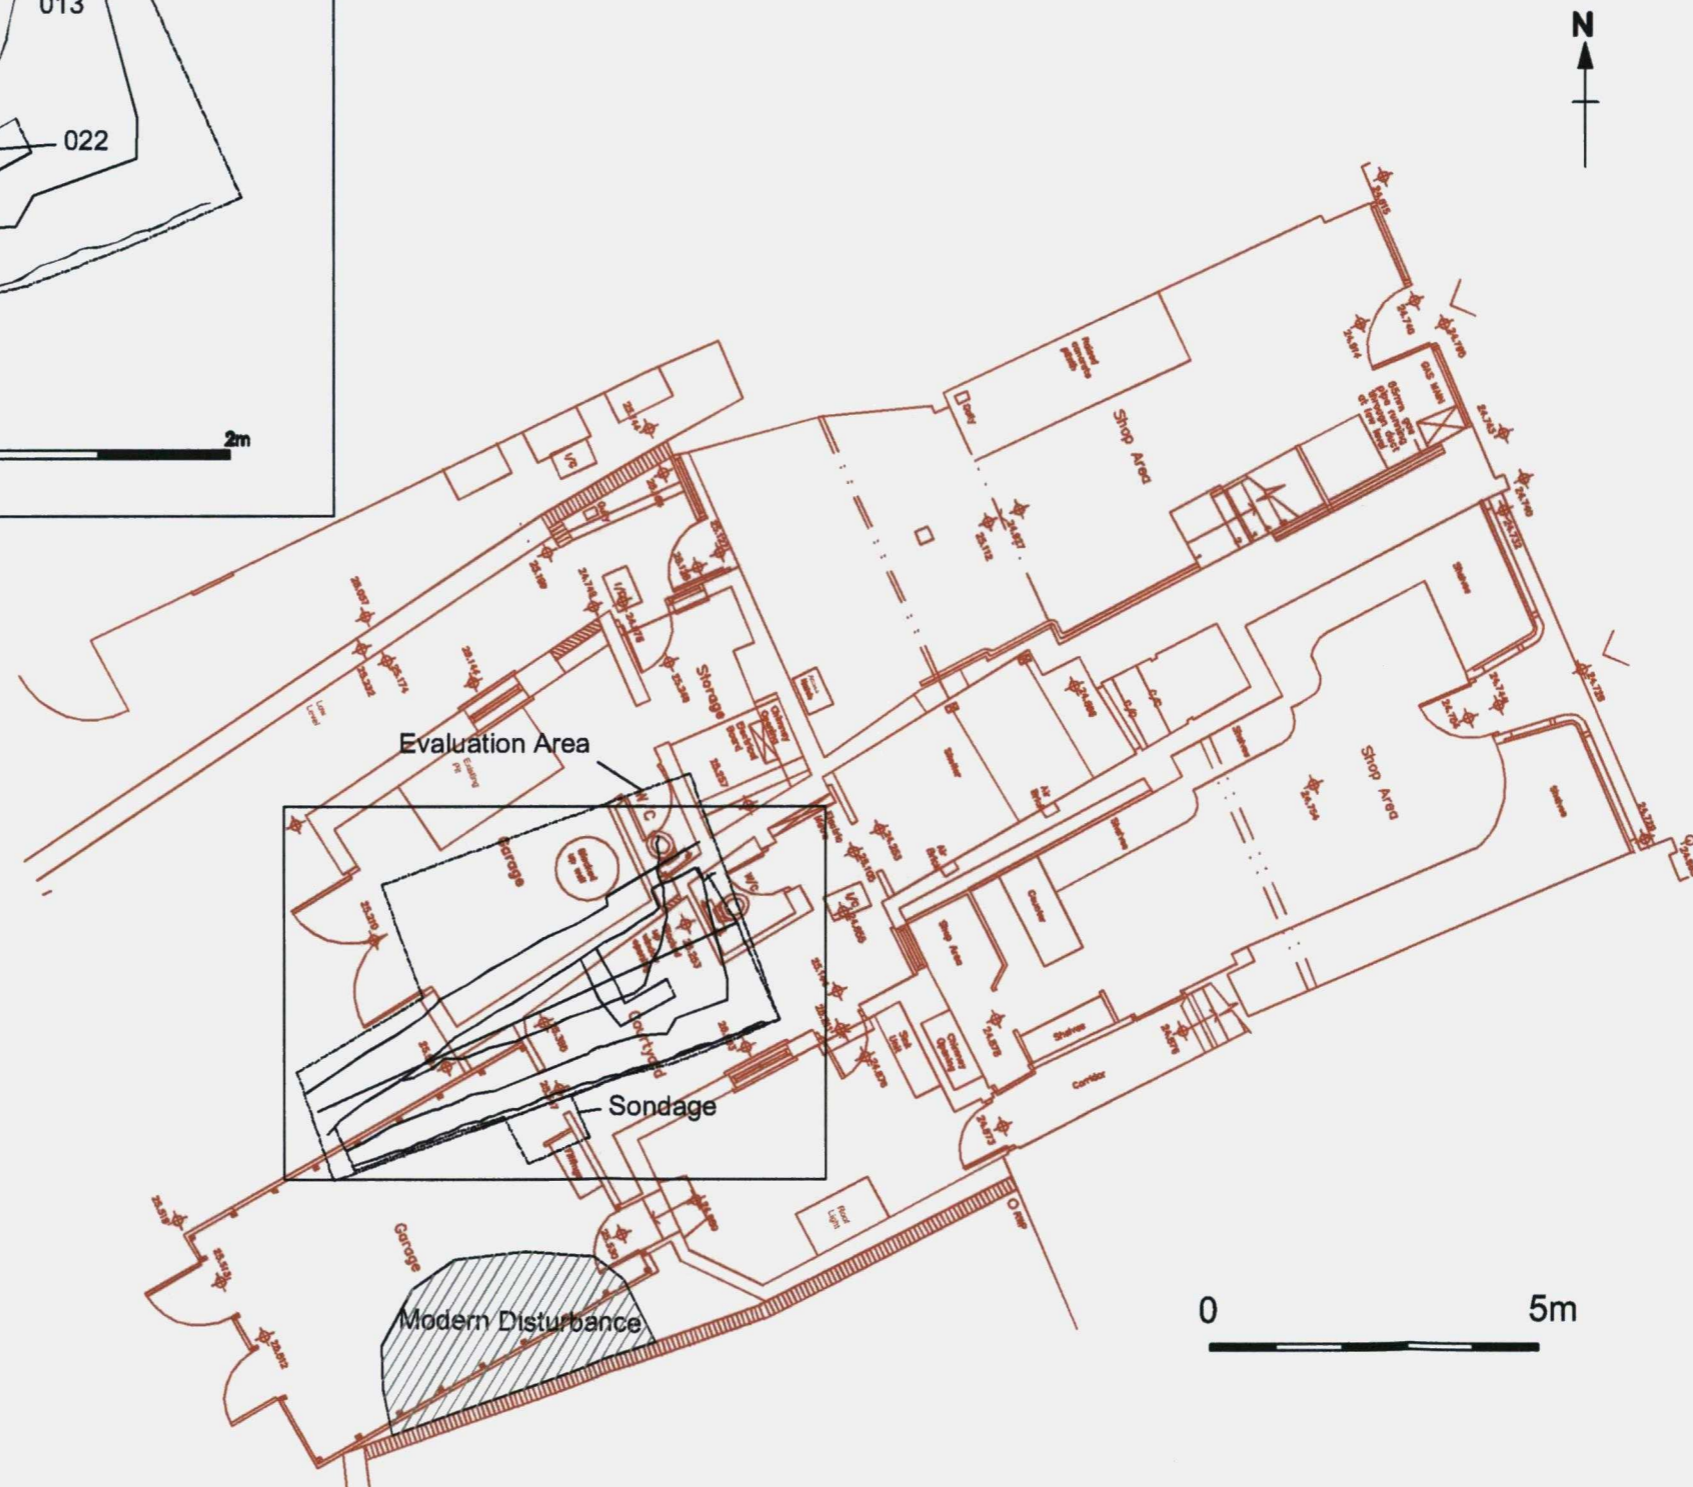
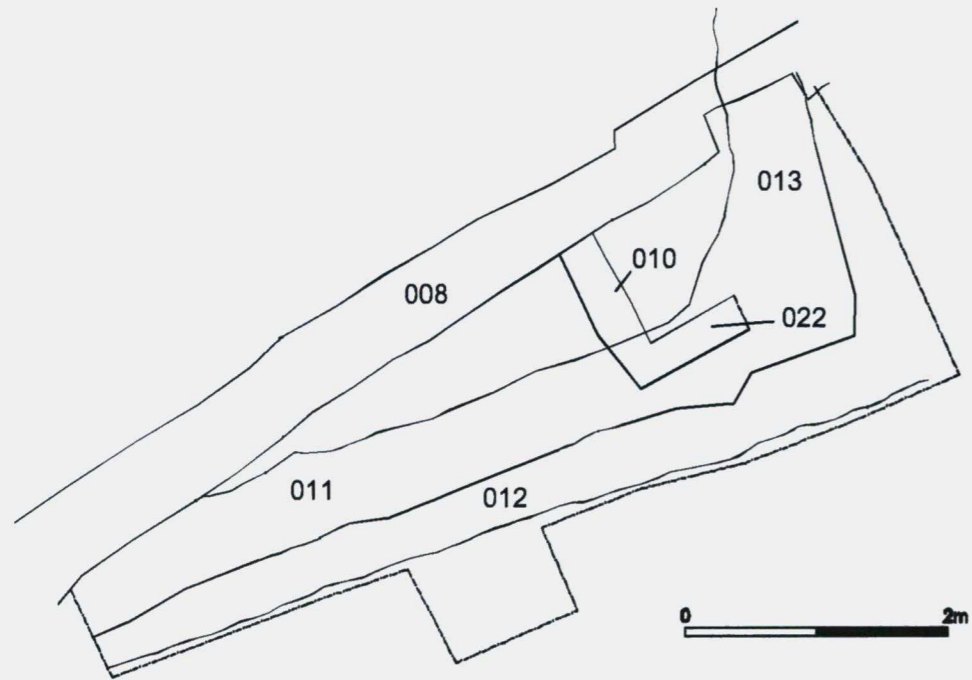
Figure 1. Evaluation area plotted over existing layout

Following the removal by a demolition contractor of concrete floors and hard standings in the area to the rear of 11 - 13 Wheelgate, Malton a sequence of archaeological deposits was excavated in an irregular area chosen to maximize the understanding of the sequence and its relationship with the proposed development of the site (Fig. 1)

The earliest feature in the sequence of deposits encountered at Wheelgate was a substantial limestone wall (012) consisting of at least seven courses and standing to a height of 0.56m (A O D). The limestone blocks were irregularly sized but the face was vertical and the whole structure was of high quality. The upper fill (027) of a construction trench was encountered at the base of a small sondage (Fig. 1) excavated against this wall. A deposit of homogeneous fine silt (026), probably cultivated soil had built up against the southern face of the limestone wall suggesting that this was the exterior face. A medieval date for the material is suggested by the few finds that were recovered from this deposit. On the northern side of the wall a deposit of clay containing frequent, well sorted, inclusions of limestone appeared to be ground make-up (024). A feature or void under this deposit has caused the structure of the wall above to subside into a hollow caused by the settling of the leveling material into the void.

Above the uppermost course of limestone, at a level of 24.6m-24.8m A O D a second phase of walling or a later structure (011) had been constructed on the same alignment utilizing the lower wall as a foundation. The construction technique used in this element consisted of a rough sandstone block course on the southern side and a face of narrow coursed limestone blocks on the north side, the space between these faces was infilled with compact yellow brown clay forming the matrix of irregular blocks of limestone. It is possible the southern side was an eroded chamfer course again suggesting an exterior face. The uppermost surviving element of this structure consisted of the truncated remnants of a second wall face suggesting that above the chamfer the wall narrowed to half the width of the base. A curvilinear limestone structure (013) consisting of mixed single and double courses and integrated with 011 turned away to the north where it was eventually truncated by the rubble sub-floor of a later modern structure.

Inset Archaeological features

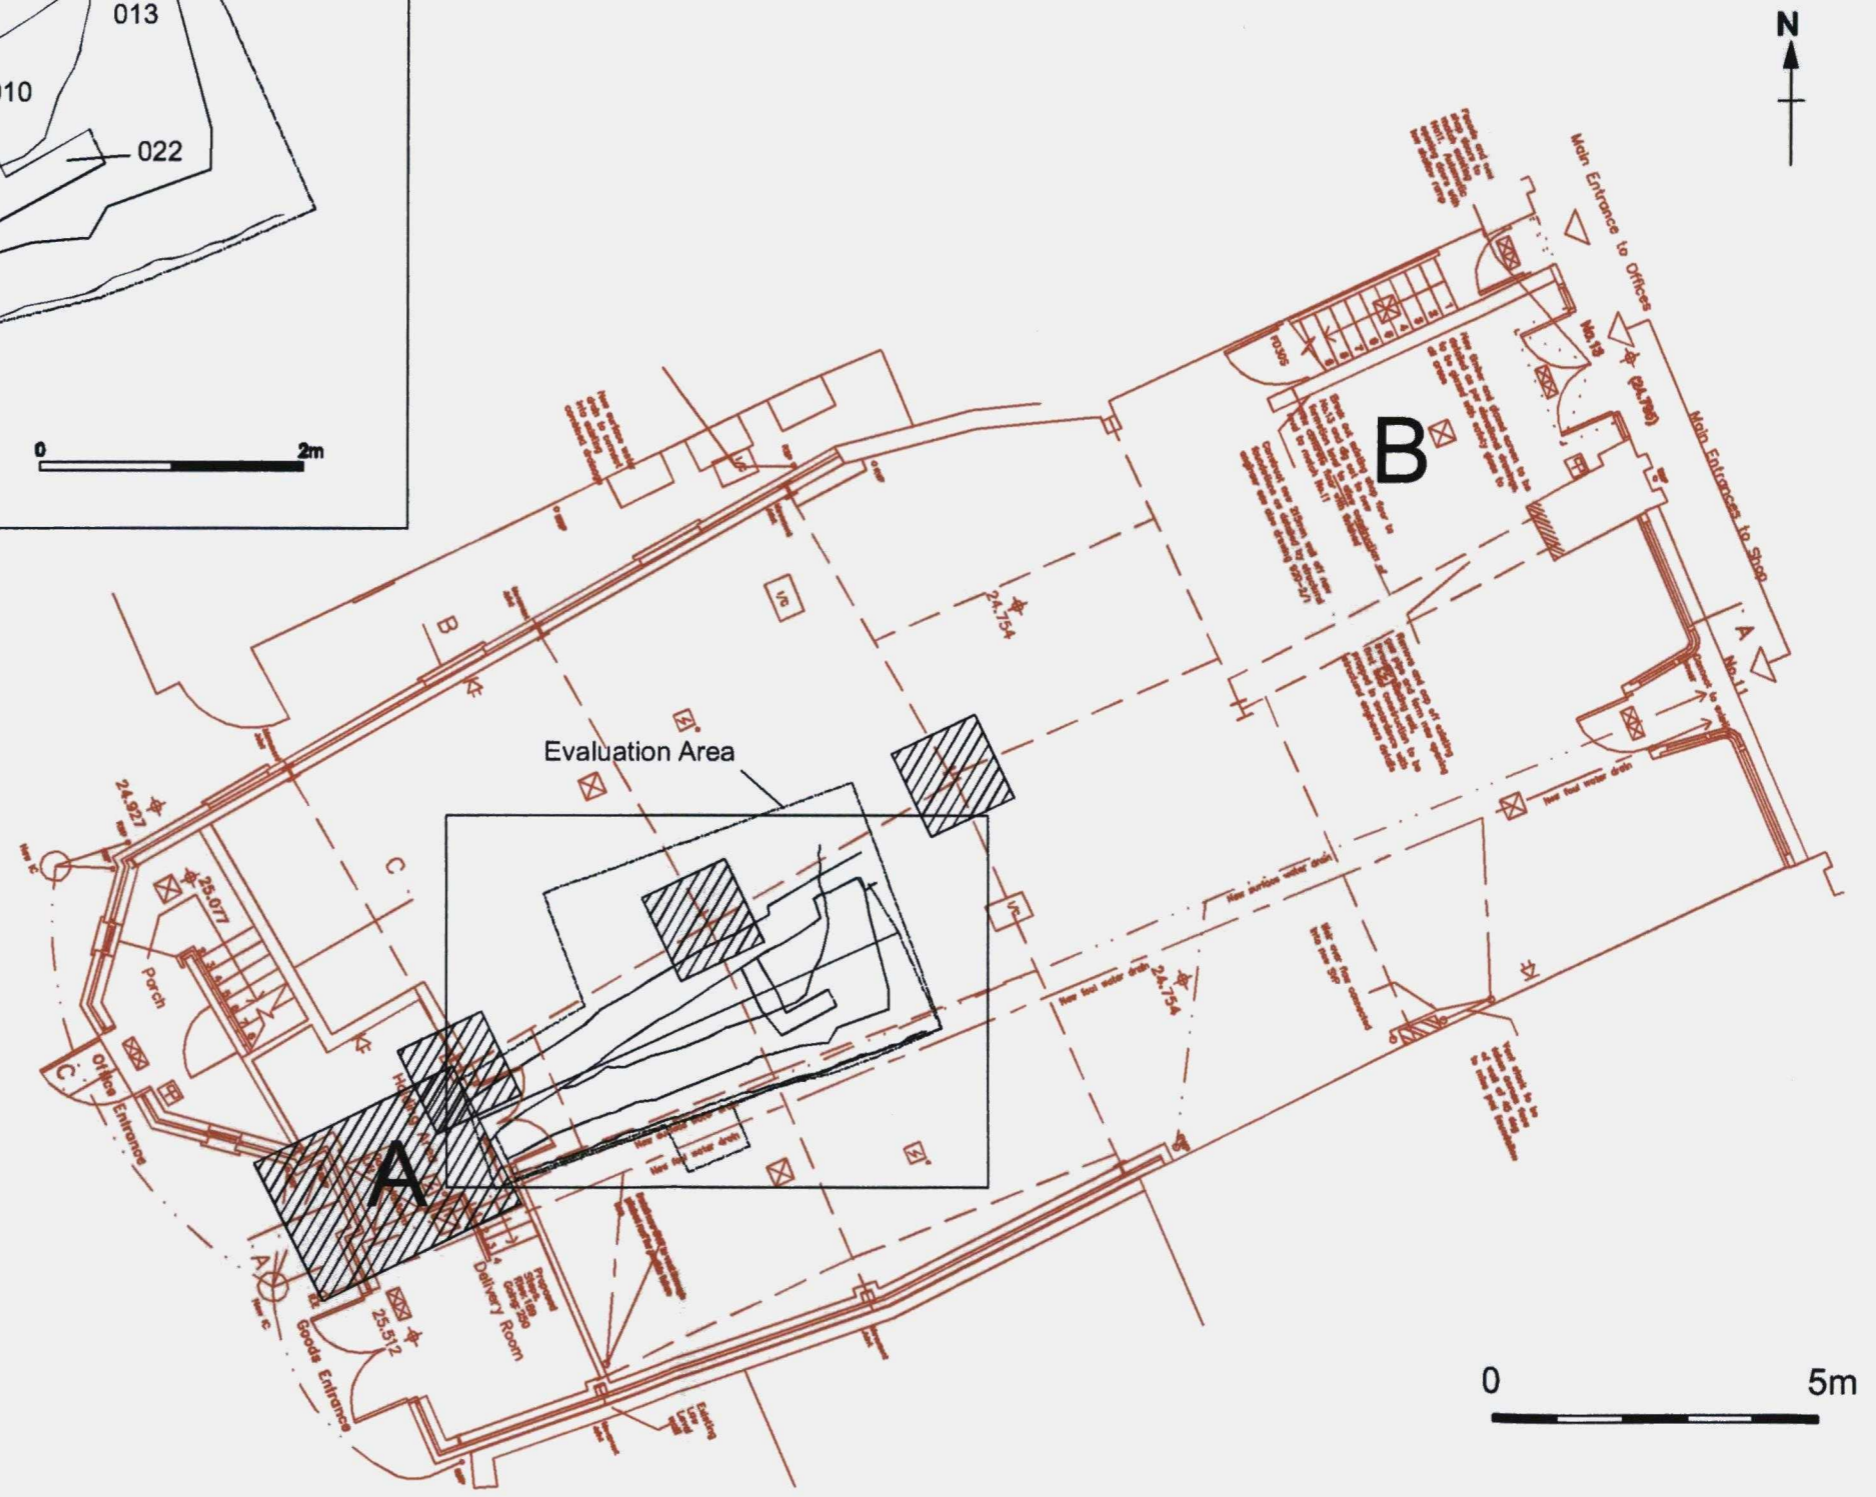
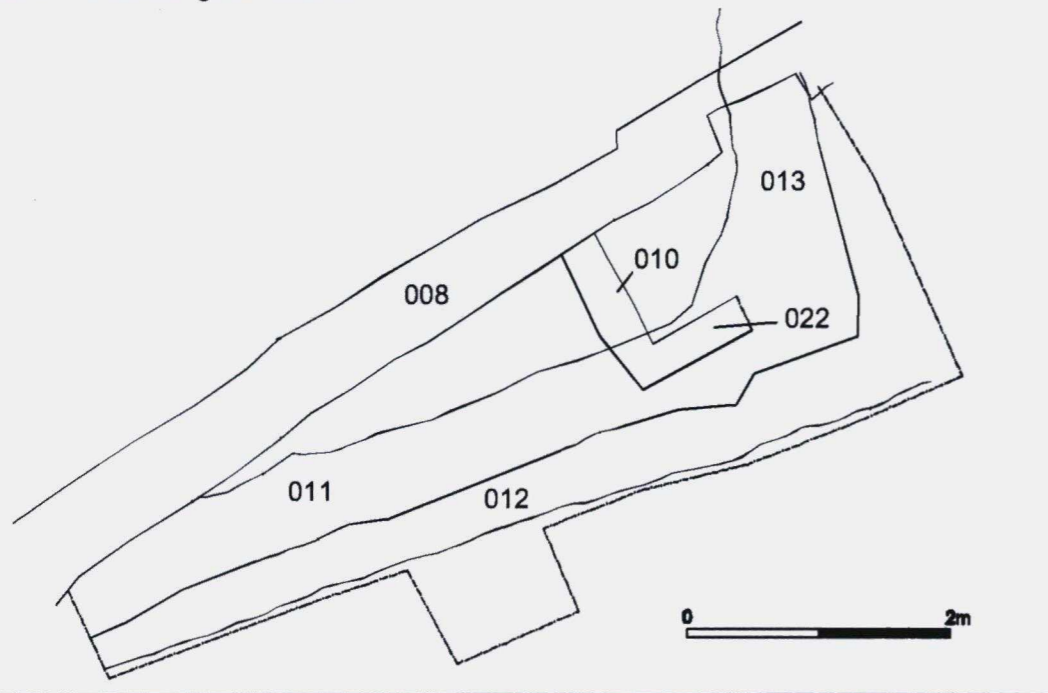
Figure 2. Evaluation area plotted over proposed layout

The construction of a floor slab for the new structure on the western side of the properties requires the reduction of the area to a level of 24 354m A O D In addition the original proposal requires the excavation of a series of pads to support the steelwork of the structure (Fig. 2, central pads hatched) The pad dimensions proposed are 1 4m square (half size, 1 4m by 0 7m, along the edges) The base of the pads would extend to a depth of 24 004m A O D In addition 0 45m wide strip footmgs would also be excavated around the perimeter of the structure to the same depth as the pads

Within No 13 Wheelgate the existing concrete floor is to be broken out and the level reduced to a new formation depth to match the existing floor level of No 11 (Fig. 2, B) In addition pads for two internal steel columns will be excavated within the building, these will be of identical dimensions to those in the new building and will be excavated to the same depth (24 004m A O D)

- Within the development area the two intersecting walls extend beyond the evaluation area into the car park (Fig. 2, A) At this point the structures are under threat from the excavation of footings for the new building As this area represents the limit of investigation of these structures within the present development and the point at which any return or structural features might be preserved this represents the most significant threat to the preservation of the archaeological features within the development As a design solution would be difficult an extension of the evaluation excavation to fully record and reduce the walls in the same way as was proposed for the original evaluation area would seem to be the most appropriate strategy

- The proposed pads for the steelwork of the new building would extend 0 6m below the level reached in the evaluation excavations The central pad of the row in the middle of the building is of particular concern, as it would require excavation below the evaluation depth into known archaeological deposits, possibly internal to the major building A design solution has been proposed to replace the external pads with

Inset Archaeological features

a pile, requiring a smaller and shallower pile cap minimizing the intrusion into the archaeology. Design details of this solution are not available at this moment.
