ARCHAEOLOGICAL WATCHING BRIEF

CHAPEL STREET / HIGH STREET,

TADCASTER

ARCHAEOLOGICAL WATCHING BRIEF AT CHAPEL ST/HIGH ST, TADCASTER

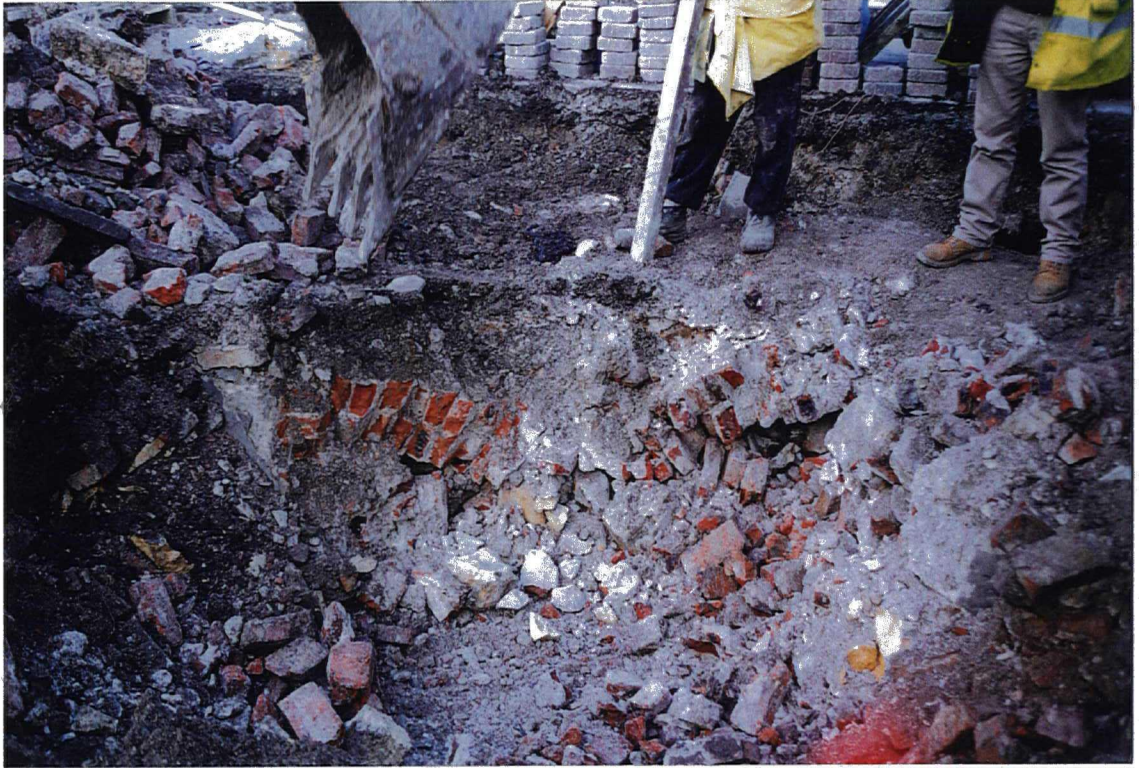
PLATE 1 Brick vaulting and remains of cross wall (looking north)

In the central part of the site the hole for the tree was machine excavated. The rubble spread proved to be overlying and partly filling a cellar area. This extended from 3.6 metres north-west of the footpath, up to and probably beyond the northern edge of the site. Two parallel walls ran, 1.75 metres apart, from the eastern edge of the site (Plate 2). The southern wall appeared to define the southern end of the cellar and was made of substantial dressed limestone blocks. The northern wall, also of limestone blocks, was narrower. To the north of this wall brick vaulting was visible forming two arches that appeared to continue to the northern edge of the site (Plate 1). The cellar floor was not reached.

The excavations proved that the area of the site had been formerly occupied by a cellared building. It is not known when the building was demolished, but the variety of building materials, including bricks of different ages, indicates a structure of some antiquity, possibly eighteenth century.

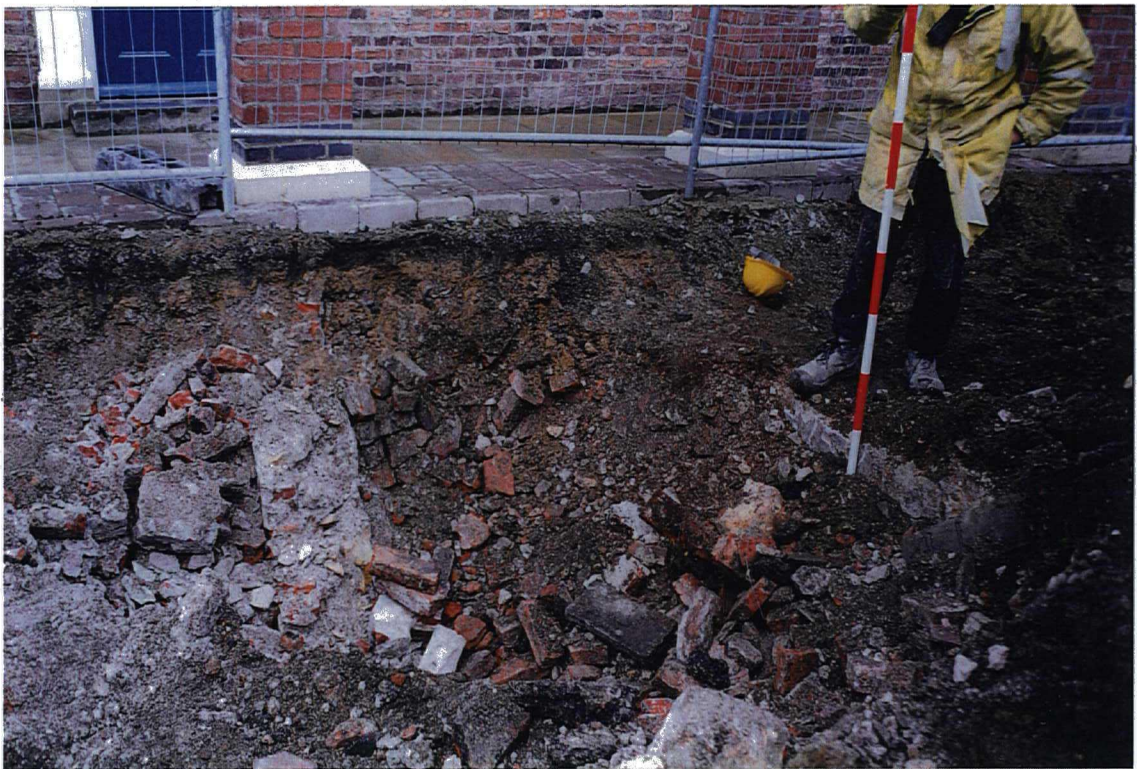
Plate 2 Remains of cellar walls crossing site (looking SE)
