ARCHAEOLOGICAL WATCHING BRIEF

233, HIGH STREET,

NORTHALLERTON

ALISON CLARKE

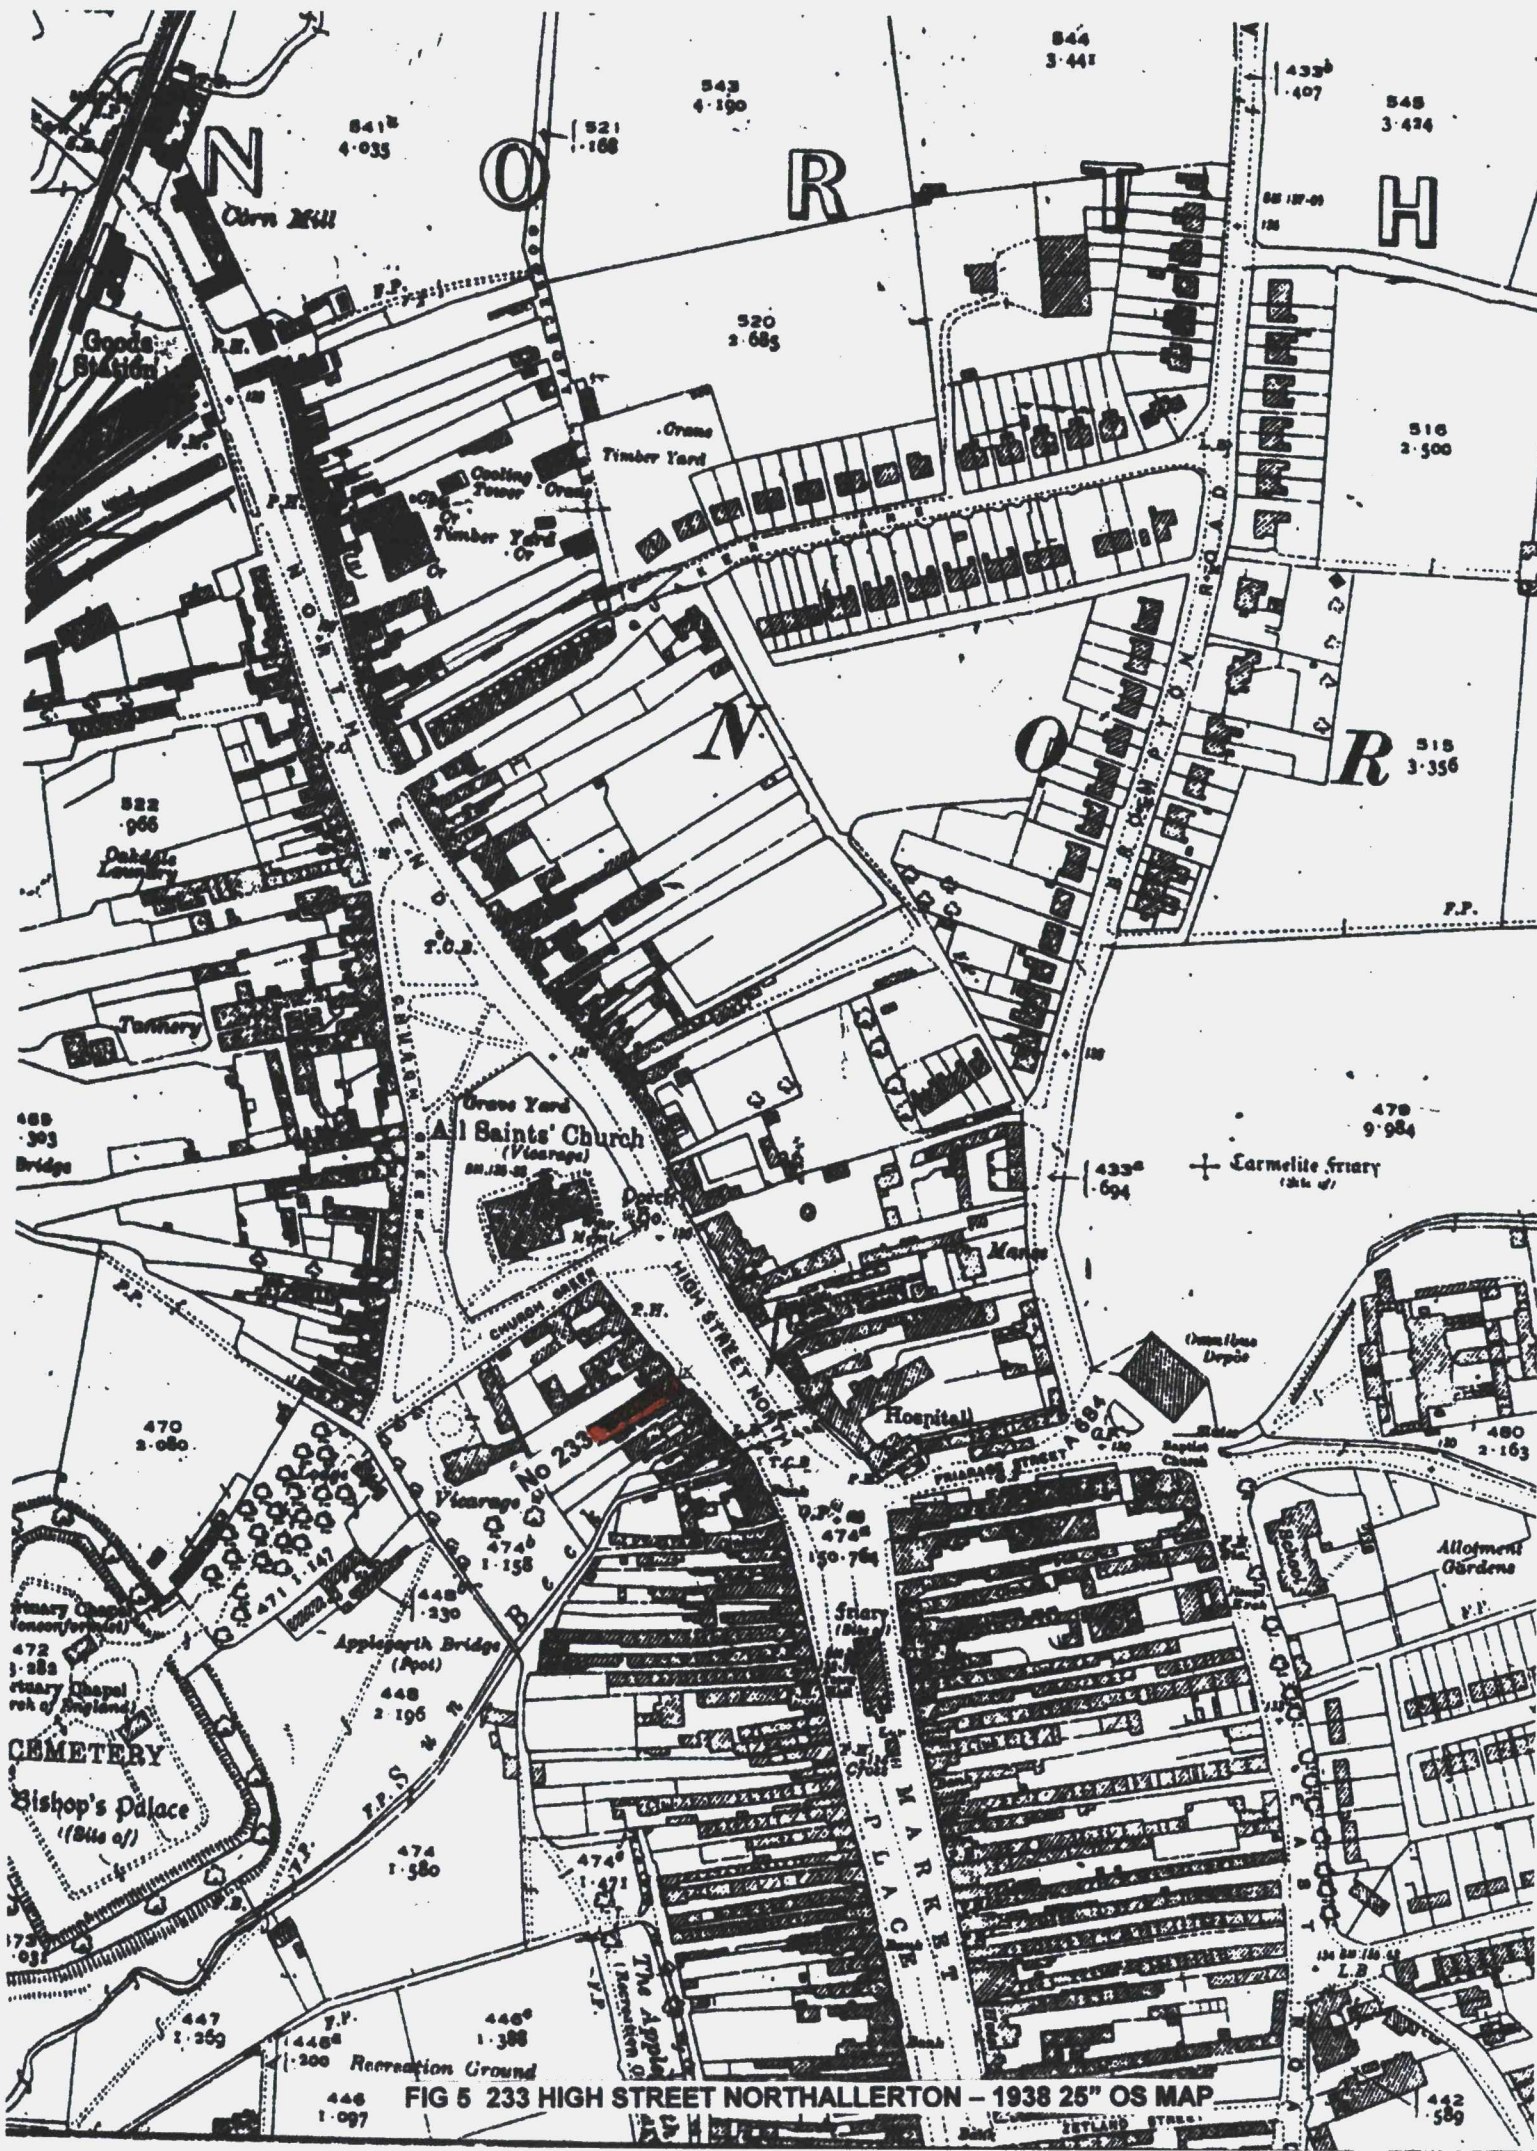
FIG 5 233 HIGH STREET NORTHALLERTON - 1938 25" OS MAP

A sequence of use may therefore be outlined. There has been low-level use of the site from the medieval period onwards. Buildings occupied the eastern end of the plot from at least the 18th century, with the rest of the plot used as a garden. At some point between 1842 and 1938 the layout of the buildings was altered, and extended westwards along the northern side of the plot. The cobble wall dates from this period, though parts of it might be earlier. The westernmost part of the buildings was subsequently demolished and the whole open portion of the plot concreted.
